# Framework for the Treatment of Character Defining Features for the Reactivation of the Hollywood Theater

CPED Staff Presentation to the  
Heritage Preservation Commission  
March 10, 2009

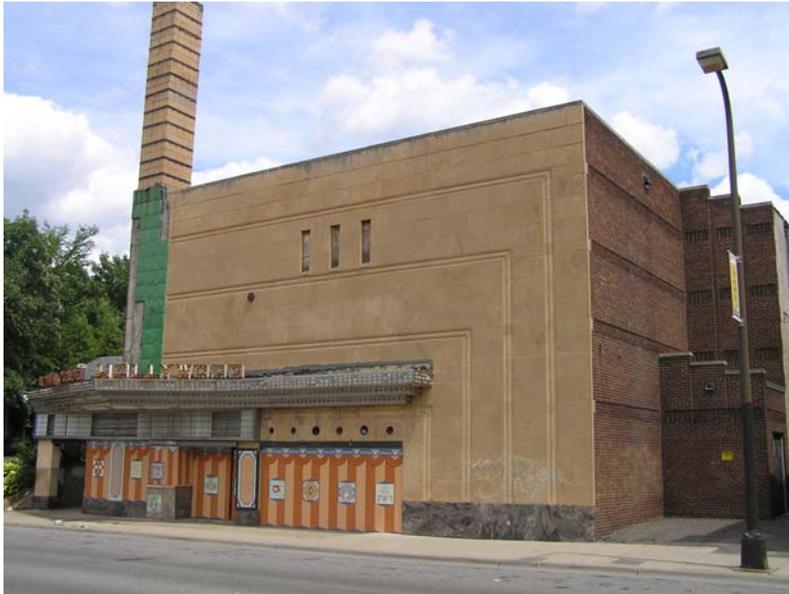
# Materials

The front façade is wrapped in Kasota stone with a granite base. The sides and rear are common brick with brick details in toward the front of the sides of the structure. The stone around the chimney is reinforced with steel banding, which is not original.

The materials shall be rehabilitated and repaired as needed. New or enlarged openings in the front façade shall be prohibited.

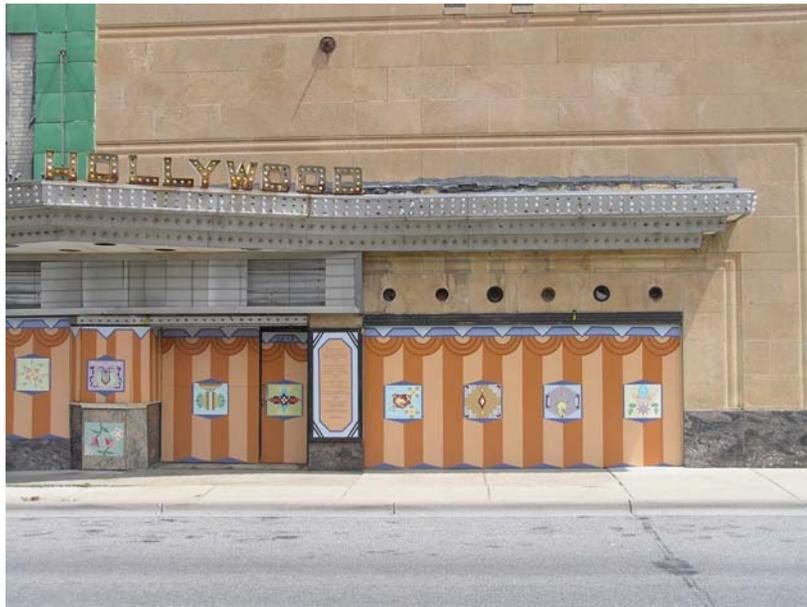
# [ Ticket Booth ]

The ticket booth is a character defining feature of the Hollywood as it depicts the significance of the structure as a theater. The original materials for the ticket booth appear to be missing. It is currently plywood and other structural materials.

The ticket booth shall be reconstructed.

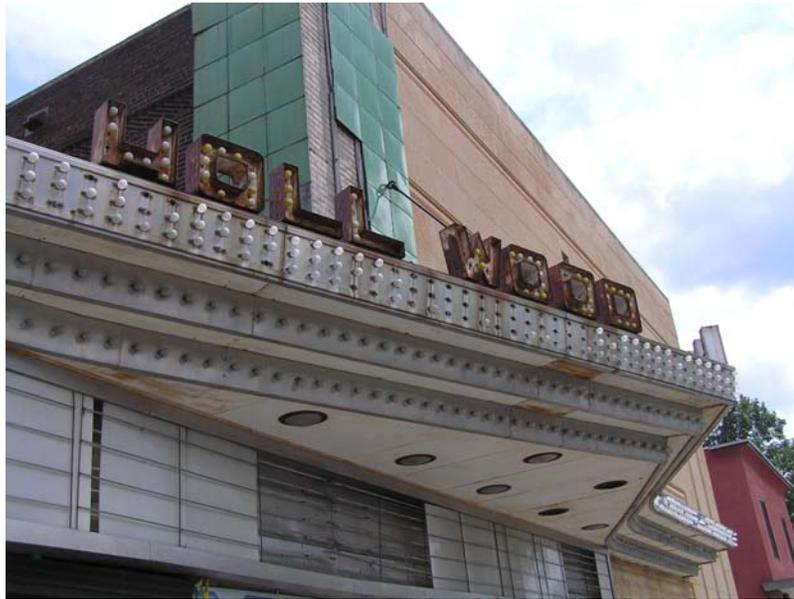
# [ Marquee, Canopy, & Sign ]

The current canopy, sign and marquee are not original; however they were designed by Liebenberg and Kaplan, the original architects, and installed in 1948. While they are not original they are historically significant features that warrant preservation and shall be rehabilitated.

While they are not original they are historically significant features that warrant preservation and shall be rehabilitated.

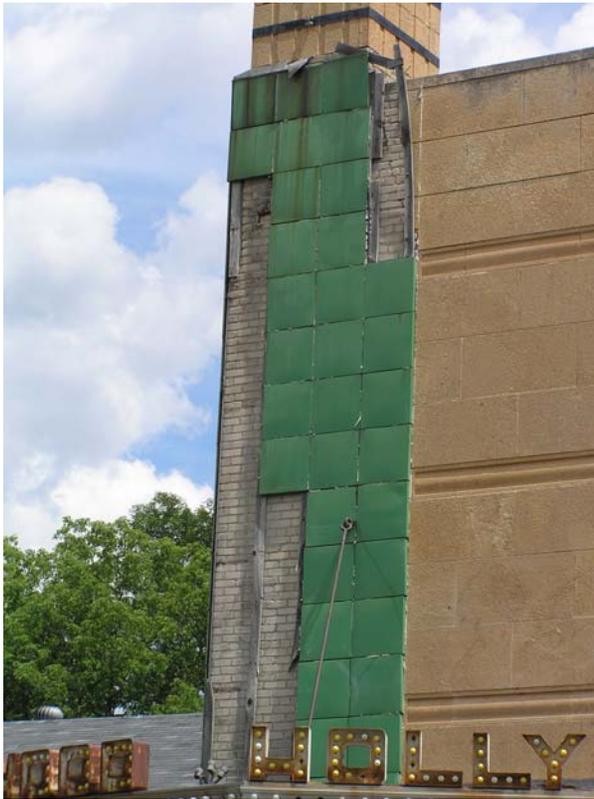
# [ Green Tile ]

The green tile system was added in 1948 when the original sign and marquee were removed. The green tile above the canopy has been removed to protect the structure from damage caused by falling tile due to the failure of the system used to fasten the tile to the building.

The green tile may not be original, but it is historically significant and warrants preservation. Green tile system shall be reinstalled with rehabilitated tile or replacement tile.

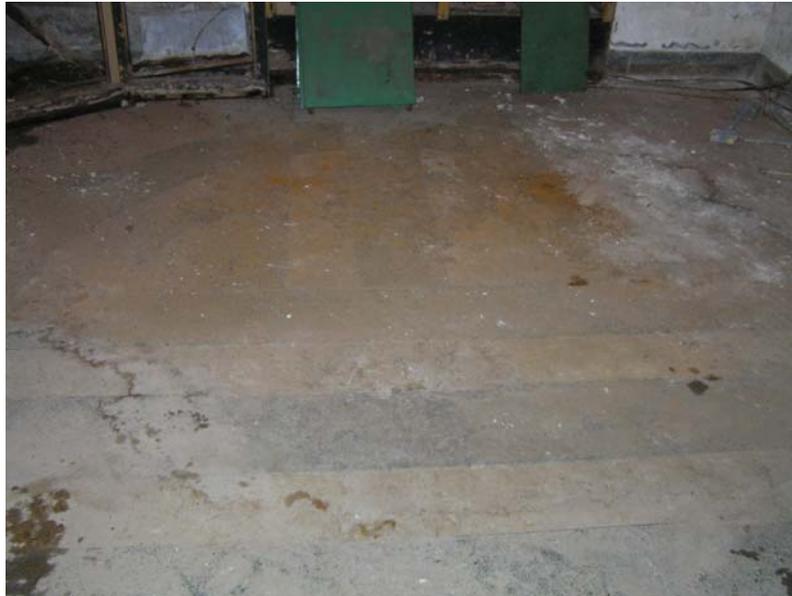
# [ Terrazzo Floor ]

The multicolored terrazzo floor inlaid in grey, yellow, black and pink is covered in dust and dirt.

All efforts shall be made to rehabilitate the floor. It may be covered up if proven necessary, that it is reversible, and that it won't damage the floor. See below for further guidance.

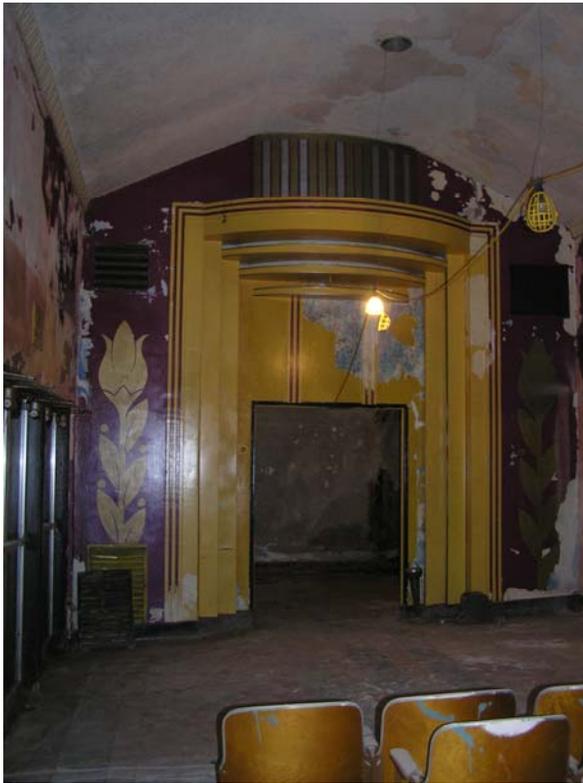
# [ Volume of Space ]

The entrance vestibule and main lobby have a unique feeling which is created by the height of the ceiling and the scale of the features contained in these spaces

This volume of space is important to convey in future reuse of the structure. The volume of space shall be maintained and dropped ceilings shall be avoided.

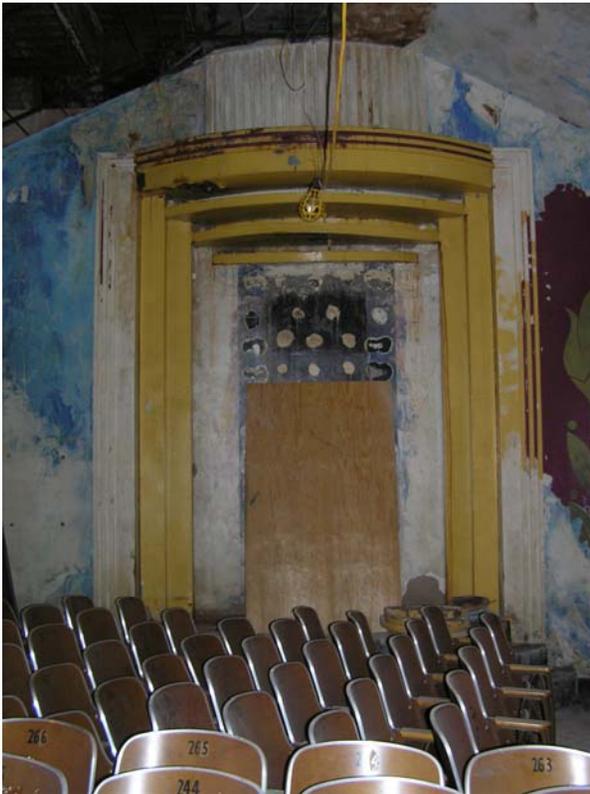
# [ Alcove Features ]

Symmetrically designed architectural alcove features flank the north and south walls of the main lobby. The northern feature contains the entrance to the main lobby from the entrance vestibule. The south feature contained an engraved mirror and water fountain; both of which are gone.

The features do not have to be reconstructed to original levels including the mirror and fountain details. The features shall not be enclosed and shall be maintained and repaired as necessary. The plaster fluting above the feature shall also be maintained and repaired as necessary. The features can be painted as desired

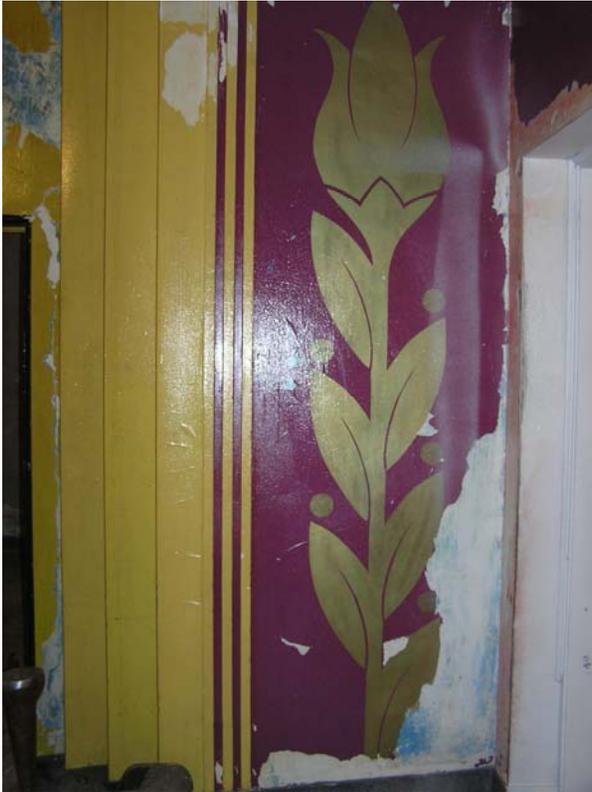
# [ Tulip Detail ]

Flanking the north and south wall alcove features are stenciled tulip details. Analysis of the pictorial evidence suggests that the current tulip is not the same as the original tulip.

These features could be are not required to be preserved or maintained.

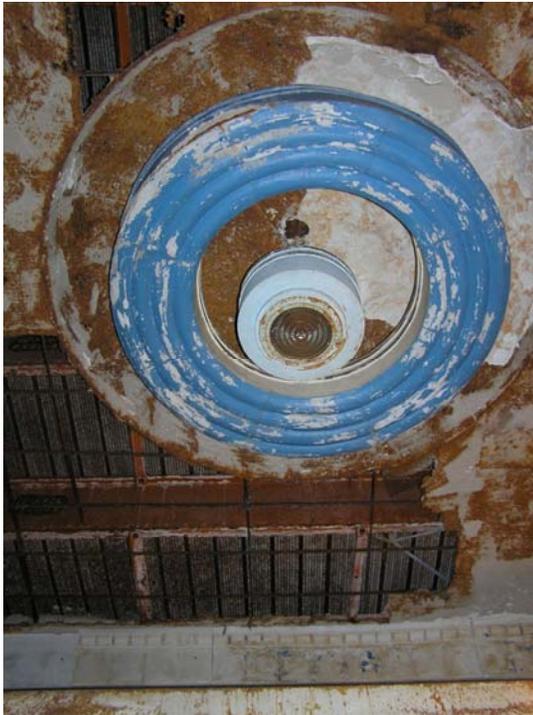
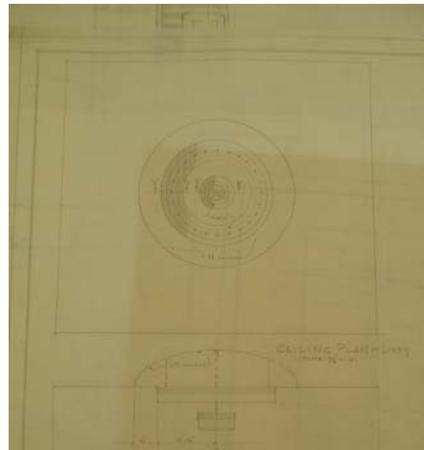
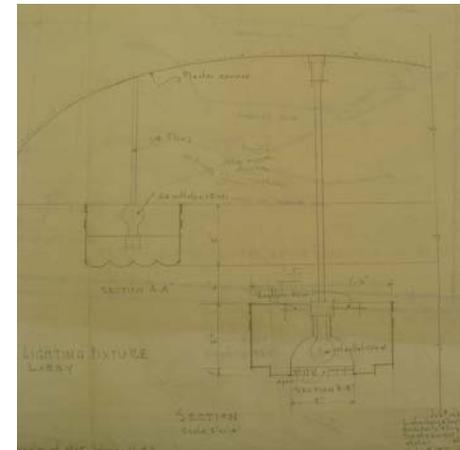
# Circular Ceiling Light in Entrance Vestibule

An elaborate circular light feature sits above the entrance vestibule. The feature, shown below in the original drawings by the architect, consists of a circular feature with indirect light that shines onto a concaved plaster ceiling. In the center of the circle a light fixture provides direct light. The portions of this feature are intact.

The design of the light is important as it is indicative of the streamline moderne design of the Hollywood Theater. Efforts shall be made to rehabilitate the fixture and plaster.

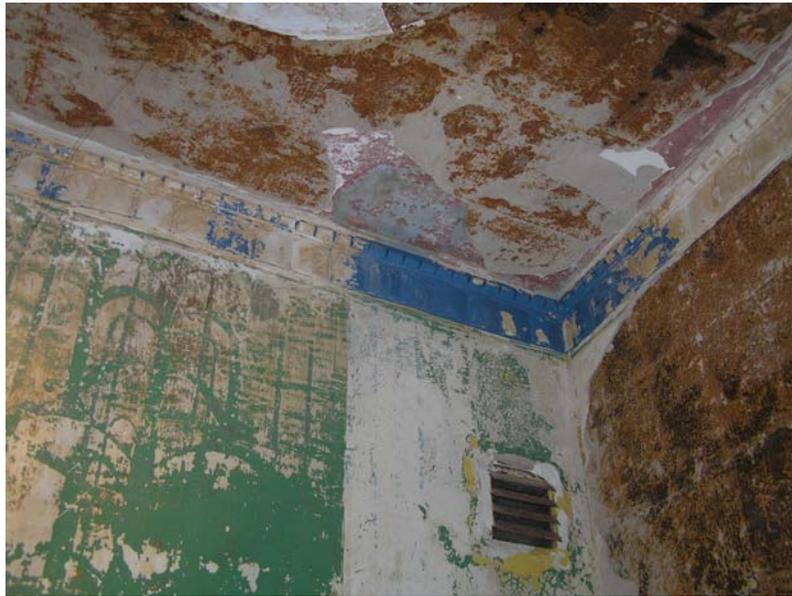
# [ Crown Molding in Entrance Vestibule ]

The moldings in the entrance vestibule are missing in some locations and severely deteriorated in others.

The molding can remain its current state or be removed.

If the molding is removed, profile and pattern drawings of the molding shall be done to mitigate the loss.

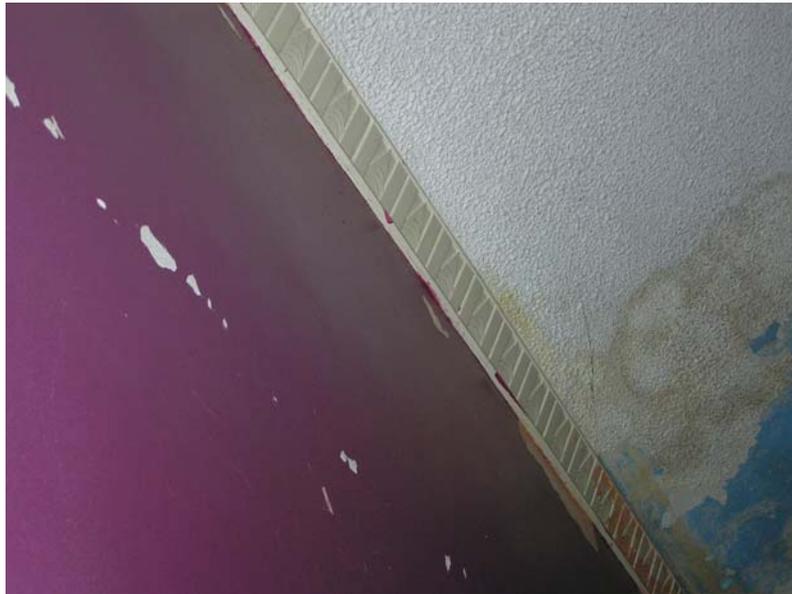
# [ Crown Molding in Main Lobby ]

The crown molding is original and appears intact.

Moldings shall be rehabilitated

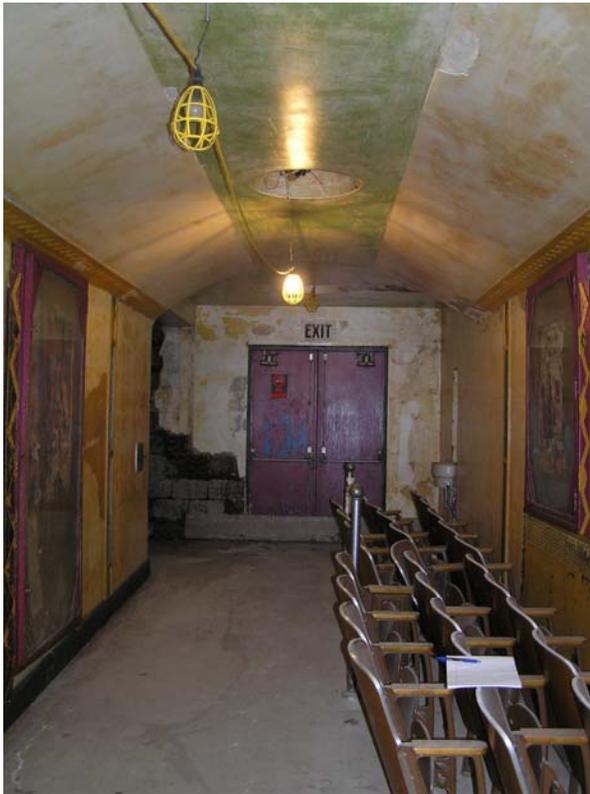
# [ Volume of Space ]

The volume of space is intact. The feeling created by the lower vaulted ceilings in the inner lobby is more intimate than other areas of the theater which contain larger volumes of space

The feeling created by the vaulted ceilings is important to convey in future reuse of the structure. The volume of space should be maintained and dropped ceilings shall be avoided.

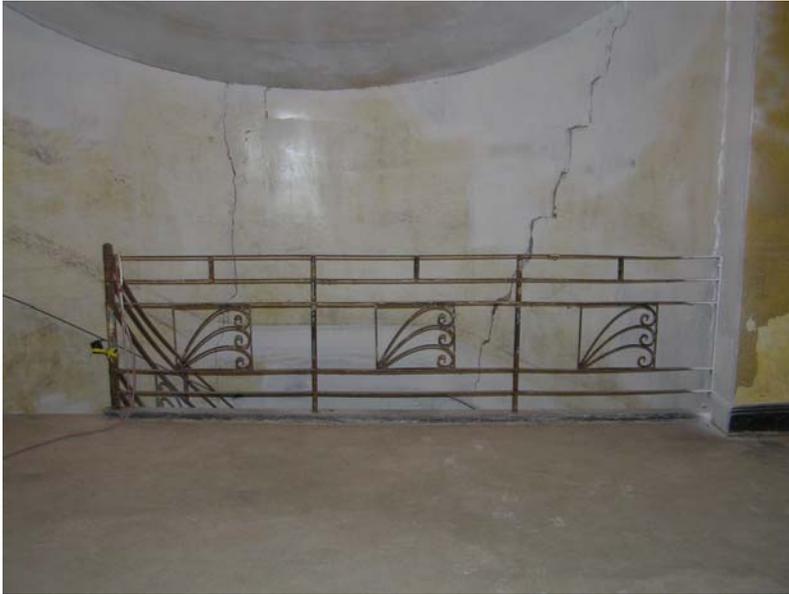
# [ Railing ]

The railing is one of the most prominent features of the inner lobby. The railing is intact.

The railing shall not be enclosed or obscured; it shall be maintained and rehabilitated as necessary

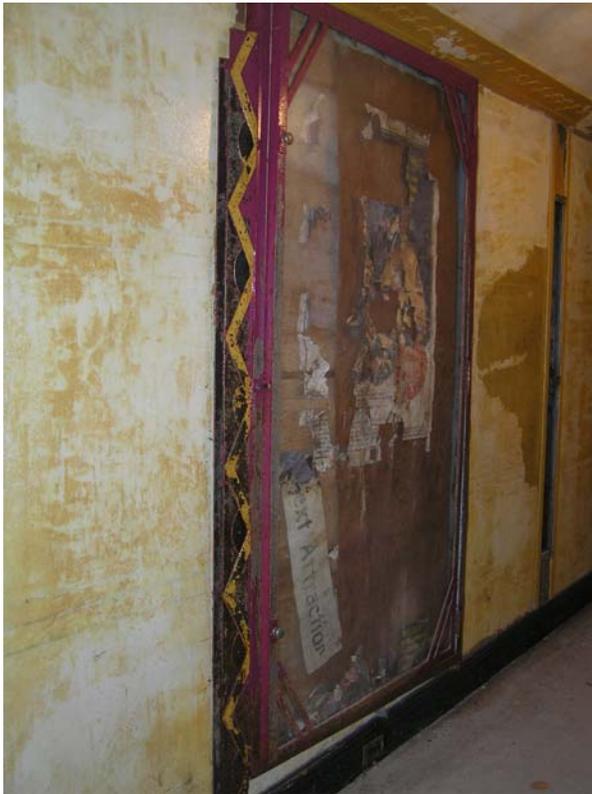
# [ Poster Cases ]

The poster cases are characteristic of the zig-zag art deco design themes that influenced the streamline moderne style of the theater.

The features appear to be original and shall not be removed or enclosed. The features shall be repaired and incorporated into the reuse of the structure.

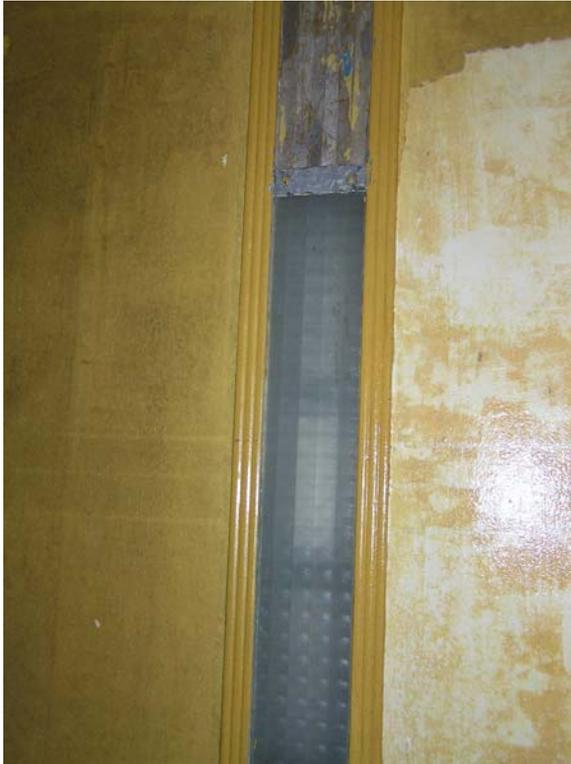
# [ Linear Light Features ]

The light features are characteristic of the original design aesthetic of the Hollywood. The metal on the top and bottom of the feature needs repair and cleaning. The glass may not be original- the original plans from 1935 called for glass rods.

Features shall be rehabilitated and incorporated into the reuse of the space

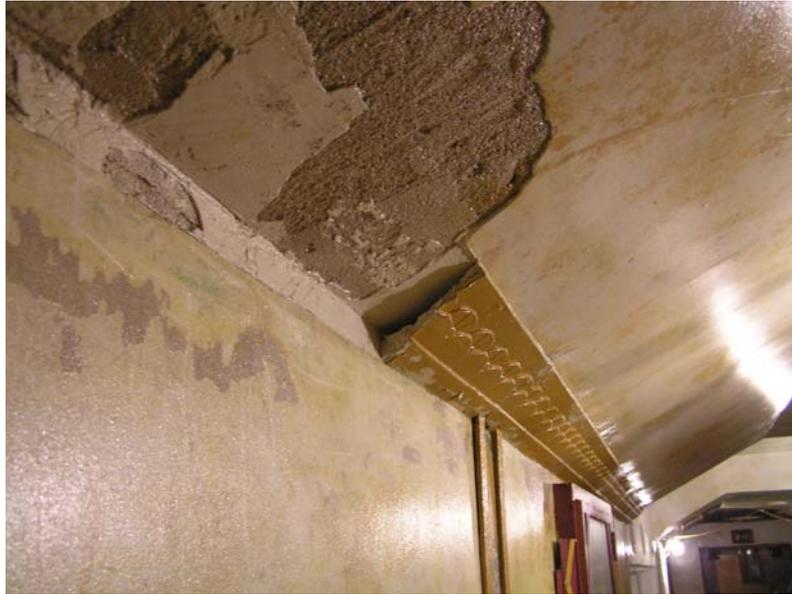
# [ Crown Moldings ]

Much like the poster cases and light features the crown moldings are characteristic of the art deco design themes. The moldings remain fairly intact with the exception of a few locations.

Missing features shall be reconstructed and existing moldings rehabilitated.

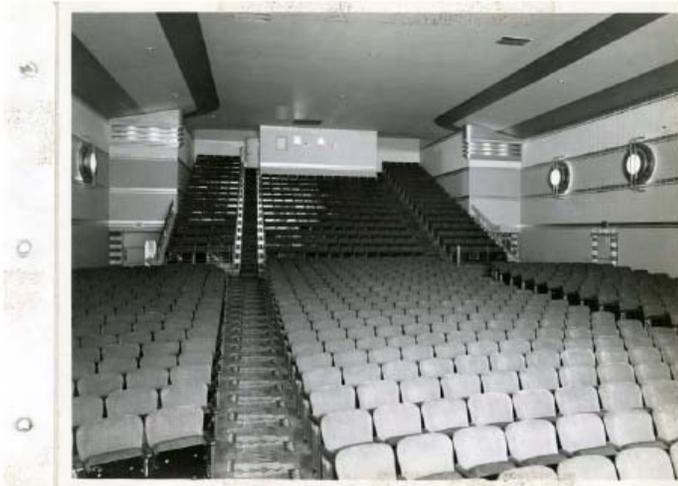
# Volume of Space

The volume of the auditorium is intact. The plaster of the roof was removed during remediation and roof replacement- this slightly changes the feeling of the volume of the space.

The subdivision of the space can be done, however, the sense of space associated with the volume of the space and theater activity shall be conveyed in the subdivision. See below for details.

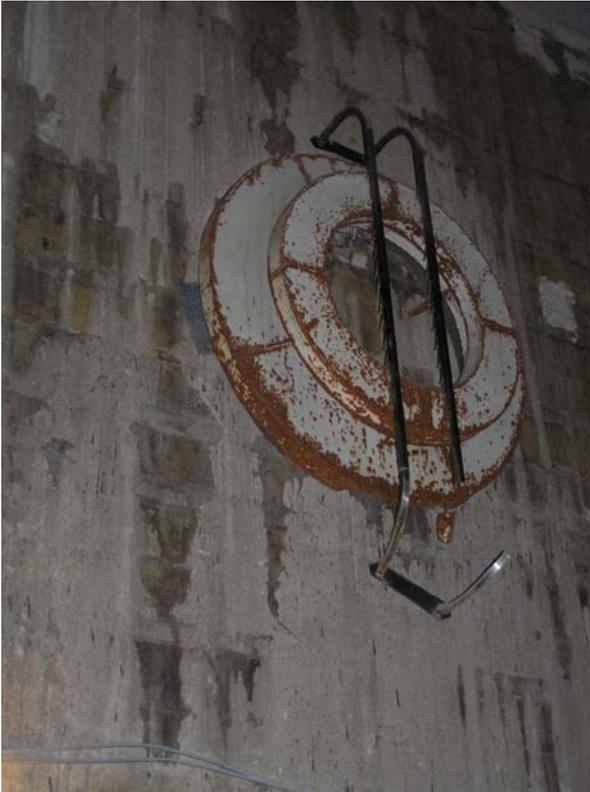
# [ Porthole Lights ]

The porthole lights are important feature that exemplify the streamline moderne design of the Hollywood. The metal frames of the porthole lights are intact. The condition of some of the metal is deteriorated due to moisture exposure. The finish materials are missing.

The existing features shall be stabilized to prevent further deterioration and the frames repaired. The features do not have to be reconstructed to their original finish.

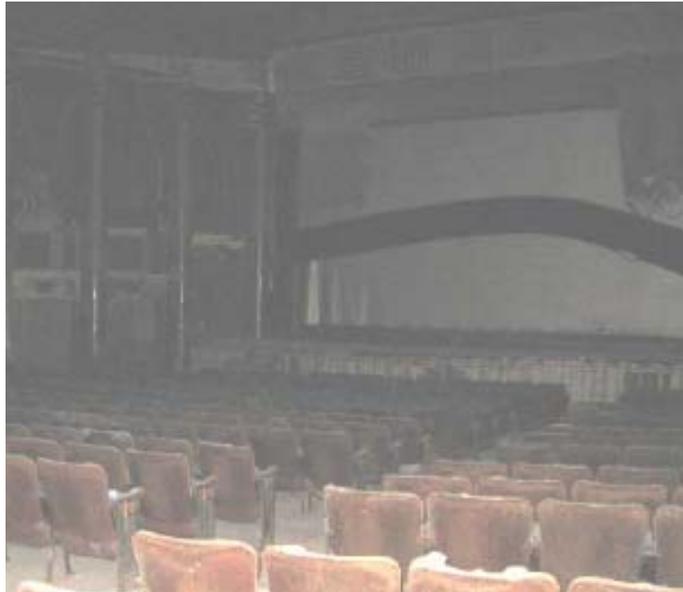
# [ Stage ]

The original proscenium appears to be intact, but in serious disrepair. A plywood addition has been made to the stage and the pillars surrounding the stage appear to be intact

The removal of the proscenium will be allowed with proper mitigation and documentation. The addition to the stage can be removed. The configuration of the stage shall be maintained. A reconfiguration of the stage may be considered to allow for an entertainment reuse of the Hollywood.

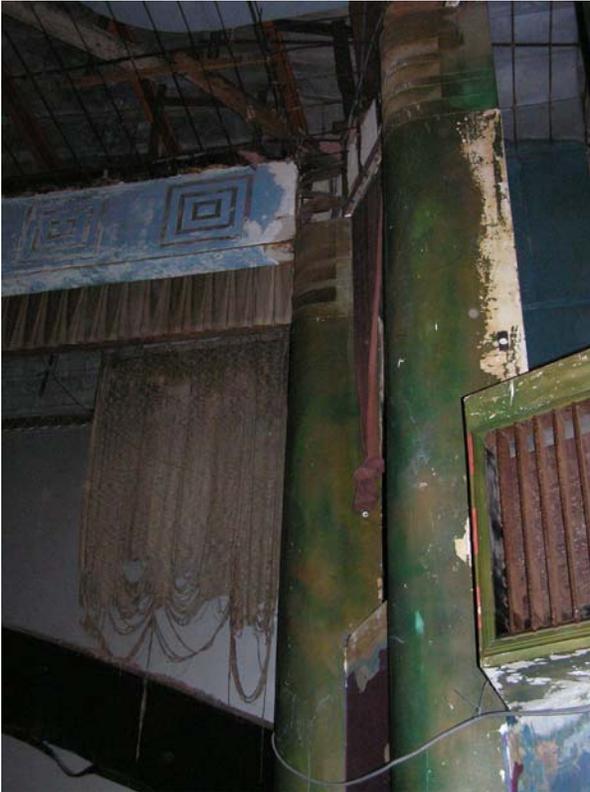
# [ Pillars ]

The ten pillars that flank the stage are important in conveying the nautical themes of the streamline moderne design that Hollywood is significant for.

The pillars do not have to be restored to their original finish, but they shall be maintained and shall not be enclosed or covered up. The leveling of the floor shall be done in a way that is sensitive to the pillars.

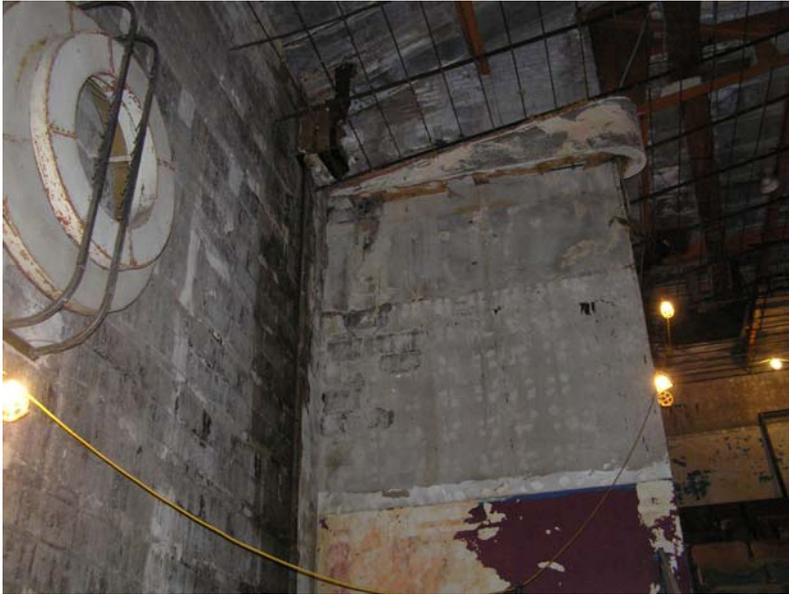
# [ Rear-wall Cornices ]

Two wall cornices flank either side either side of the balcony wall. As is evident in the historical photographs these cornices had horizontally banded metal mounted below which was used for decorative lighting. What remain of these features are the plaster cornices.

These plaster cornices shall be maintained.

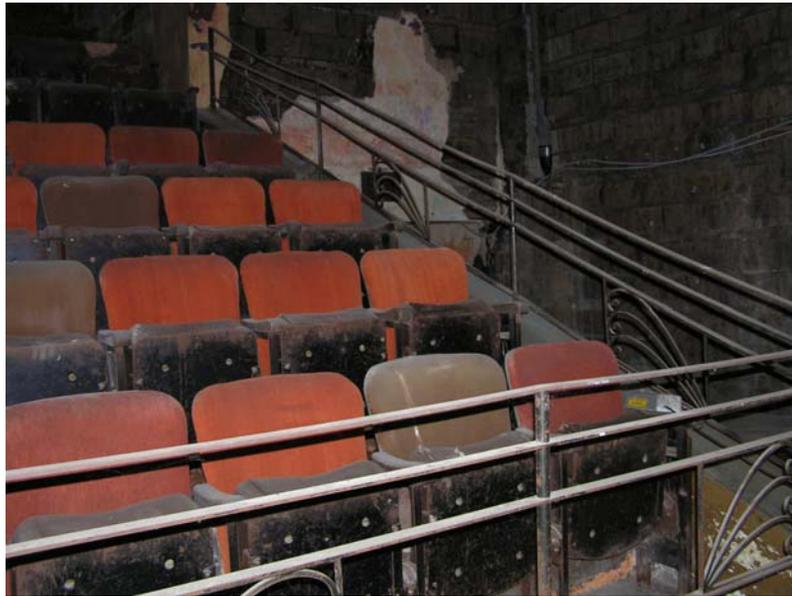
# [ Balcony Railing ]

A decorative metal railing separates the balcony from the auditorium. The design of the railing is the same as the railing in the inner lobby stairway.

The balcony railing shall be rehabilitated as needed. The railing shall be rehabilitated. The installation of walls to separate the balcony from the auditorium space shall be inset from the balcony railing.

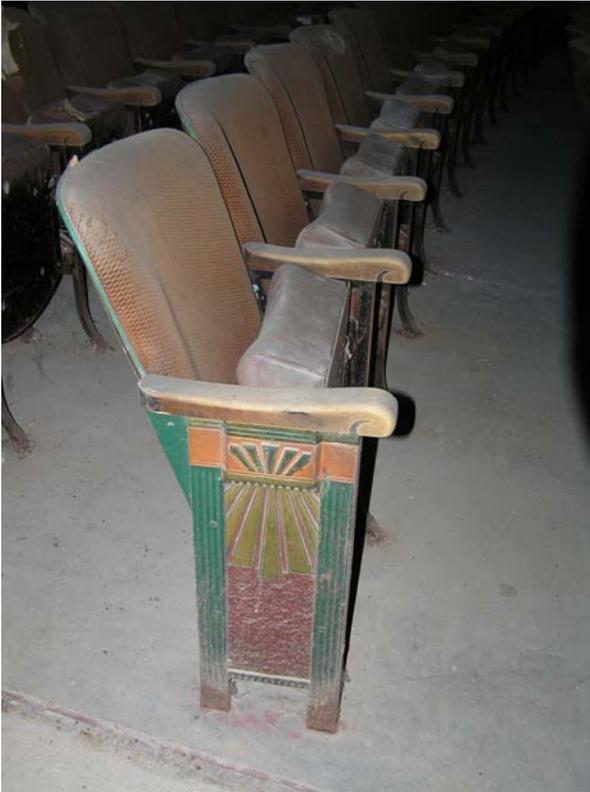
# [ Seats ]

The seats appear to be original and have survived the water intrusion and years of deferred maintenance. The metal end panels appear to be intact and in good condition. Some seats have been removed leaving metal framing

The removal of the seats is allowed with mitigation measures that include drawings of a typical seat, photographs of configuration, and the salvage and storage of the decorative metal end panels.
