910 Portland Avenue South

BZH-27888

CONTINUATION SHEET-Part 1
Historic Preservation Certification Application

The Roselle
910 Portland Avenue South, Minneapolis, Hennepin, Minnesota

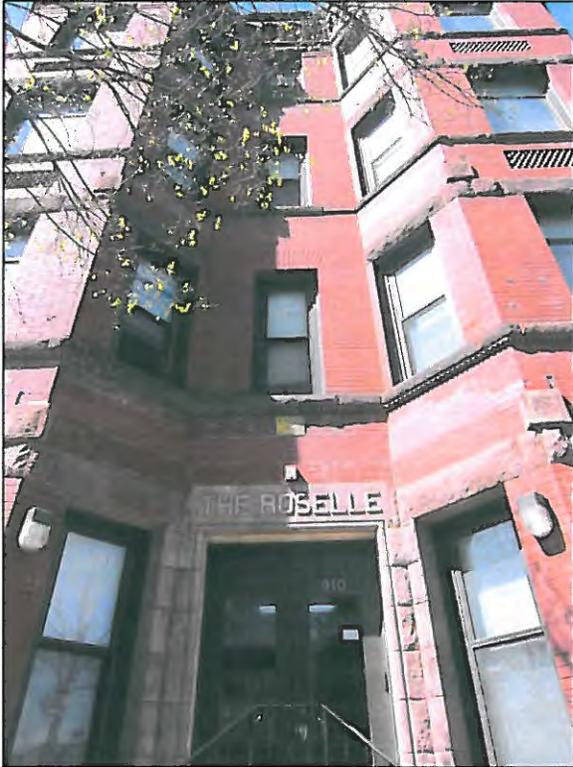
Photo 3. Detail of central bay. View to west. April 2012. Note condition of brickwork in projecting bay to the right.

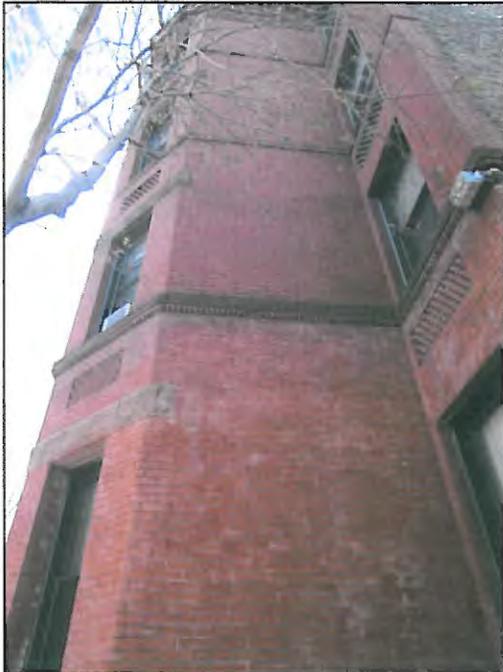
Photo 4. Detail of north wall of north projecting bay. View to south. April 2012. Note staining on brickwork.

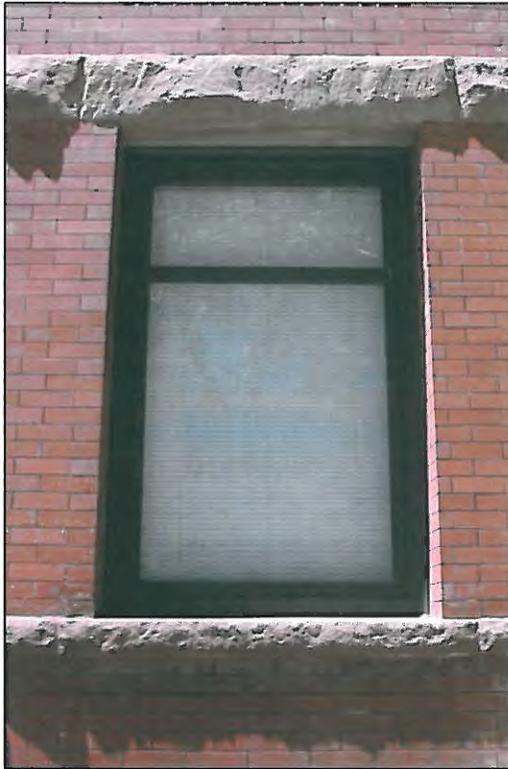
Photo 5. Detail of window opening and sash. View to west. June 2012. Note staining on brickwork.

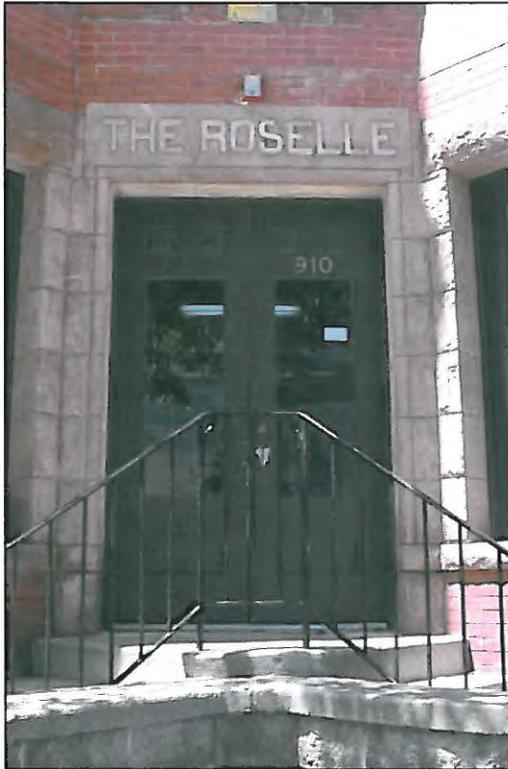
Photo 6. Detail of entrance and stoop. View to west. June 2012. Note staining on brickwork.

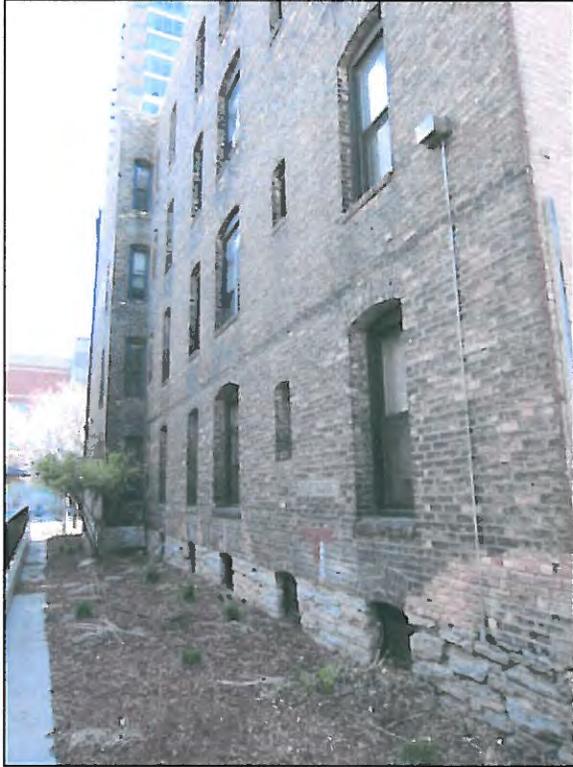
Photo 7. Overview of north elevation. View to southeast. April 2012. Note deterioration in brickwork and stone at base.

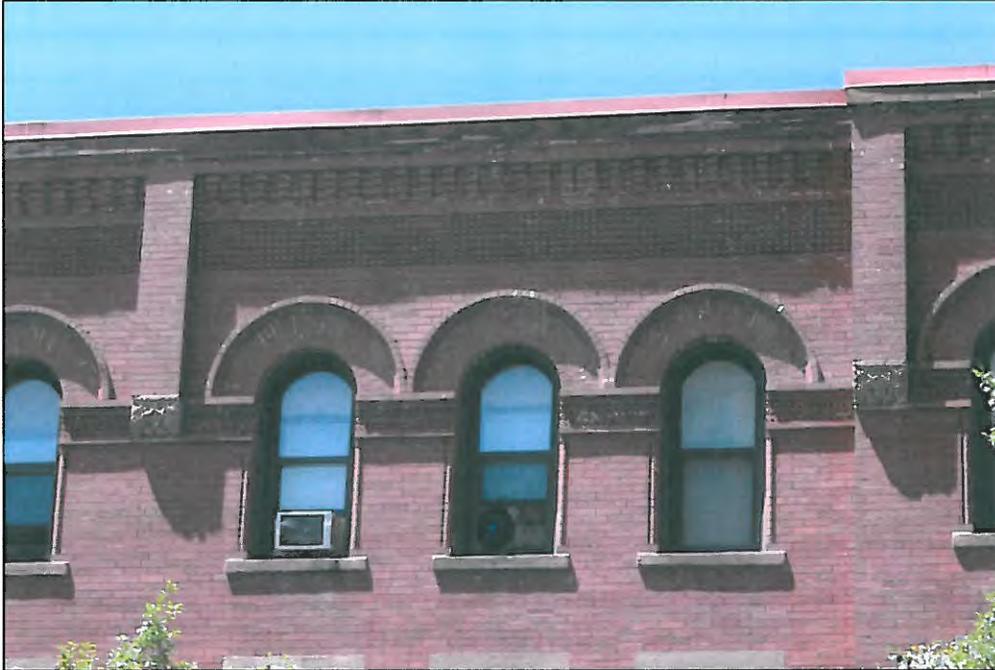
Photo 3. Detail of upper story and cornice. View to west. June 2012. Note staining on brick and deteriorated stone sills.

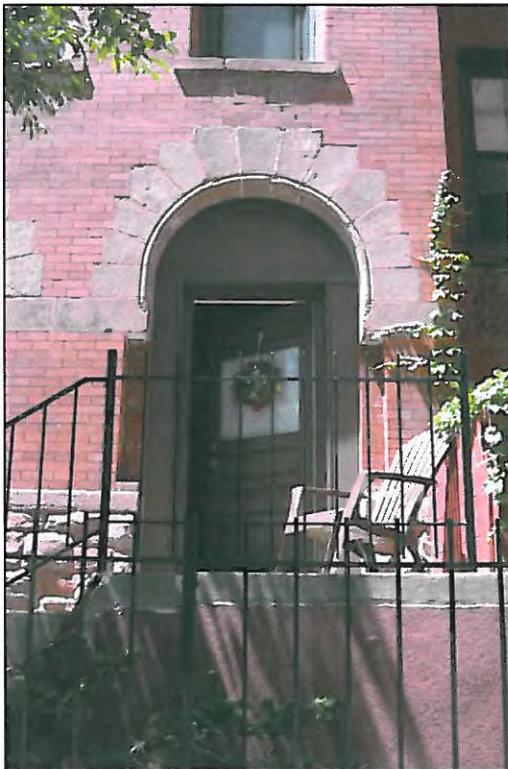
Photo 4. Detail of fence, stoop, and former entrance at 916 section. View to west. June 2012. Note deteriorated stone sill and arch over doorway.

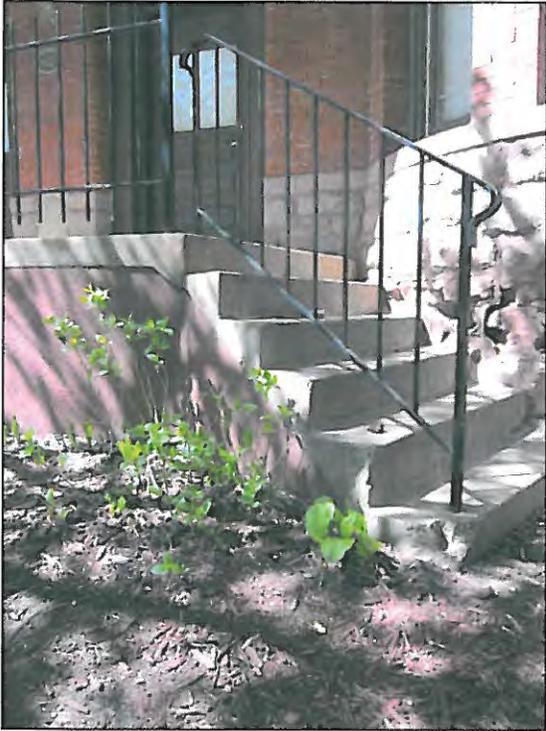
Photo 5. Detail of stoop and former entrance at 922 section. View to southwest. April 2012. Note deteriorated stonework by the steps.

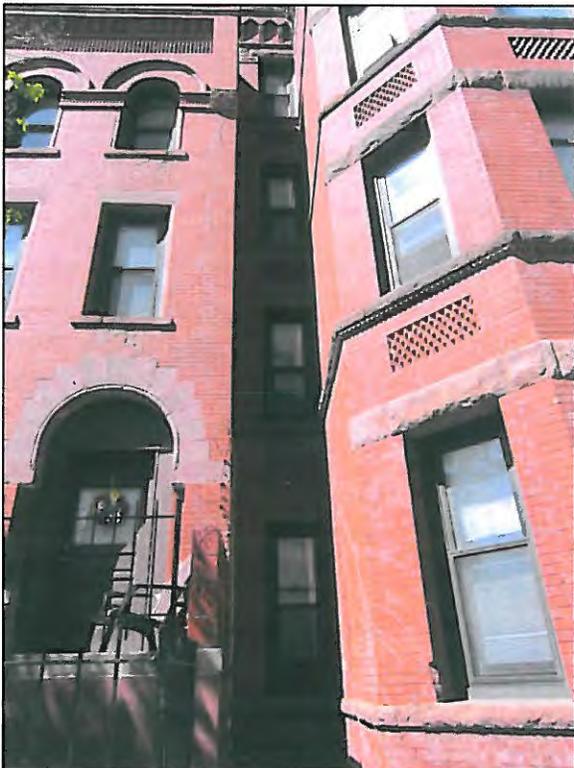
Photo 6. Detail of the juncture of the Melrose (left) and Roselle (right). View to west. April 2012. Note cracking in brick and deteriorated stonework.

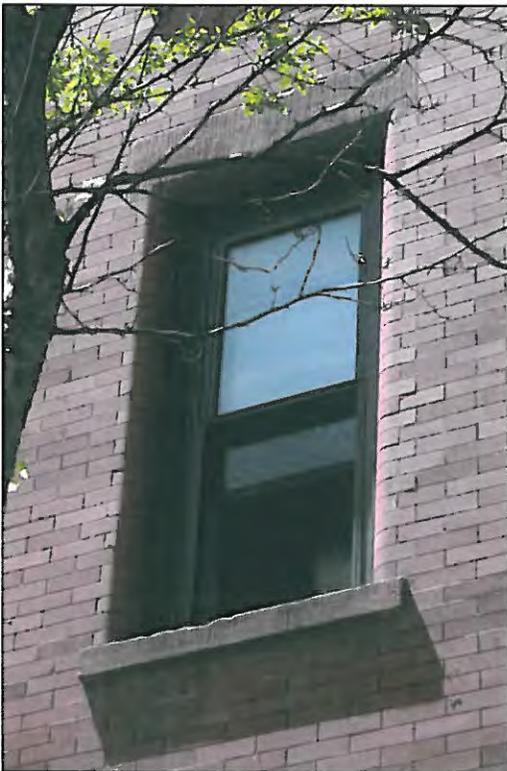
Photo 8. Detail of window opening and sash. View to west. June 2012. Note deteriorated brick and stone sill.

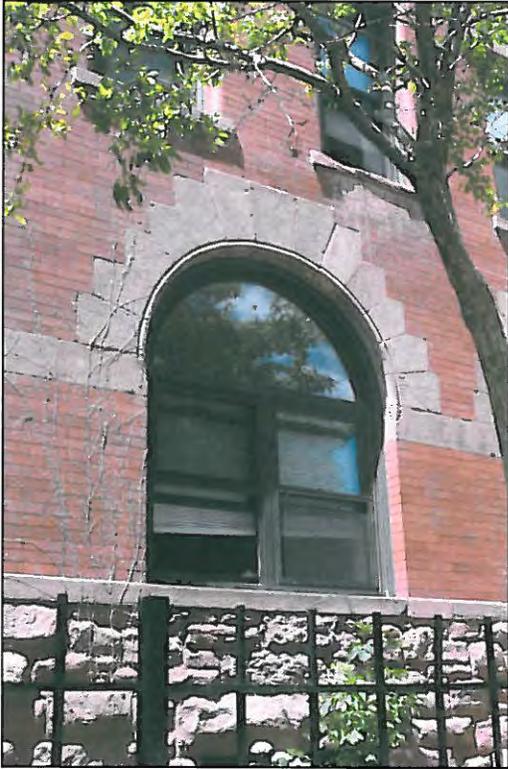
Photo 9. Detail of arched window opening in 916 section. View to west. June 2012. Note staining of brick and deteriorated stonework.

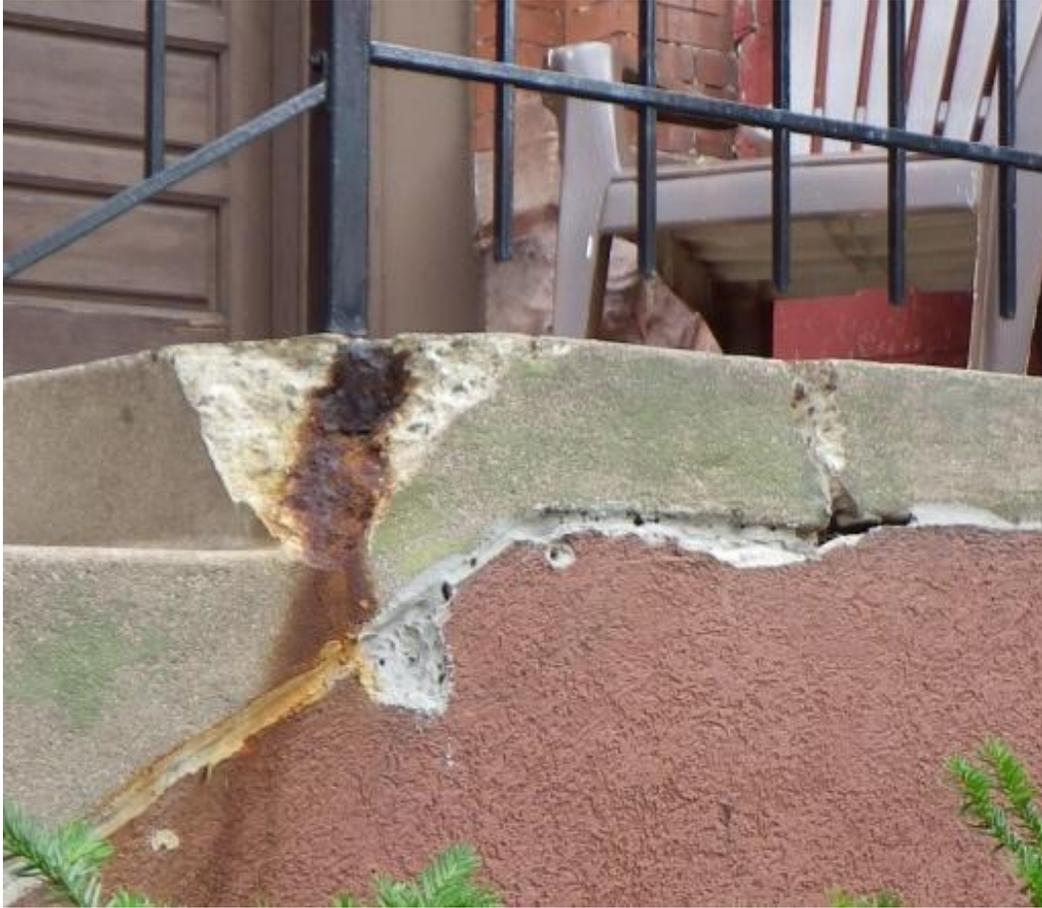
Roselle- Hand rail corrosion and concrete damage

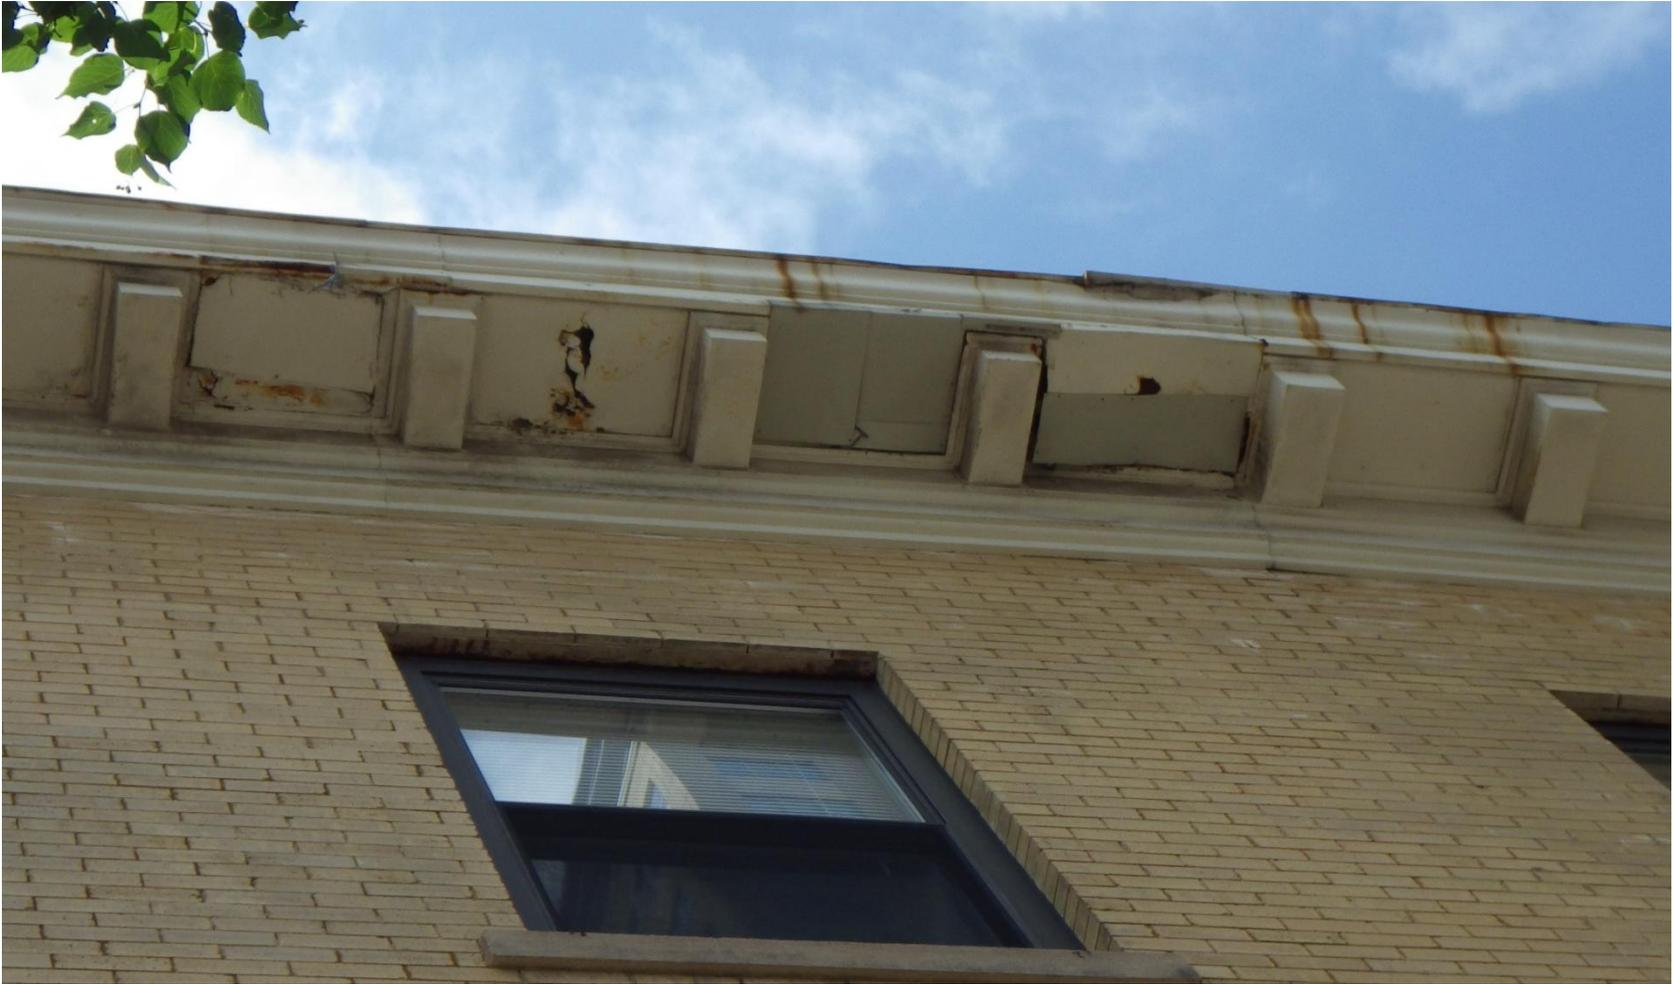
Milton- Soffit Damage

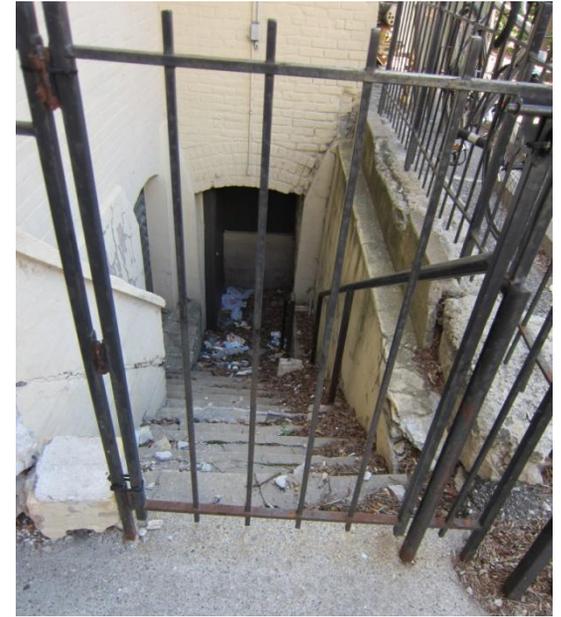
Milton- Stairway deterioration

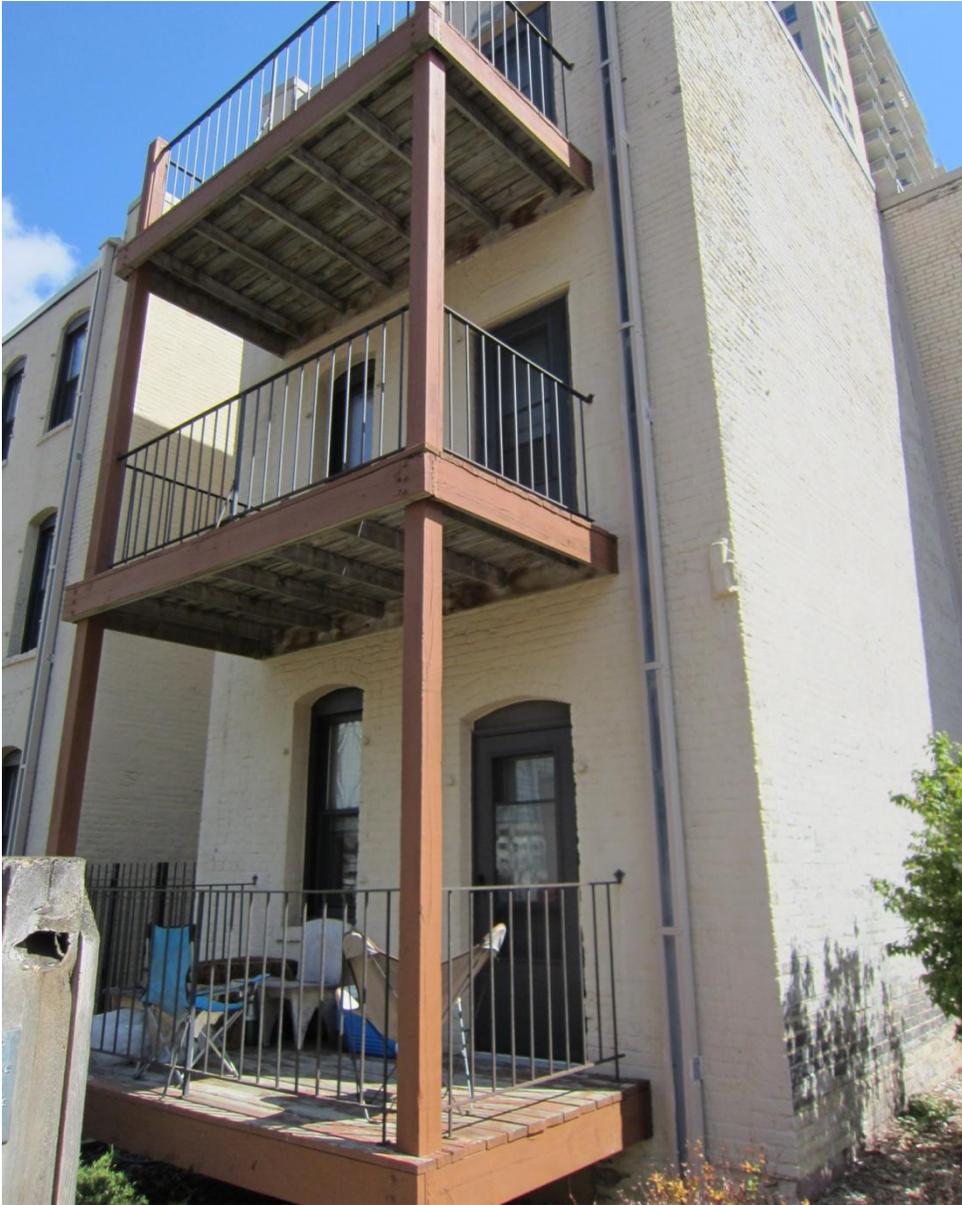
Melrose- Deteriorated wood decks

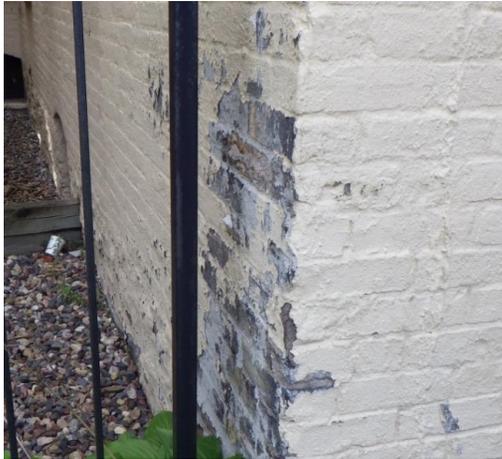
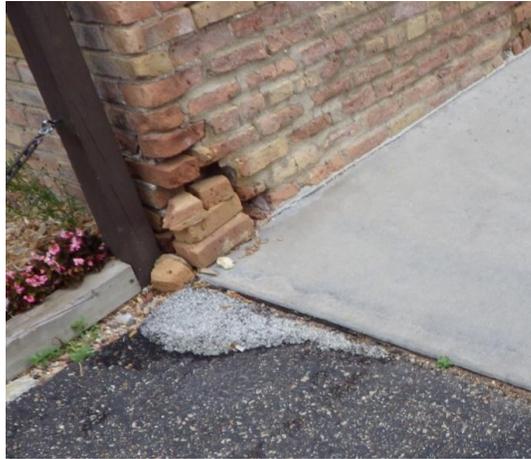
Roselle- Deterioration of brick

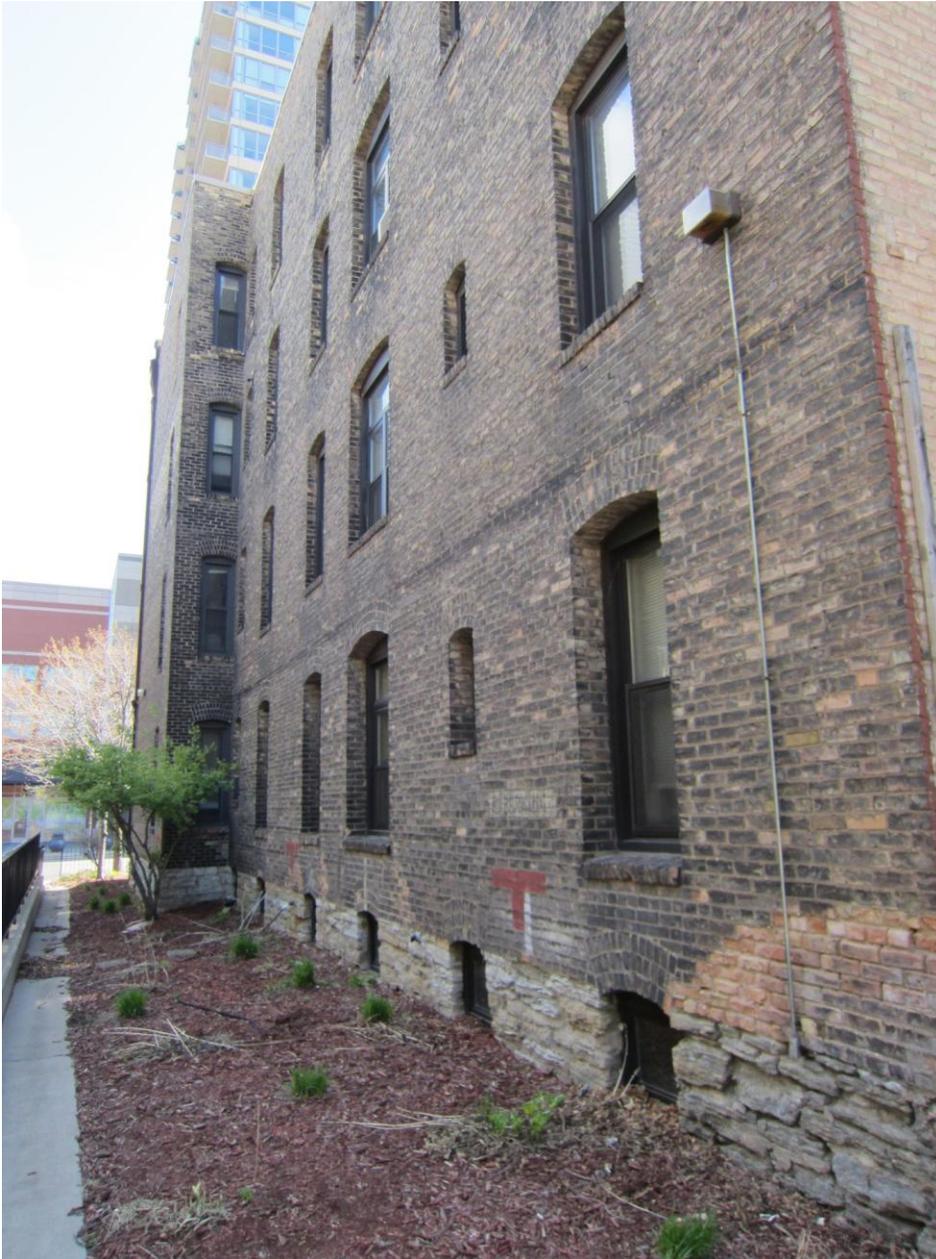
Roselle- Stone deterioration

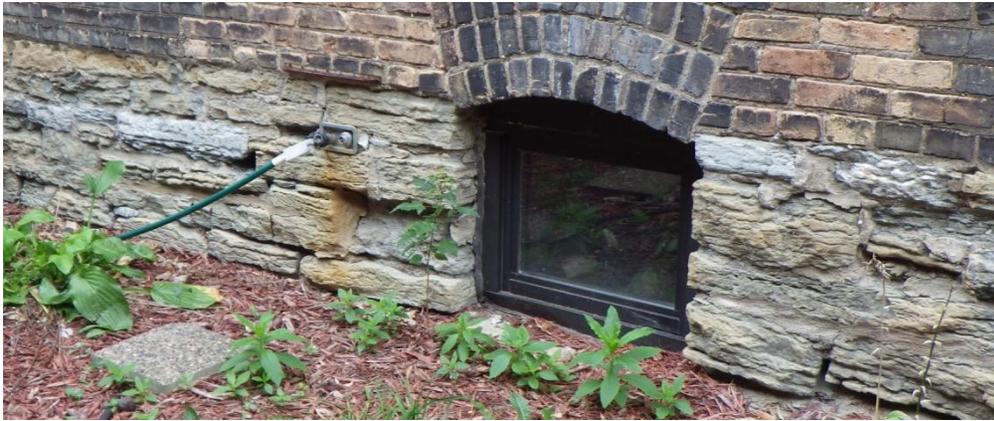
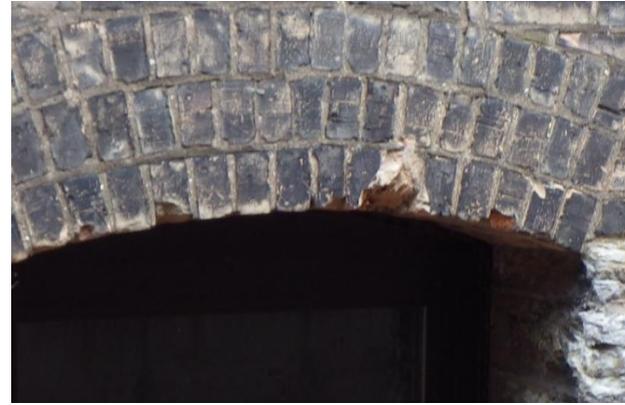
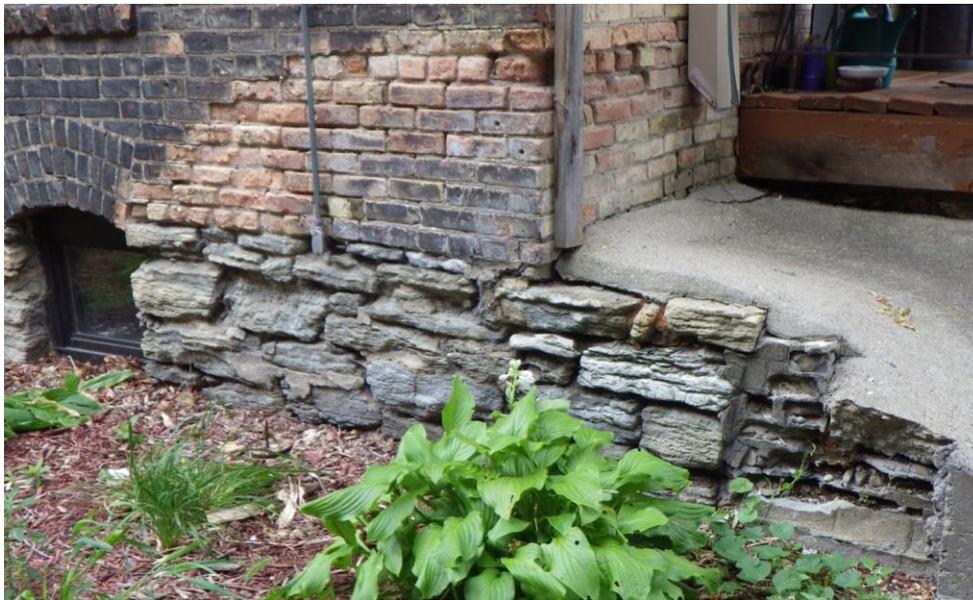
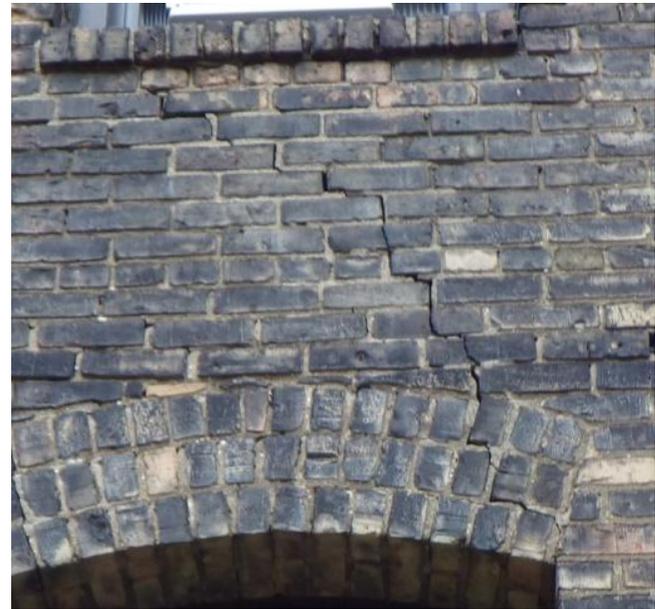
Roselle- North Elevation

Deterioration of stone and brick
