Pillsbury A Mill Tunnel Historic and Engineering Condition Study

Report prepared for
City of Minneapolis

May 2014

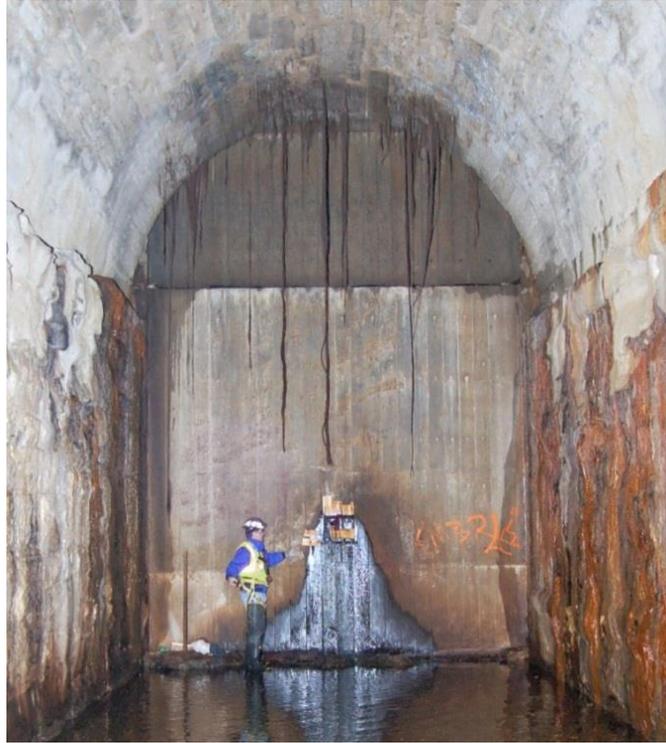
The bulkhead currently contains two penetrations. There is a 1-foot by 1-foot opening in the bulkhead centered approximately 5 feet above invert. The opening is currently closed by a sliding steel plate gate. Centered along the bottom of the bulkhead, approximately 1 foot above the invert is an 8-inch pipe penetration that has been capped. Water is currently seeping through both penetrations. A number of plant or tree roots penetrate through the crown of the tunnel within a 5-foot region of the bulkhead.

Figure 11. Headrace inlet bulkhead.

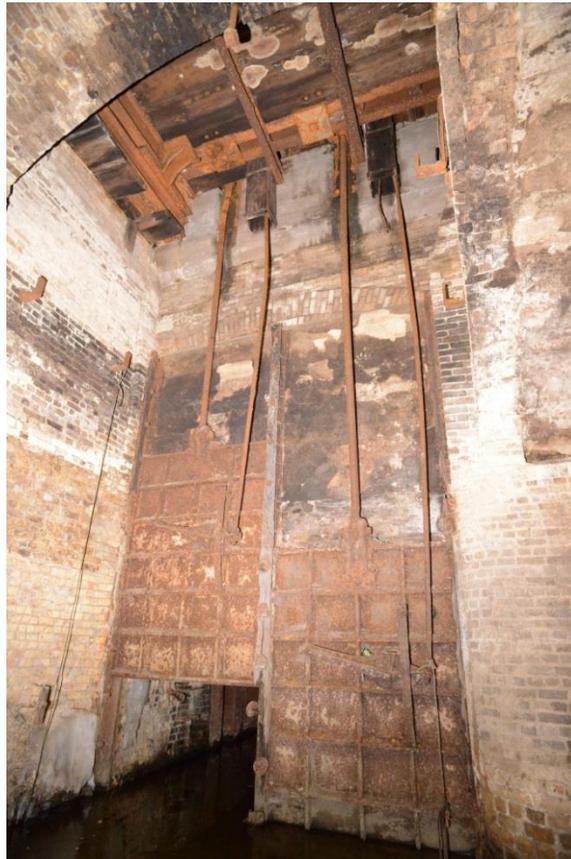
Figure 12. Downriver drop shaft gates.

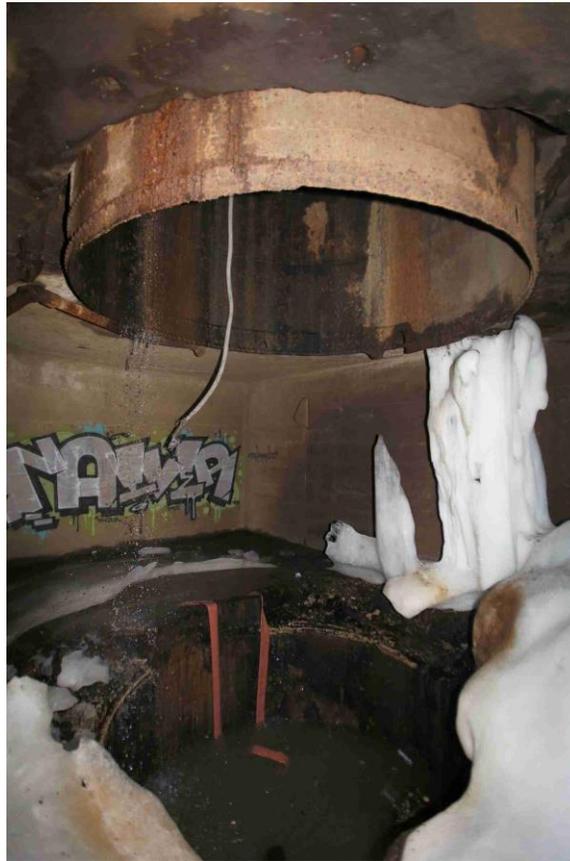
The edge of the drop shaft is located approximately 14 feet from the sluice gate frame. The sluice gates are partially supported on a timber and steel header. The timber portion of the header has suffered severe deterioration. The channel between the sluice gates and drop shaft is brick lined, approximately 12 feet wide with a limestone invert. A stop log gate is located approximately 8 feet from the sluice gate. The channel roof structure consists of a pair of 3-foot-wide brick arches and timber decking. Figure 14 shows the downriver drop shaft.

Figure 14. Downriver drop shaft, tailrace service room. The white formations visible in the photo are ice.

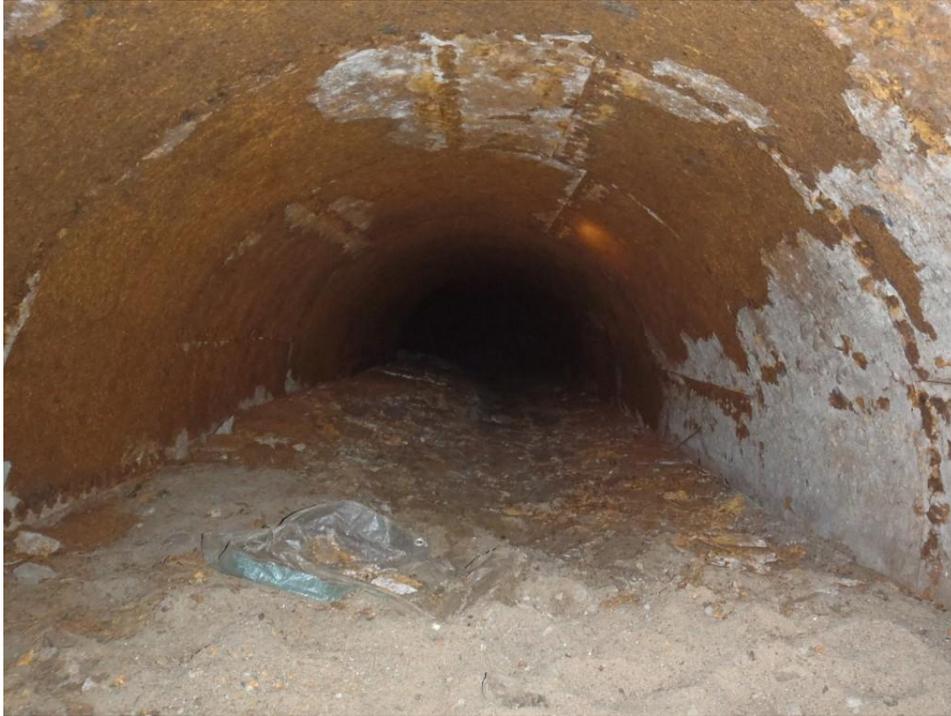
The entrance to the machine shop headrace is located in the tunnel's southeast end wall. It is partially obstructed by a 5-foot by 7-foot steel sluice gate. The sluice gate is highly corroded. The machine shop headrace is a 5-foot-diameter pipe constructed of bolted steel plate segments. The pipe has approximately 3 feet of sand in it. Figure 17 shows the machine shop headrace pipe.

Figure 17. Machine shop headrace pipe.

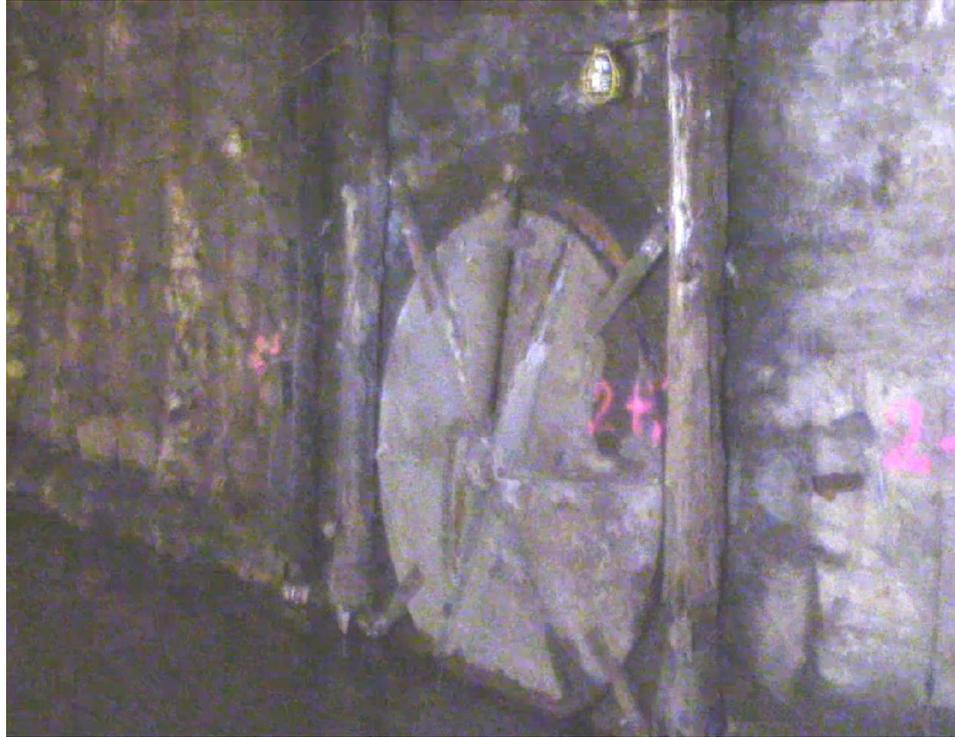
The Phoenix Mill Headrace crosses the Pillsbury A Mill tunnel at a 90-degree angle between Station 2+70.4 and Station 2+84. A large hole covered by a steel plate punctuates the inland side of the tunnel, whereas the river side of the tailrace has been bricked-in (see Figures 28, 29, and 30). This feature is important because it evidences the evolution of the tunnel system and east bank milling district. The plate covering the inland side of the Phoenix Mill Headrace has been replaced since 2010 (see Figures 31 and 32). Unfortunately, the methods used to reattach the plate to the wall do not appear to have incorporated historic techniques, using bright galvanized bolts that are not in keeping with the historic nature of the tunnel.

Figure 28. Phoenix Mill headrace in Pillsbury A Mill tunnel's inland wall showing reattached plate.

Another example of physical alteration to the tunnel includes the covering of the Phoenix Mill headrace on the inland side of the tunnel. In 2010 the cover was detached and resting on the tunnel floor, but it has since been attached to the tunnel wall over the inland headrace opening. Although re-attaching the artifact to the canal wall might have been both necessary and appropriate, the method used is not in keeping with the feel, design or materials used in the tunnel construction and maintenance. Because modern materials were used to attach the plate to the wall, the repair does not convey the historic sense of the feature and results in an unsympathetic alteration to the tunnel.

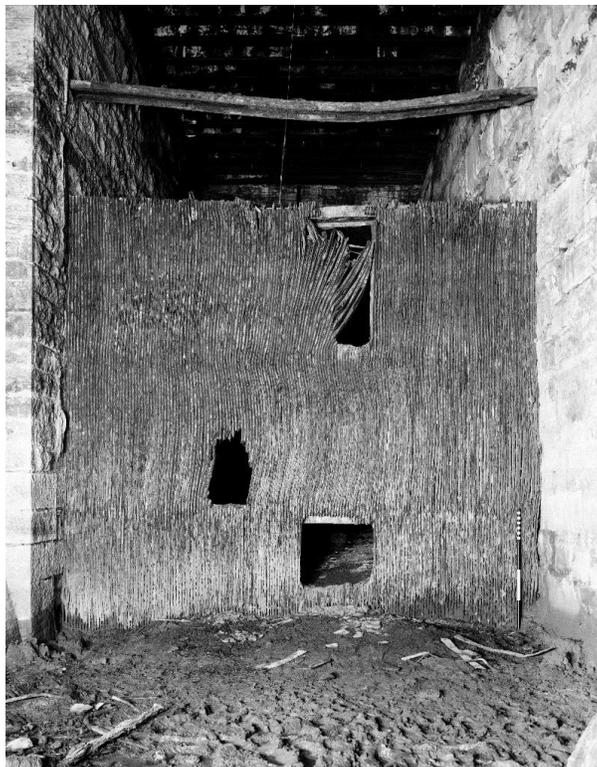
During tunnel investigations in 2010, a trash rack for the machine shop turbine was still in place and attached to the tunnel walls at approximately Station 0+40 (see Figure 38). In 2013 the trash rack was removed as part of the overall tunnel cleanout. The rack was quite corroded and presumably bore rather little resemblance to its original appearance, so its removal does not appreciably threaten the tunnel's importance or the site's eligibility. Nonetheless, the trash rack constituted an integral part of the tunnel system and thereby contributed to overall site integrity. While it is good that the rack was photographed prior to its removal, it is unfortunate that the feature was not more fully documented with textual description and more in-depth illustrations because that documentation would have provided additional breadth and depth to the tunnel and site's permanent National Historic Landmark file.

Figure 38. Extant trash rack in-place as of 2010, near the downriver end of the tunnel in front of the machine shop headrace.

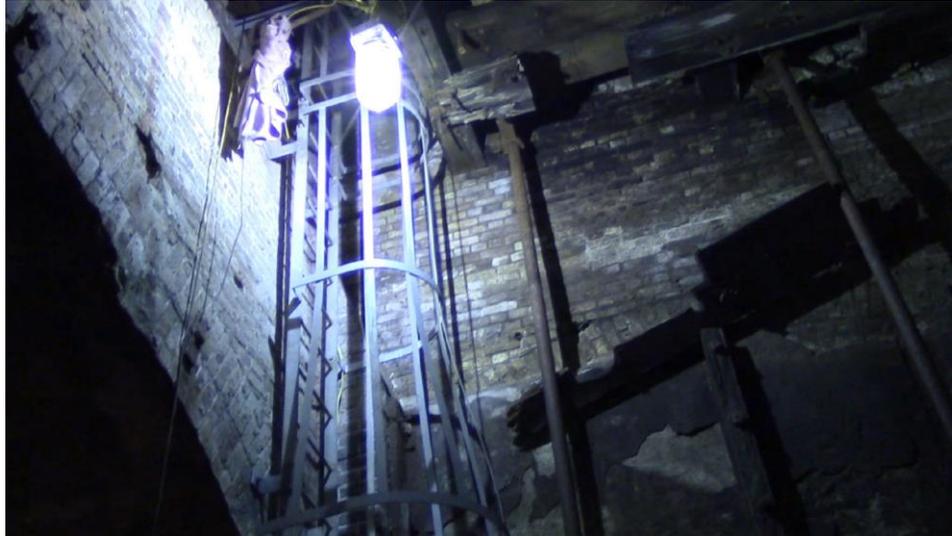
Figure 39. Modern ladder located in the forebay area.

On the other hand, removal of intrusive features could improve the integrity of the tunnel. For example, if it is no longer necessary, simply removing the previous access ladder from the forebay area would enhance the historic nature of the tunnel by removing an intrusive element (see Figure 39).

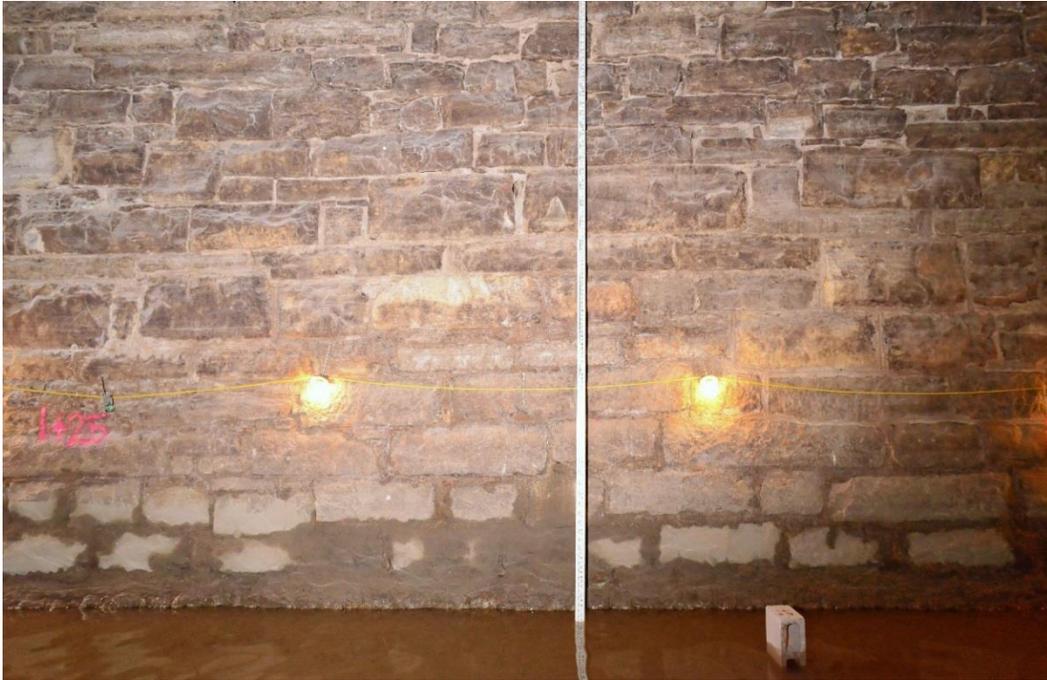
Photo 9. Wall segment in fair condition.

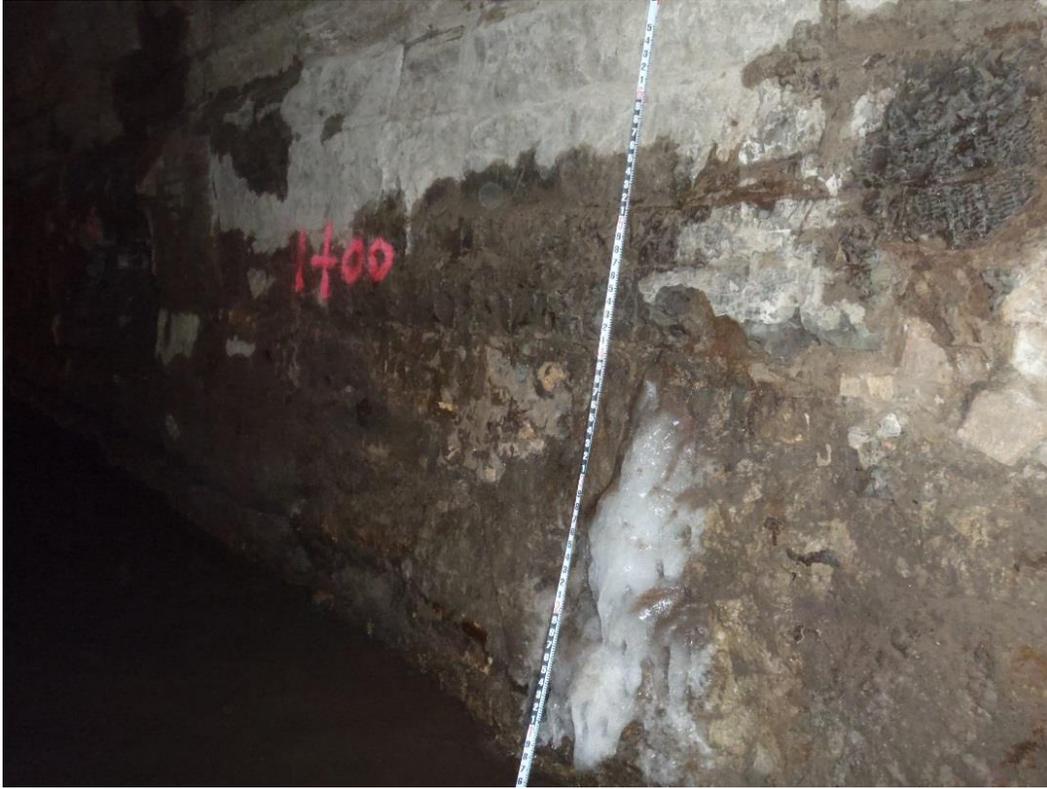
Photo 11. Frozen infiltrating groundwater at Station 1+10 on river side wall.

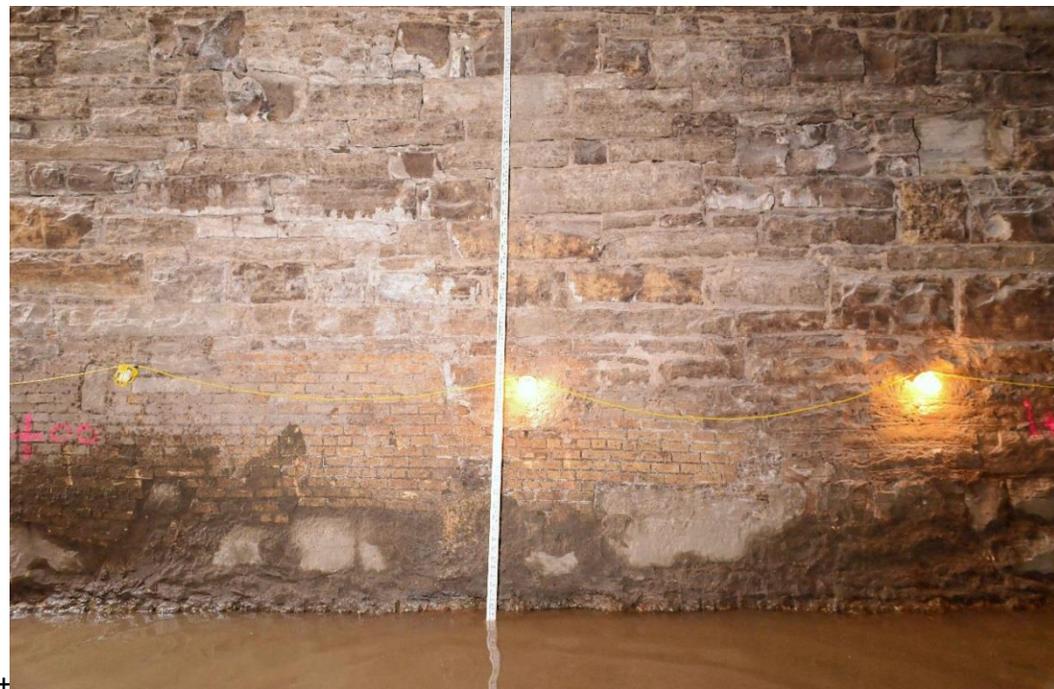
Photo 12. Brick patch and missing mortar (Station 1+00 to Station 1+25).

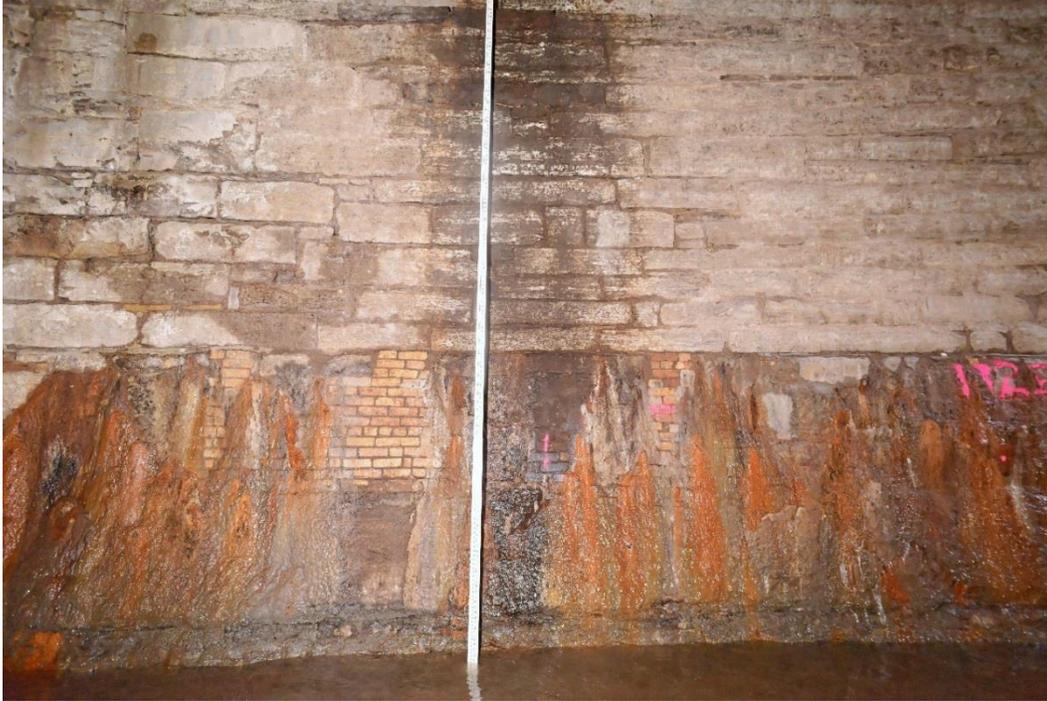
Photo 15. Infiltration above brickline, under catch basin at Station 1+35.

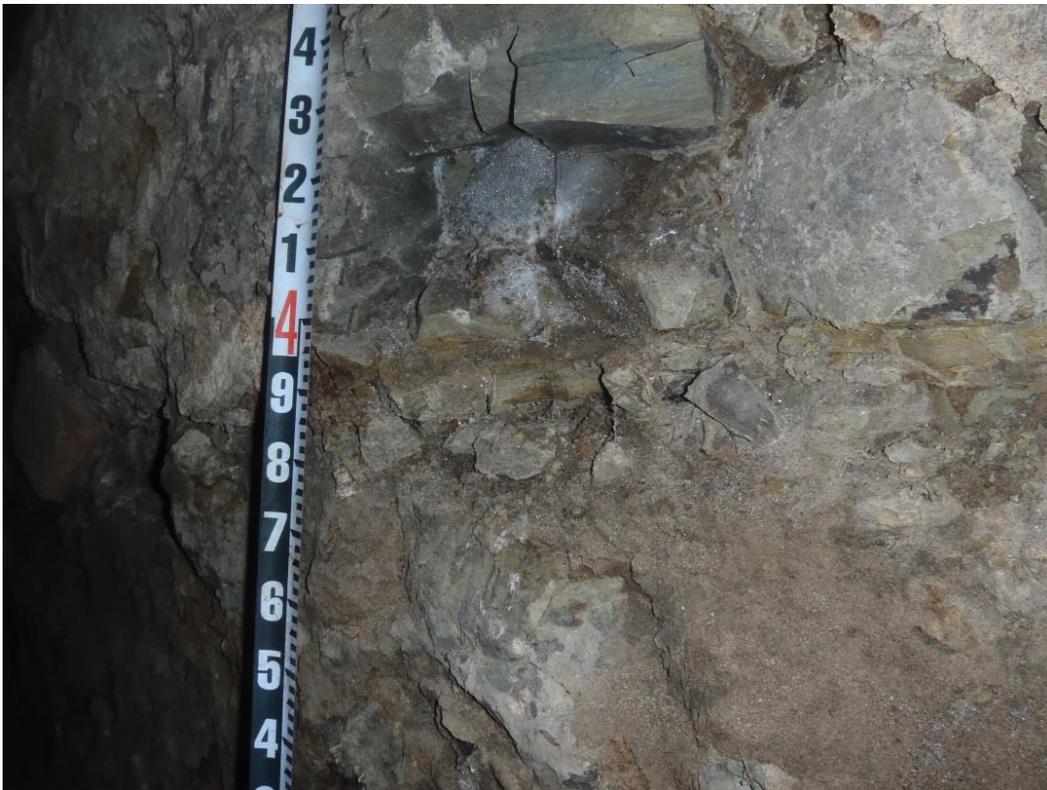
Photo 20. Fractured Limestone and missing stone.

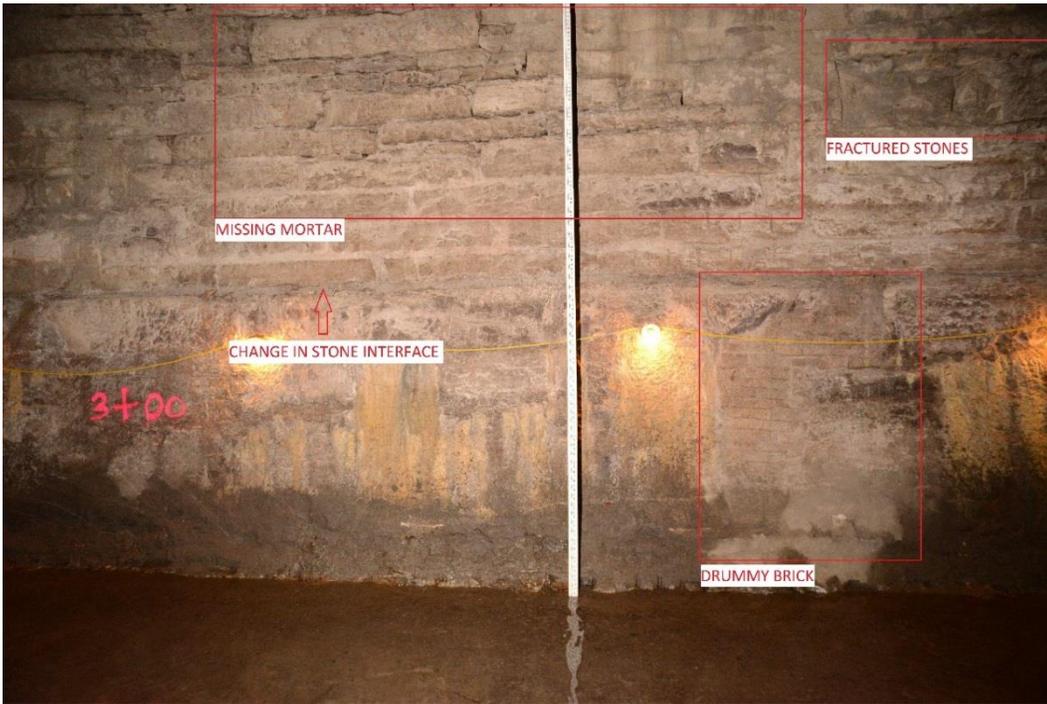
Photo 26. Drummy brick patches, change in stone 7 inches from invert, missing mortar and missing stones.

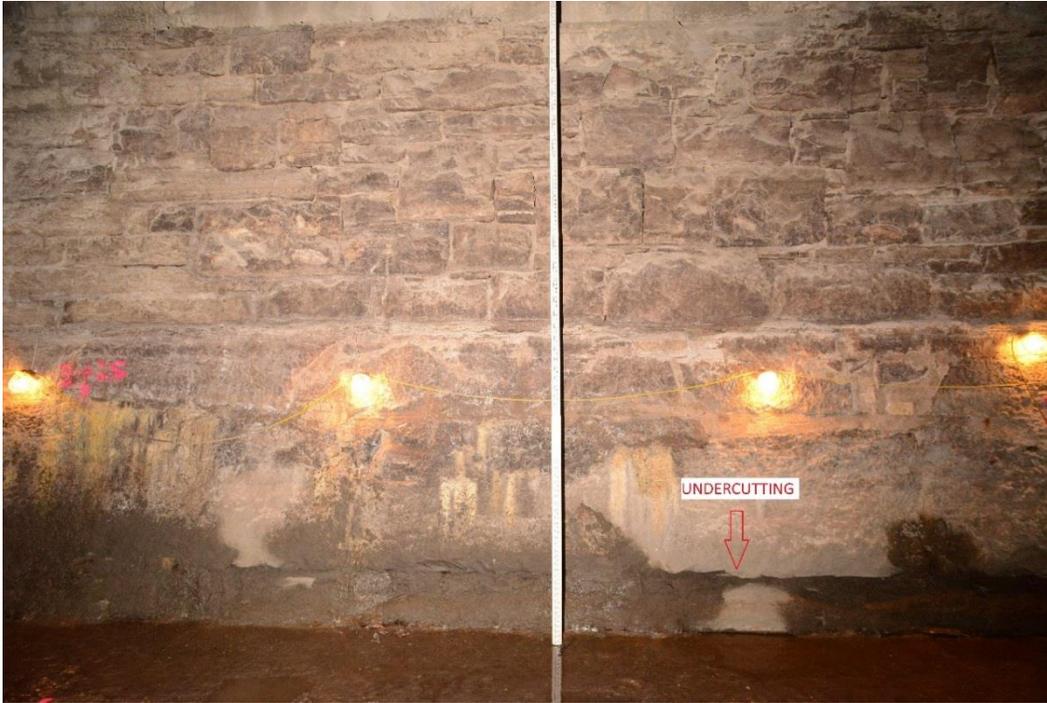
Photo 27. Undercutting of stone wall near invert.

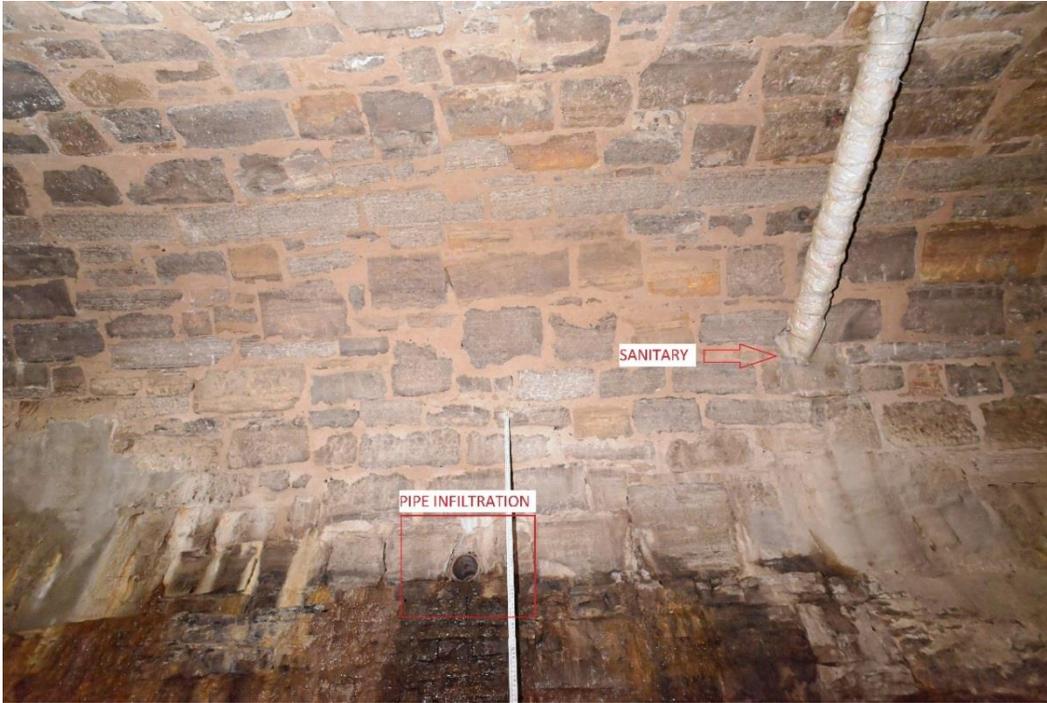
Photo 29. Sanitary intersection near crown of tunnel at Station 4+02, and pipe infiltration at Station 4+13.

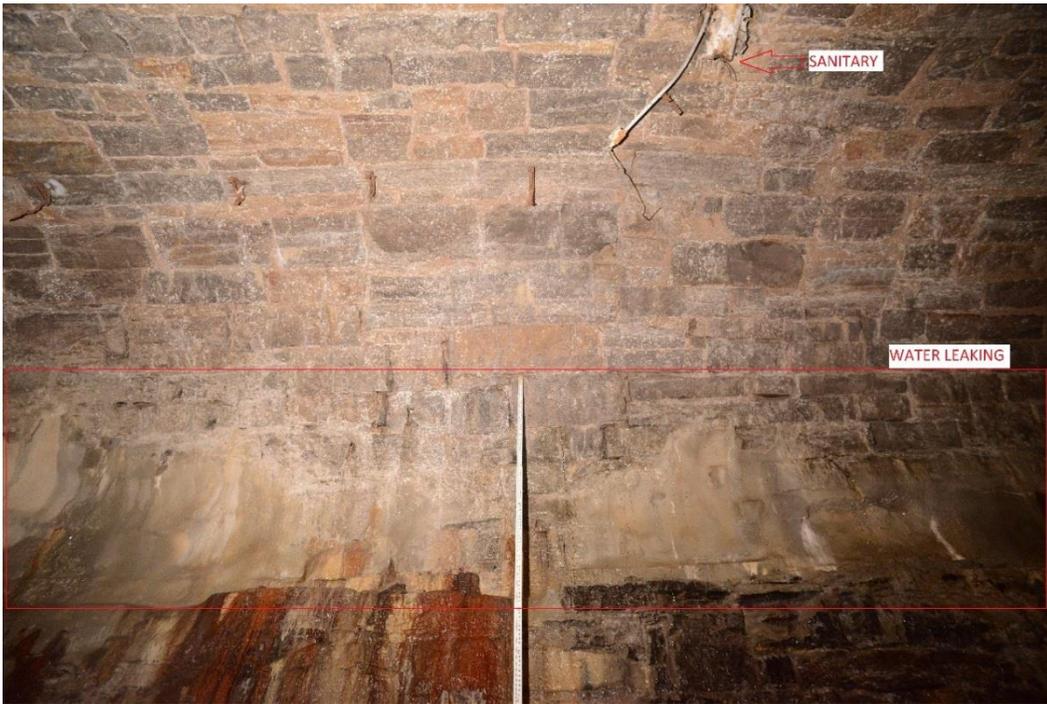
Photo 30. Water infiltration from leaking water pipe.

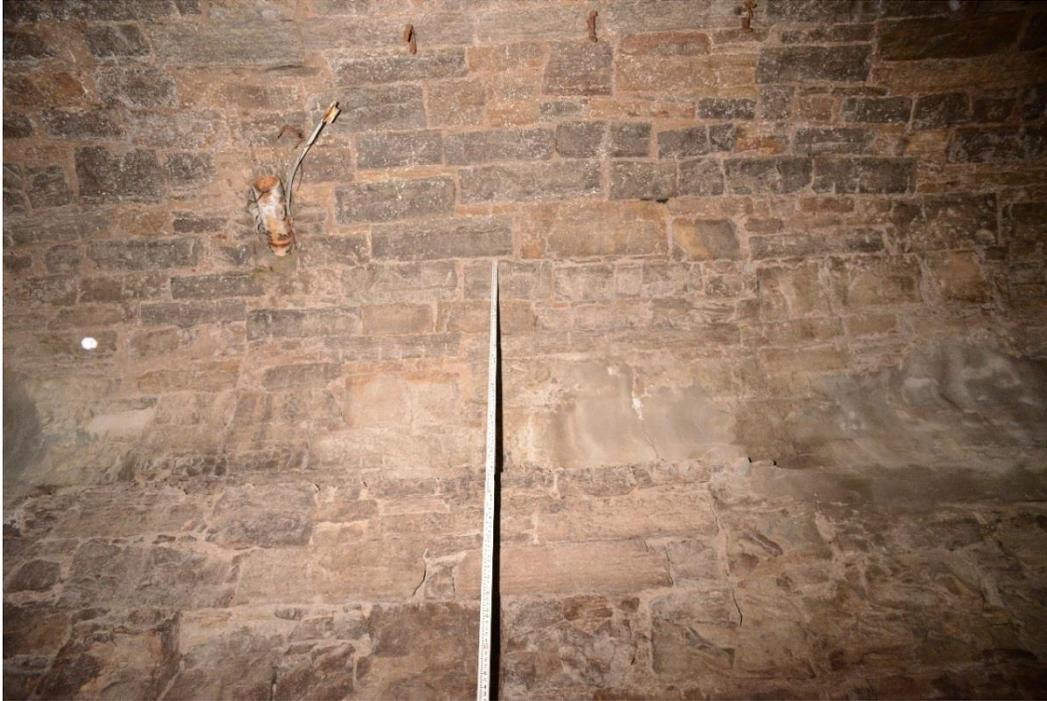
Photo 31. Downstream end of broken live sanitary pipe intersecting arch near crown at Station 4+55.

While not a structural concern, the recently repaired sanitary connection and associated piping from Station 4+55 to Station 4+93 should be routinely monitored and inspected.

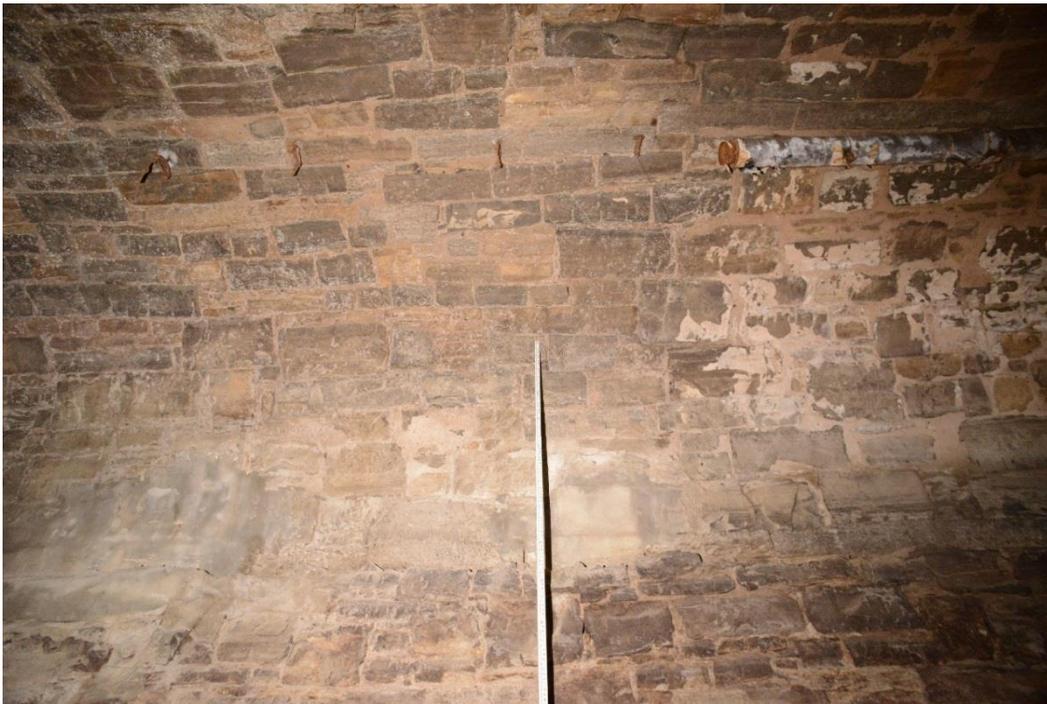
Photo 32. Upstream end of broken live sanitary pipe on crown of tunnel at Station 4+93.

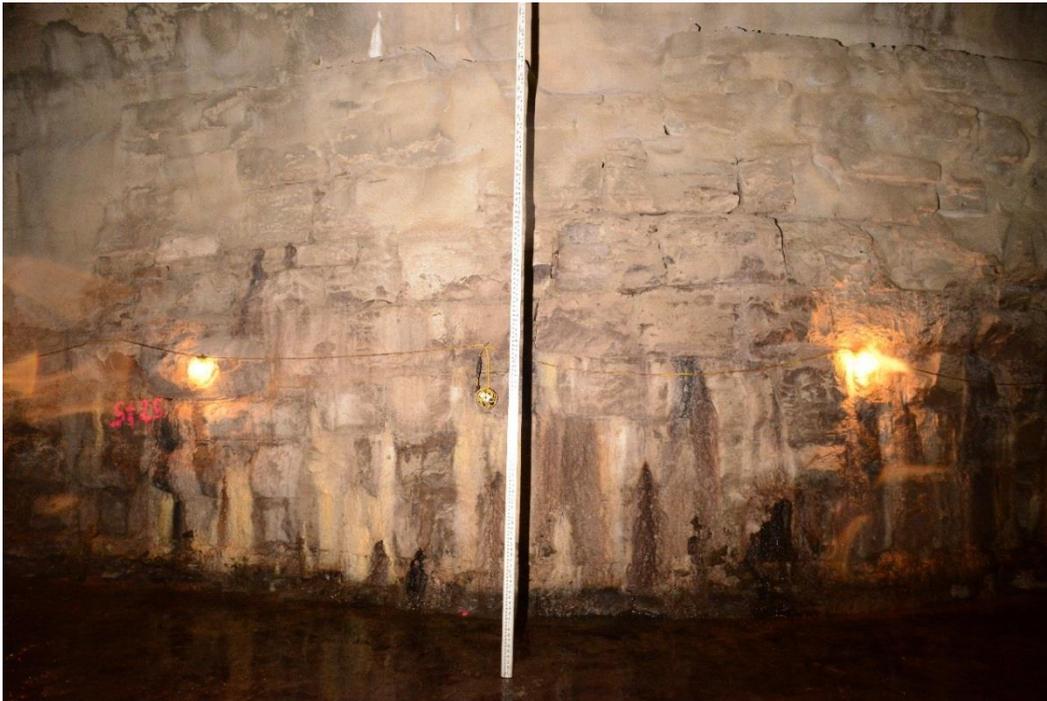
Photo 34. Shotcrete on river side wall 90-degree bend, and missing ledge.

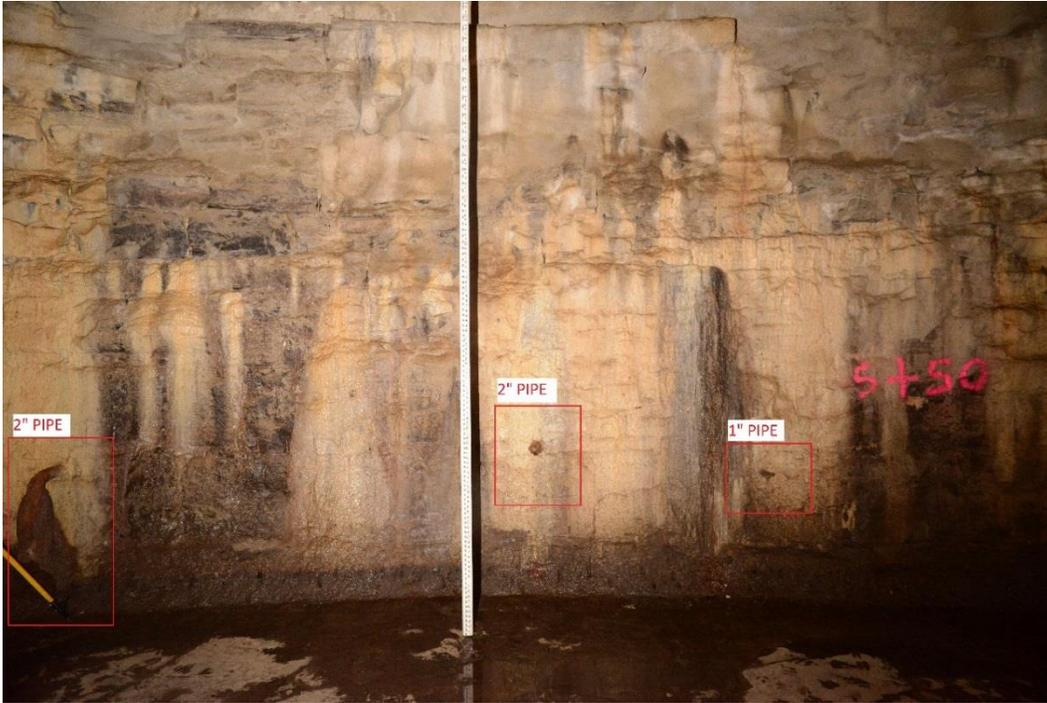
Photo 35. Groundwater pipes on inland wall at 90-degree bend.
