# CPED STAFF REPORT

HPC Agenda Item #1  
 August 19, 2014  
 BZH-28149

*Property Location:* 400 2<sup>nd</sup> Street Southeast  
*Project Name:* Pillsbury “A” Mill Machine Shop Rehabilitation  
*Prepared By:* [John Smoley](#), Ph.D., Senior City Planner, (612) 673-2830  
*Applicant:* Schaffer Richardson  
*Project Contact:* Amanda Janzen  
*Ward:* 3  
*Neighborhood:* Marcy Holmes  
*Request:* To rehabilitate the Pillsbury “A” Mill Machine Shop for a new office use  
*Required Applications:*

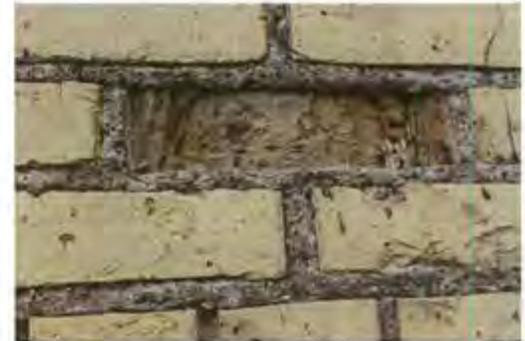
Damaged individual brick in field at random locations

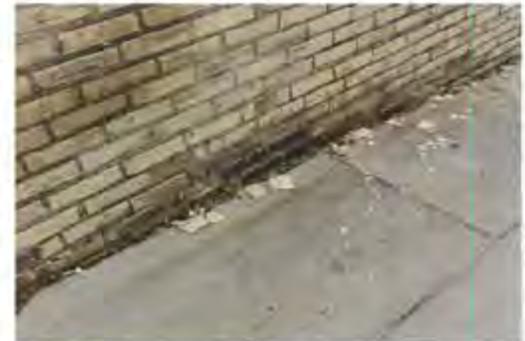
50 % brick replacement at the base of the structure sidewalk is needed.

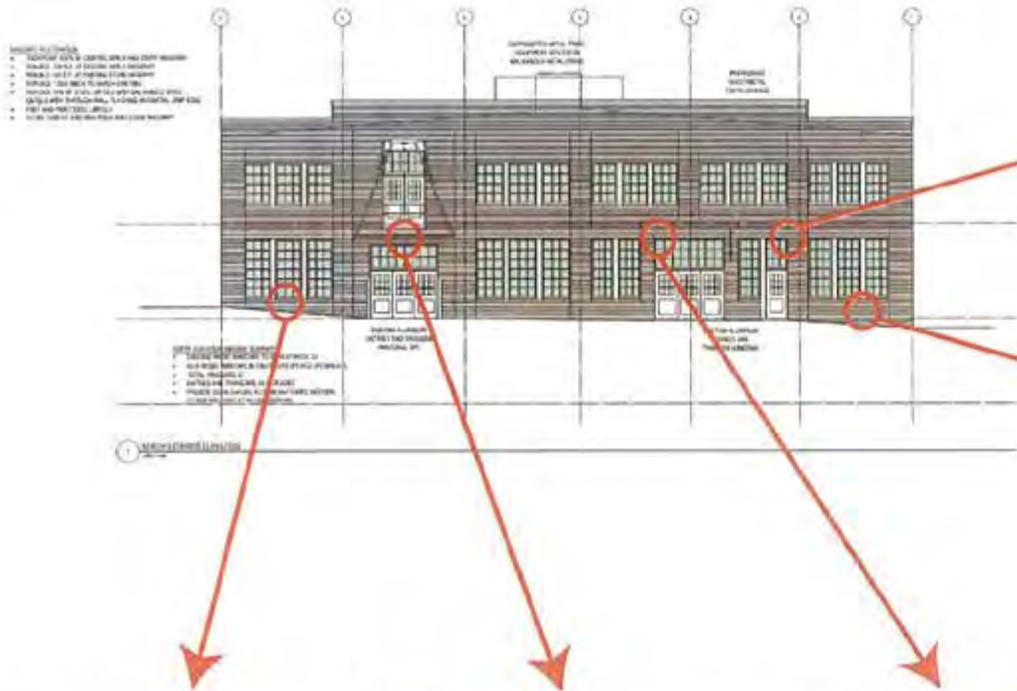
Brick over lintels delaminating and will be replaced with new brick to match.

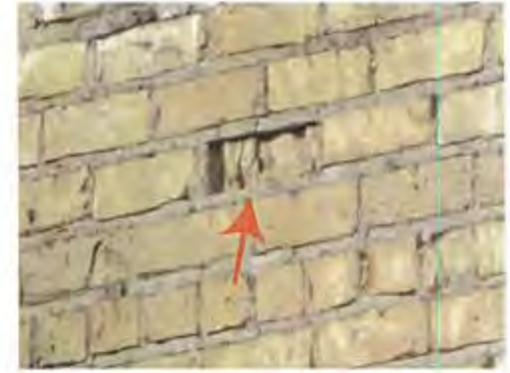
Typical delaminated brick in field  
Random locations.

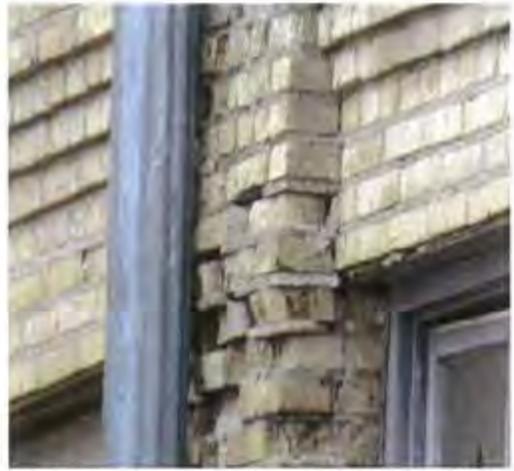
Column to require large field of brick replacement.

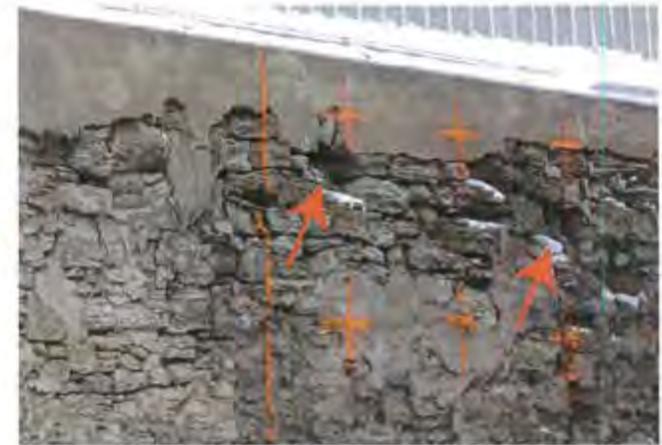
Missing stone sections.

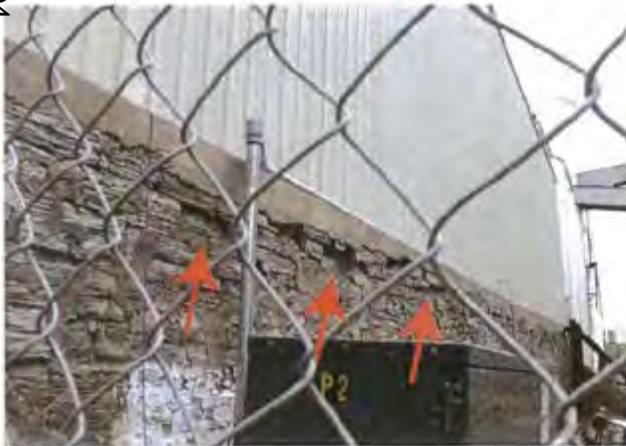
Missing stone to have new Platteville stone installed to match the existing.

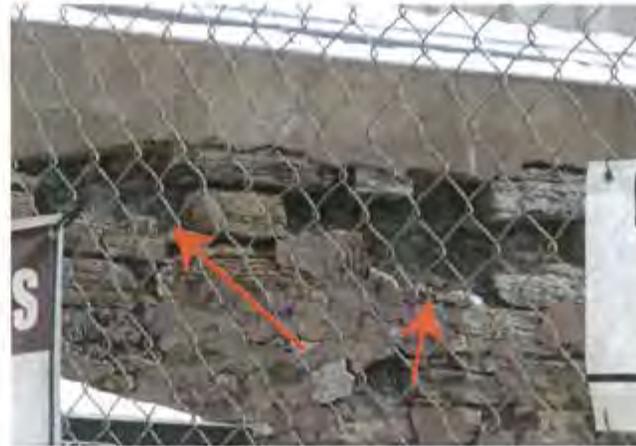
Missing stone sections.

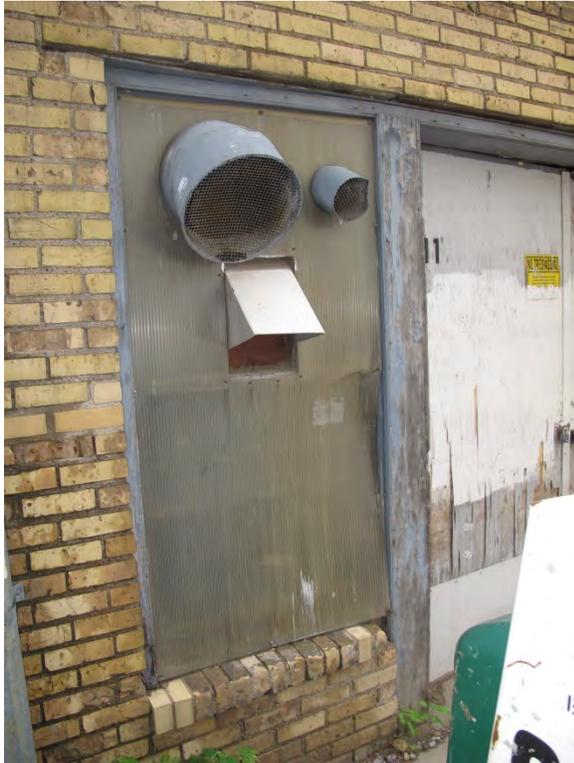
Window 001 Exterior

Frame and sash show rot at exterior. Upper sash heavily has been modified for mechanical penetration. Lower 6" of sash stop at right jamb is damaged.

*Note: Windows 001 through 010 are in generally poor condition, presumably due to their proximity to the sidewalk and resulting winter salt treatments and rain splash.*

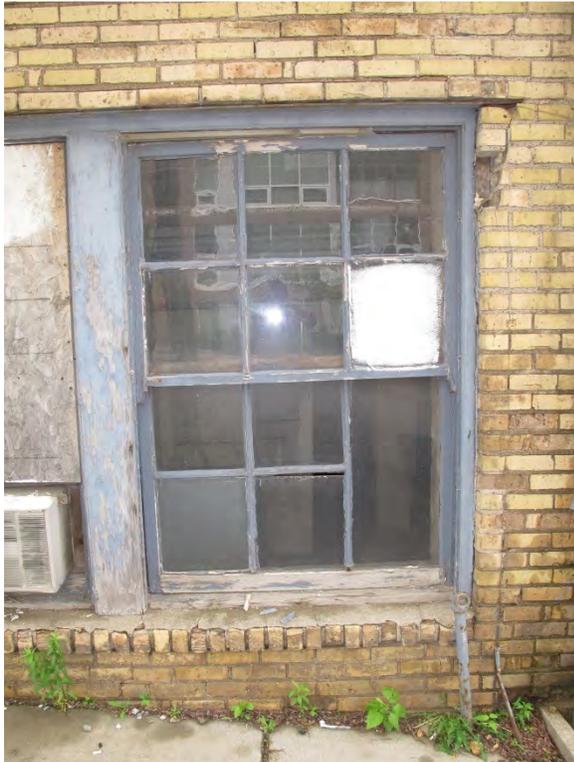
*Window 002 exterior*

Top rail of lower sash is rotten through. Sash stop at left jamb is splintered at upper sash. Muntins in lower sash modified.

*Note: Windows 001 through 010 are in generally poor condition, presumably due to their proximity to the sidewalk and resulting winter salt treatments and rain splash.*

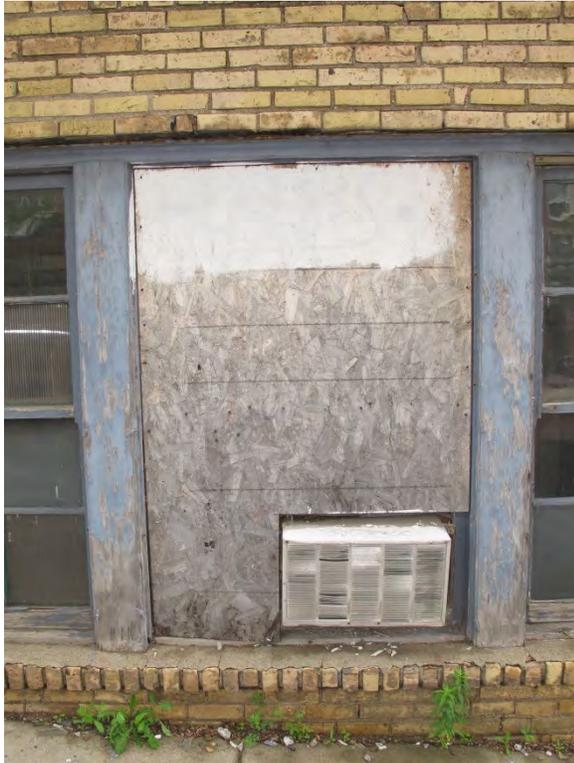
*Window 003 exterior*

Frame and sash show rot at exterior. Frame and lower sash have been heavily modified for A/C unit.

*Note: Windows 001 through 010 are in generally poor condition, presumably due to their proximity to the sidewalk and resulting winter salt treatments and rain splash.*

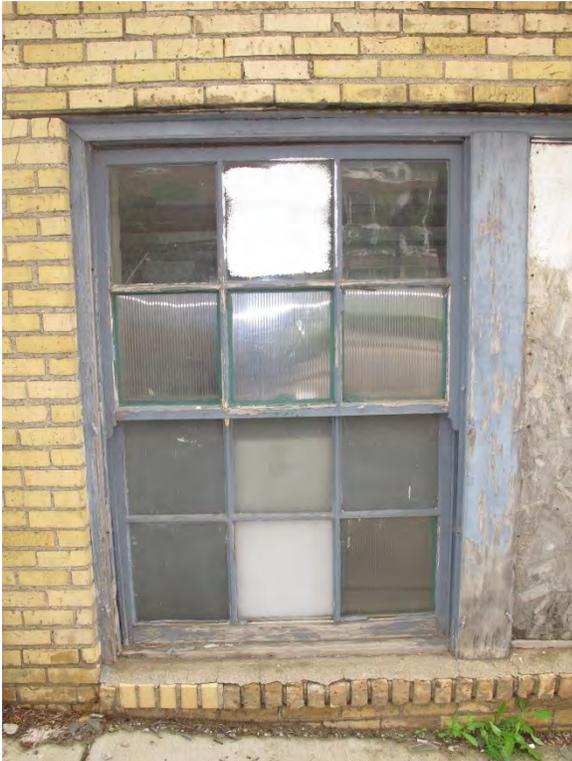
*Window 004 exterior*

Sash stops at left and right jambs are broken.

*Note: Windows 001 through 010 are in generally poor condition, presumably due to their proximity to the sidewalk and resulting winter salt treatments and rain splash.*

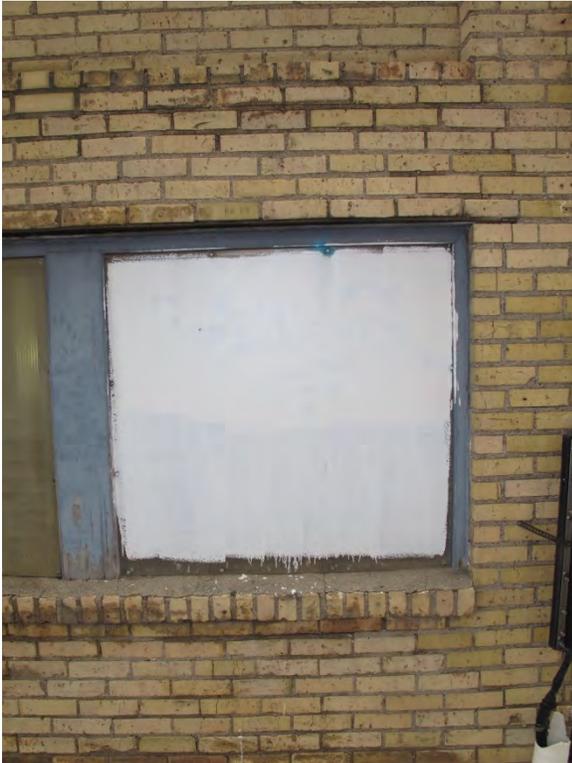
Window 005 exterior

Frame and sash show rot at exterior. Lower sash has been heavily modified for ventilation equipment.

*Note: Windows 001 through 010 are in generally poor condition, presumably due to their proximity to the sidewalk and resulting winter salt treatments and rain splash.*

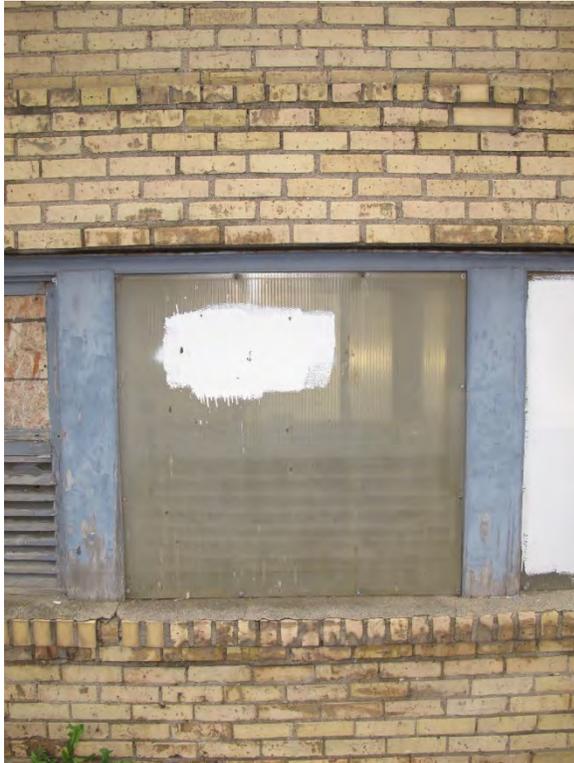
Window 006 exterior

Frame and sash show rot at exterior. Wood louvers have been added at exterior of lower sash. Sash stops at right and left jambs are missing.

*Note: Windows 001 through 010 are in generally poor condition, presumably due to their proximity to the sidewalk and resulting winter salt treatments and rain splash.*

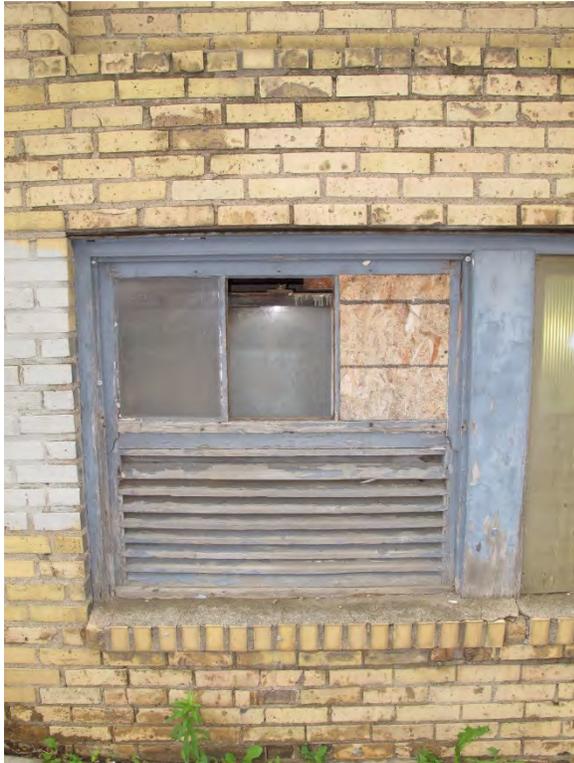
*Window 007 exterior*

Frame and sash show rot at exterior. Wood louvers have been added at exterior of lower sash.

*Note: Windows 001 through 010 are in generally poor condition, presumably due to their proximity to the sidewalk and resulting winter salt treatments and rain splash.*

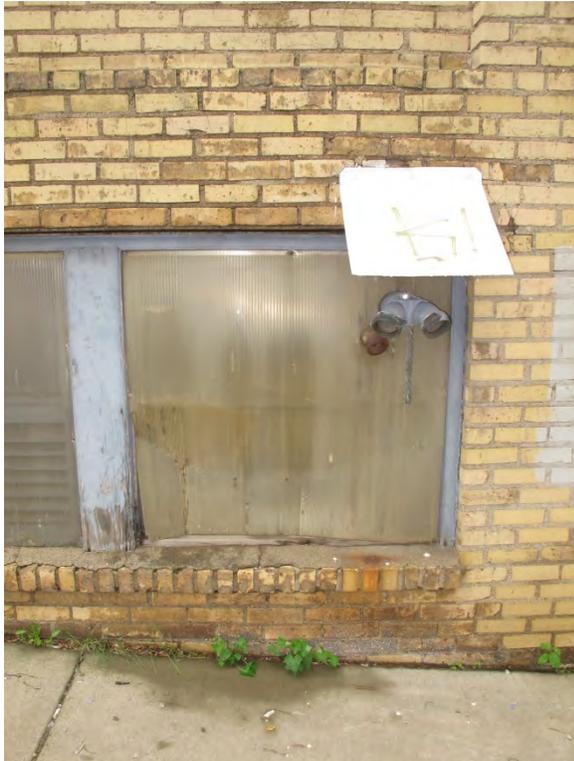
*Window 008 exterior*

Frame and sash show rot at exterior. Upper sash has been modified for pipe penetrations.

*Note: Windows 001 through 010 are in generally poor condition, presumably due to their proximity to the sidewalk and resulting winter salt treatments and rain splash.*

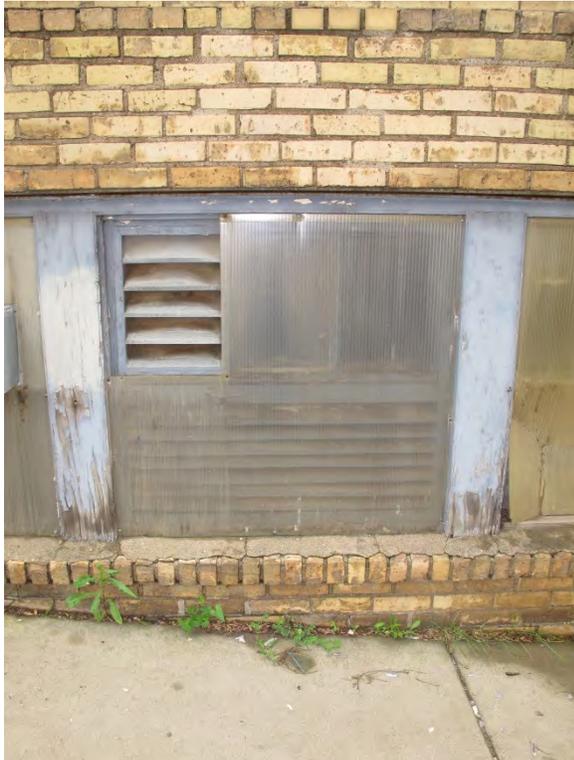
Window 009 exterior

Frame and sash show rot at exterior. Wood louvers have been added at exterior of lower sash. Upper sash modified for mechanical penetrations.

*Note: Windows 001 through 010 are in generally poor condition, presumably due to their proximity to the sidewalk and resulting winter salt treatments and rain splash.*

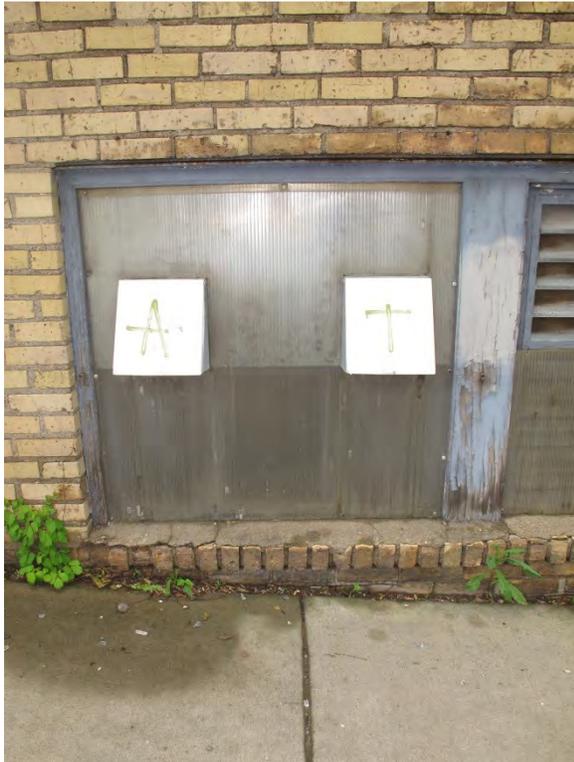
*Window 010 exterior*

Frame and sash show rot at exterior. Upper sash has been removed for mechanical penetrations. Sash stops at right and left jambs missing.

*Note: Windows 001 through 010 are in generally poor condition, presumably due to their proximity to the sidewalk and resulting winter salt treatments and rain splash.*

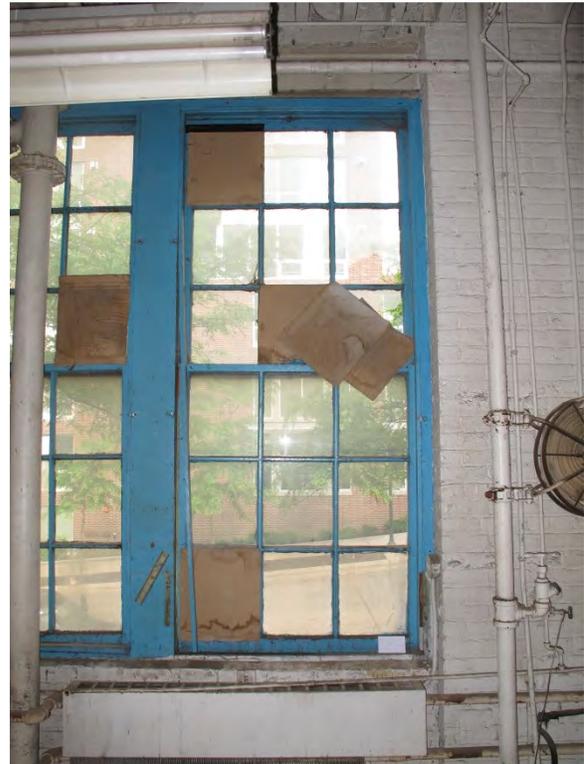
*Window 112 interior*

Interior stool is missing. Sash stop at left jamb is loose.

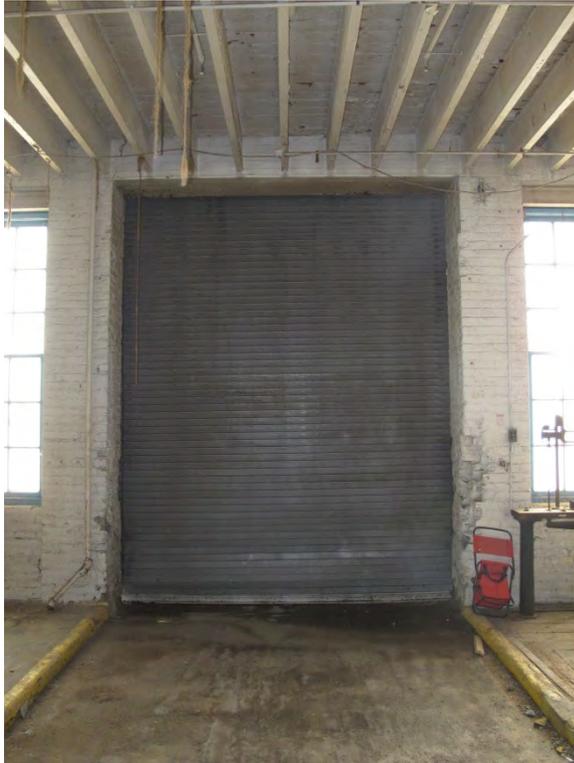
Original door/transom has been replaced with coiling overhead door.

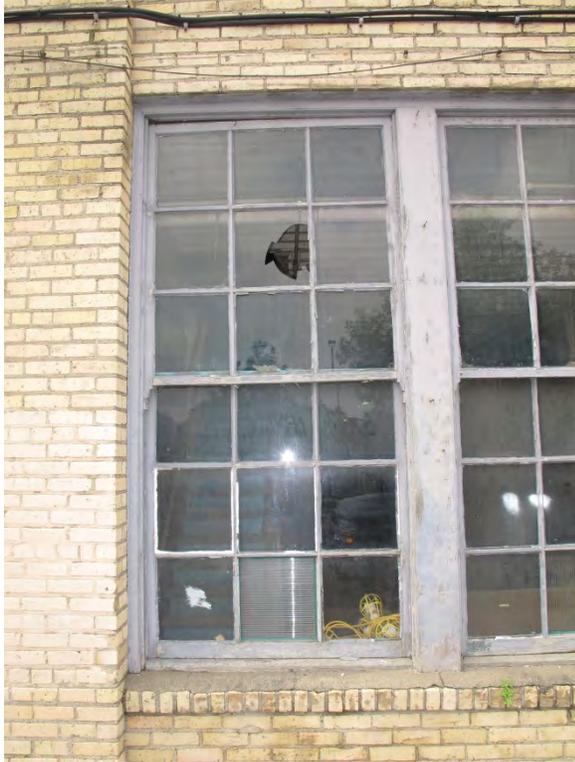
*Window 132 exterior*

Portion of sash stop at left jamb has been replaced and is mismatched.

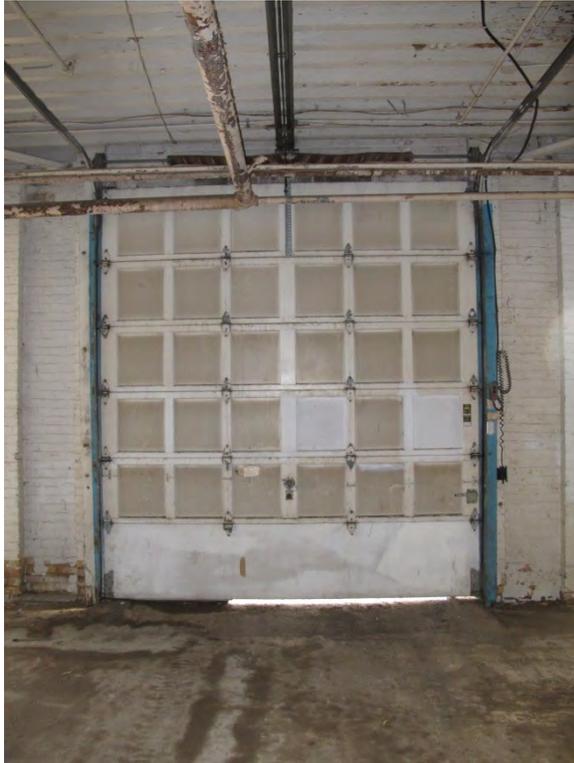
Original door/transom has been replaced with segmental overhead door.

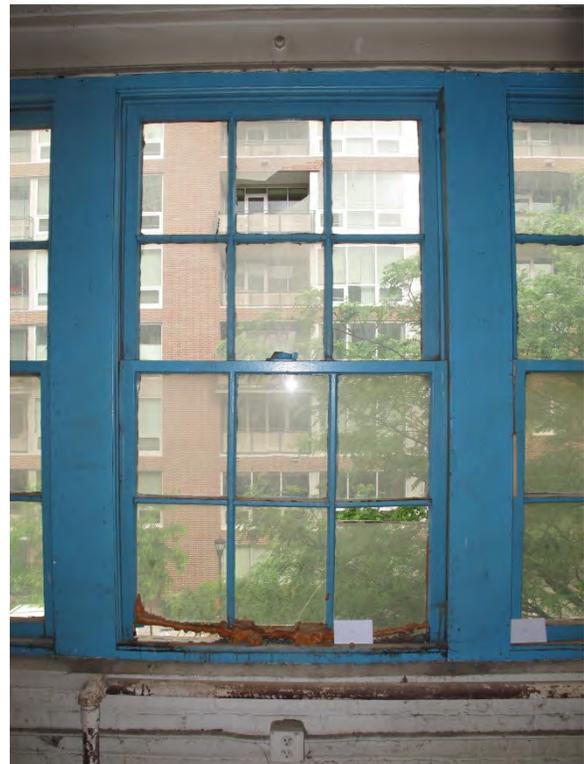
*Window 202 interior*

Sash stop at right jamb is missing. Bottom rail of lower sash is missing.

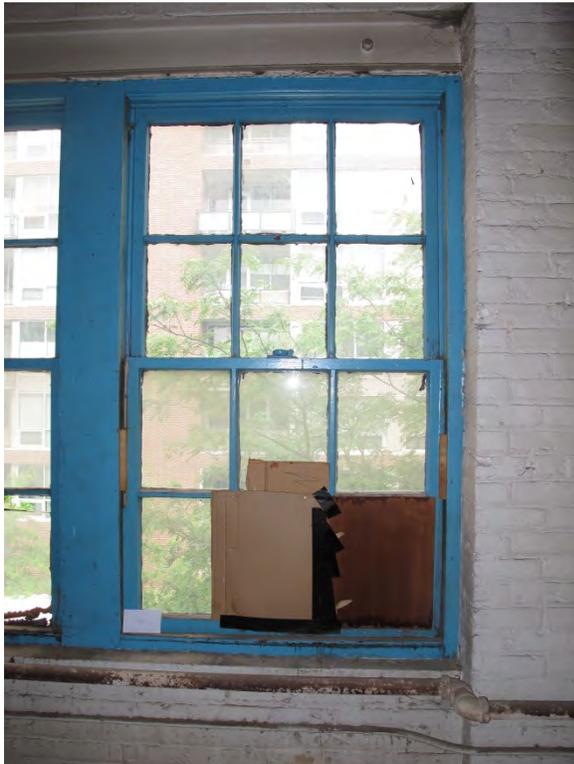
*Window 203 interior*

Sash stops at both jambs missing. Bottom rail of lower sash is rotten through.

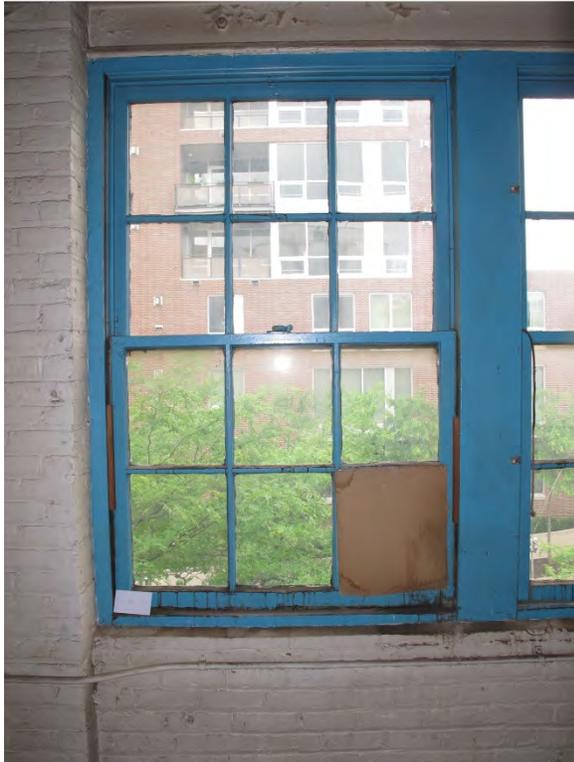
*Window 210 interior*

Interior stool is missing. Sash stops at both  
jamb are missing.

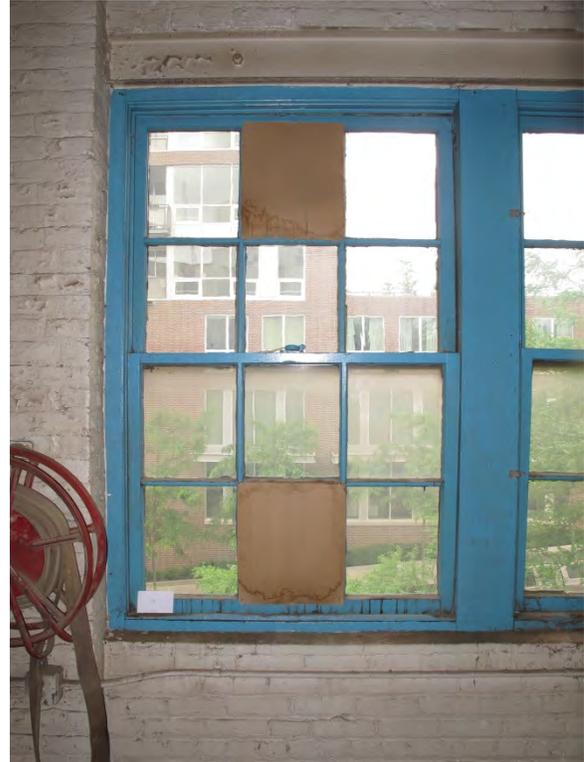
*Window 213 interior*

Sash stop at right jamb is missing.

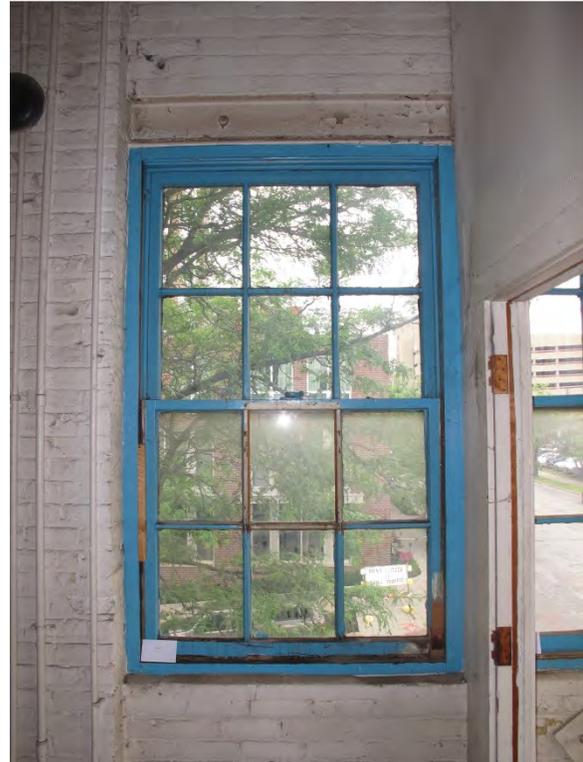
*Window 219 interior*

Interior stool and sash stops at both jambs  
are missing.

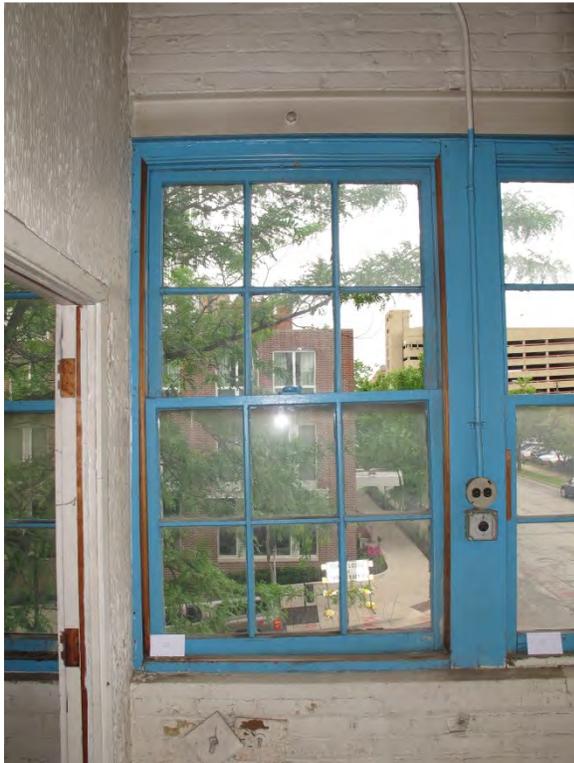
*Window 220 interior*

Sash stops at both jambs have been replaced and are mismatched.

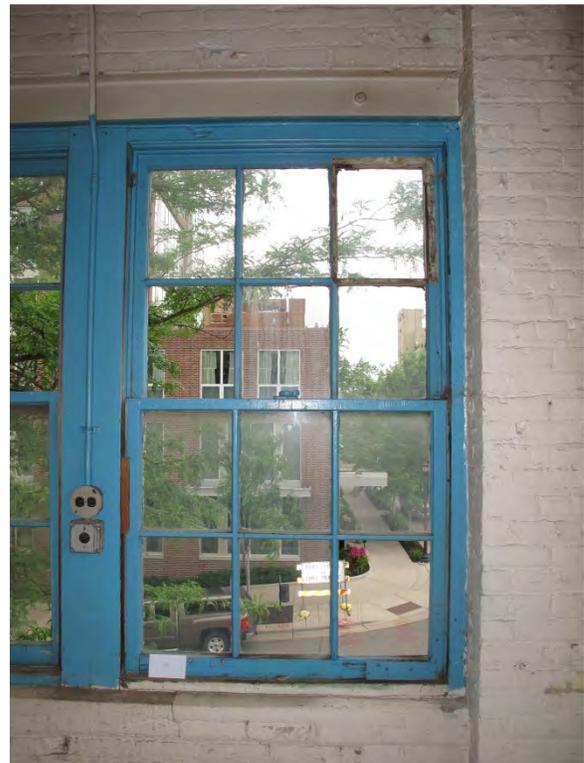
*Window 221 interior*

Interior stool and sash stops at both jambs are missing. Bottom rail of lower sash is rotten through. Lower right corner of lower sash is reinforced with a steel gusset.

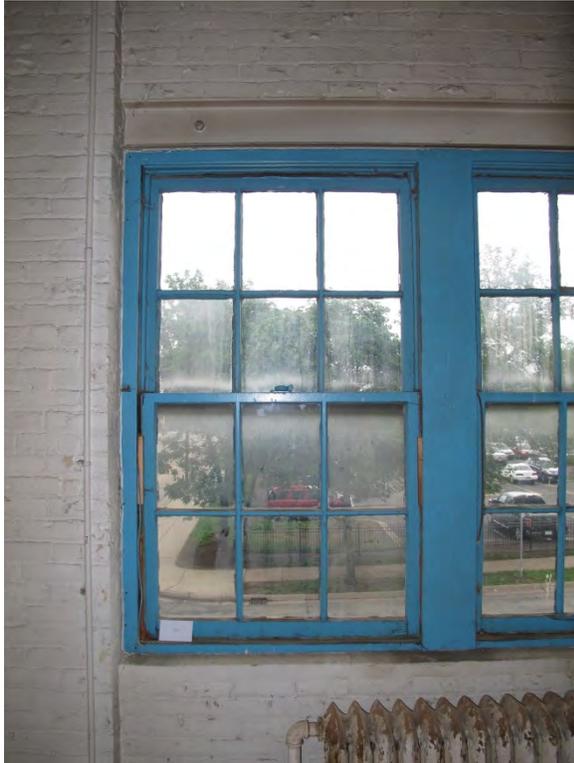
*Window 222 interior*

Interior stool and sash stops at both jambs missing.

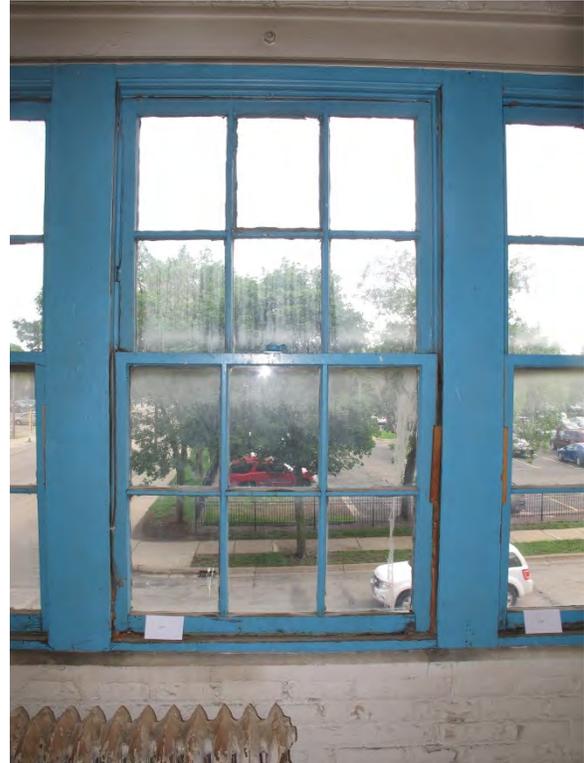
*Window 223 interior*

Interior stool and sash stops at both jambs missing.

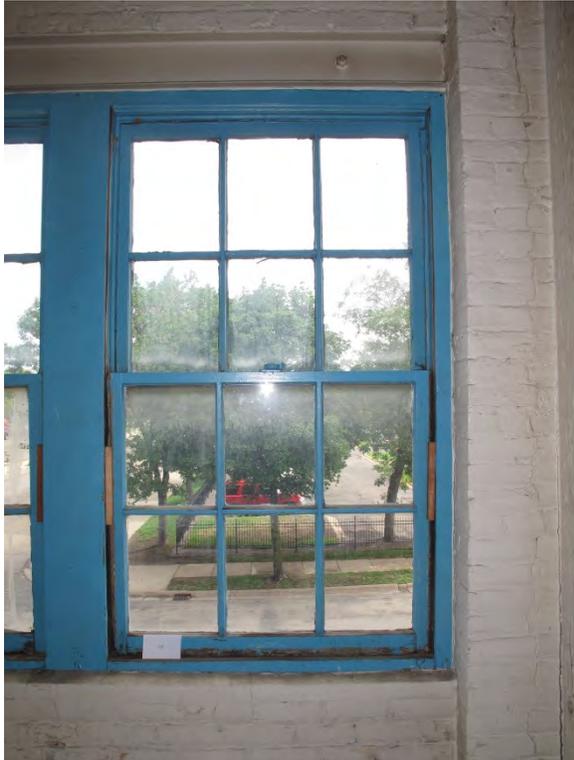
*Window 224 interior*

Interior stool and sash stops at both jambs missing.

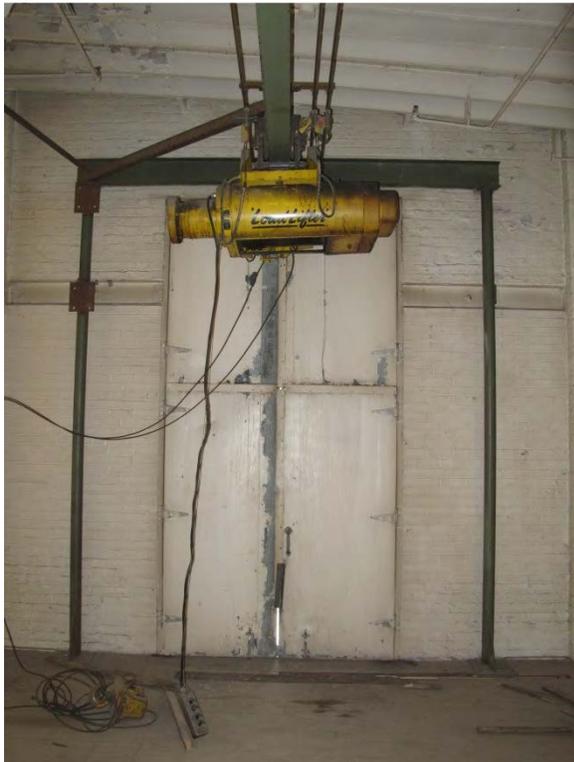
*Window 234 interior*

Per the original construction documents, a typical gang of three hung windows was originally present in this location. The masonry opening has been modified and the windows have been replaced with a solid door to accommodate a trolley crane.

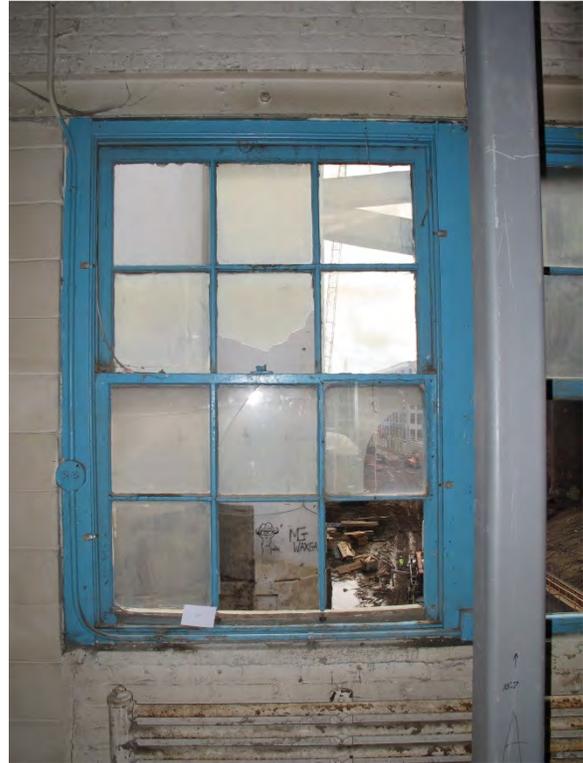
*Window 254 interior*

Bottom rail of lower sash is missing.

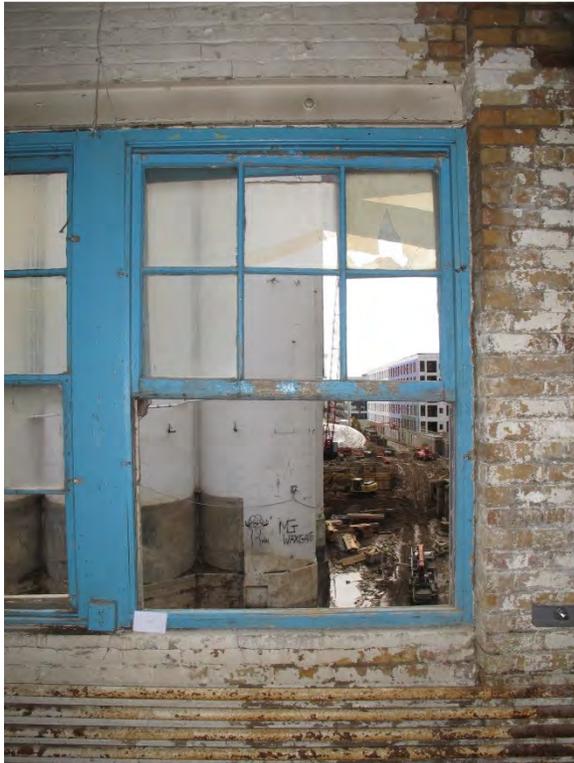
*Window 255 interior*

Most of upper sash is missing.

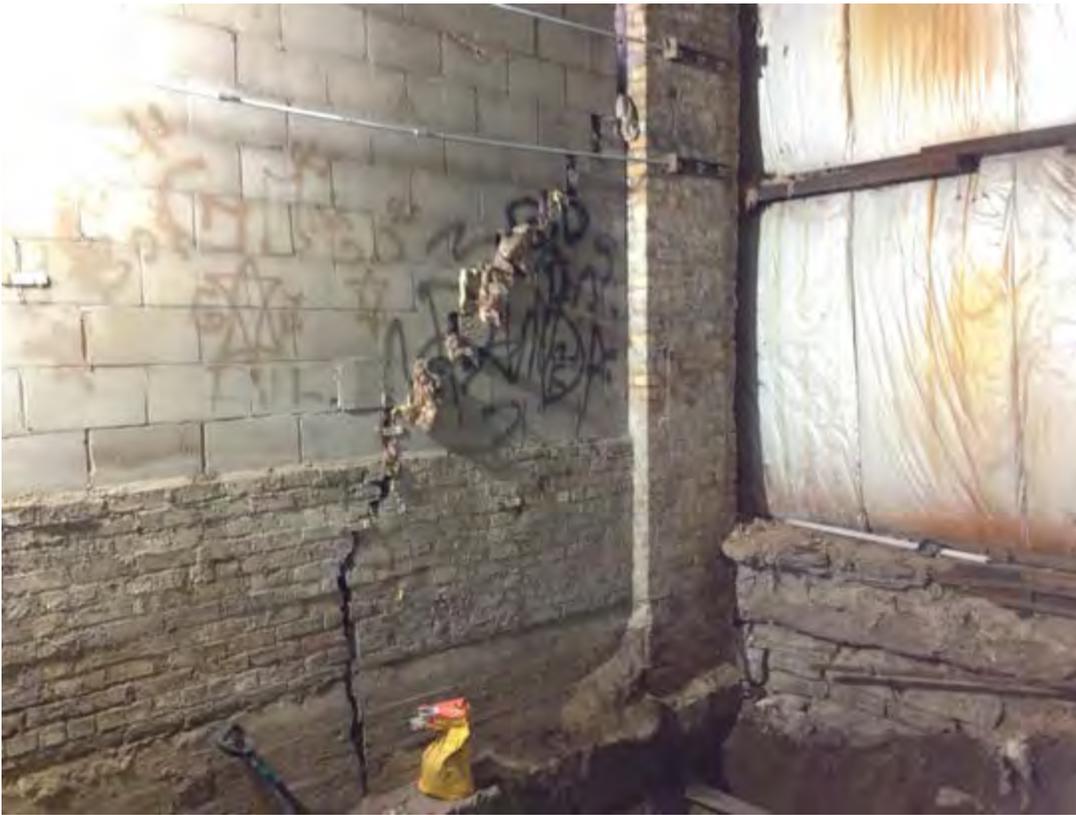
Interior view of southeast corner that will be stabilized and repaired.

proposed work is at the corner of the building that is least visible from the public right-of-way and is in keeping with the rehabilitation guidelines of *The Secretary of the Interior's Standards for the Treatment of Historic Properties*. Attachment E5 includes notes that propose to both restore the masonry wall and also leave temporary bracing in place. For clarity's sake, staff recommends the project be conditioned to ensure the temporary exterior bracing be removed once stabilization of the southeast corner is complete.

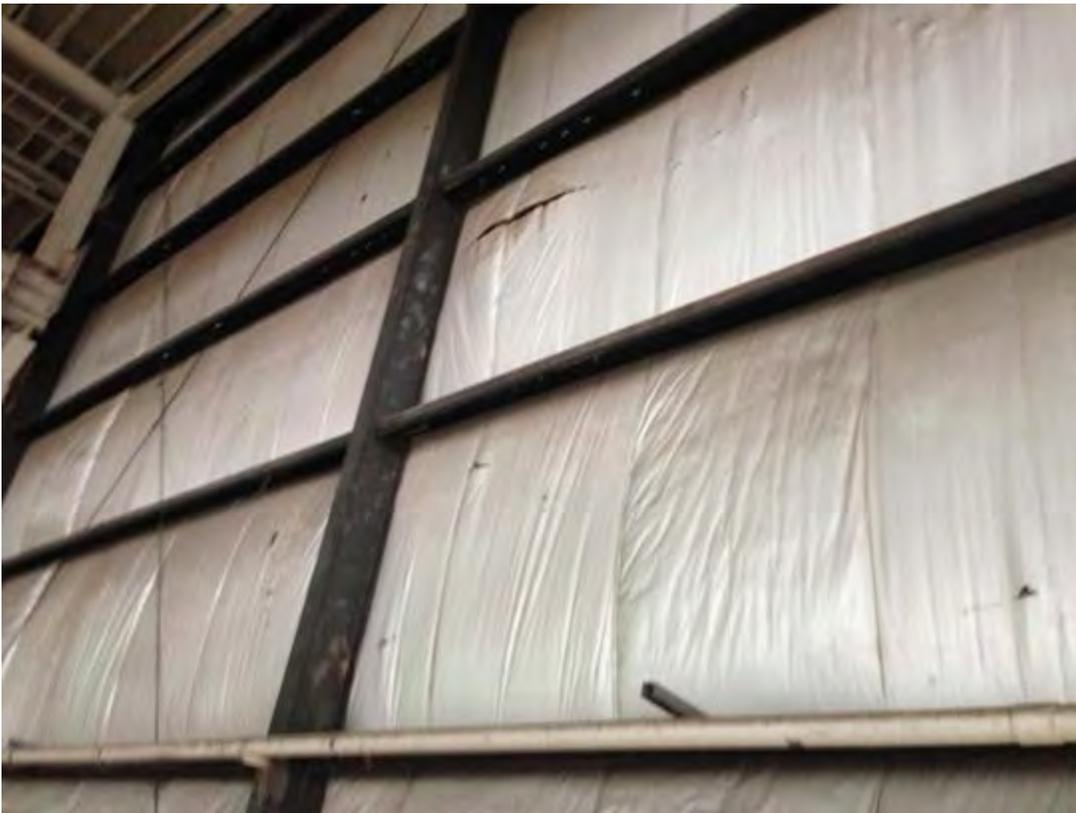
South wall to be removed and replaced with glass and aluminum curtainwall.
