# CPED STAFF REPORT

Prepared for the Heritage Preservation Commission  
 HPC Agenda Item #2  
 May 17, 2016  
 BZH-29075

*Property Location:* 1721 University Avenue SE  
*Project Name:* Re-Stucco of the Students' Cooperative  
*Prepared By:* Shanna Sether, Senior City Planner, (612) 673-2307  
*Applicant:* Students' Co-Operative, Inc.  
*Project Contact:* Madeline Reed  
*Ward:* 2  
*Neighborhood:* University, near Prospect Park  
*Request:* To apply new stucco over the existing stucco building, remove permastone on the front and sides of the building and reapply stucco, repair window sills, repair the existing front porch and add a new metal railing.

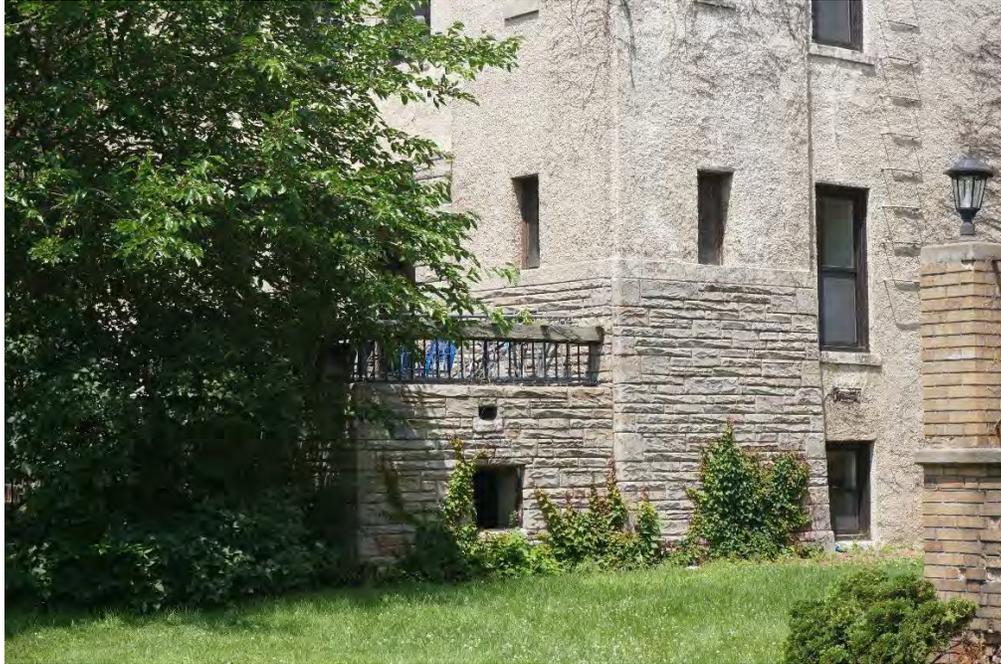
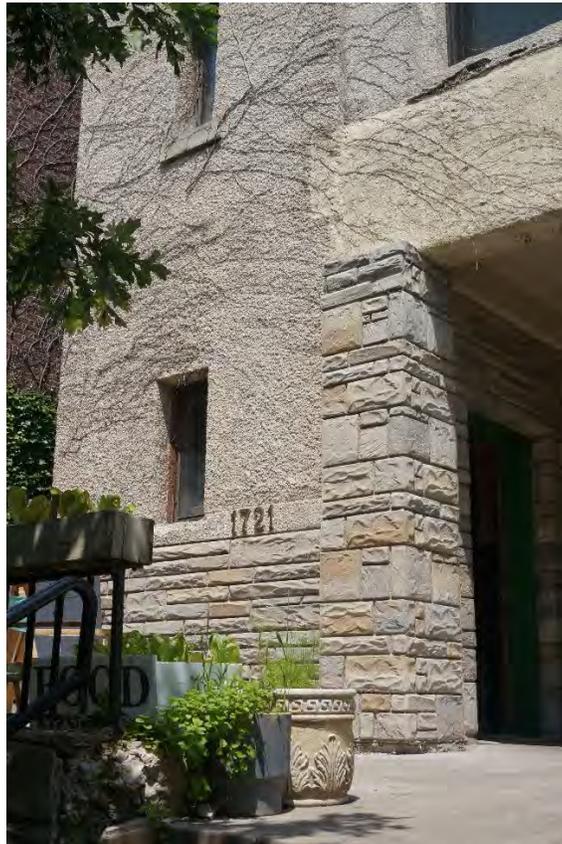
On the front of the building, including some areas wrapping around the sides, Permastone was installed over the original stucco. Permastone was a brand name for a stucco-like simulated stone that was popular in the 1950's, and was probably added to the building about that time. In order to properly restore the original historic façade, we will remove all the remaining Permastone. We will then install new stucco using galvanized metal lath, a two-coat stucco base, and a stucco finish.

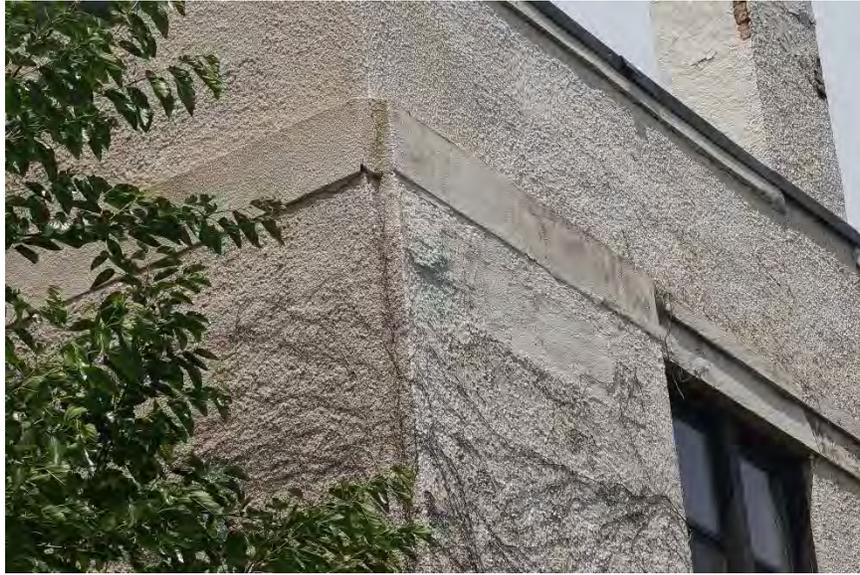
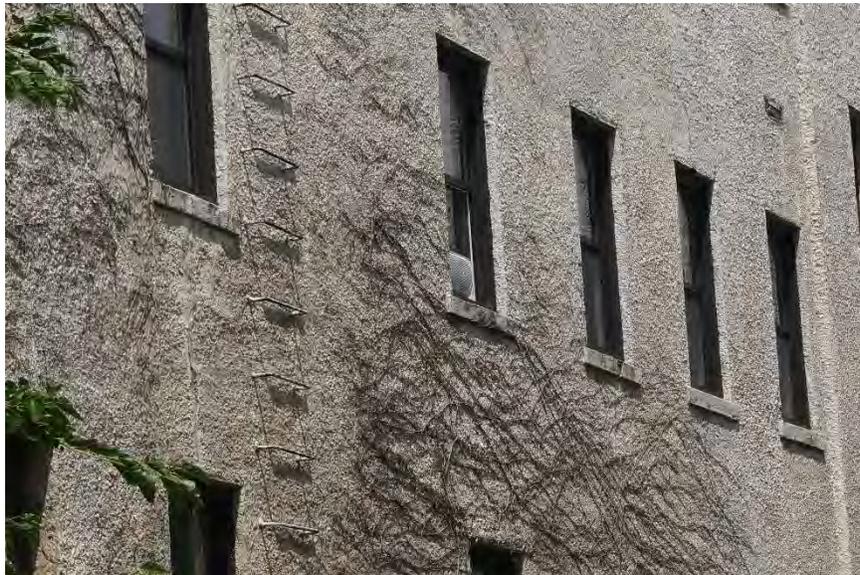
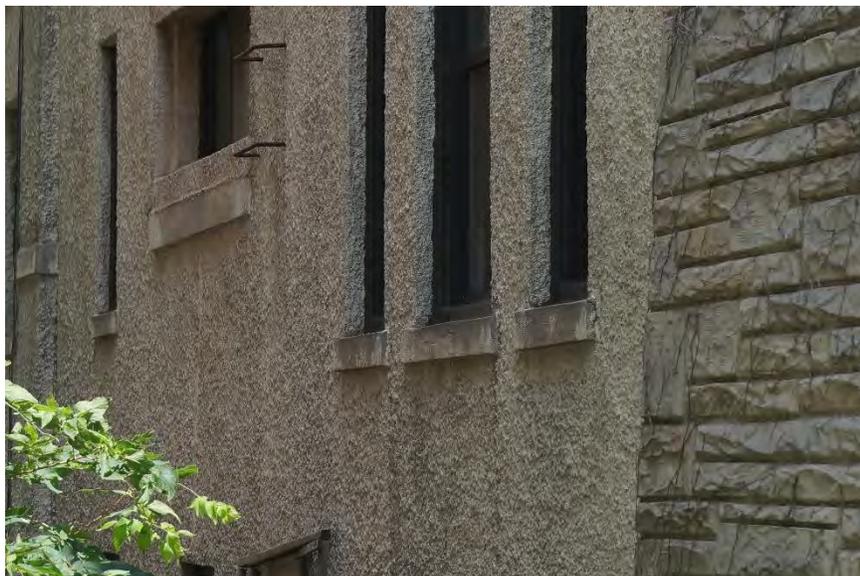
On the horizontal bands and window sills, we will repair all of the loose and missing stucco. We will replicate these accent bands and sills with galvanized metal lath and corner beads. We will then apply a two coat base. We will then apply an acrylic finish, enabling an exact color match combined with the smoother finish.

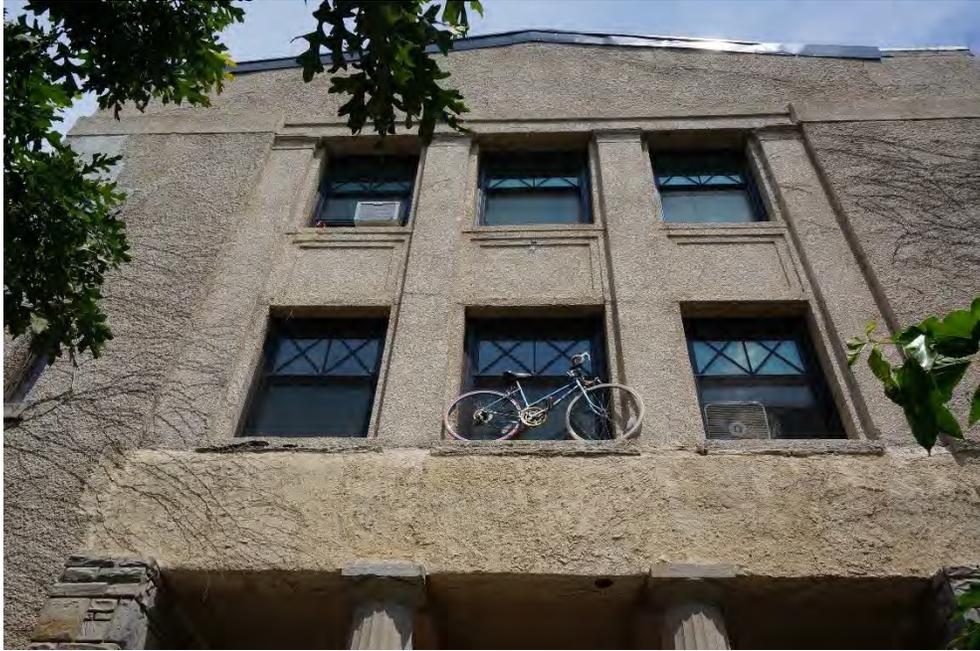
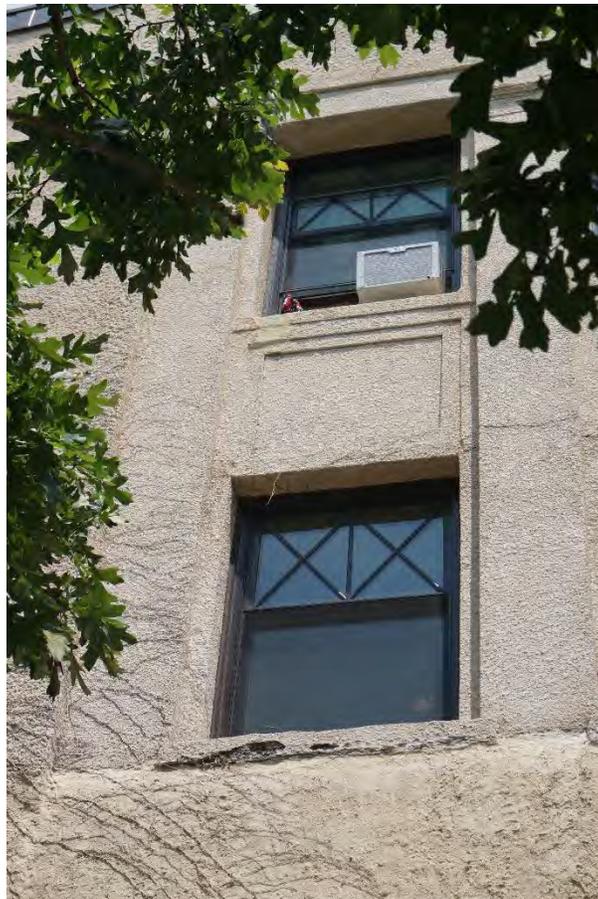
On the façade facing University Avenue, the center/inset details of the building originally had a smooth stucco finish. At some point in the building's history, these areas were "dashed," or textured with the same stucco texture that is on the main body of the rest of the building. We will first install galvanized metal lath and corner beads to recreate these details. We will then apply a stucco base coat to these areas, which will be leveled and floated to prepare the surface for the new stucco finish coats. We will then apply an acrylic stucco finish to these areas, which will restore the original color and texture of the inset areas and details.

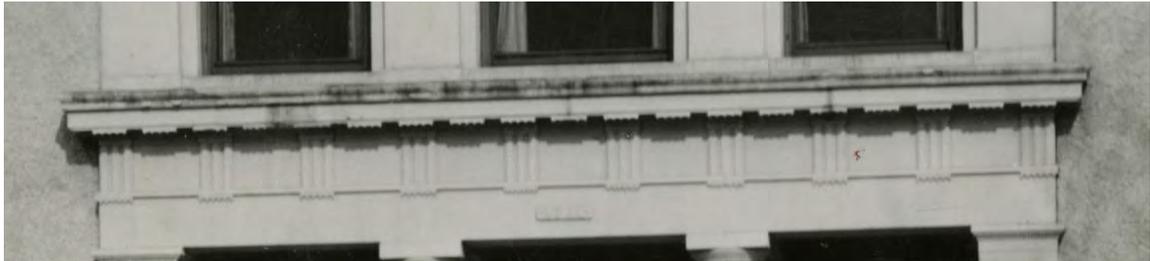
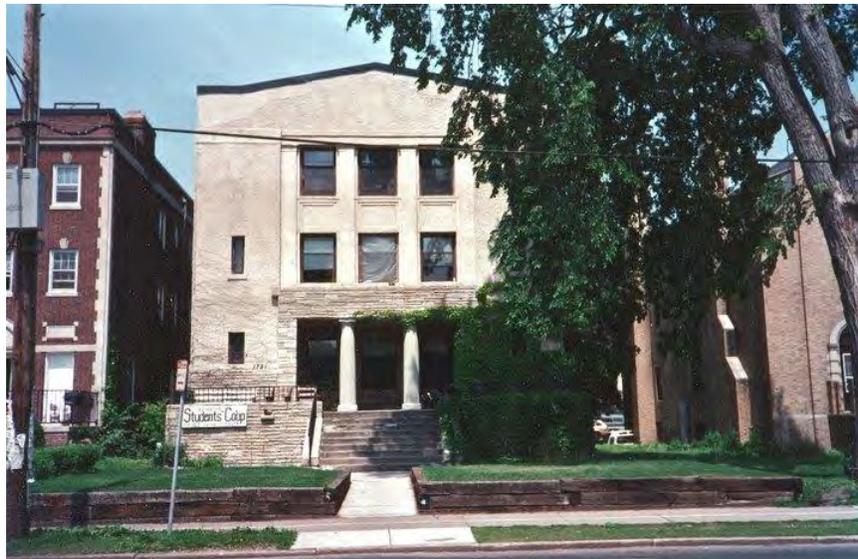
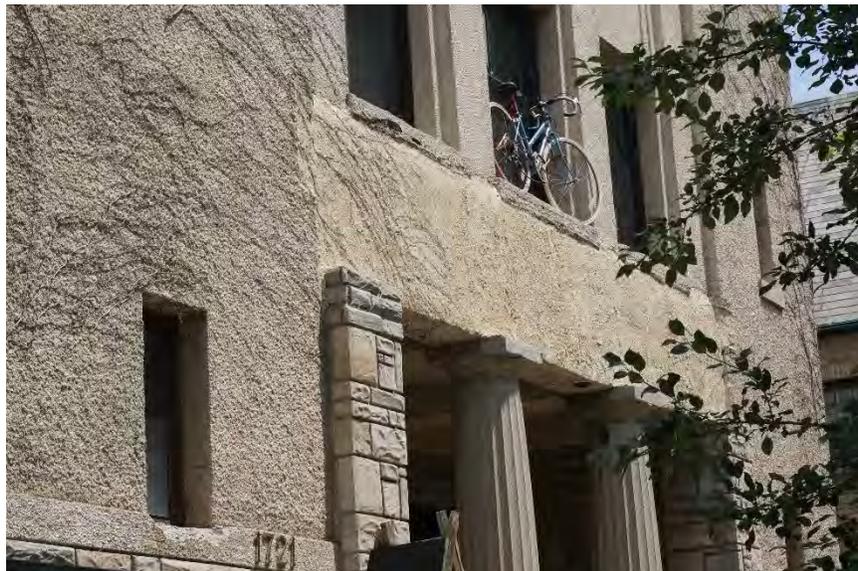
Also on the façade facing University Avenue, we will replicate the original detail over the front entrance. We will recreate this molding using a foam substrate, which will be covered with fiberglass mesh and an acrylic stucco base coat. The foam will enable us to create a similar shape to the original, while being much lighter than the original concrete. It appears that the original detail fell off or was removed prior to the 1950's, as an image from 1981 shows identical Permastone to the other areas at that location. More recently, this Permastone also deteriorated or fell off, and was patched with stucco.

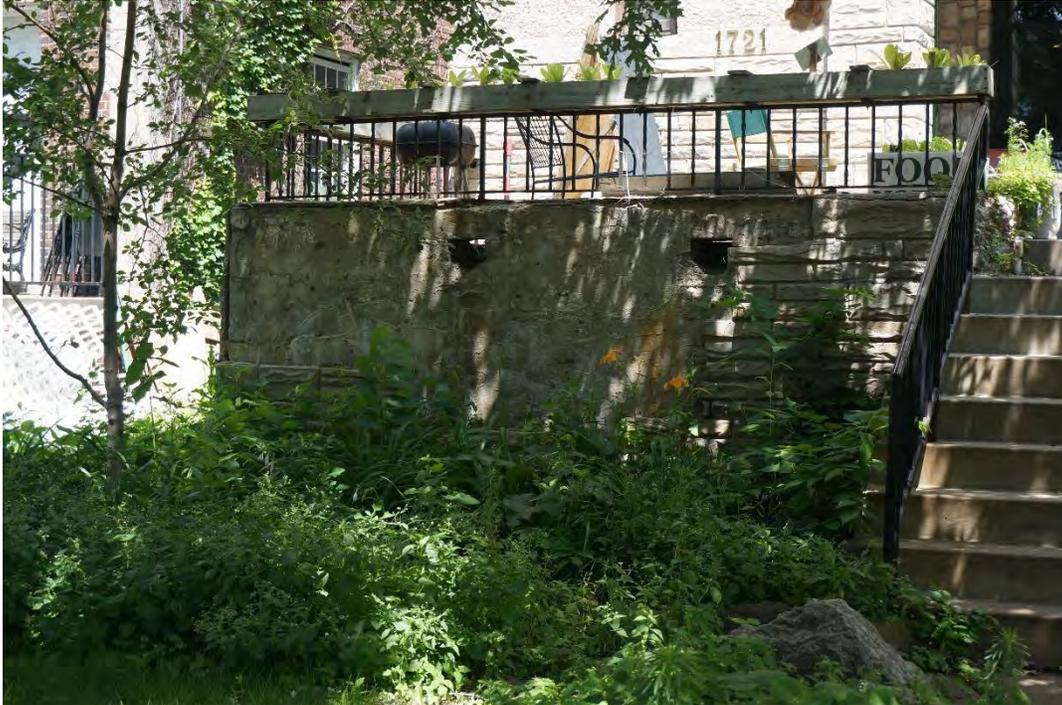
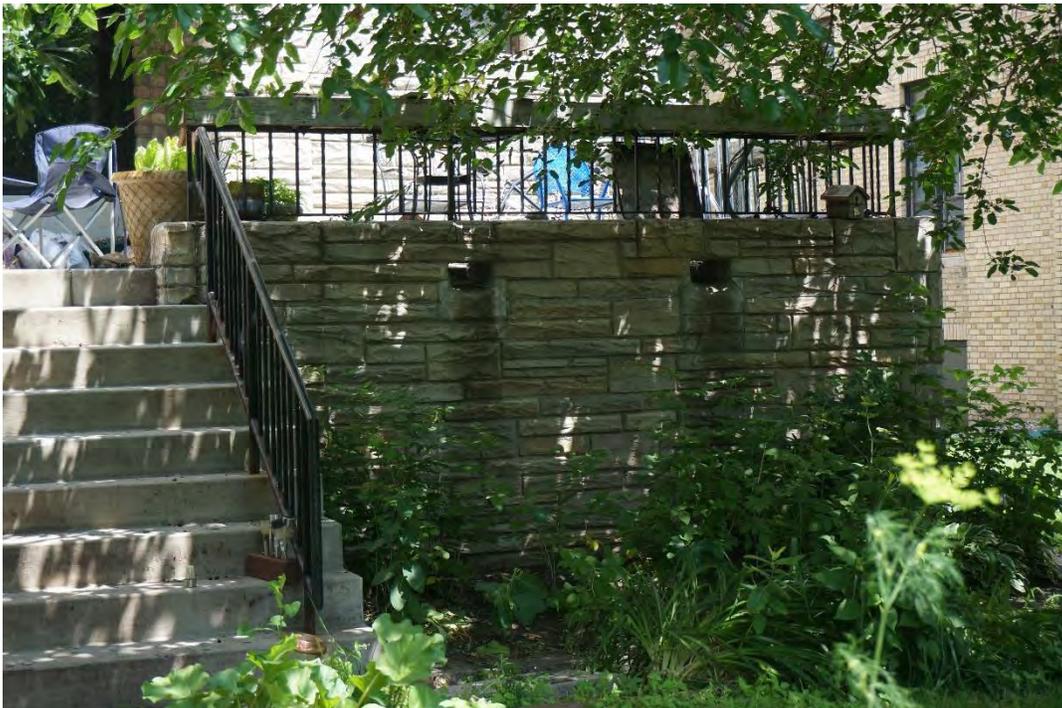
On the front porch, we will remove all of the remaining PermaStone from the walls. We will also remove the existing railing. We will pour concrete cap to match the historic look of the original porch, while providing a drip edge for the walls of the porch. We will install galvanized metal lath to the walls of the porch, followed by a two-coat stucco base. We will then apply a two-coat traditional stucco finish, matching the color and texture of the body of the building. Following the installation of the new stucco to the porch, we will install a 36" high aluminum railing on top of the new cap in order to meet municipal code standards.

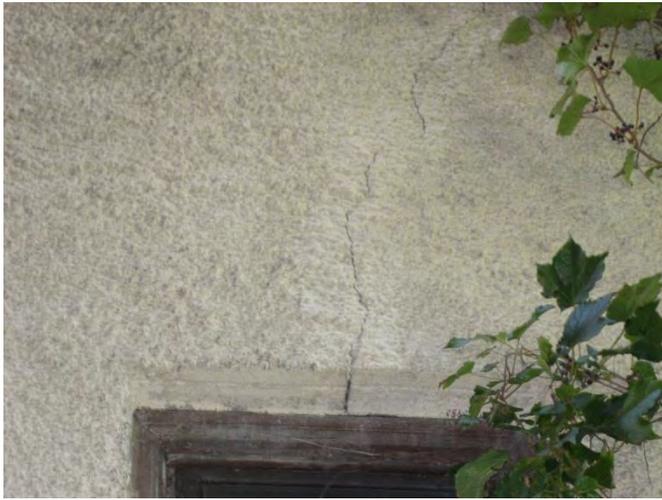
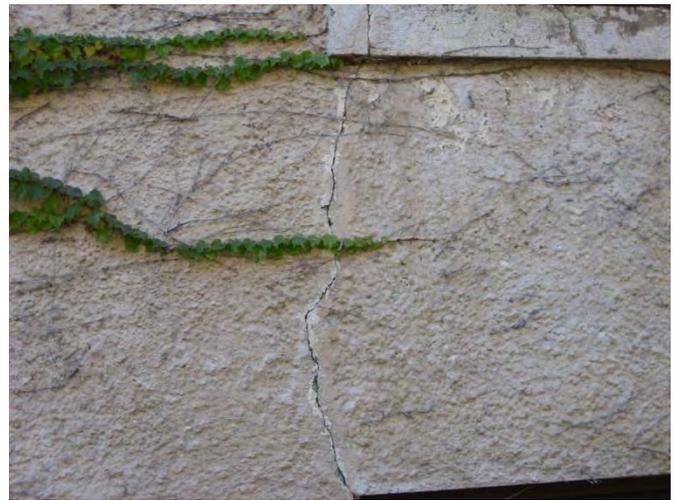
These are typical cracks that currently exist in the stucco. There are several areas that have similar cracks. We will install new galvanized metal lath to all of the existing stucco on the building. We will fasten the lath into the existing stucco using  $\frac{3}{4}$ " and 1" stub nails. We will install stucco expansion joints wherever necessary and appropriate. We will apply a two-coat stucco base to the lath, which will be leveled and floated to prepare for the stucco finish. We will allow the base coats to dry and cure, and then we will return to apply a two-coat stucco finish, using a color and texture that is appropriate for the overall historic restoration project.

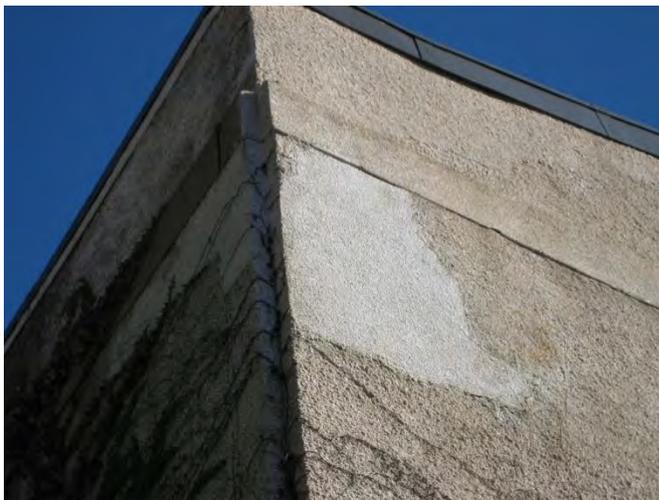
This is an example of an area of the stucco that has been previously repaired. The color and texture of these patches are not consistent with the rest of the building. With the installation of the new three-coat stucco system, the new finish coats will provide a uniform color and texture to the entire building, matching the color and texture of the historic stucco as closely as possible.

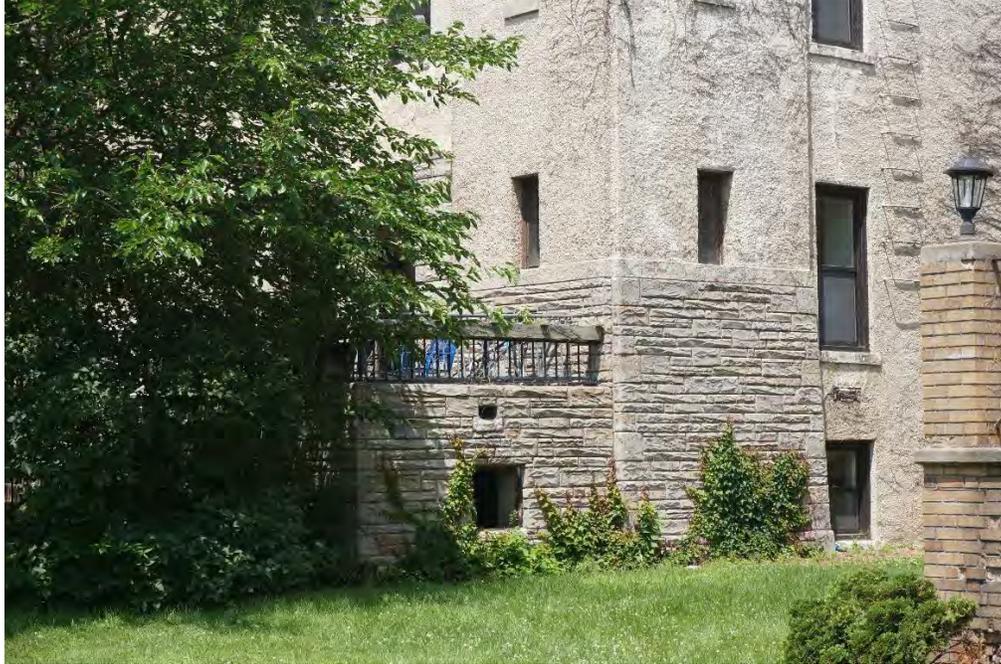
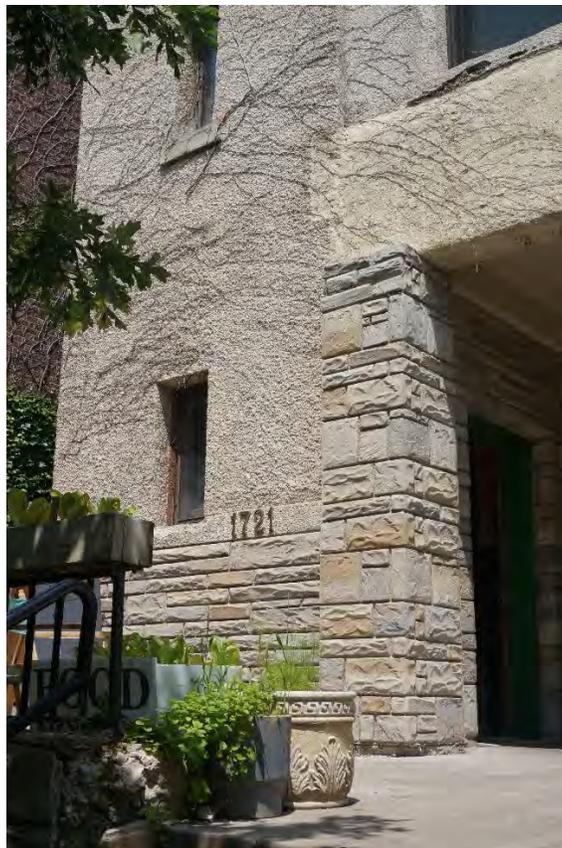
On the front of the building, including some areas wrapping around the sides, Permastone was installed over the original stucco. Permastone was a brand name for a stucco-like simulated stone that was popular in the 1950's, and was probably added to the building about that time. In order to properly restore the original historic façade, we will remove all the remaining Permastone. We will install new stucco using galvanized metal lath, a two-coat stucco base, and a stucco finish.

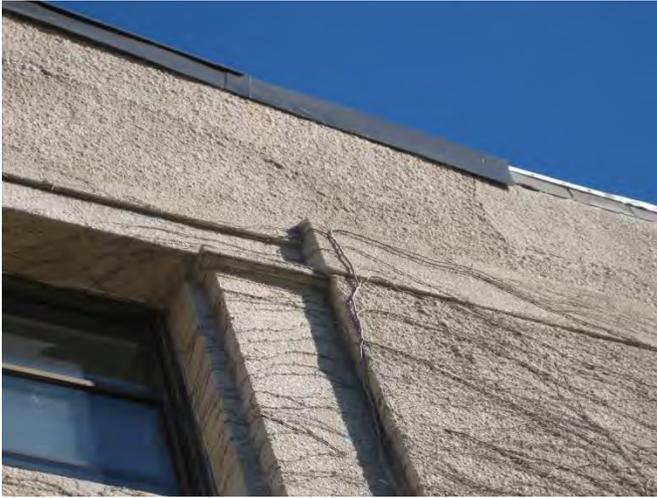
On the building's front façade, there are areas where the existing stucco appears loose, and is bulging. We will remove any and all loose existing stucco on the building before installing the new galvanized metal lath, in order to ensure that the new stucco is properly fastened to a sound and sturdy surface.

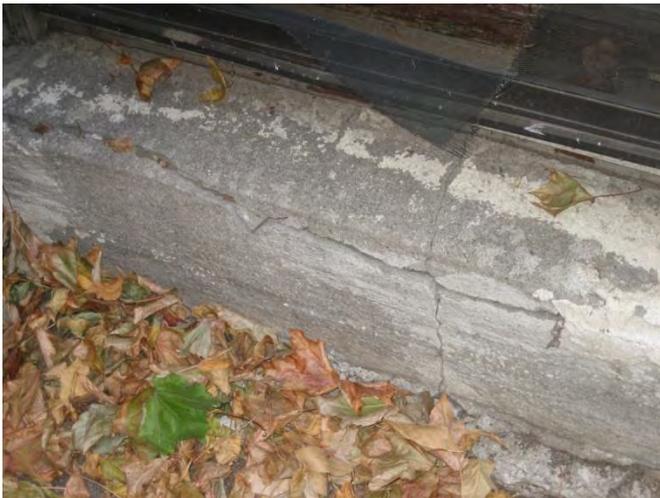
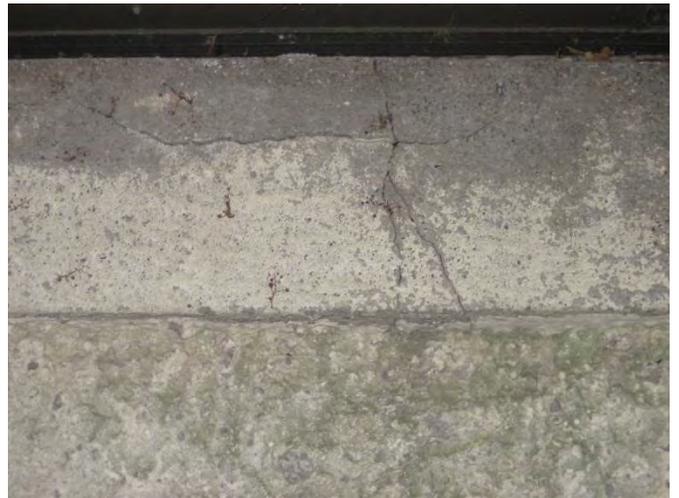
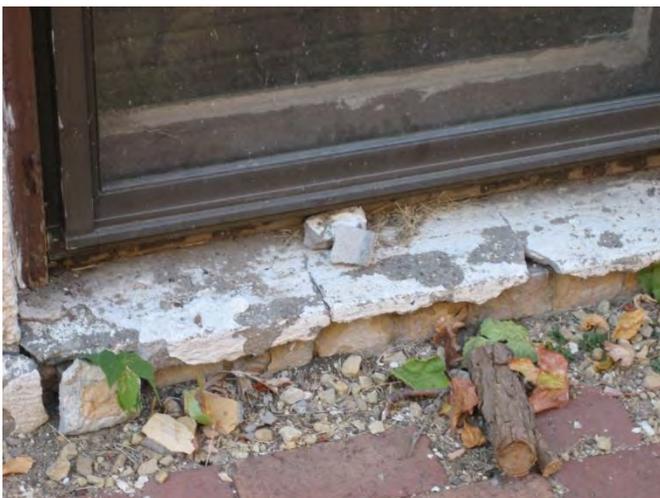
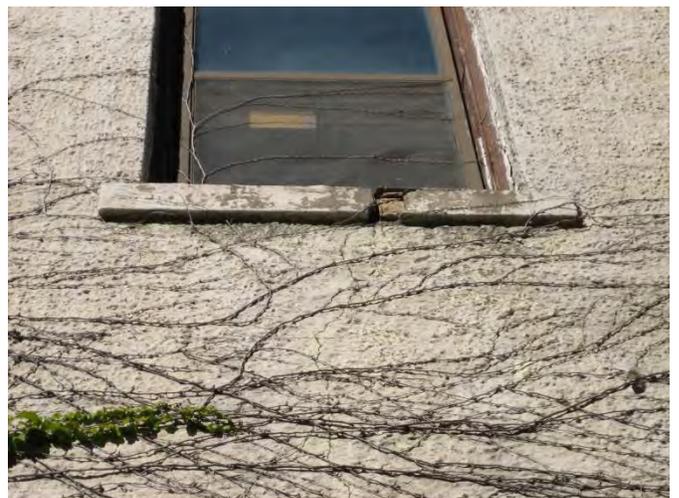
Many of the window sills are cracked and deteriorated. We will install galvanized metal lath and new stucco on the sills in order to repair and restore them. We will apply a smooth stucco finish to the sills to match the historic appearance of the building.

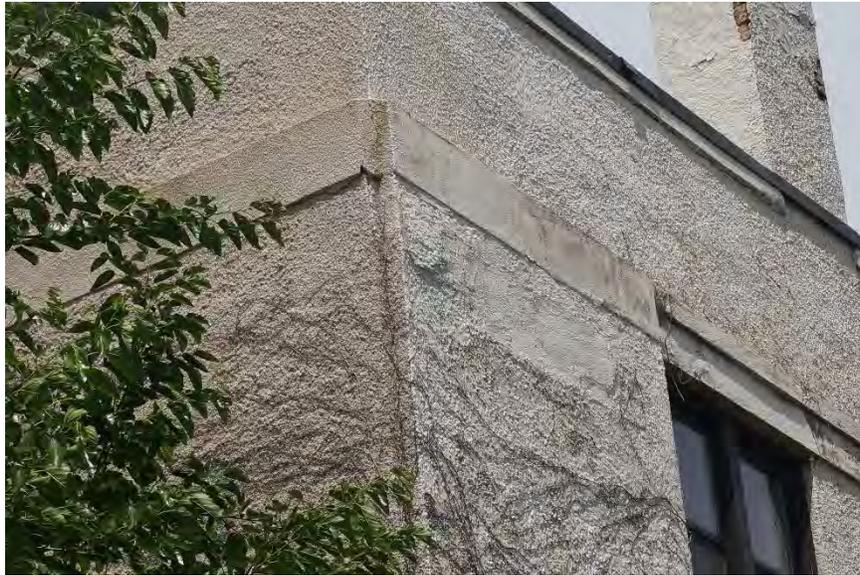
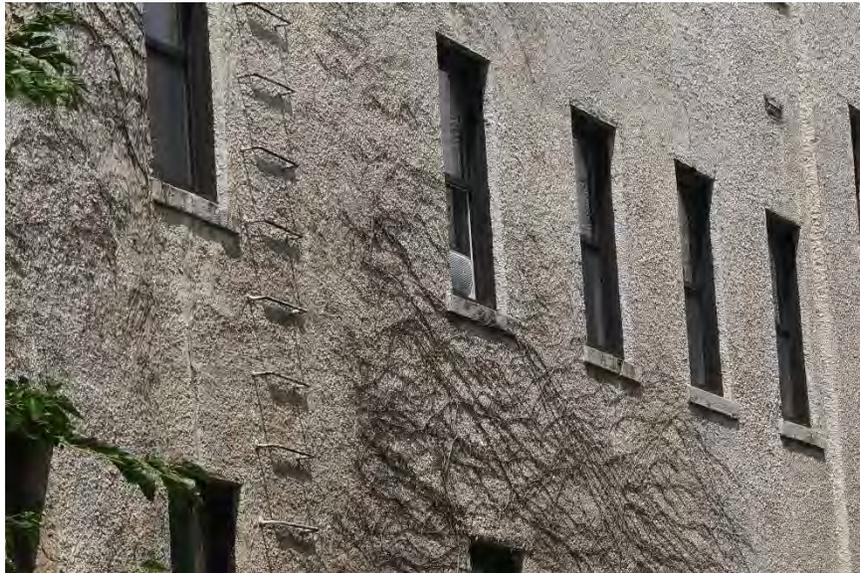
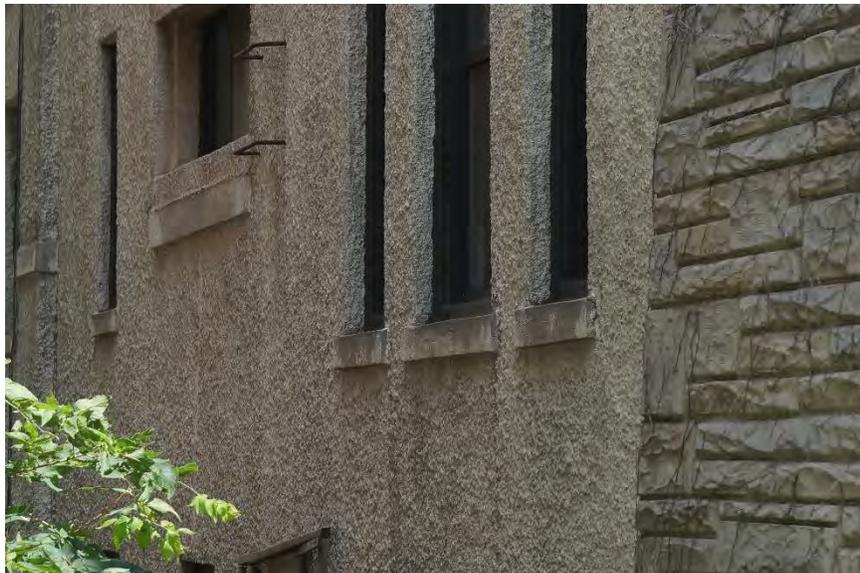
On the horizontal bands and window sills, we will repair all of the loose and missing stucco. When the stucco is finished, we will apply an acrylic finish, enabling a uniform color match combined with the smoother finish.

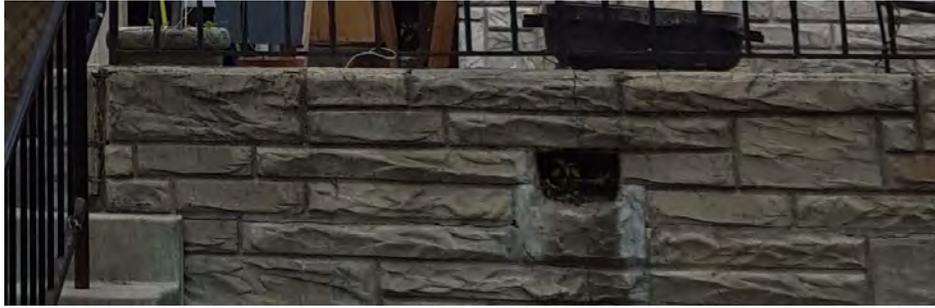
On the front porch, we will remove all of the existing permastone. We will also remove the metal railing from the top of the existing wall. We will ensure that the existing wall is sturdy, and will support the new concrete cap. We will build a form in order to replicate the concrete cap that appears in the historic photo. We will install all necessary rebar and metal ties in order to strengthen the new cap and ensure it will tie into the existing wall. We will pour the new concrete cap, and float it to match the historic photos. We will install a new 42" high metal railing (for a total finished height of 48"), using a metal finish and design chosen by the Students' Co-op and approved by the necessary parties. The allotment for the railing will be \$125.00 per lineal foot.

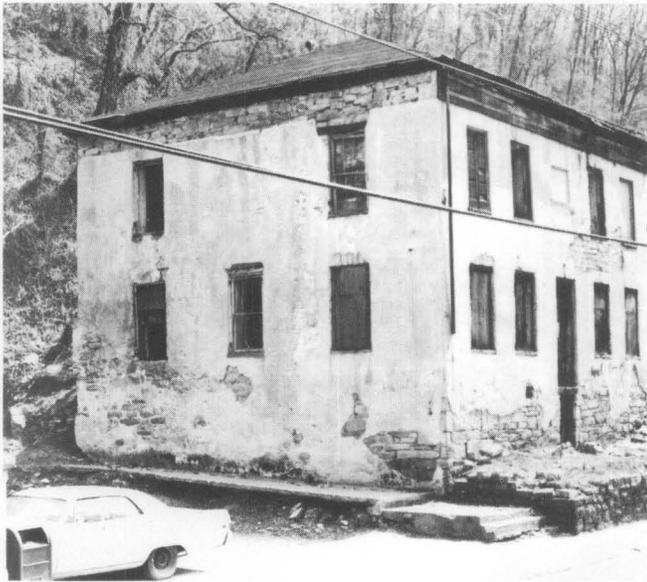
Fig. 7. Patches of stucco have fallen off this derelict 19th century structure exposing the rough-cut local stone substrate. The missing wood entablature on the side and the rough wood lintel now exposed above a second-floor window, offer clues that the building was stuccoed originally. Photo: National Park Service Files.

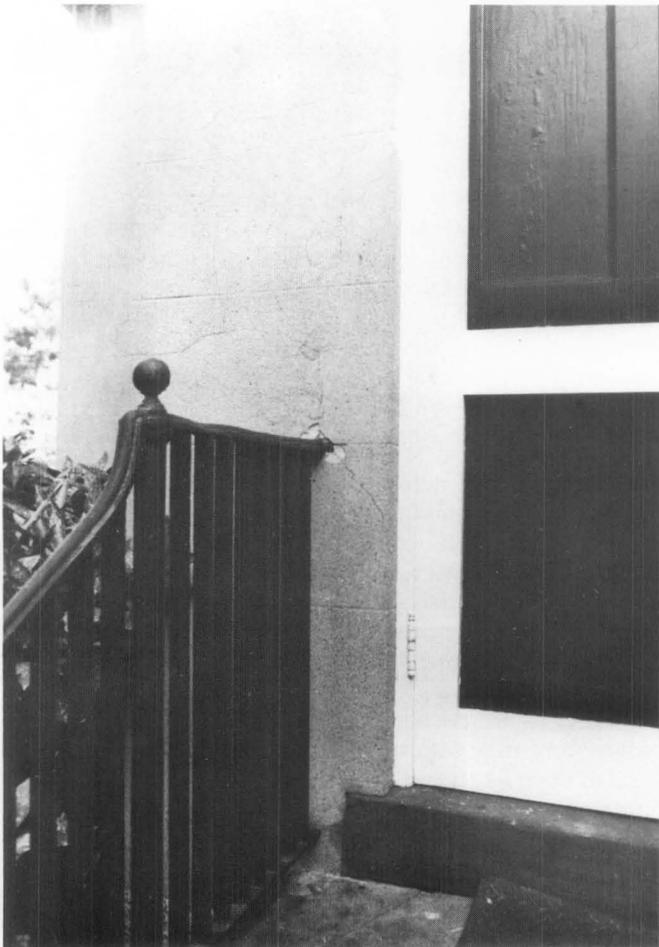
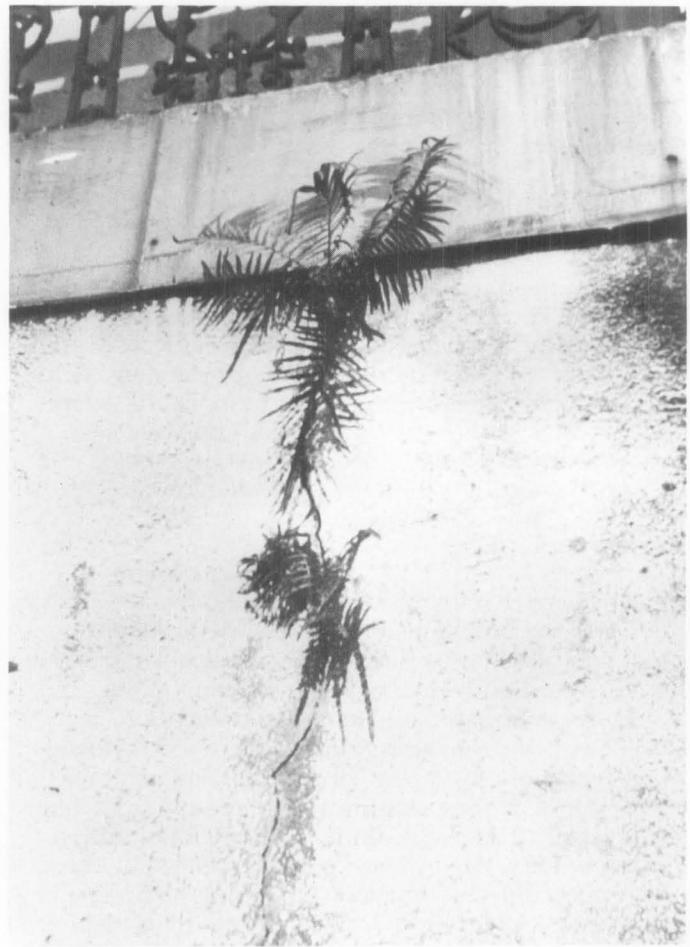
Fig. 12. (a) Water intrusion caused by rusting metal, or (b) plant growth left unattended will gradually enlarge these cracks, resulting in spalling, and eventually requiring extensive repair of the stucco. Photos: National Park Service Files.

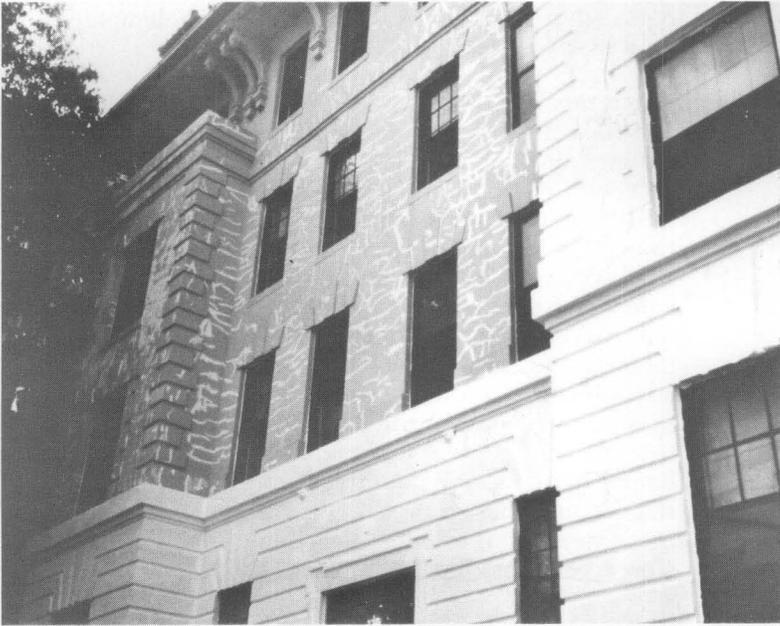
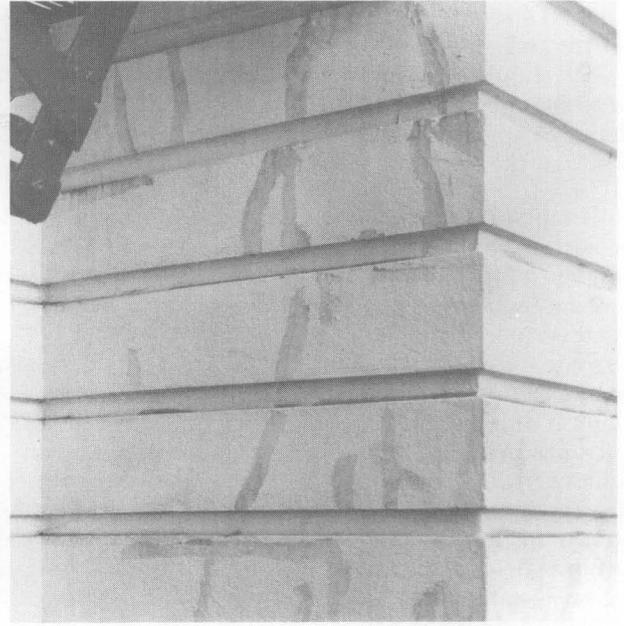
Fig. 13. (a) In preparation for repainting, hairline cracks on this Mediterranean style stucco apartment building were filled with a commercial caulking compound; (b) dirt is attracted and adheres to the texture of the caulked areas, and a year after painting, these inappropriate repairs are highly obvious. Photos: Anne Grimmer.

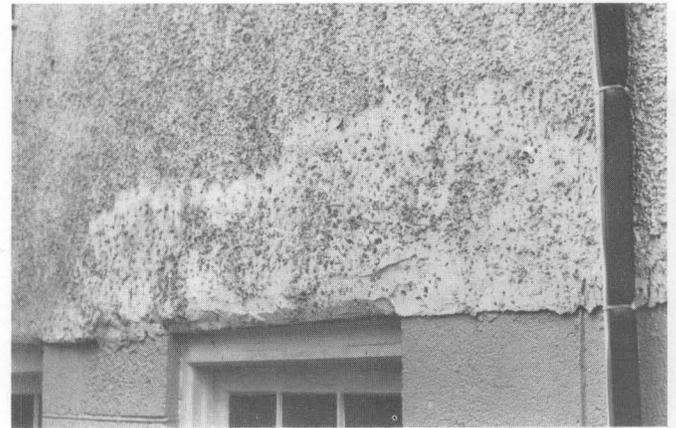
Fig. 14. This poorly executed patch is not the work of a professional plasterer. While it may serve to keep out water, it does not match the original surface, and is not an appropriate repair for historic stucco. Photo: Betsy Chittenden.
