# V. Specific Street Analysis, Concept Plans and Recommendations

### **Heritage Street Analysis and Concept Plans**

3rd Street Existing Conditions  
 WAREHOUSE DISTRICT HERITAGE STREET PLAN

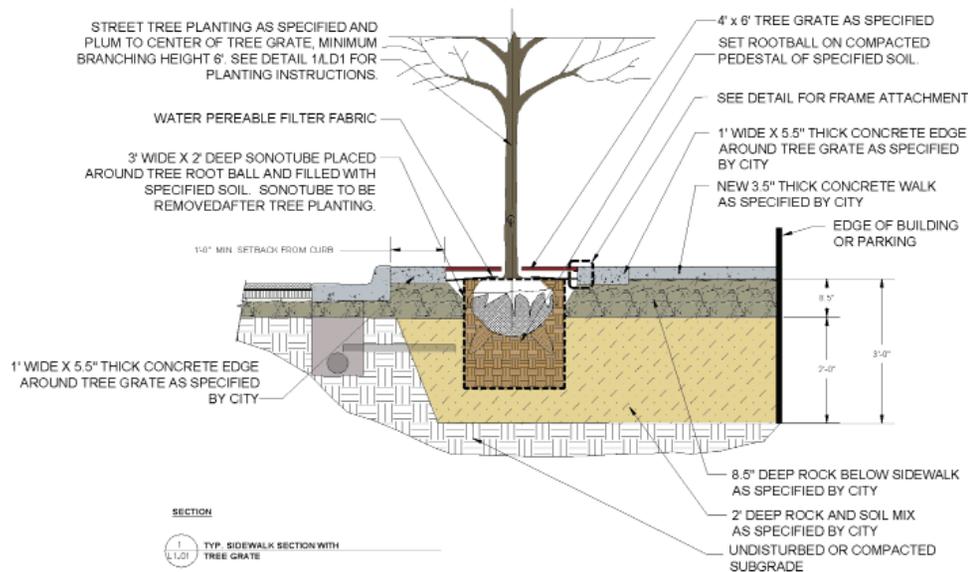
Street Tree Infiltration Detail A

- The proposed street tree plantings should integrate stormwater management. The street trees should be planted in accordance with the recommended street tree planting detail found on this page.
- Coordinate street tree plantings with Public Works staff, Minneapolis Park Board and the Heritage Preservation Commission.

- Coordinate street tree plantings with Public Works staff and Minneapolis Park Board.
- Stormwater management: The proposed street tree plantings should integrate stormwater management. The street trees should be planted in accordance with the recommended street tree planting detail found on page V-39.

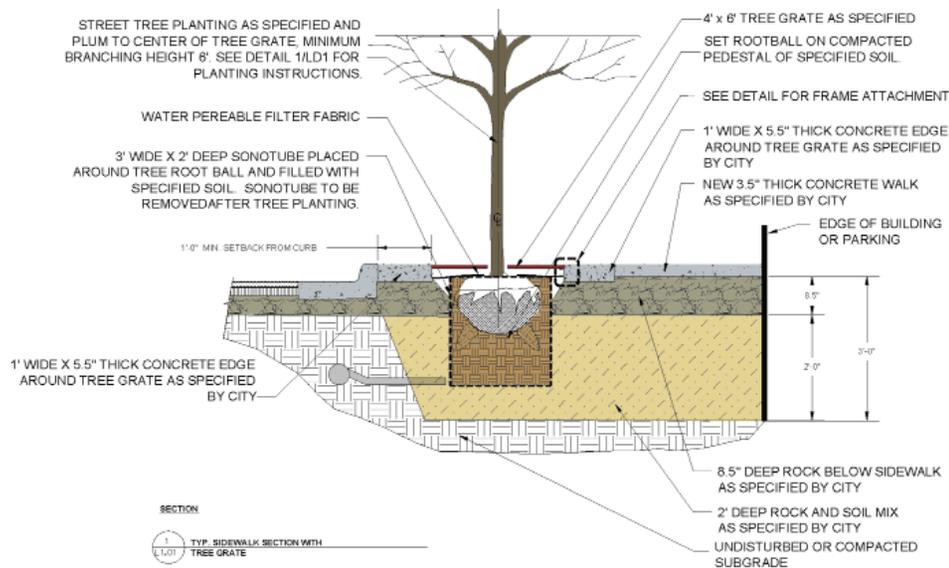
Street Tree Infiltration Detail B

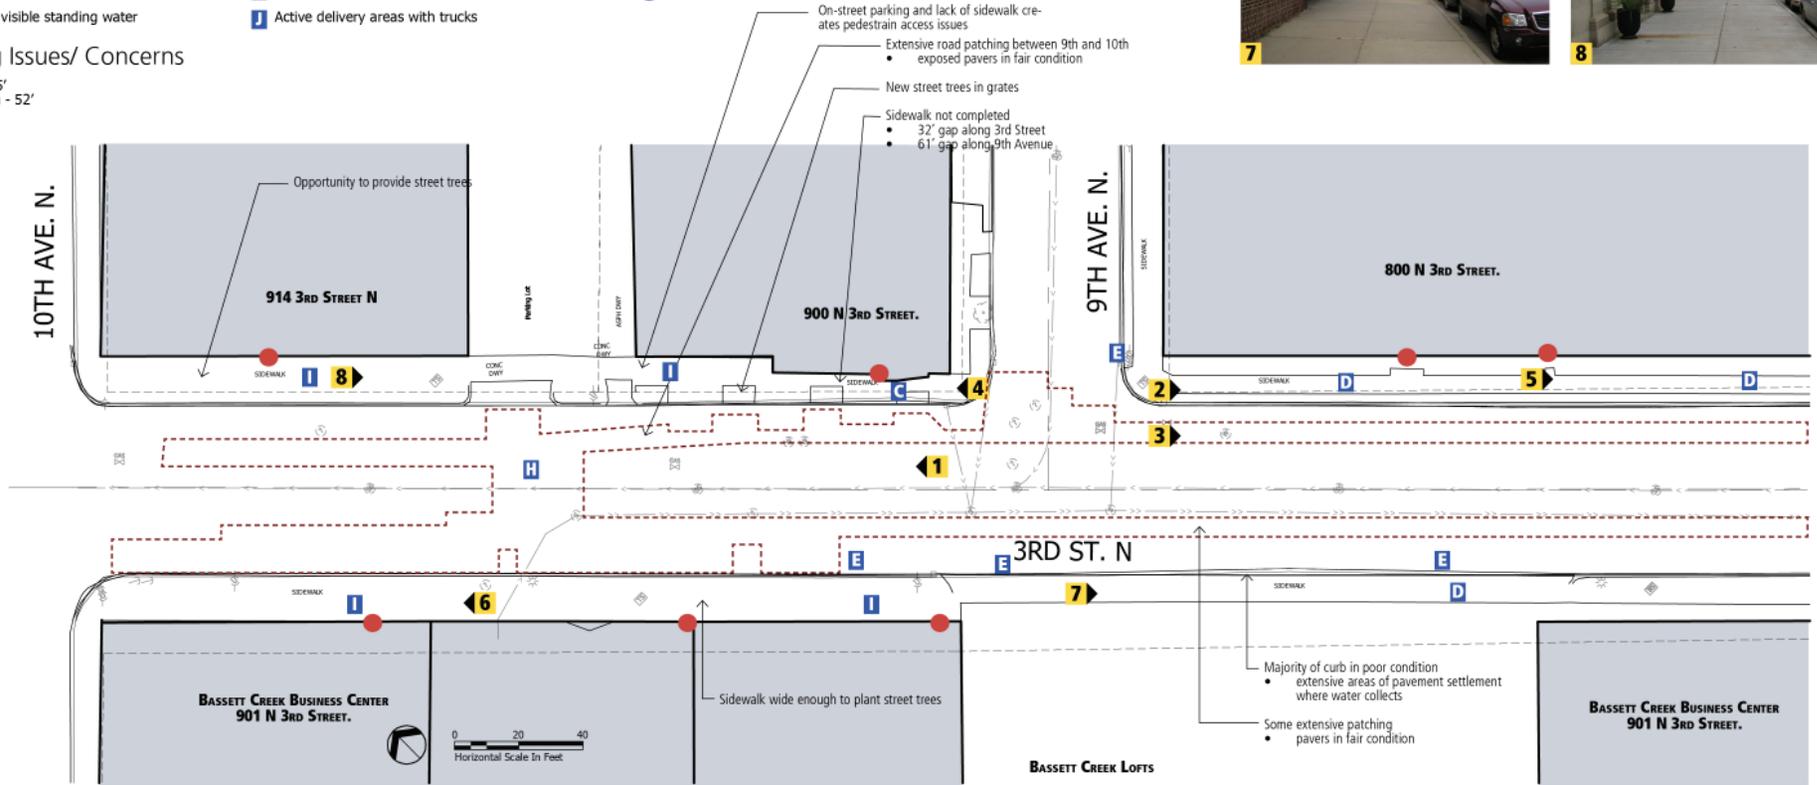
Areas of street patching - Approximately 9,900 sf  
 38 parallel parking stalls

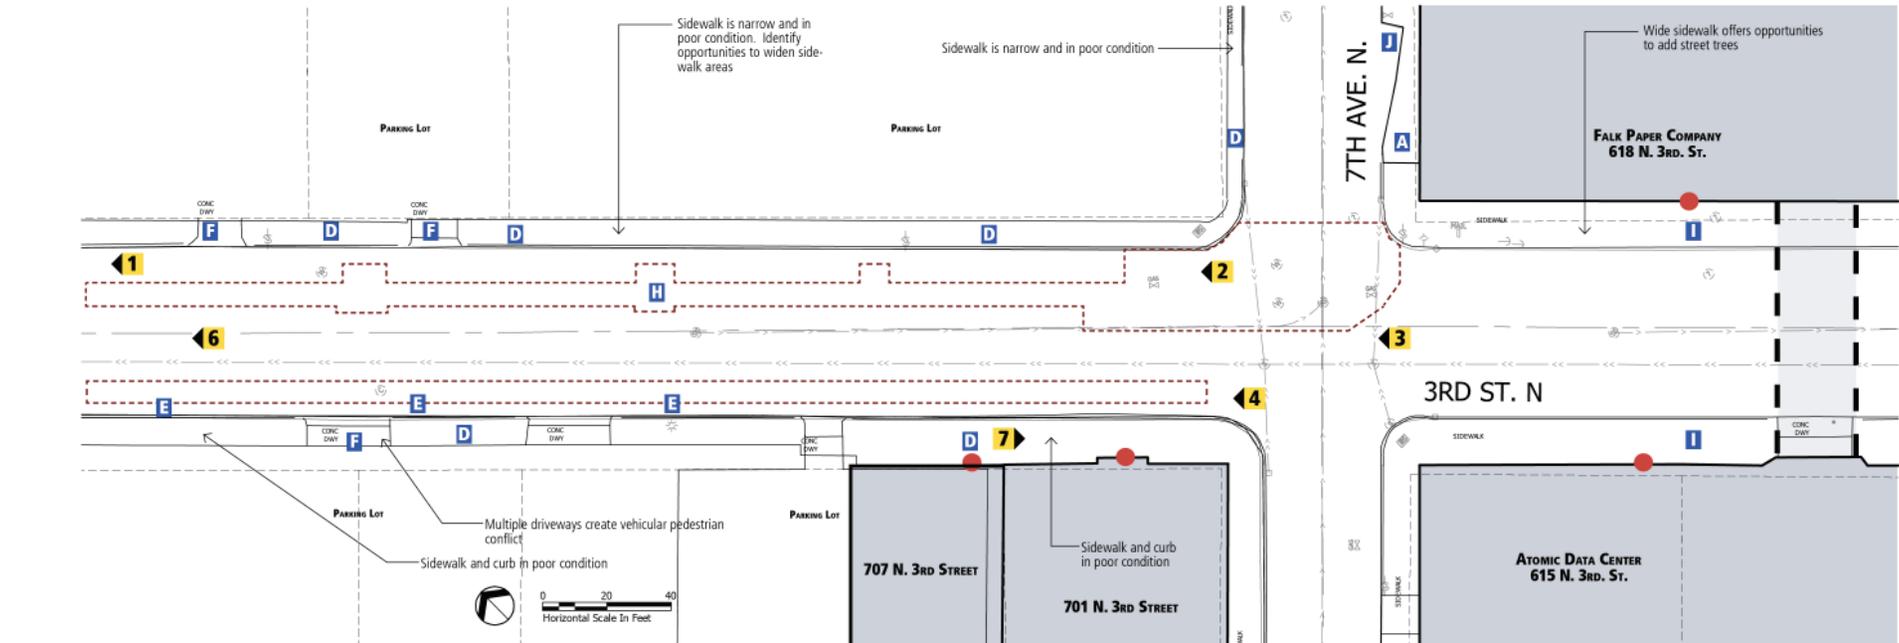
3rd Street Existing Conditions

ROW - 82.45'  
Street Width - 52'  
ADT - 1700

Areas of street patching - Approximately 4,800 sf  
33 parallel parking stalls

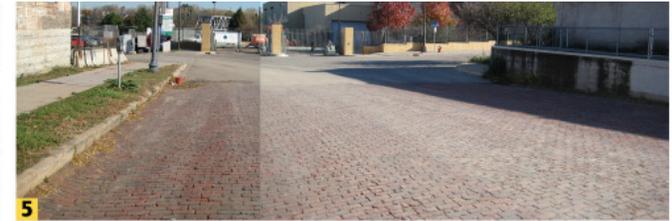
Wide view of 2nd Avenue N. Paving is generally in good condition and remains very level throughout the entire roadway

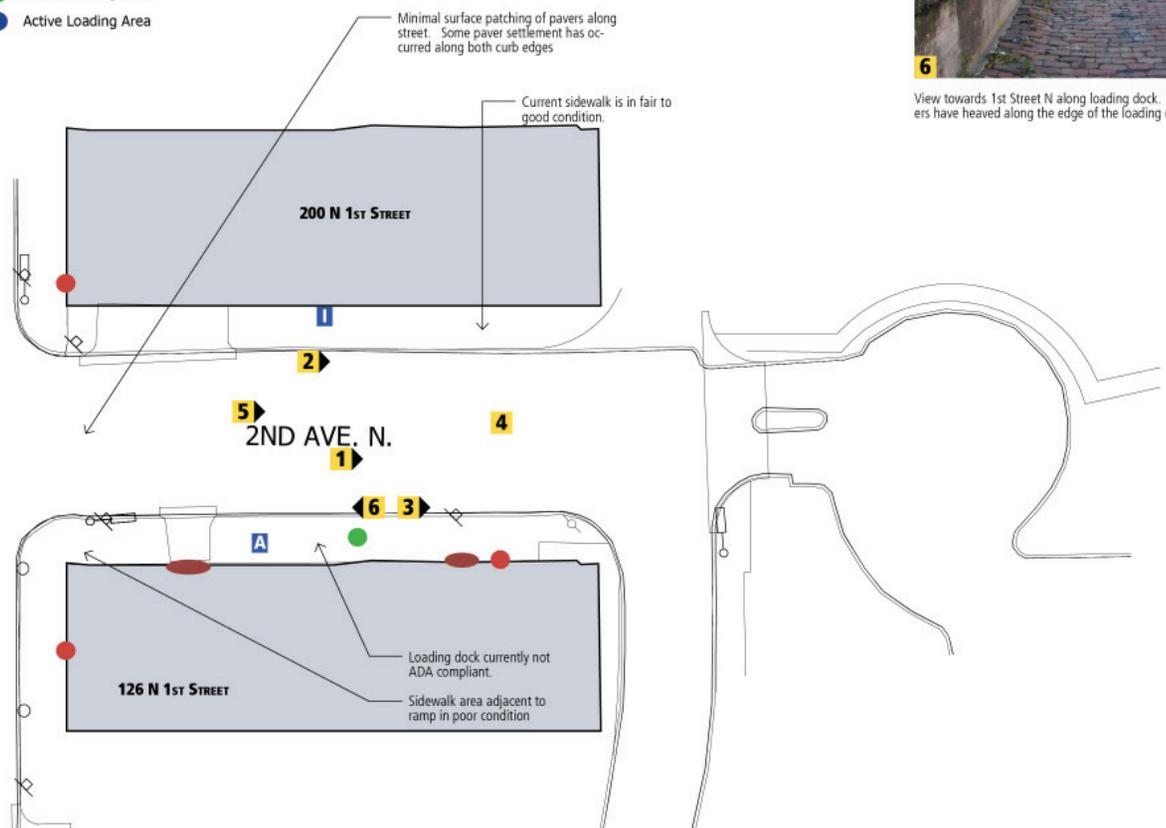
View towards 1st Street N along loading dock. Some pavers have heaved along the edge of the loading dock area

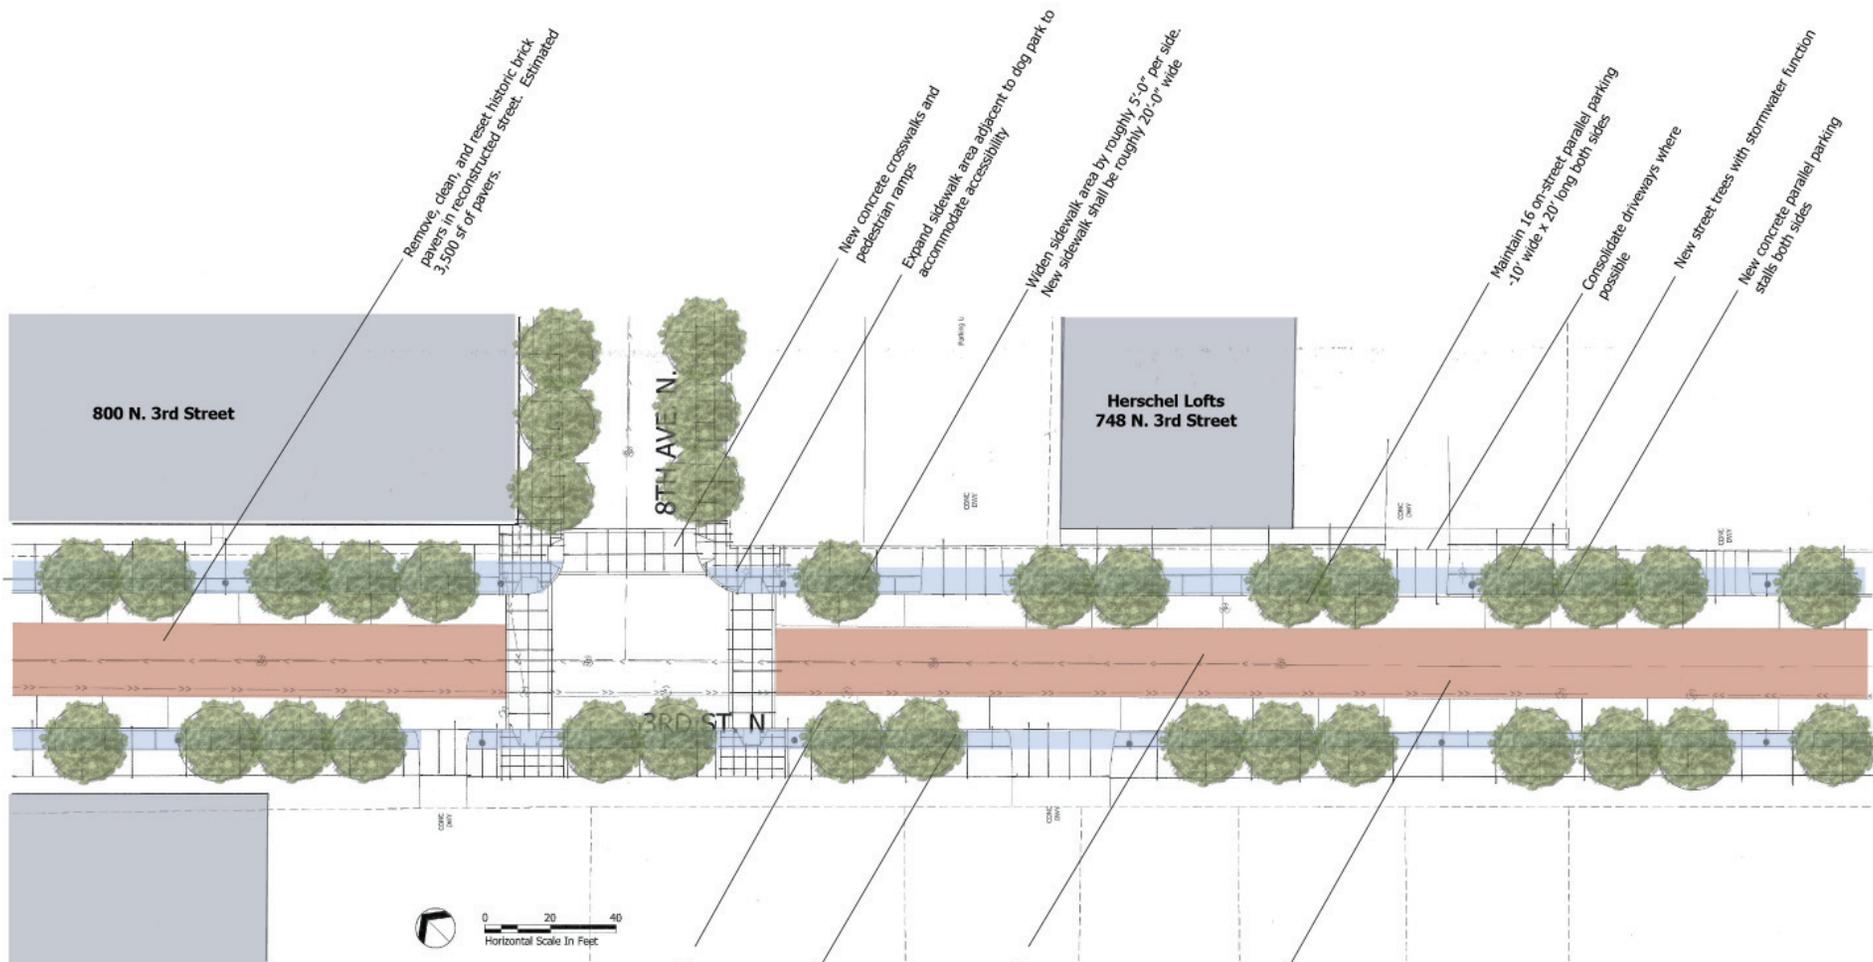
Existing ROW: 82'-4"  
 Current Street Width: 52'-0"  
 Proposed Street Width: 42'-0"

- ROW width: Existing ROW along 3rd Street N is 82.45' wide. Final recommendation to maintain the width of the existing ROW.
- Street width: Current Street width is 52'-0" wide. Final recommendation to narrow the existing street to 42'-0" wide. The proposed street section would be (2) 11'-0" drive lanes and (2) 10' wide parallel parking lanes on both sides of the street.

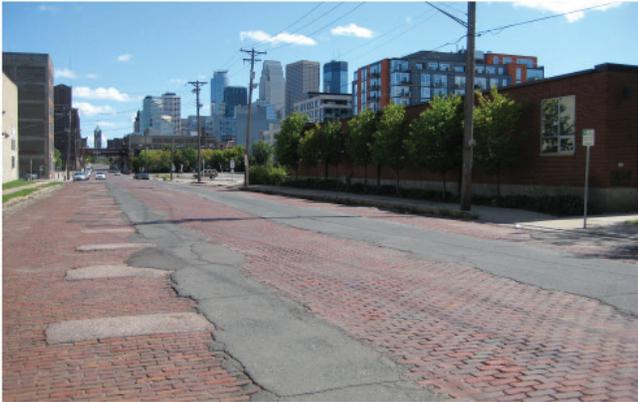
Existing view of 3rd Street looking east

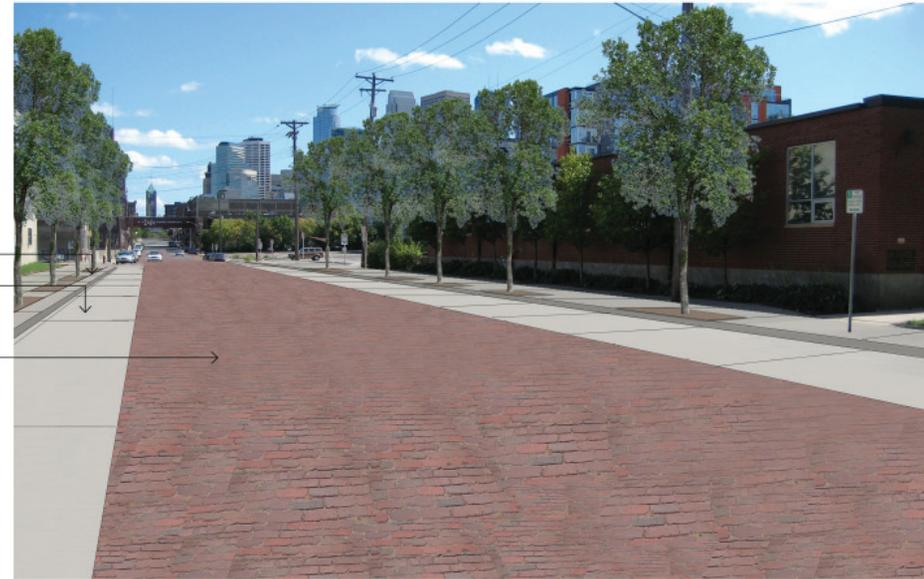
- Expand existing sidewalk and add street trees
- New concrete parallel parking stalls
- Remove, clean, and reset historic brick pavers on majority of 3rd Street.

Proposed view of 3rd Street looking east

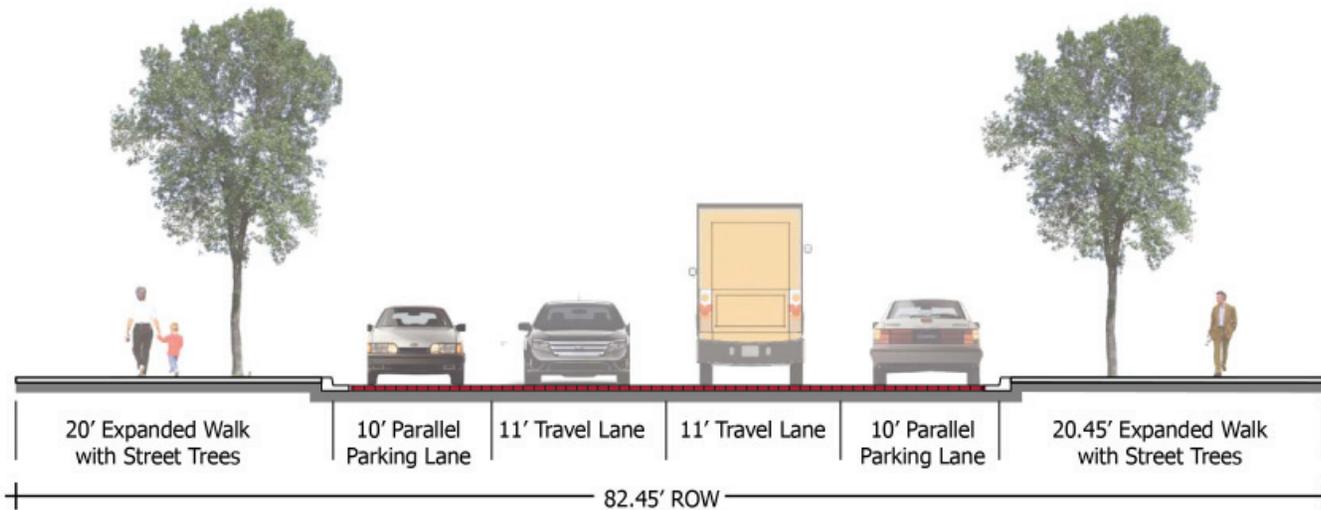
Proposed Cross-Section  
3rd Street North (10th Avenue North to 7th Avenue North) looking east

- Brick pavers: Historic brick pavers along 3rd Street N should be removed, cleaned and reinstalled to the proposed new 11'-0" wide drive lanes in the center of the new street cross-section. This recommendation would require approximately 32,768 sf. of pavers to be reinstalled.

- On-street parking: Concrete should replace the historic brick pavements in the 10'-0" wide parking lanes on both sides of the street. Proposed parking lanes are 10'-0" wide x 20'-0" long. There are approximately 99 parking stalls that will remain as part of the proposed street improvements.

- Sidewalks: Recommendation to widen sidewalk areas on both sides of the street by approximately 5'-0". The proposed sidewalks will be approximately 20'-0" wide and should be designed to meet City design standards and be ADA compliant.

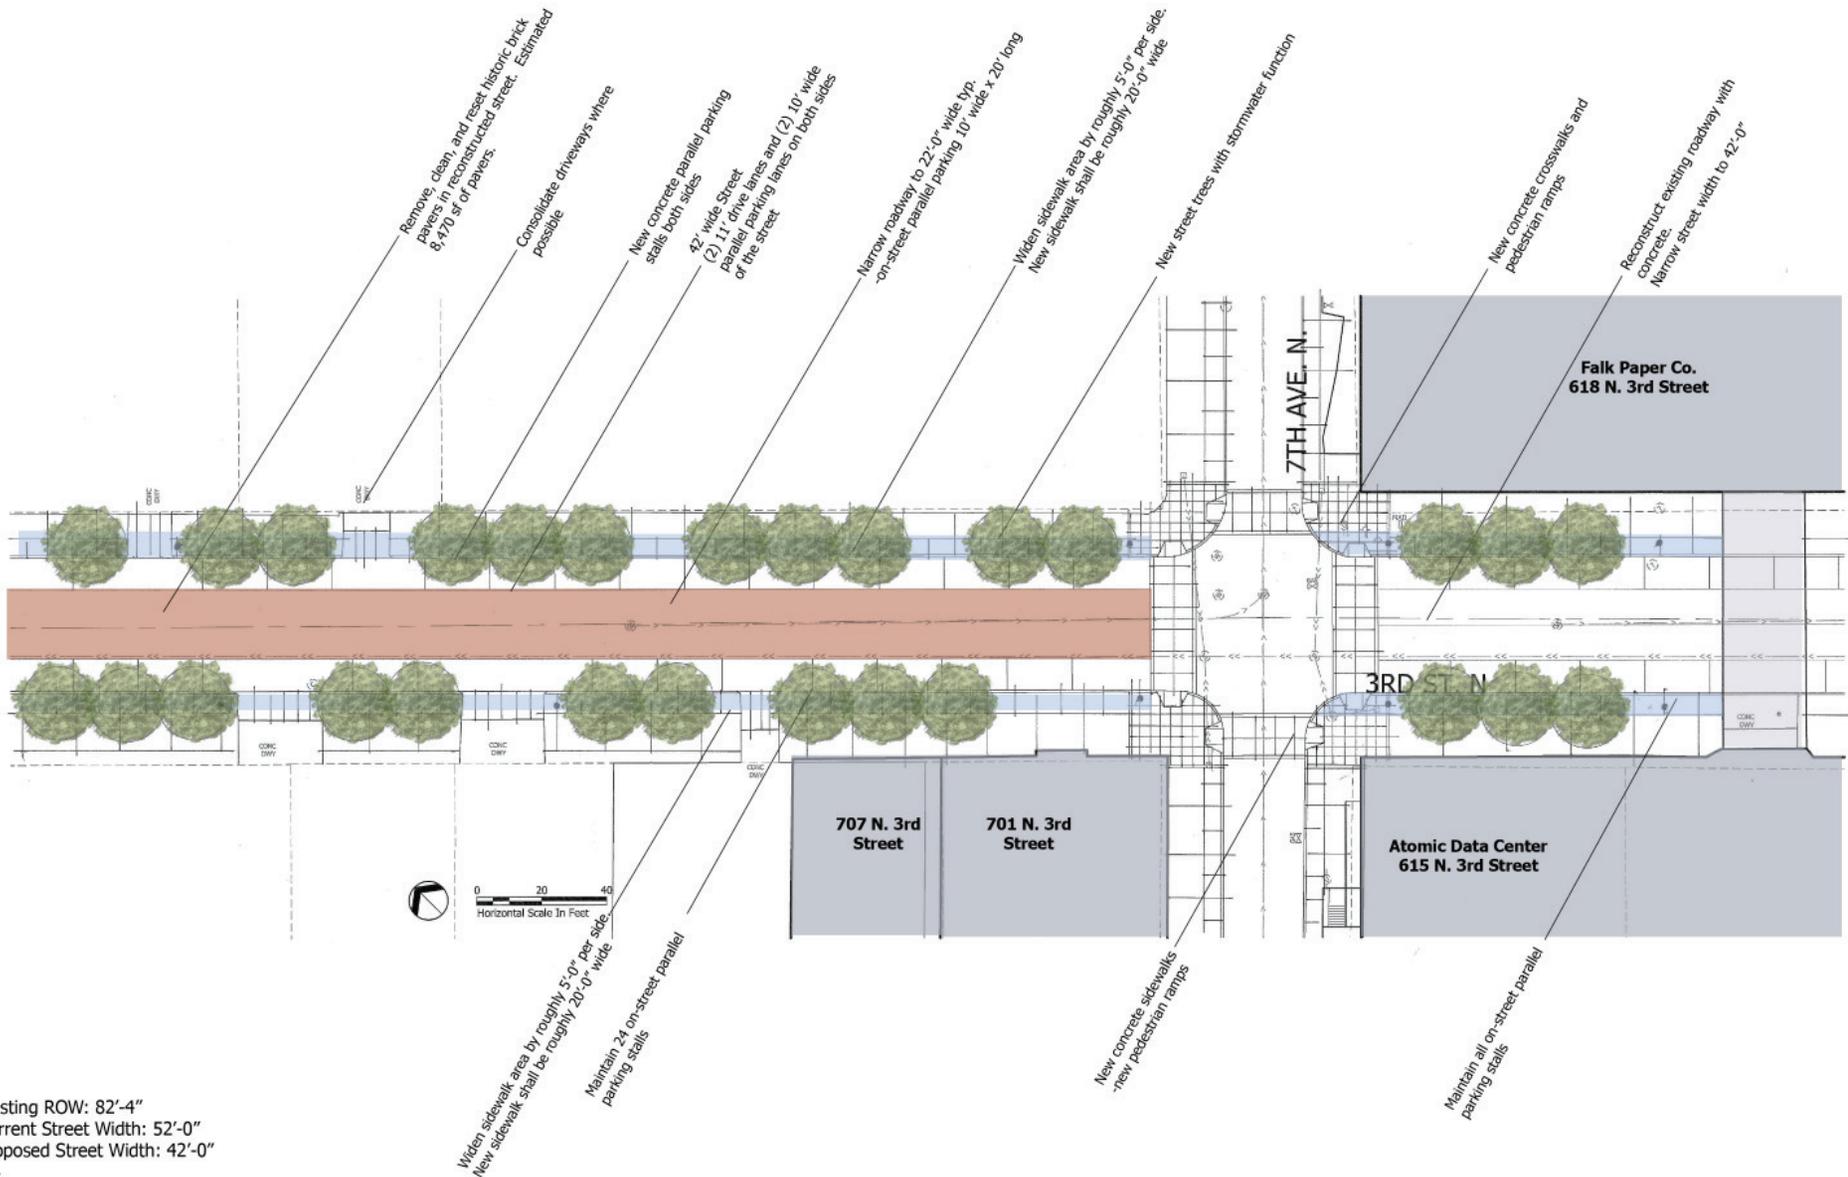
Existing ROW: 82'-4"  
 Current Street Width: 52'-0"  
 Proposed Street Width: 42'-0"

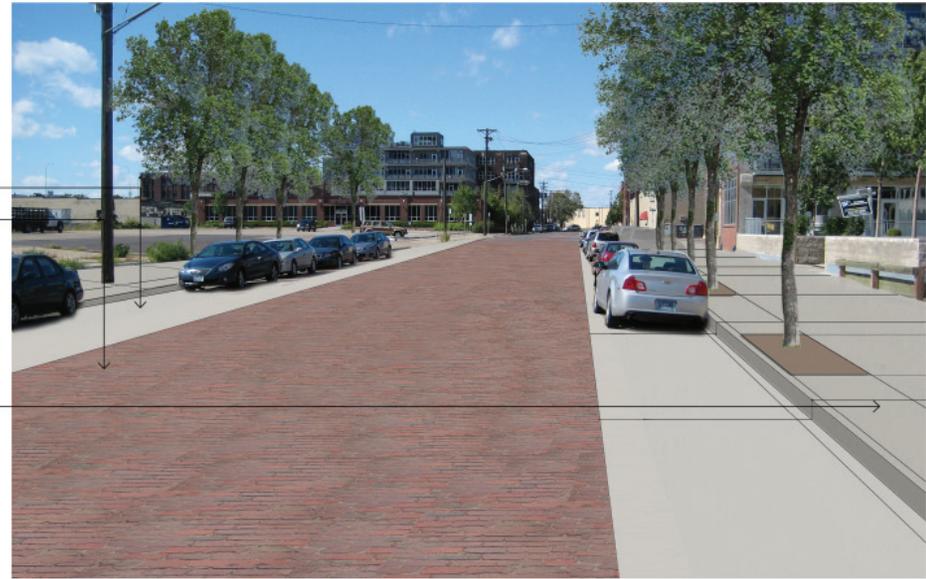
New concrete parallel parking stalls  
 Remove, clean, and reset historic brick pavers on majority of 3rd Street  
 Expand existing sidewalk and add street trees

Proposed view of 3rd Street looking west

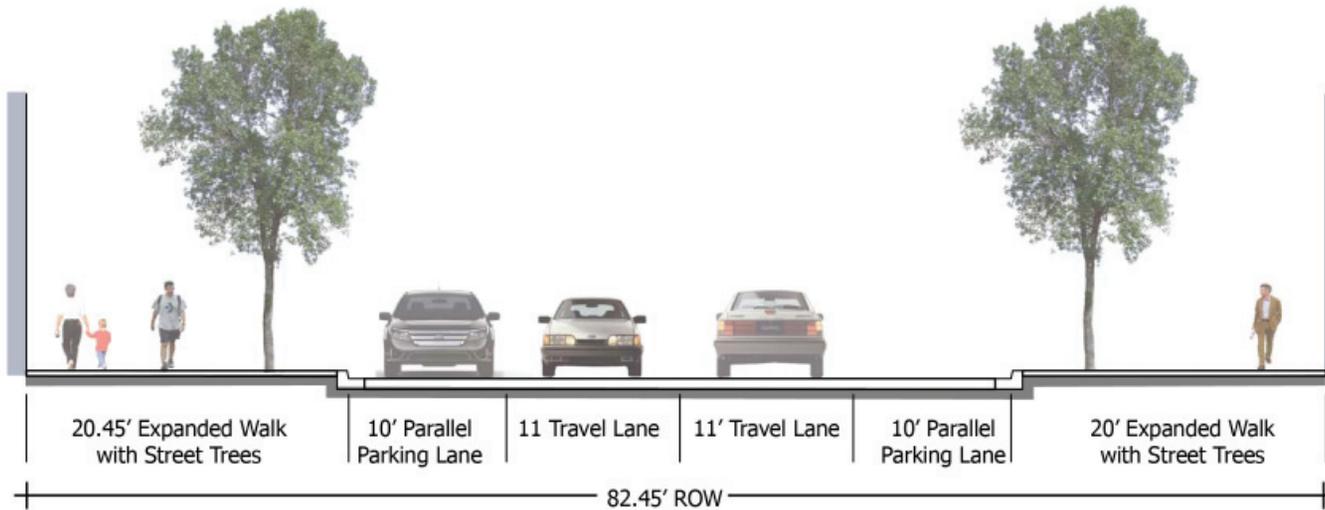
Proposed Cross-Section  
 3rd Street North (7th Avenue North to 5th Avenue North) looking west

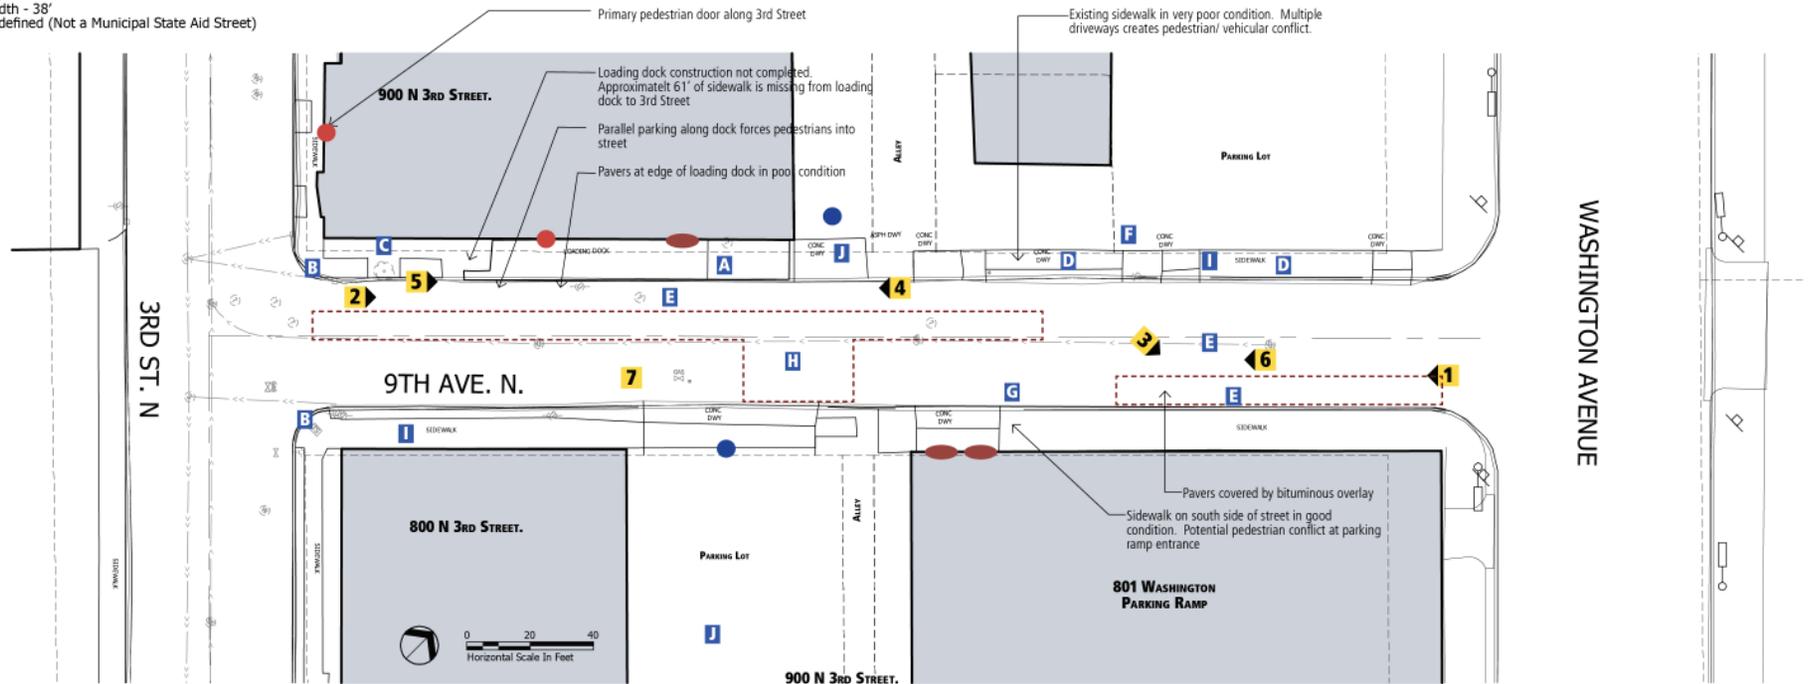
9th Avenue Existing Conditions  
**WAREHOUSE DISTRICT HERITAGE STREET PLAN**

ROW - 64'  
Street Width - 38'  
ADT - Undefined (Not a Municipal State Aid Street)

Areas of street patching - Approximately 3,375 sf  
18 parallel parking stalls

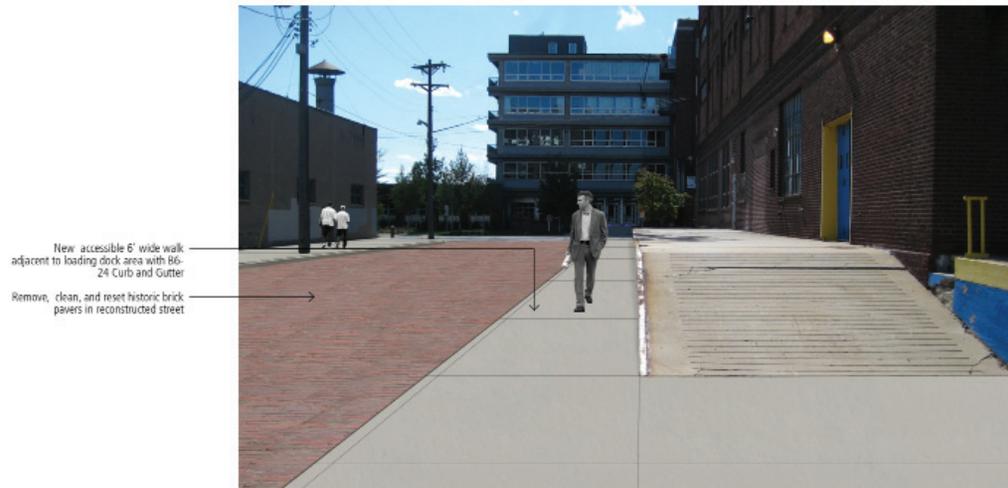
Proposed view looking north along 9th Avenue.

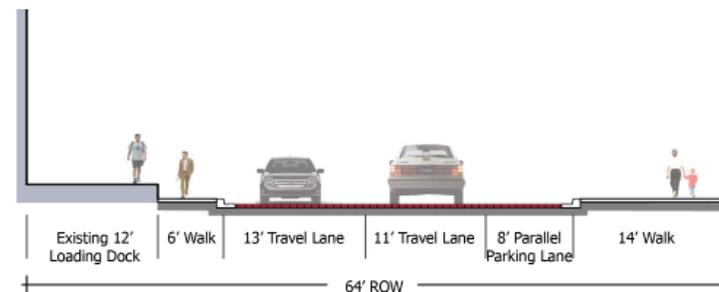
Proposed Cross-Section  
9th Avenue North (3rd Street North to Washington Avenue North)

- On-street parking: Proposed parking lanes are 8'-0" wide x 20'-0" long. There are approximately 10 parking stalls (13 existing stalls) that will remain as part of the proposed street improvements.

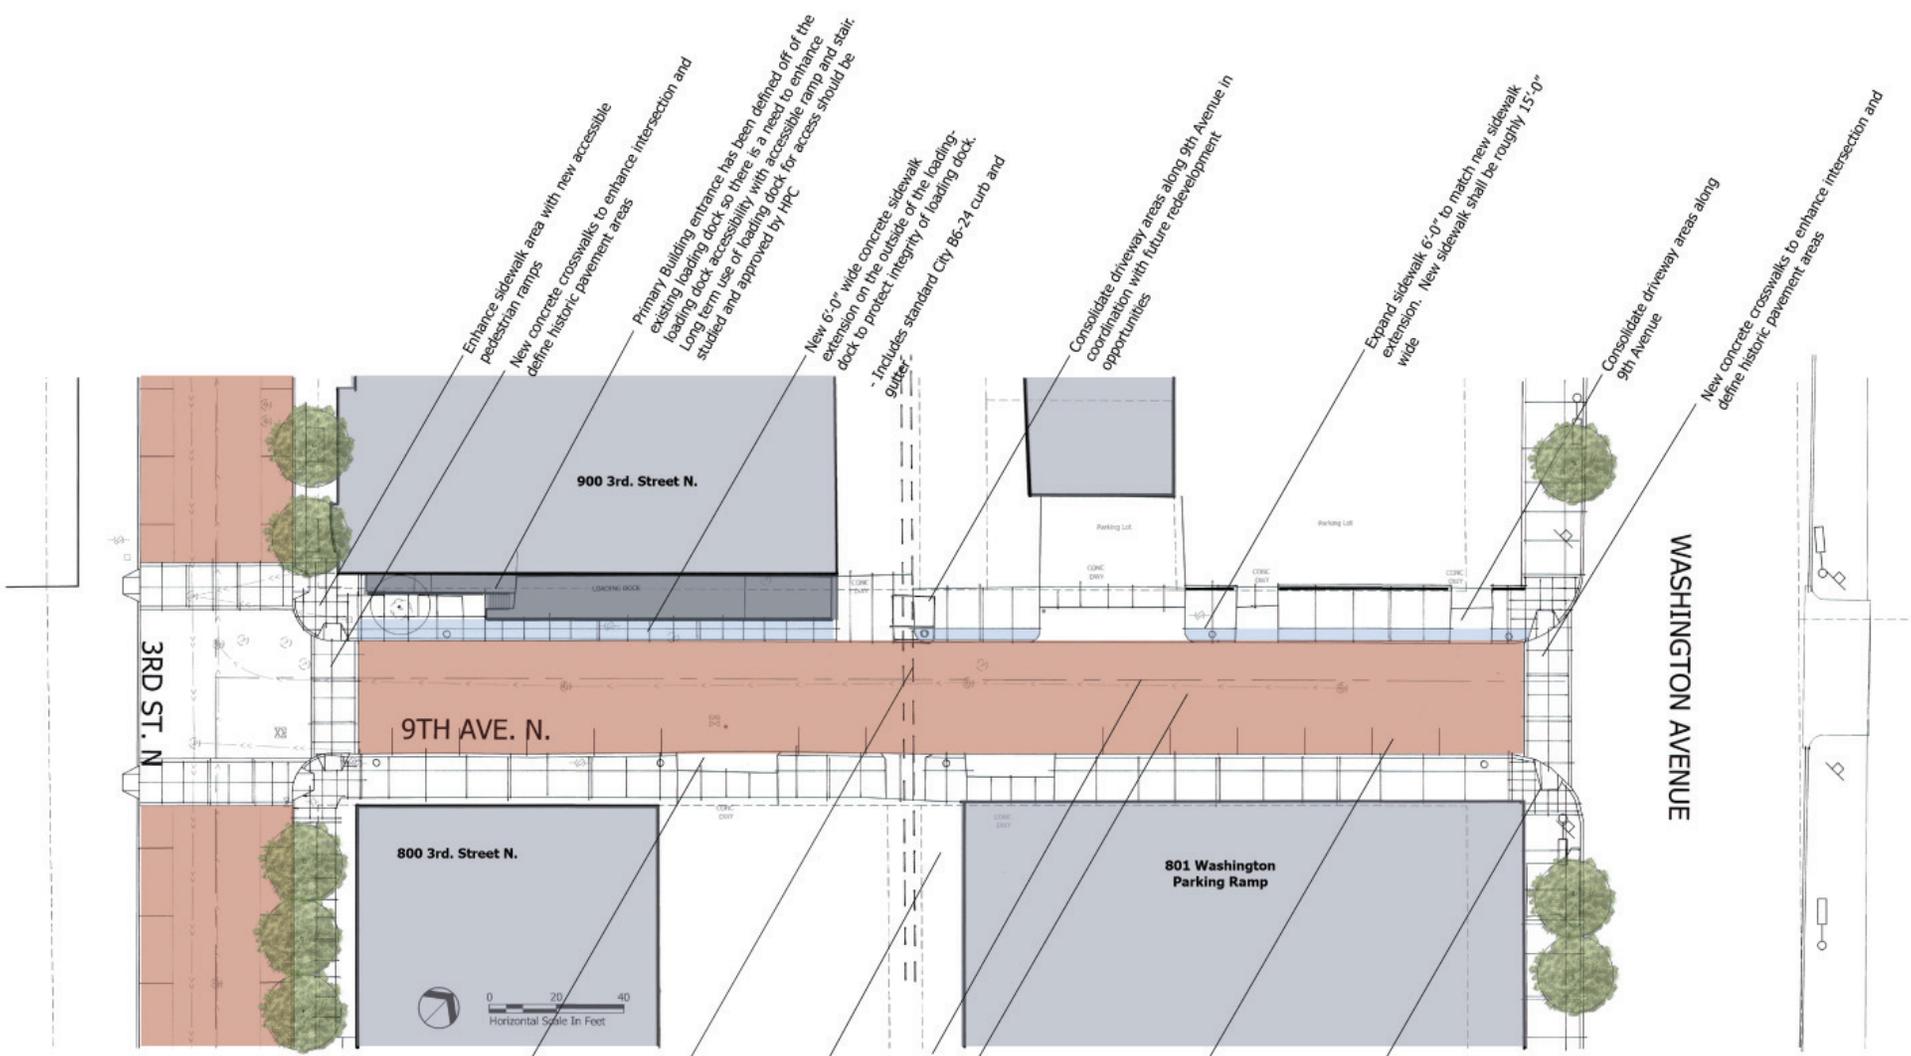
Existing ROW: 64'-0"  
 Current Street Width: 38'-0"  
 Proposed Street Width: 32'-0"

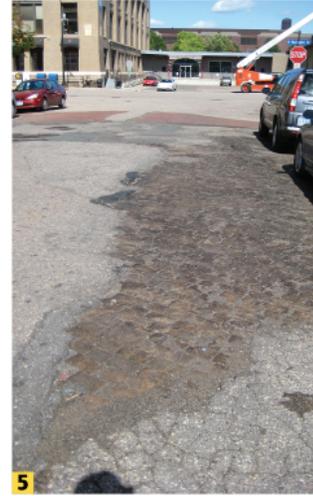
5 Existing areas of wood block pavers

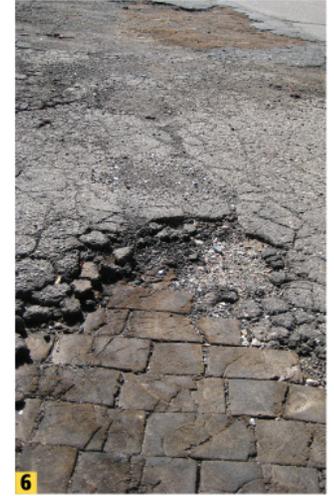
6 Extensive bituminous patching has occurred over existing wood block pavers

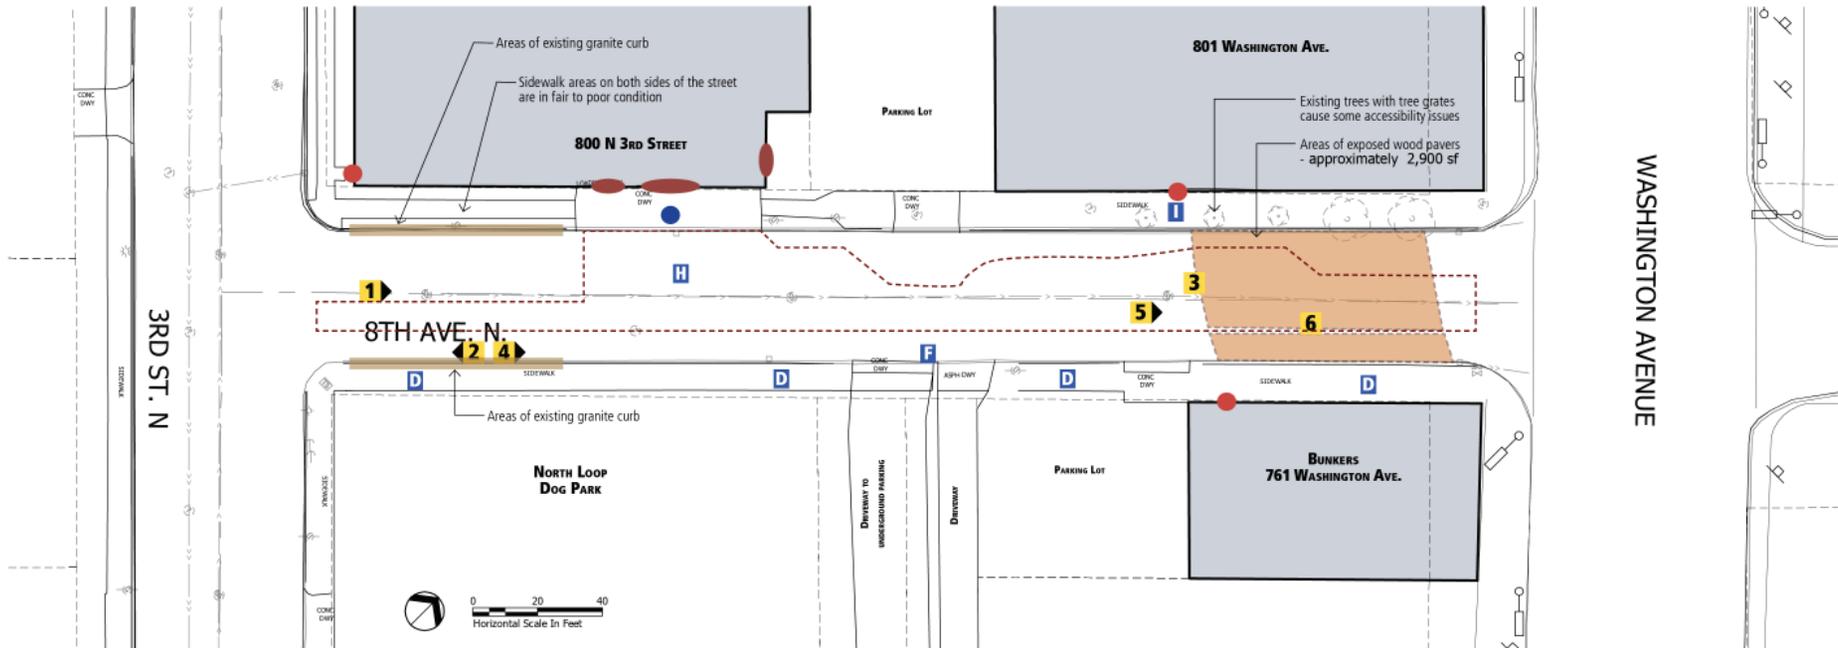
8th Avenue Existing Conditions  
**WAREHOUSE DISTRICT HERITAGE STREET PLAN**

ROW - 64'  
Street Width - 40'  
ADT - Undefined (Not a Municipal State Aid Street)

Areas of street patching - Approximately 7,240 sf  
25 parallel parking stalls

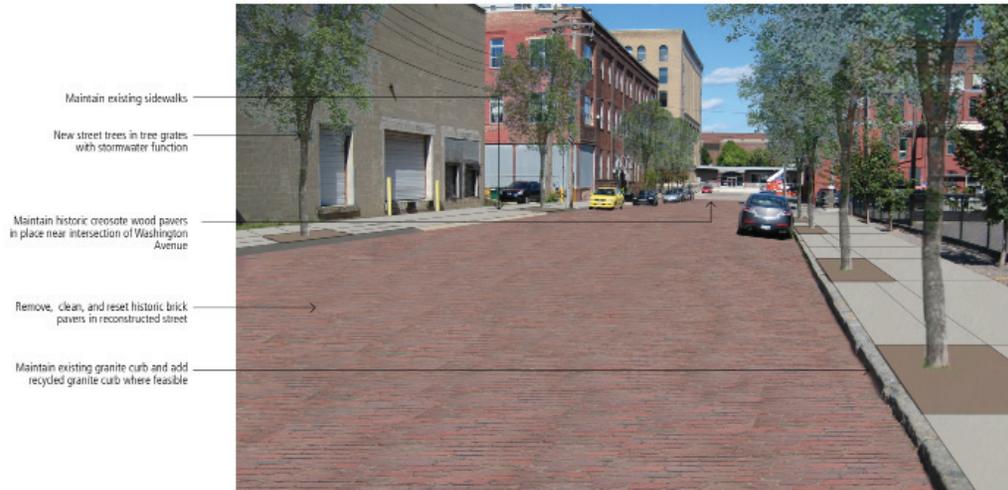
Proposed view looking north along 8th Avenue

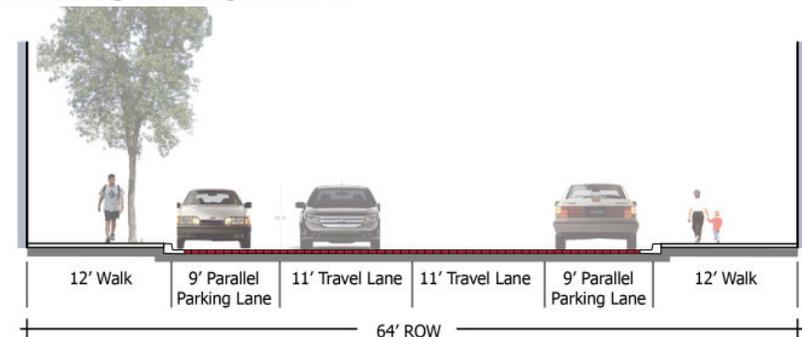
Proposed Cross-Section  
8th Avenue North (3rd Street North to Washington Avenue North)

- Street trees: Plant new street trees along 8th Avenue between the alley and 3rd Street N.

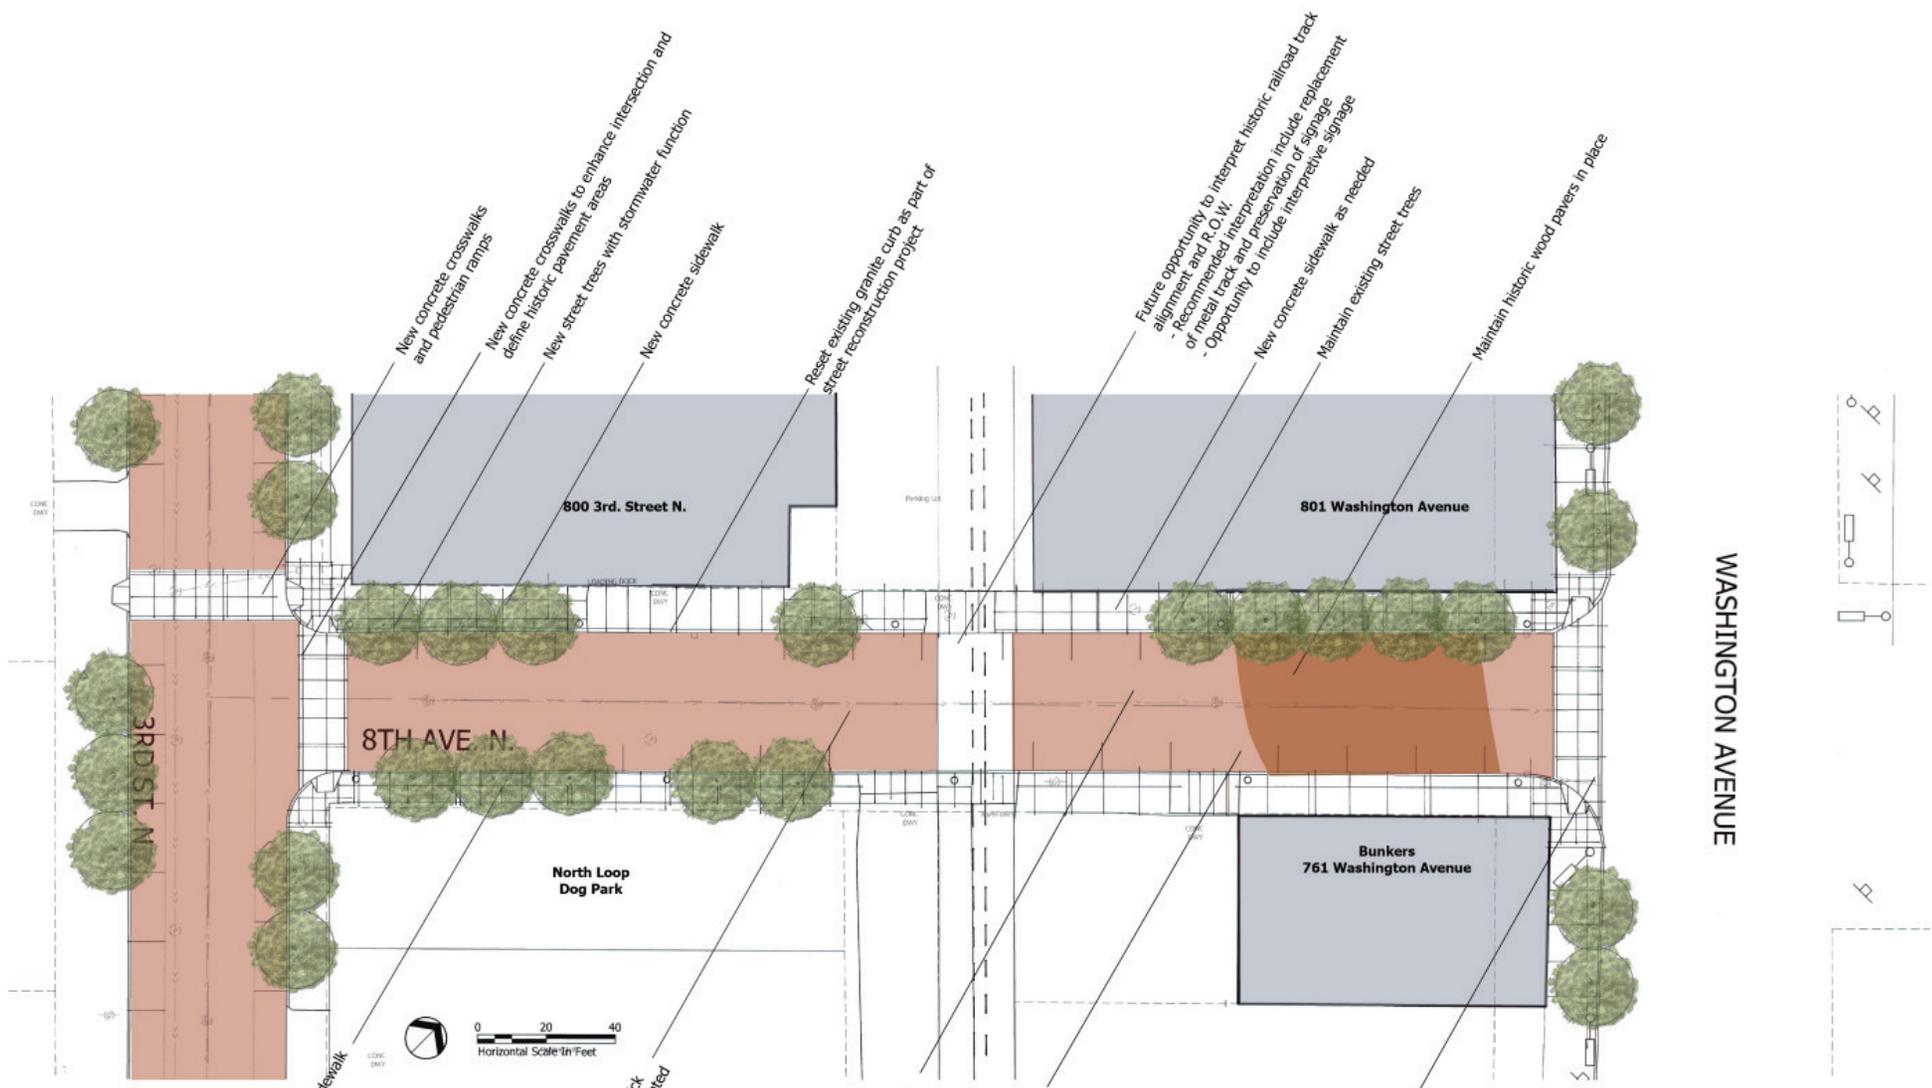
Existing ROW: 64'-0"  
 Current Street Width: 40'-0"  
 Proposed Street Width: 40'-0"

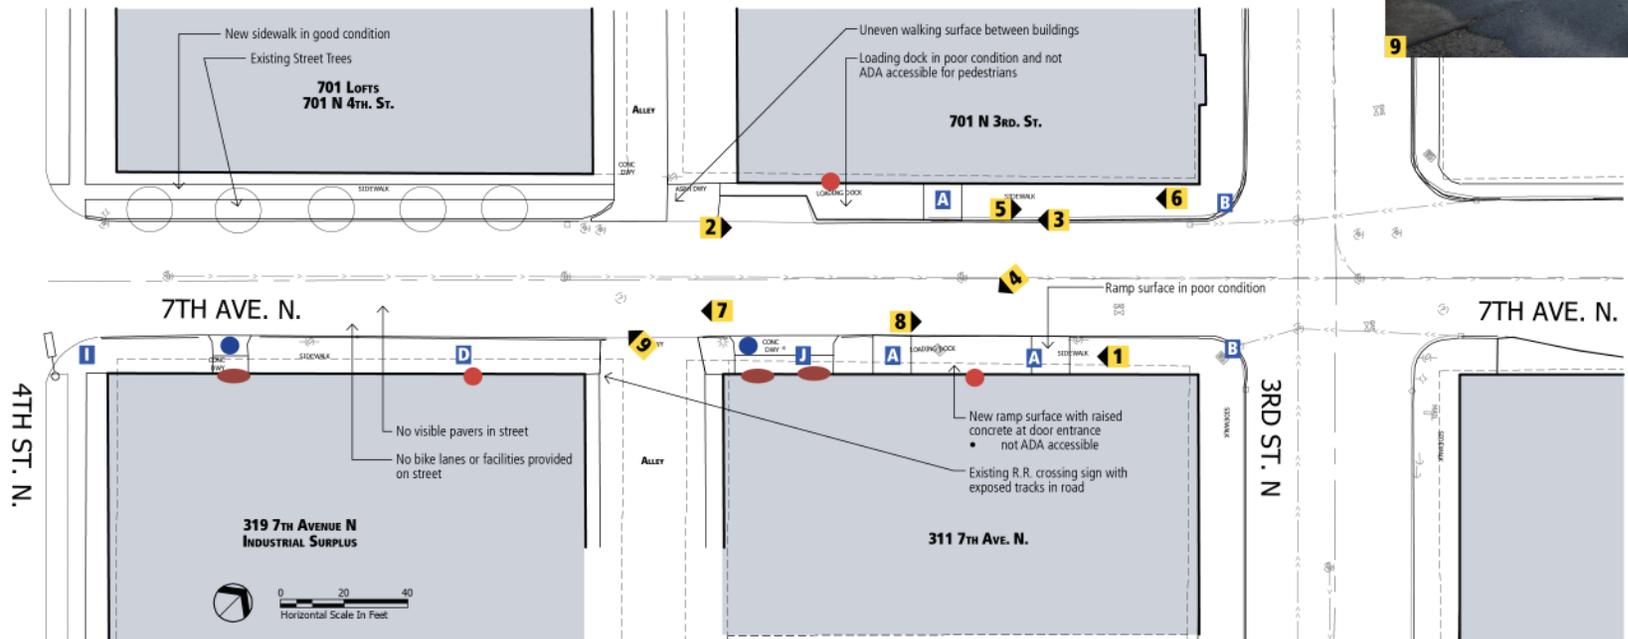
7th Avenue Existing Conditions  
**WAREHOUSE DISTRICT HERITAGE STREET PLAN**

Areas of street patching  
24 parallel parking stalls
