# V. Specific Street Analysis, Concept Plans and Recommendations

### **Heritage Street Analysis and Concept Plans**

3rd Street Existing Conditions  
 WAREHOUSE DISTRICT HERITAGE STREET PLAN

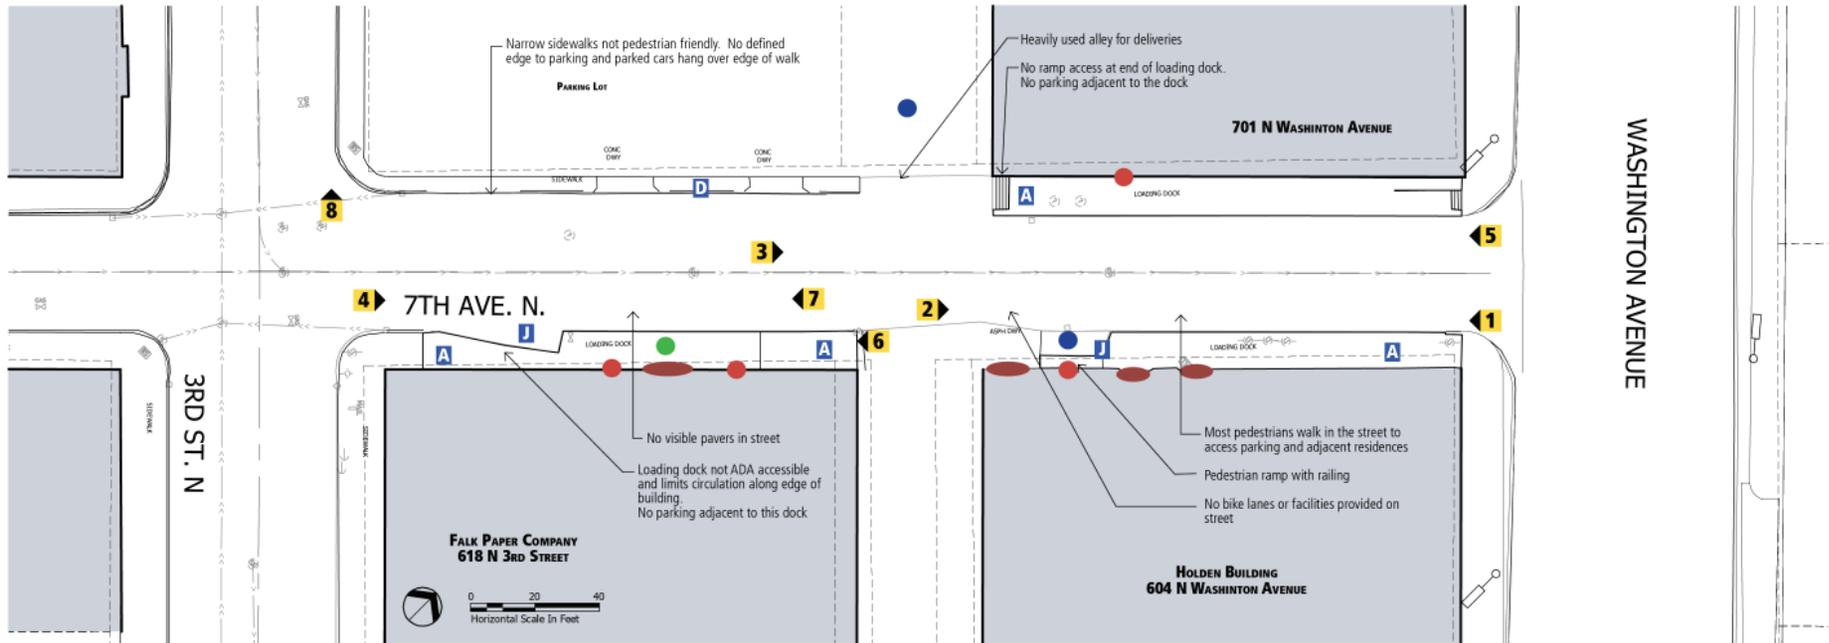
7th Avenue Existing Conditions

ROW - 60'  
Street width - 35' to 44'  
ADt - 1000

- Areas of street patching
- 5 parallel parking stalls

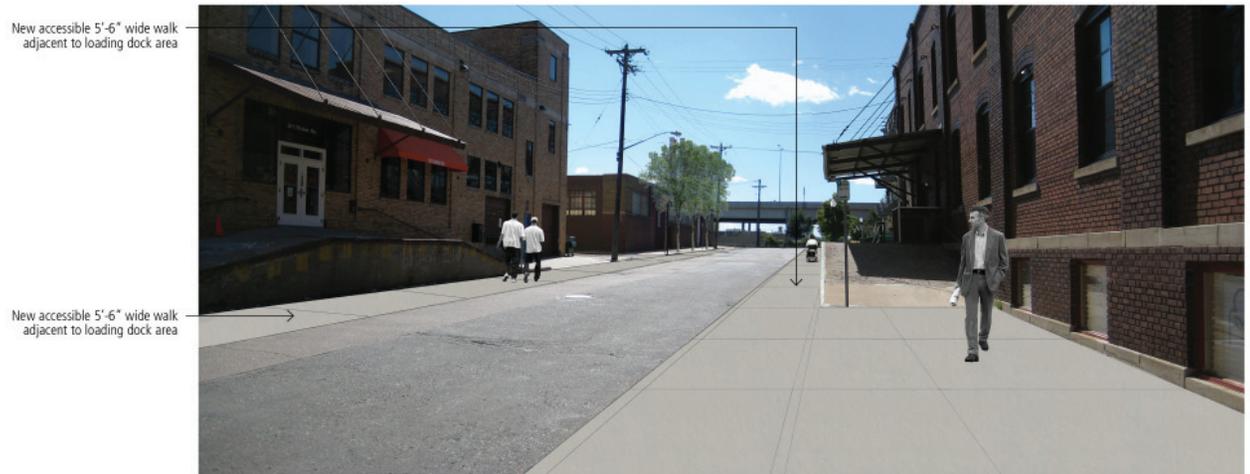
Proposed view looking south along 7th Avenue

- Sidewalks: Widen sidewalk areas on both sides of the street to approximately 5'-6". The proposed widened sidewalks would provide access around all of the existing loading docks that exist along the entire length of 7th Avenue. The proposed sidewalks should be designed to meet City design standards and be ADA compliant.
- Driveways: Consolidate and narrow existing driveways, alleys and other curb cuts along the street in conjunction with future redevelopment opportunities.
- Crosswalks: Provide new concrete crosswalks and ADA accessible pedestrian ramps at all street intersections. Pedestrian ramps shall conform to City of Minneapolis, ADA Standards for Accessible Design, and PROWAAC standards.
- Street trees: Plant new street trees along 7th Avenue between the alley and 4th Street N.

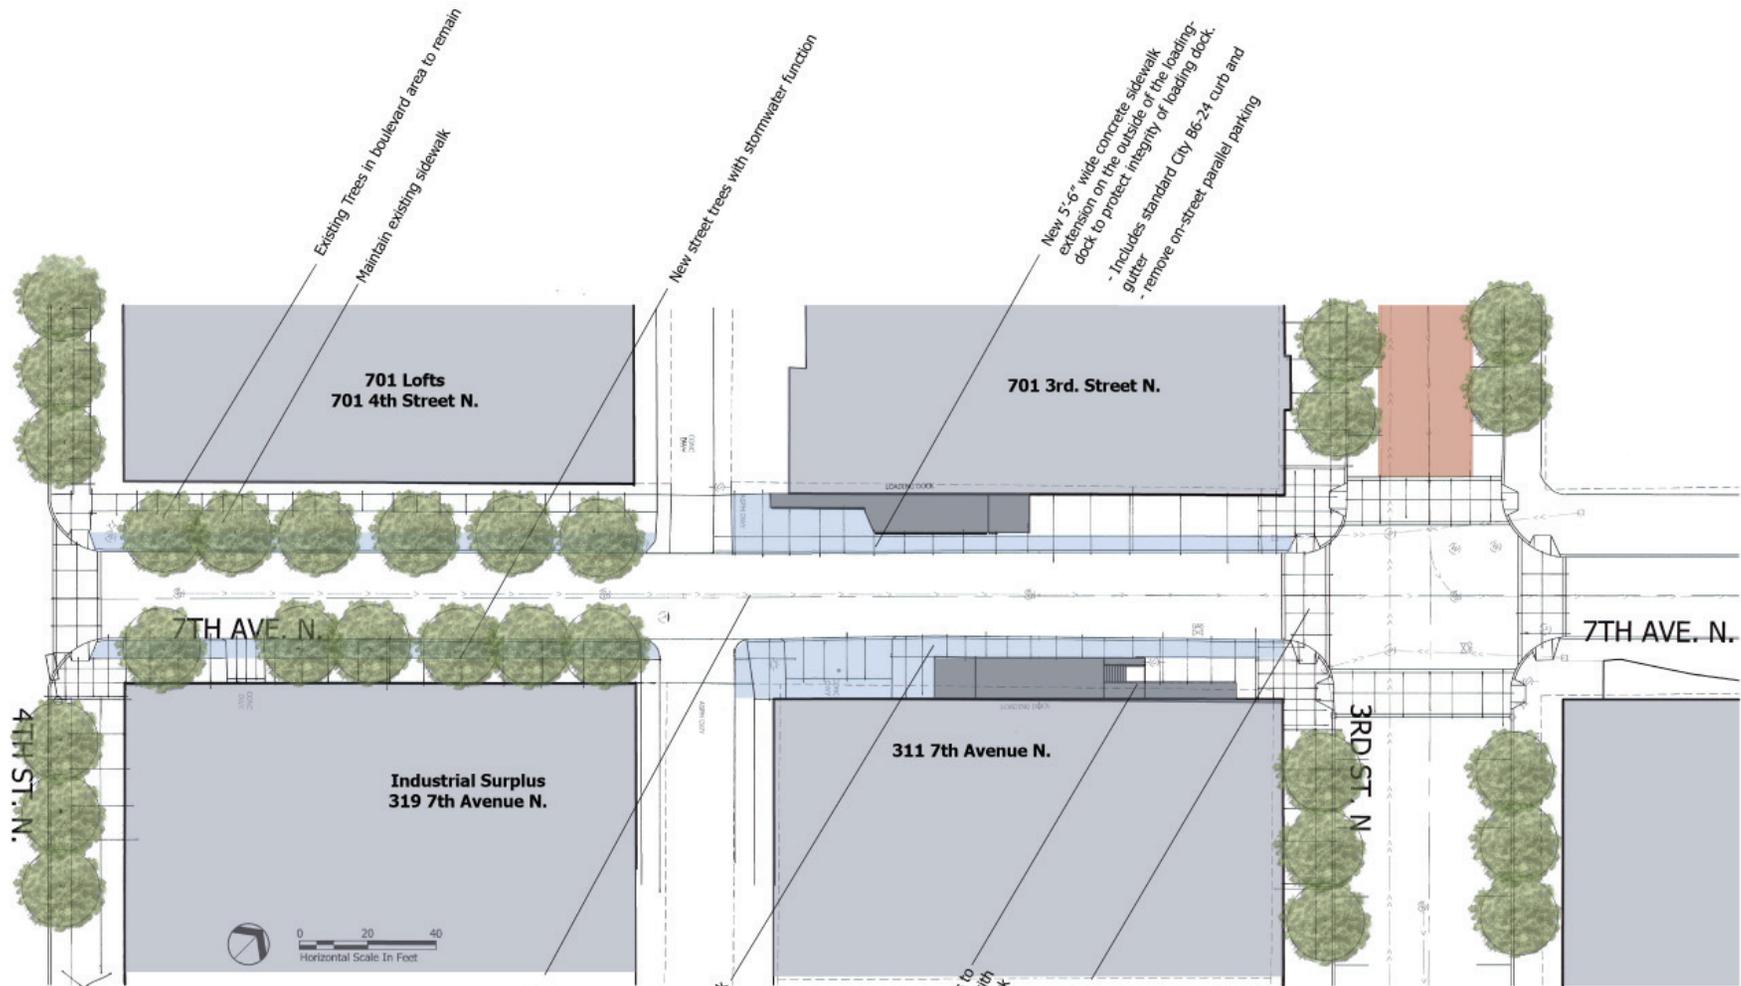
Existing ROW: 60'-0"  
 Current Street Width: 35'-0"  
 Proposed Street Width: 26'-0"

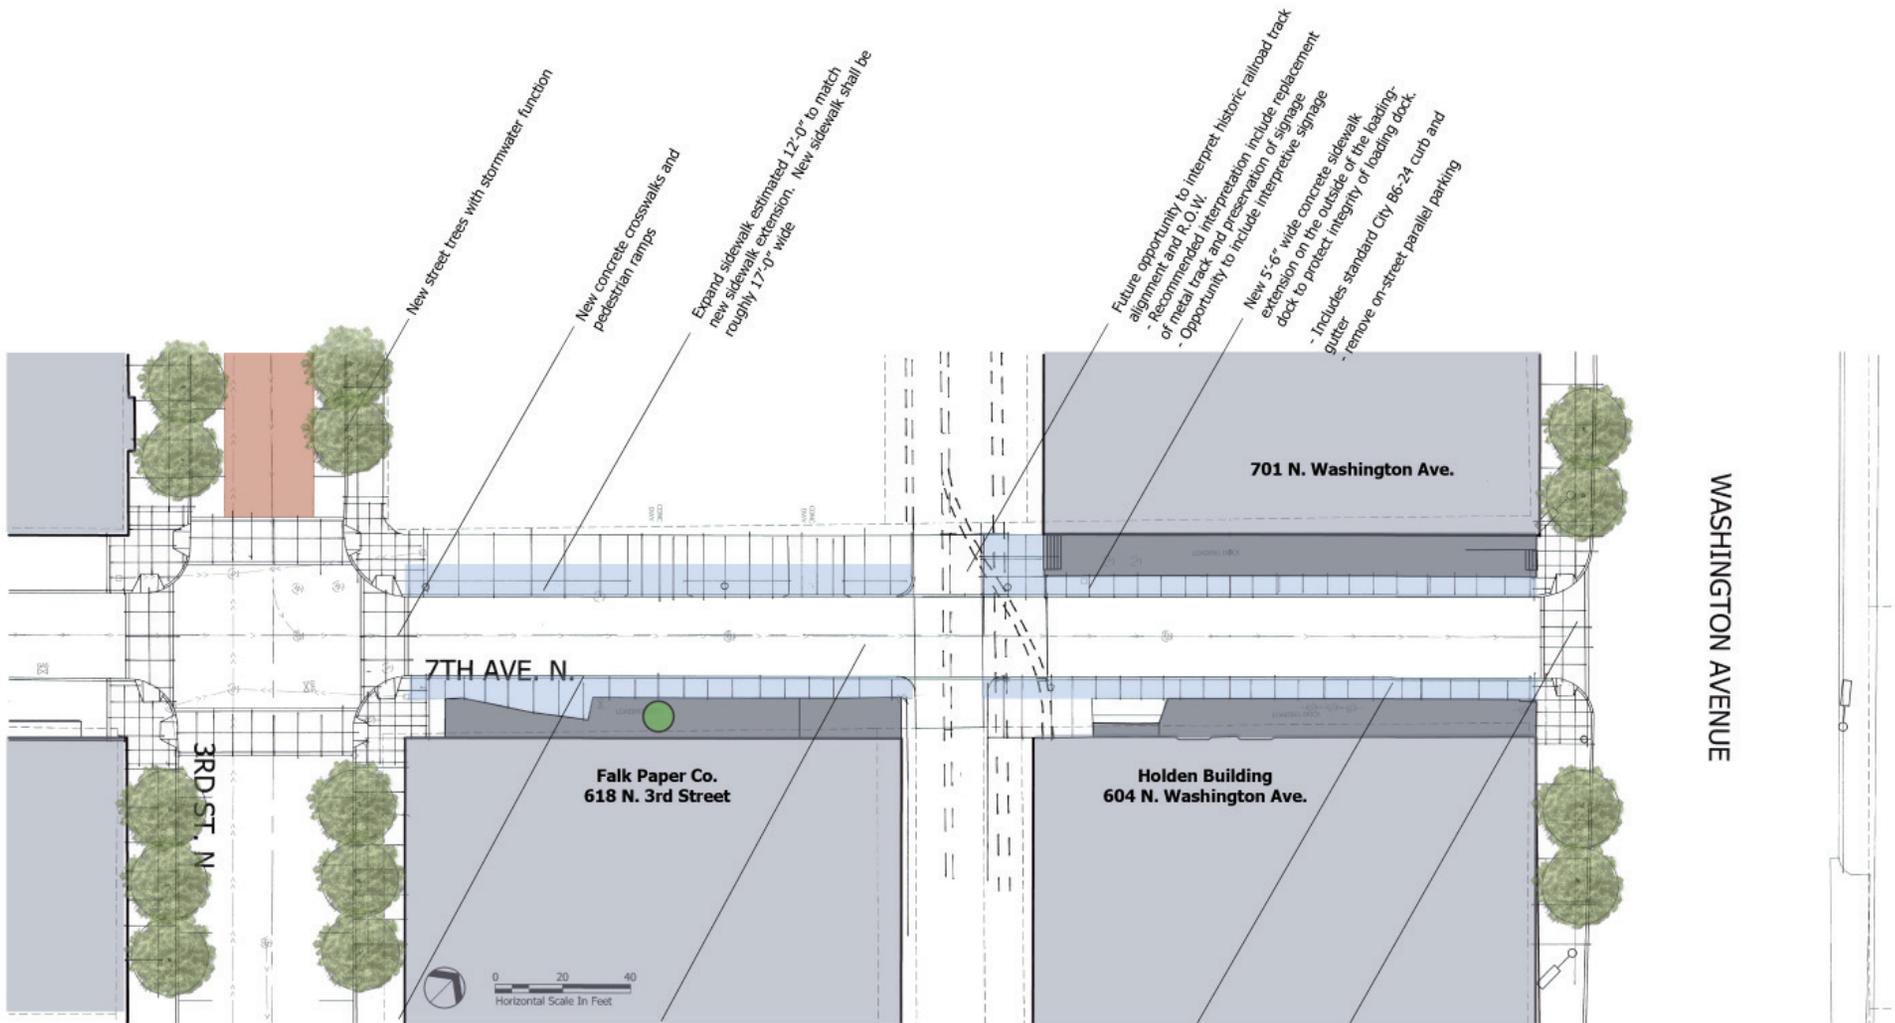
Existing ROW: 60'-0"  
 Current Street Width: 35'-0" to 44'-0"  
 Proposed Street Width: 26'-0"

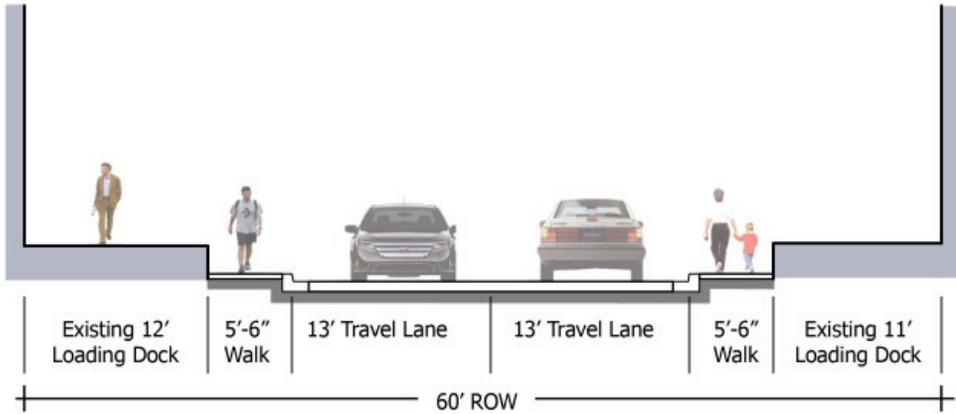
Proposed Cross-Section  
7th Avenue North (4th Street North to 3rd Street North) looking north

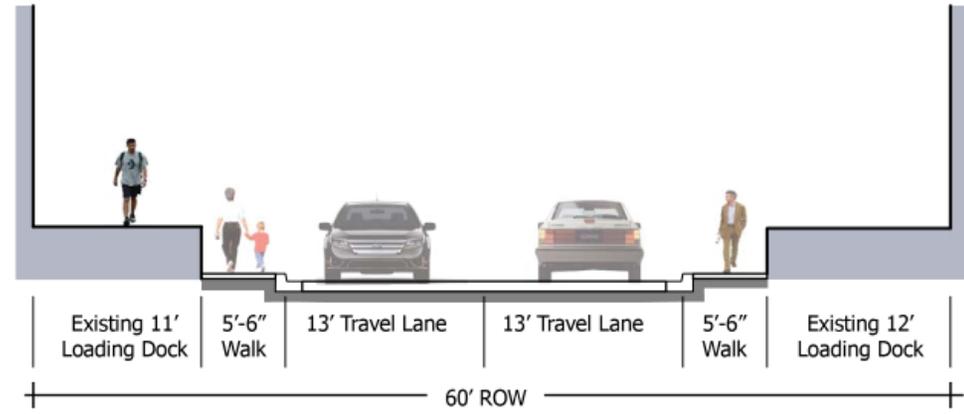
Proposed Cross-Section  
7th Avenue North (3rd Street North to Washington Avenue North) looking north

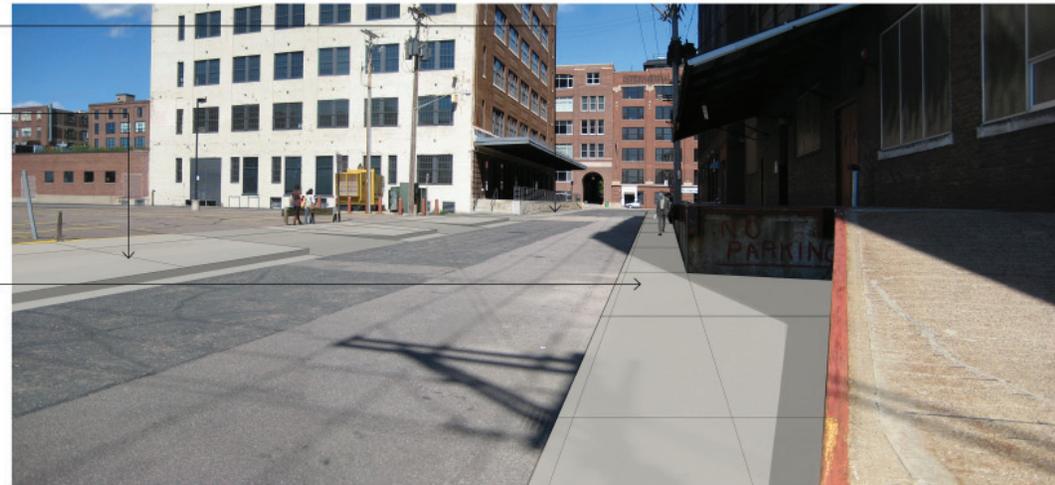
New accessible 5'-6" wide walk adjacent to loading dock area

Proposed view looking north along 7th Avenue

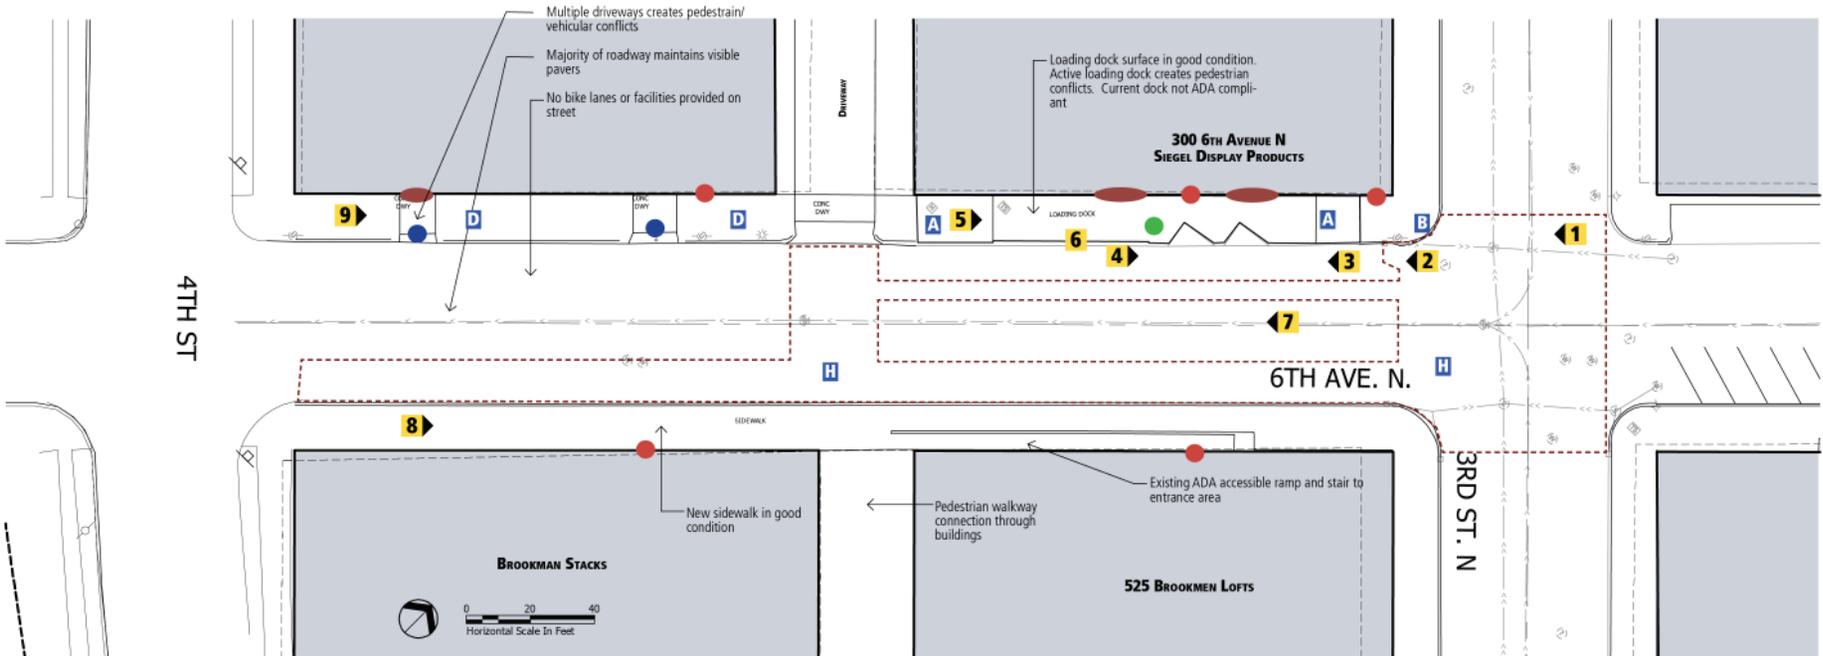
6th Avenue Existing Conditions  
**WAREHOUSE DISTRICT HERITAGE STREET PLAN**

ROW - 80'  
Street width - 50'  
ADT- 5600

Areas of street patching - Approximately 10,900 sf  
22 parallel parking stalls

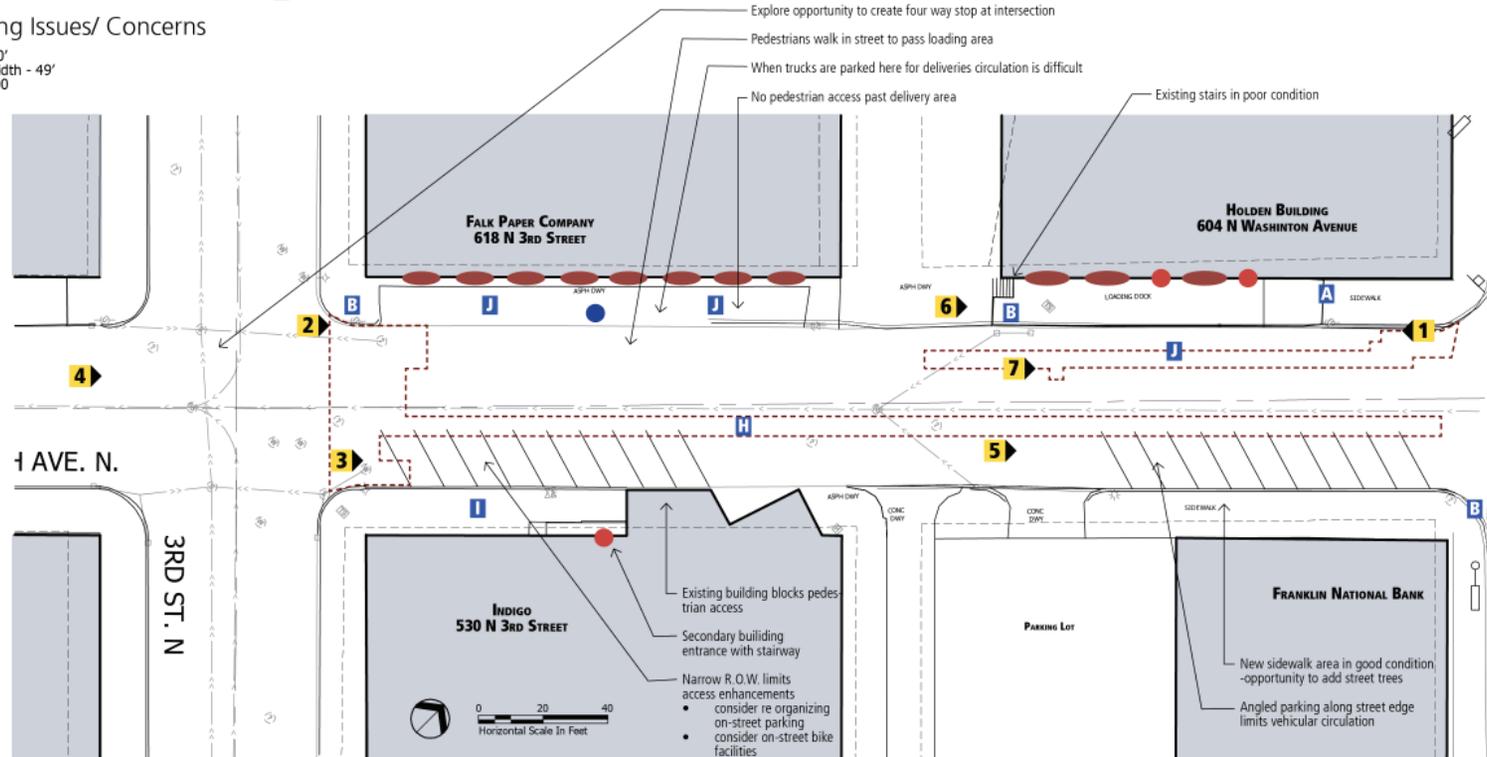
6th Avenue Existing Conditions

ROW - 80'  
 Street Width - 49'  
 ADT- 5600

Areas of street patching - Approximately 4,100 sf  
 18 angled parking stalls

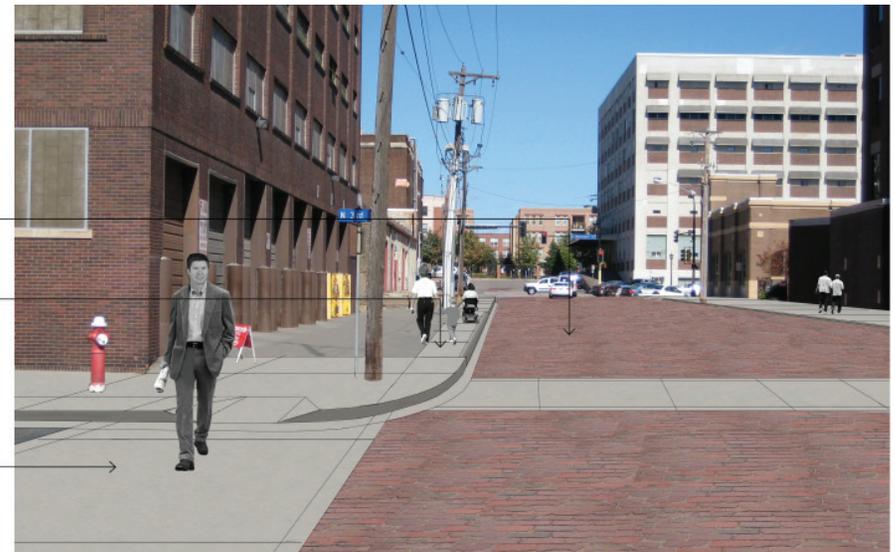
Remove, clean, and reset historic brick pavers on majority of 6th Ave. Maintain historic pavers in place as noted on plan.

New concrete crosswalks with accessible curb ramps

Proposed view looking north along 6th Avenue

- Sidewalks: Widen sidewalk areas on both sides of the street to approximately 6'-0". The proposed widened sidewalks would provide access around all of the existing loading docks that exist along the entire length of 6th Avenue. The proposed sidewalks should be designed to meet City design standards and be ADA compliant.
- Crosswalks: Provide new concrete crosswalks and ADA accessible pedestrian ramps at all street intersections. Pedestrian ramps shall conform to City of Minneapolis, ADA Standards for Accessible Design, and PROWAAC standards.
- Street trees: Plant new street trees along 6th Avenue on both sides of the street between the alley and 4th Street N.

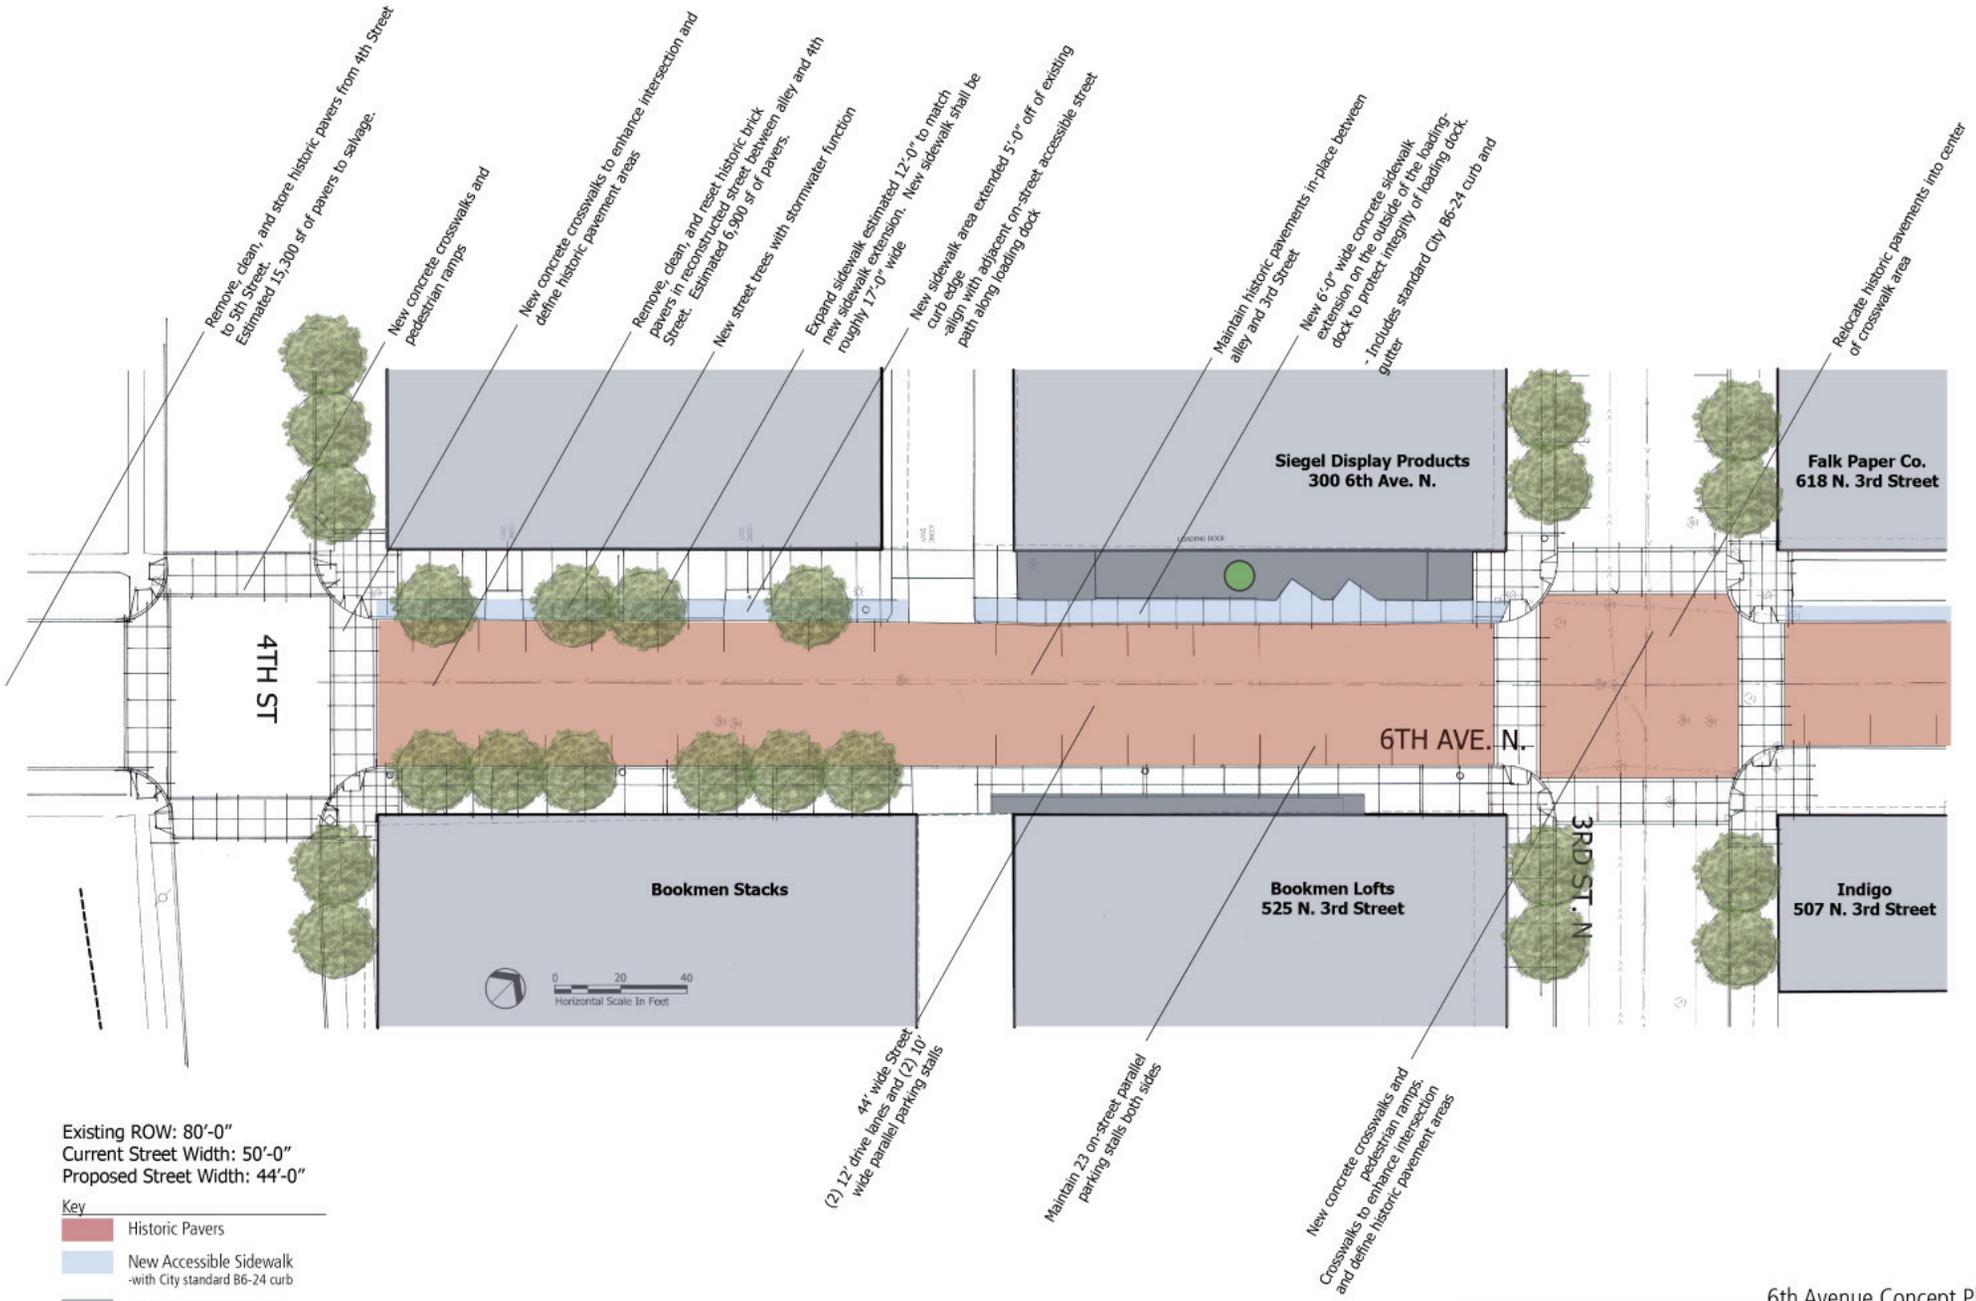
Existing ROW: 80'-0"  
 Current Street Width: 50'-0"  
 Proposed Street Width: 44'-0"

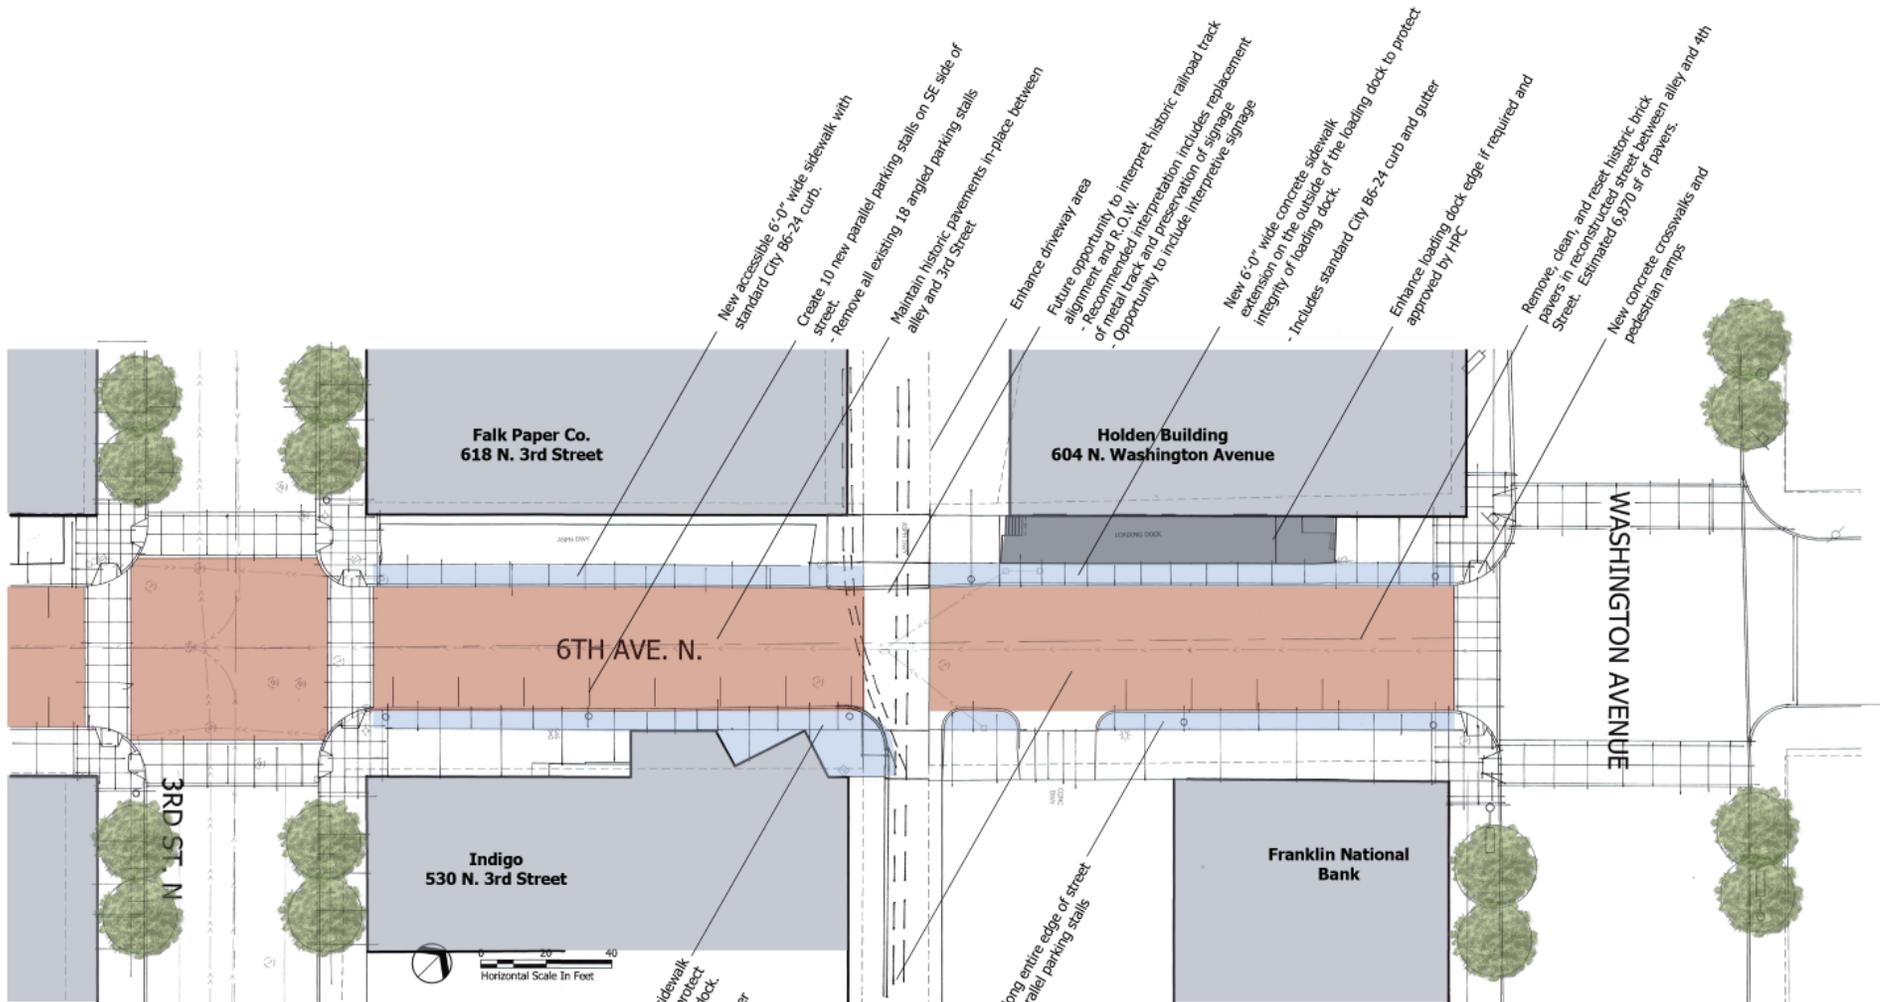
Existing ROW: 80'-0"  
 Current Street Width: 49'-0"  
 Proposed Street Width: 38'-0"

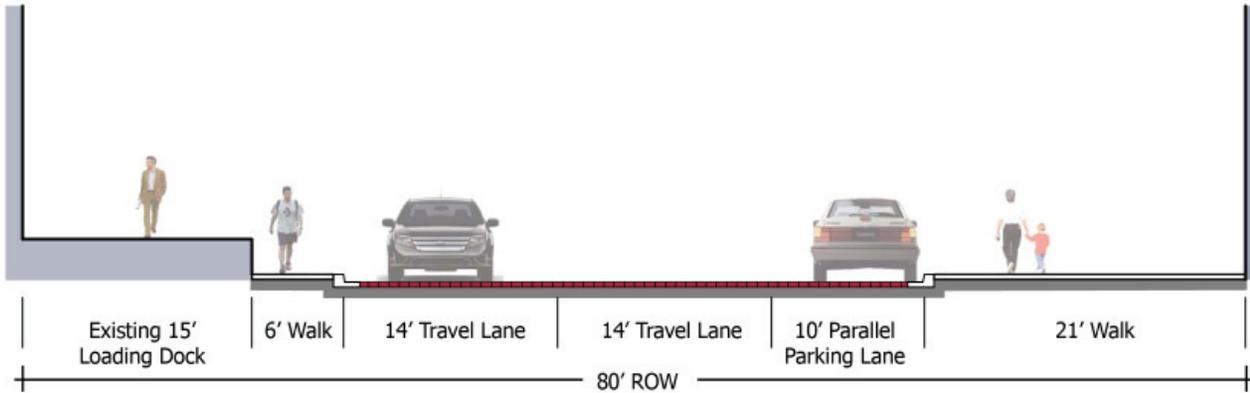
Proposed Cross-Section  
6th Avenue North (4th Street North to 3rd Street North) looking south

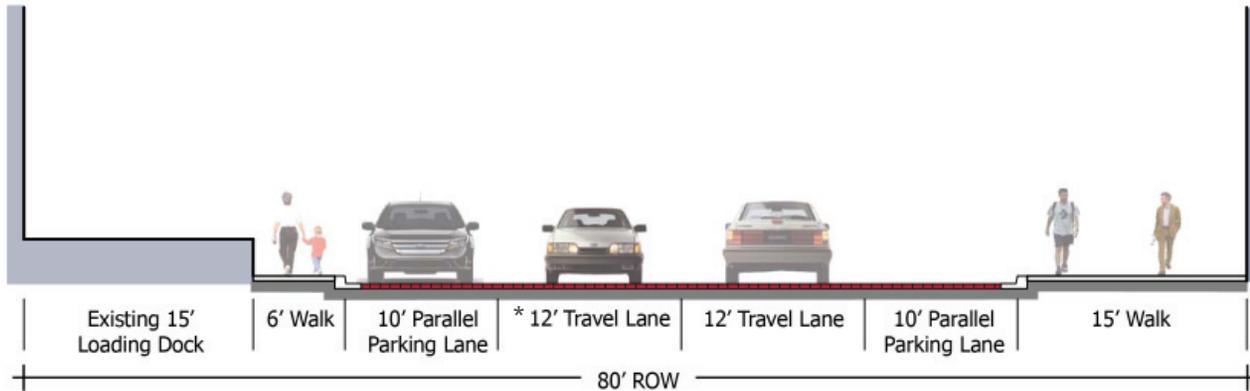
Proposed Cross-Section  
6th Avenue North (3rd Street North to Washington Avenue North) looking south

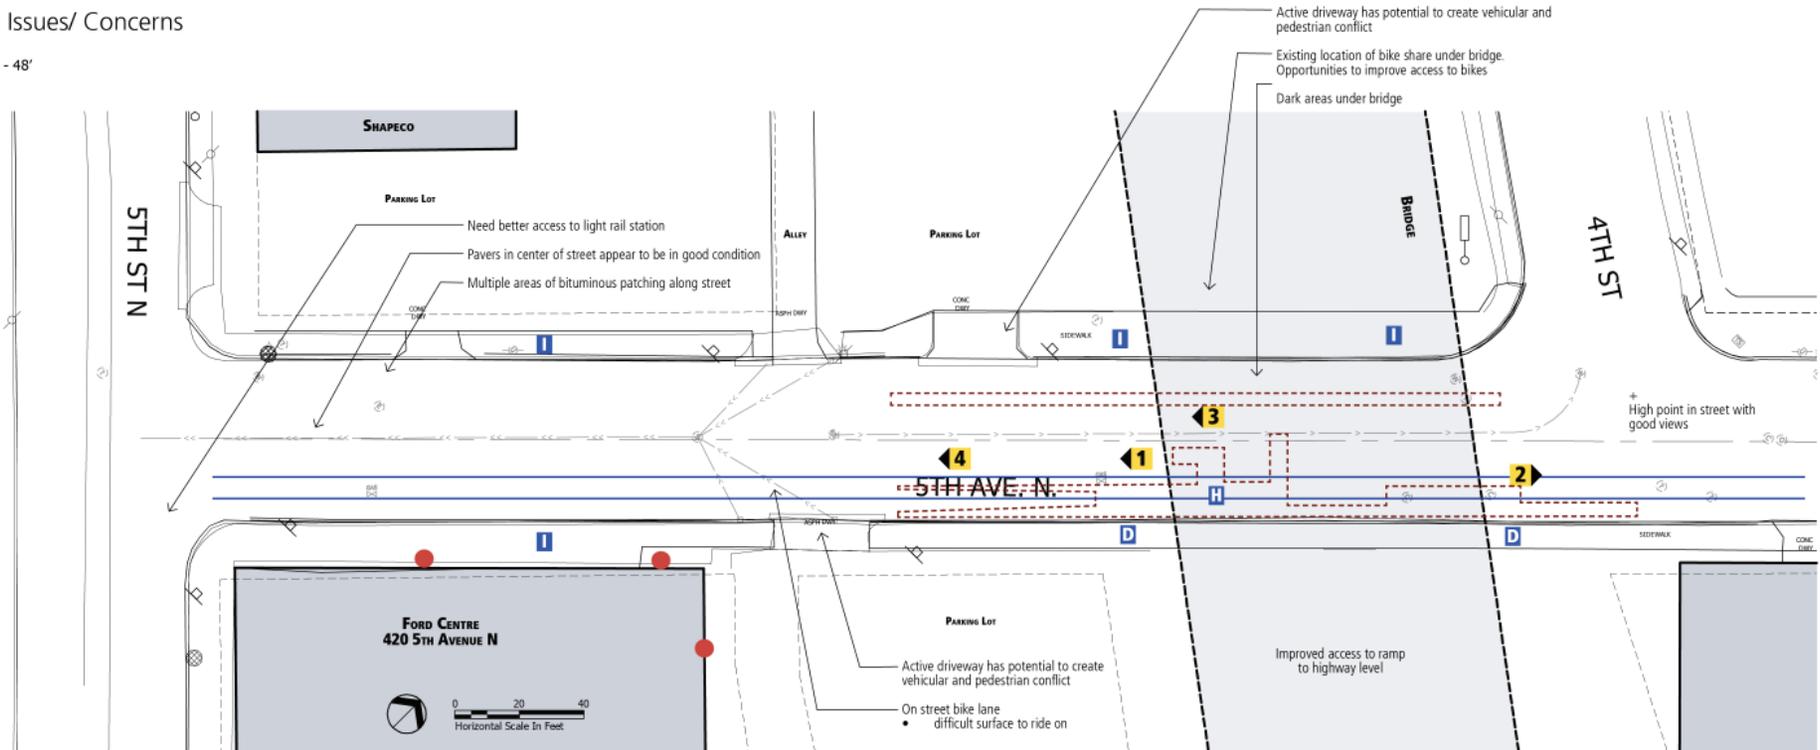
5th Avenue Existing Conditions  
**WAREHOUSE DISTRICT HERITAGE STREET PLAN**

ROW - 80'  
 Street Width - 48'  
 ADT - 3800

Areas of street patching - Approximately 2,650 sf  
 23 parallel parking stalls

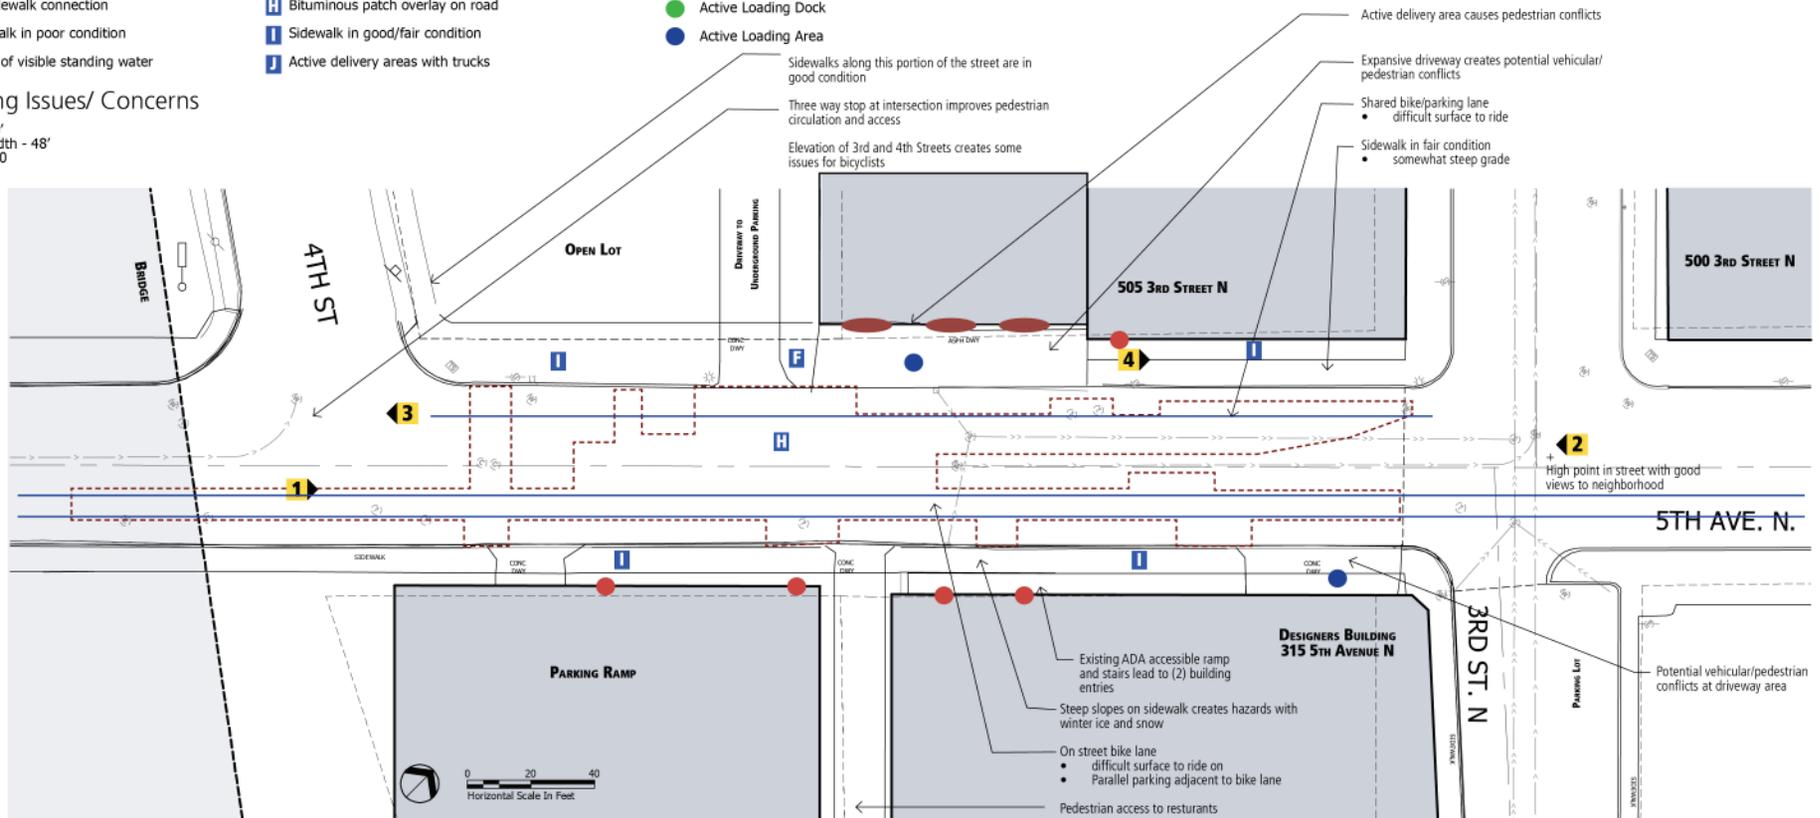
ROW - 80'  
Street Width - 48'  
ADT - 3800

Areas of street patching - Approximately 10,400 sf  
12 parallel parking stalls

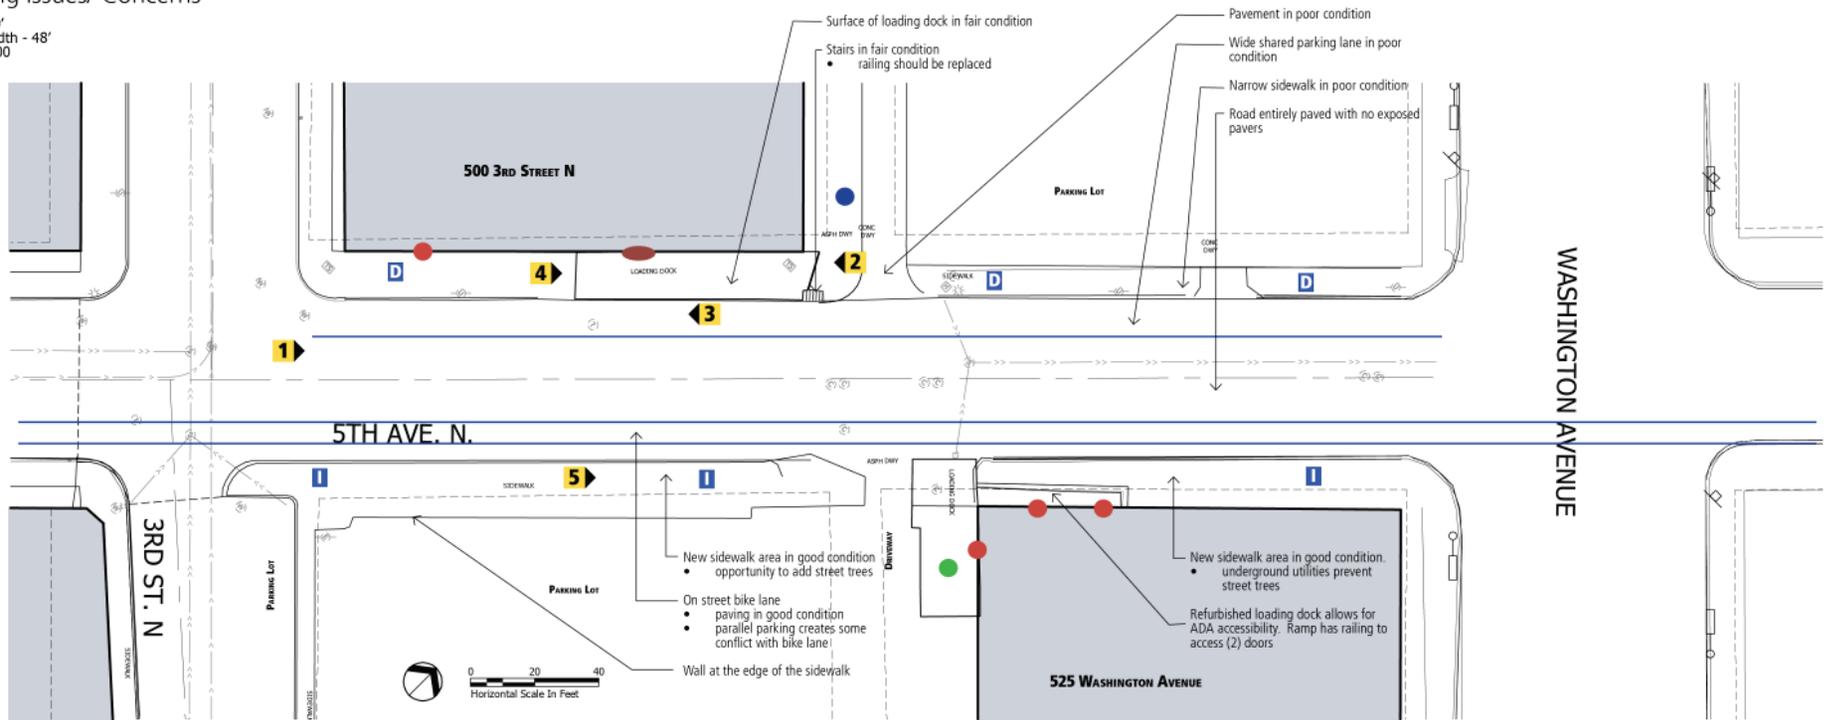
ROW - 80'  
Street Width - 48'  
ADT - 3800

Areas of street patching  
27 parallel parking stalls

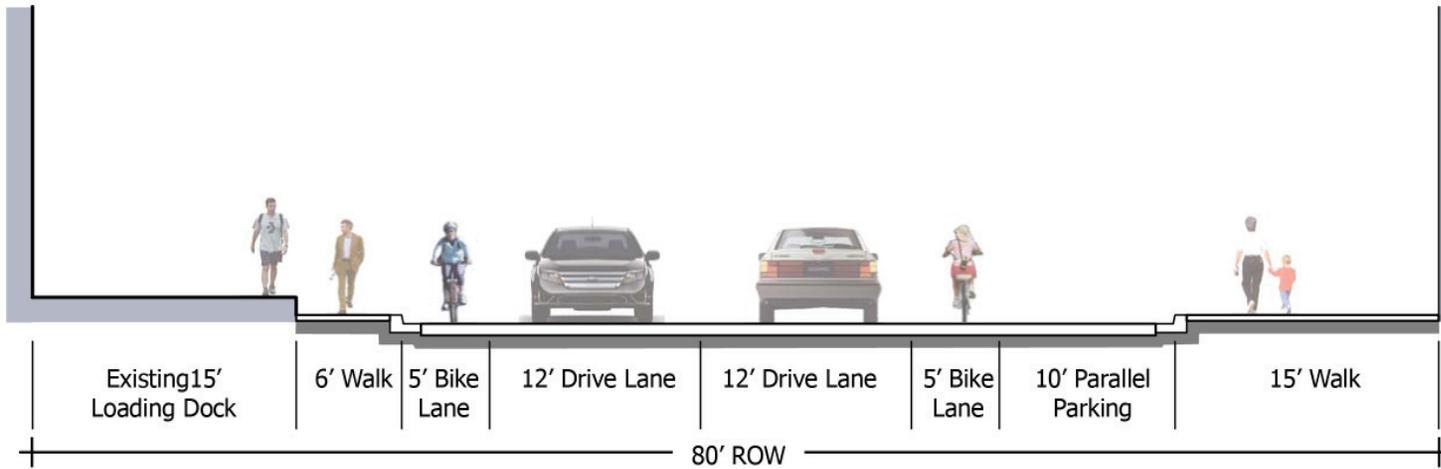
Proposed Cross-Section  
5th Avenue North (5th Street North to 3rd Street North)

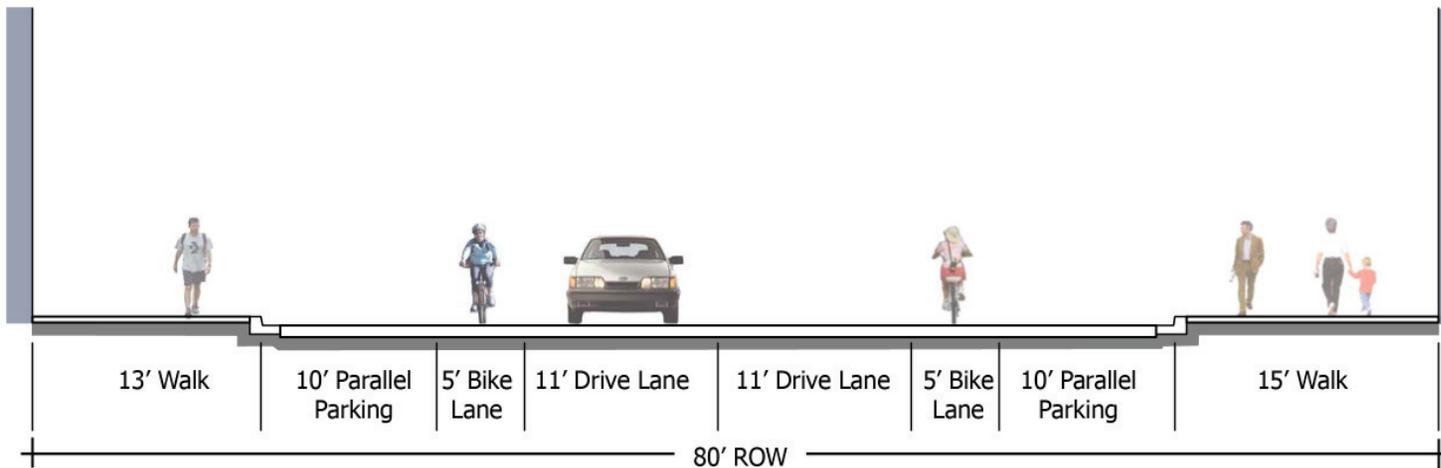
Proposed Cross-Section  
5th Avenue North (3rd Street North to Washington Avenue North)

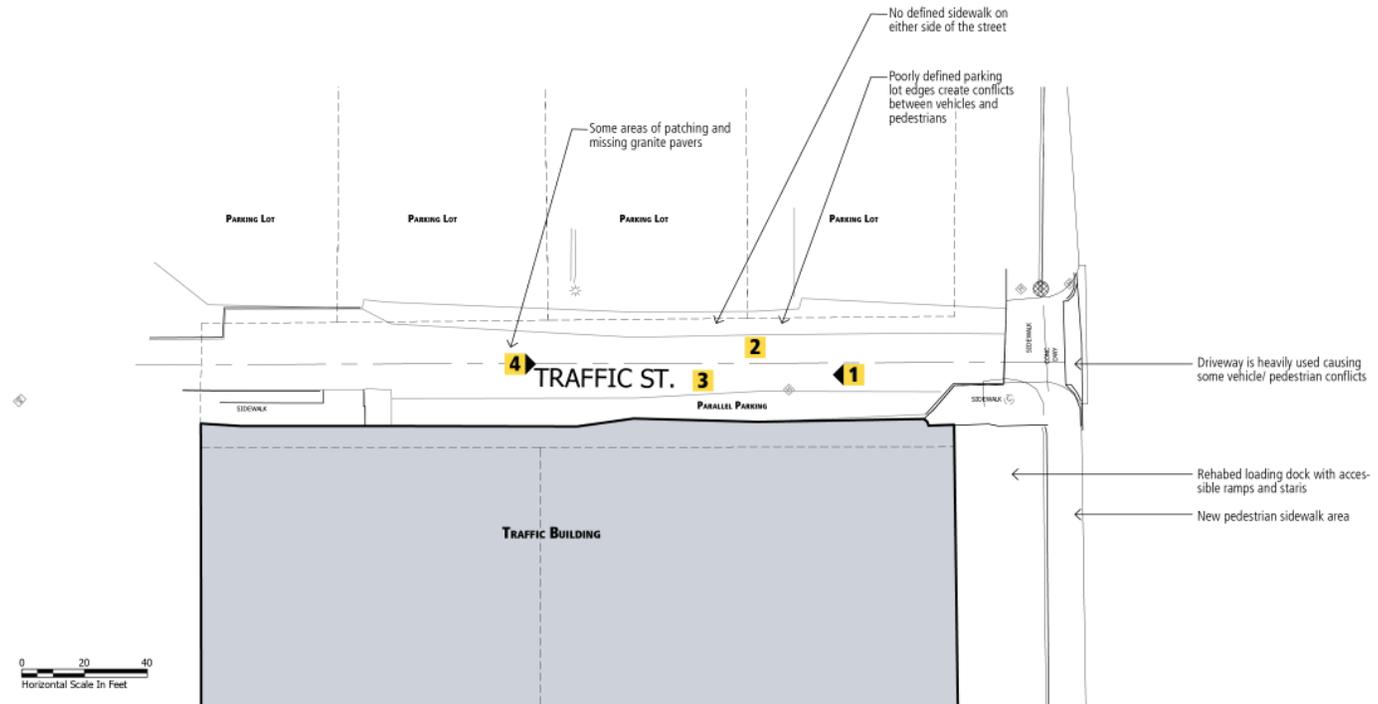
Traffic Street Existing Conditions  
**WAREHOUSE DISTRICT HERITAGE STREET PLAN**

ROW - 40'  
 Street Width - Varies (22' - 25' wide)  
 ADT - Undefined (Not a Municipal State Aid Street)

- ROW width: Existing ROW along Traffic Street is to remain at 40' wide.
- Street width: Proposed street width of 24' wide.
- On-street parking: Remove all parallel parking along Traffic Street.
- Granite paving: Remove, clean and re-install historic granite paving the entire length of the street from the curb line along 3rd Avenue North to the proposed Dock Street.
- Sidewalks: Enhance sidewalk along Traffic Zone Building and connect up to 3rd Avenue North and to accessible building entrance near proposed Dock Street.
- Street design: Define street edge with new curb and gutter along existing parking lots for adjacent buildings. Existing encroachments along Traffic Street should also be removed.

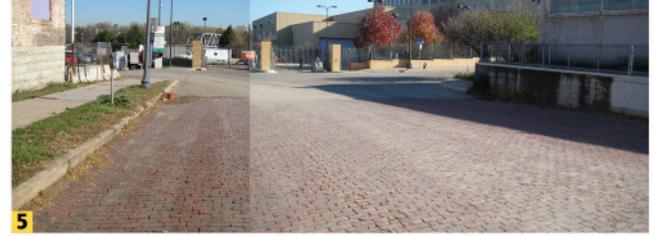
5 Wide view of 2nd Avenue N. Paving is generally in good condition and remains very level throughout the entire roadway
