# V. Specific Street Analysis, Concept Plans and Recommendations

### **Heritage Street Analysis and Concept Plans**

3rd Street Existing Conditions  
 WAREHOUSE DISTRICT HERITAGE STREET PLAN

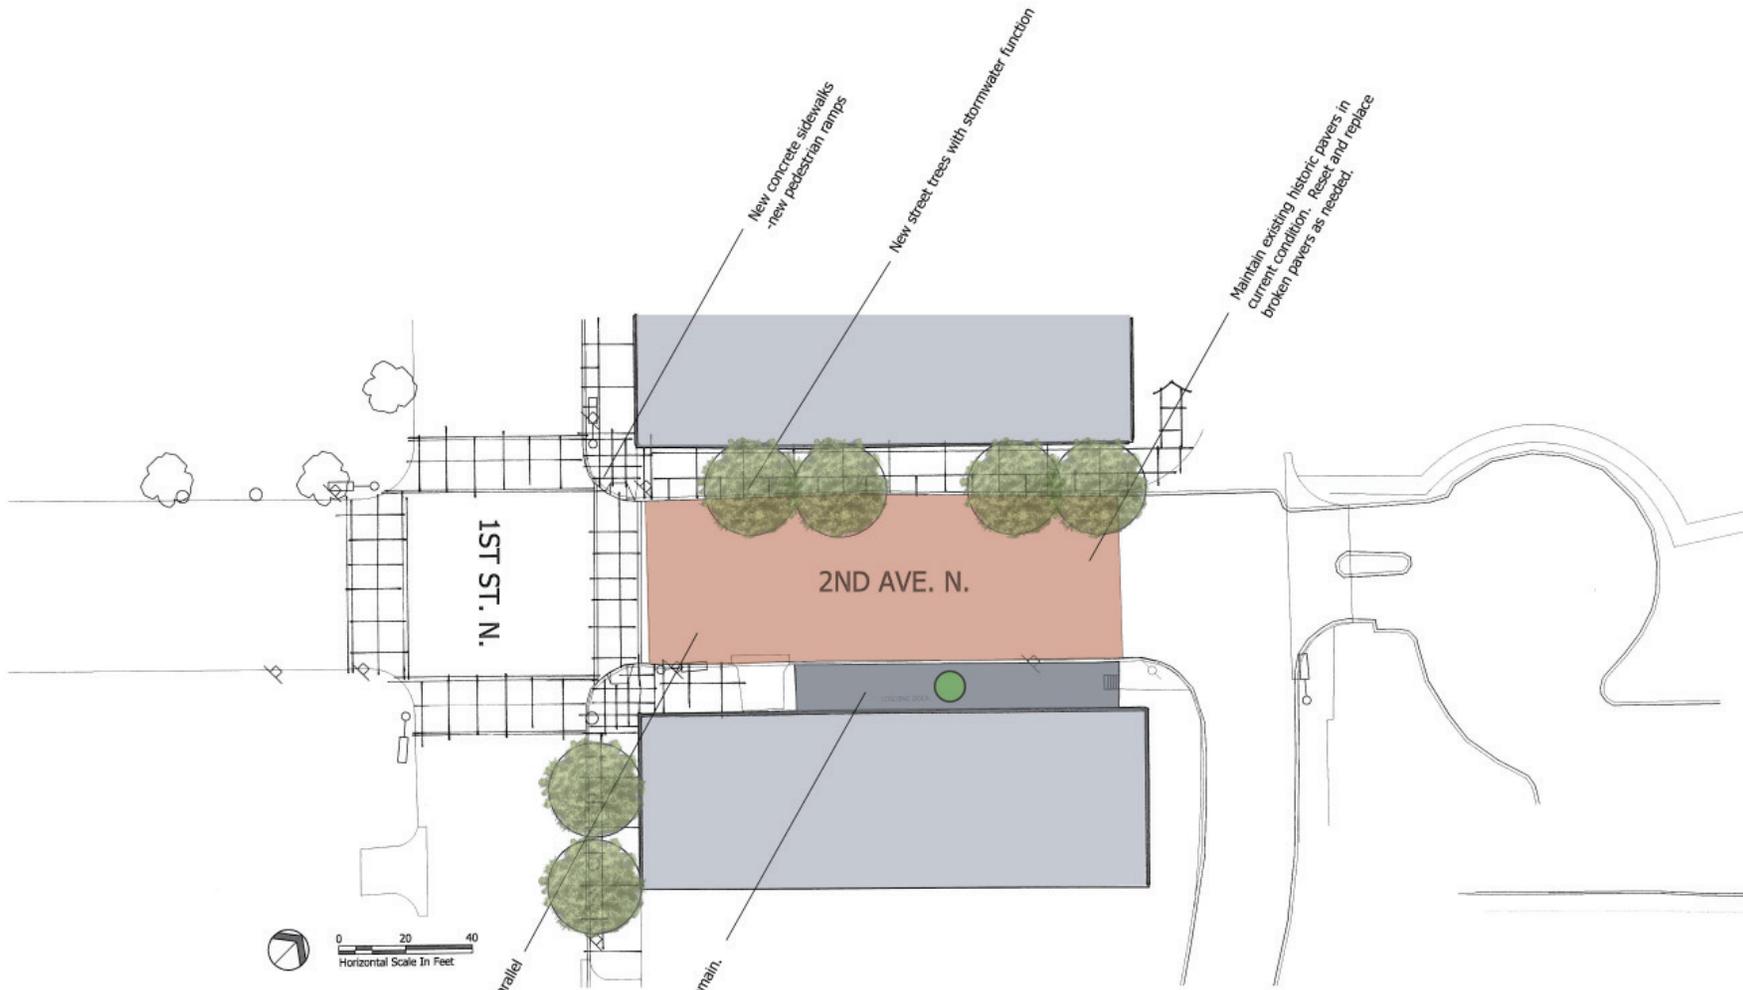
Existing ROW: 80'-0"  
 Current Street Width: 48'-0"  
 Proposed Street Width: 48'-0"

- ROW width: Existing ROW along 2nd Avenue North to remain at 80' wide
- Street width: Street to remain at a width of 47'-0"
- On-street parking: Current on-street parking to remain.
- Brick pavers: Historic pavements in very good condition and it is recommended that the paving remain in place as is until there is a future need to repair/ replace.
- Street trees: Define future opportunities to add street trees and pedestrian level lighting along the north side of the street.
- Sidewalks: Replace the existing sidewalk as needed.
