# Warehouse District Heritage Streets Project

## Task Force Meeting #2

*February 3<sup>rd</sup>, 2011*

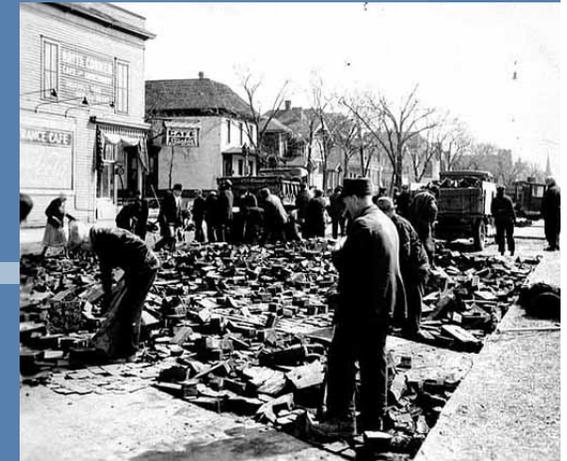
3<sup>rd</sup> Street at 14<sup>th</sup> Avenue –  
Wood block pavers

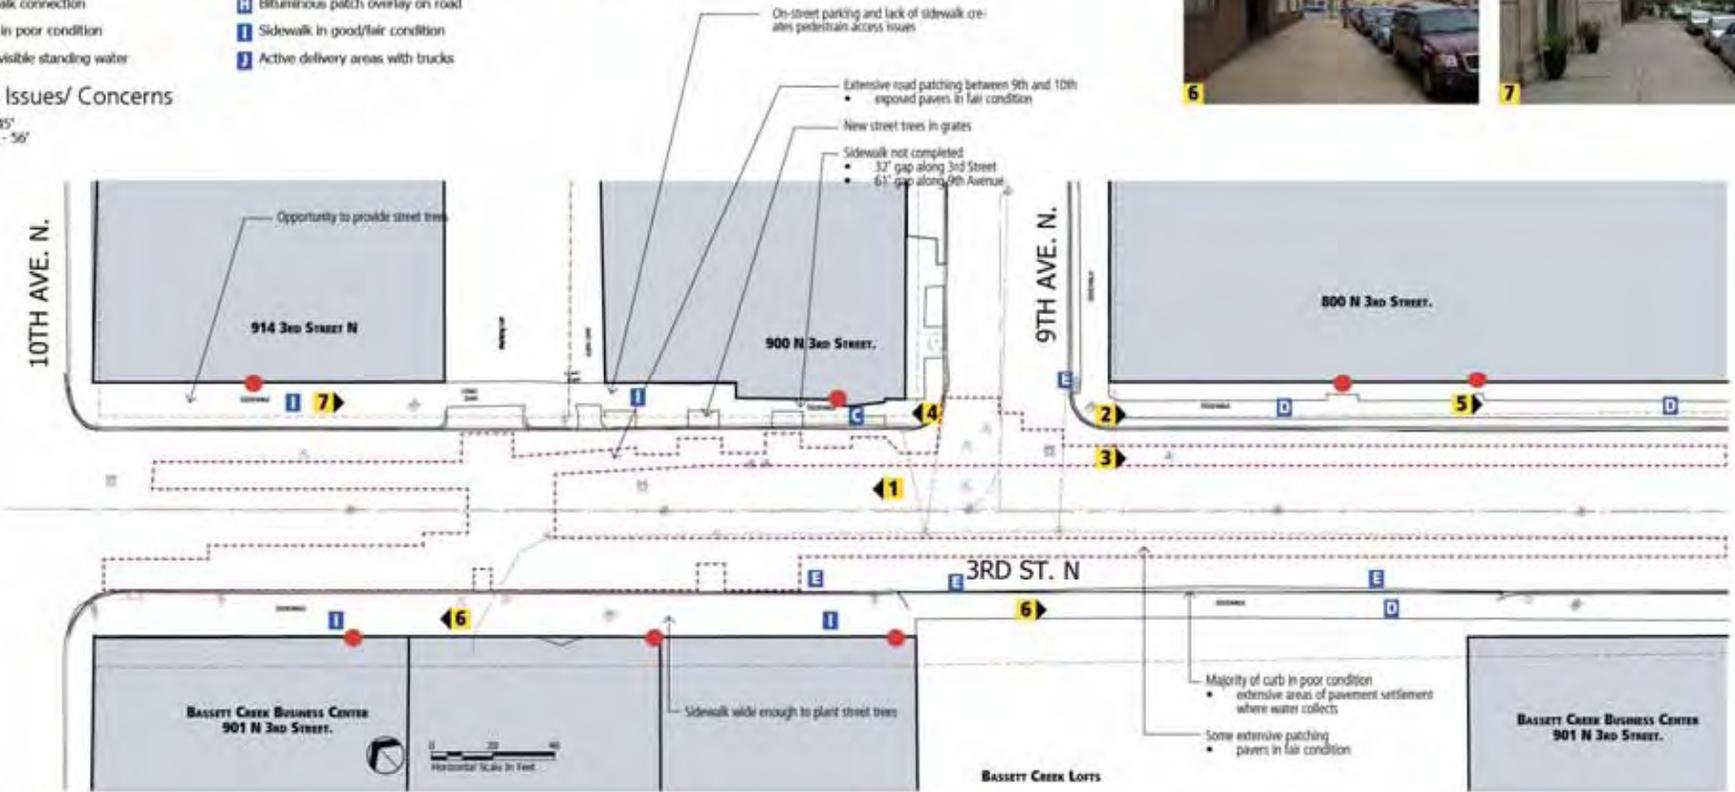
R.O.W. - 82.45'  
 Street Width - 56'  
 ADT - 1700

Areas of street patching - Approximately 9,900 sf

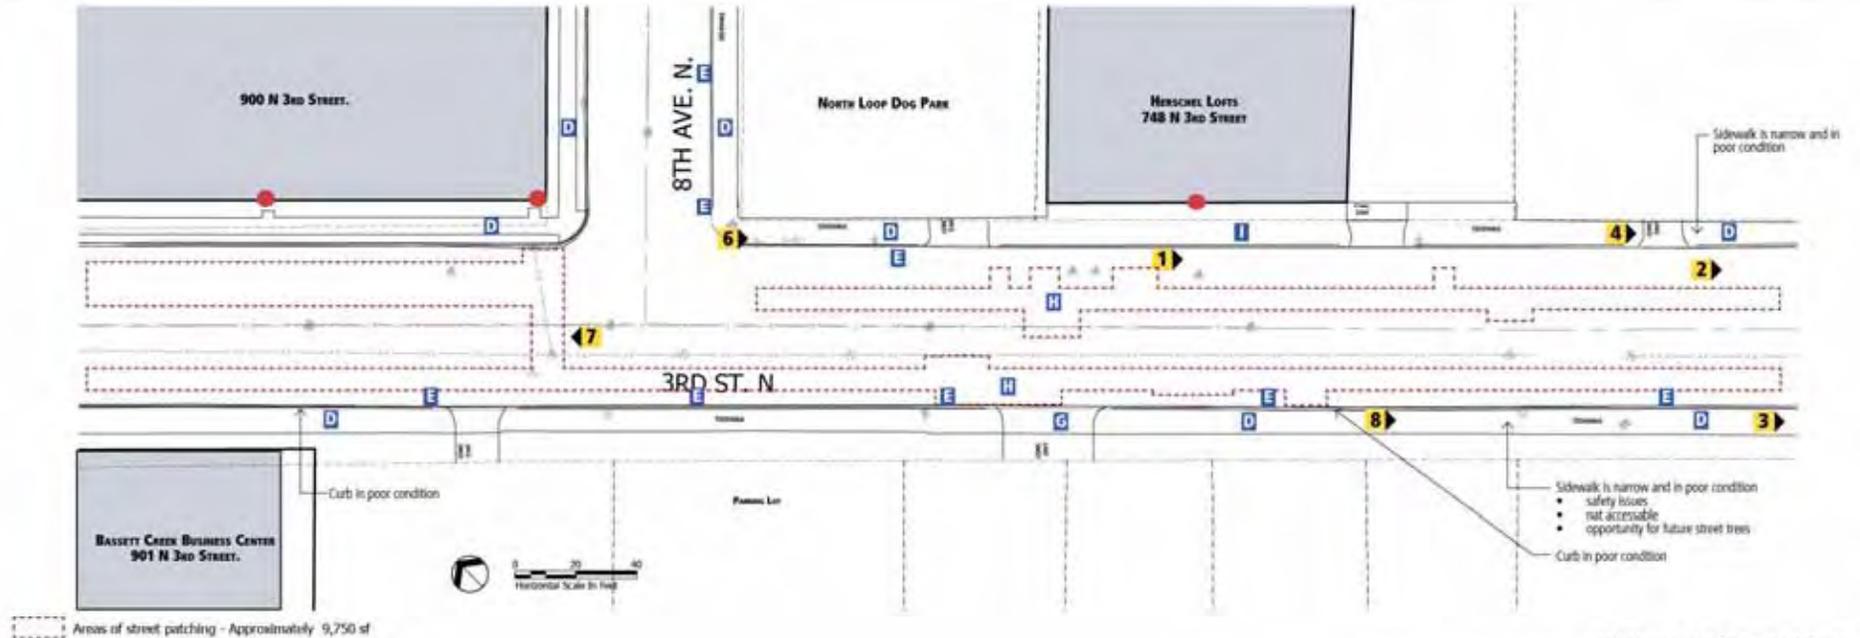
3rd Street Existing Conditions  
**WAREHOUSE DISTRICT HERITAGE STREET PLAN**

R.O.W. - 82.45'  
Street Width - 56'  
ADT - 1,700

- Estimated 75% of visible pavement appears to be in good condition
- Sidewalks on both sides on the street between 10th Avenue and 9th Avenue are in fair condition. Sidewalk on the north side of the street is interrupted by numerous driveways leading to parking areas.

- 900 N 3rd Street building has about 61' lineal feet of sidewalk missing along 9th Avenue. There is roughly 32' of sidewalk missing along 3rd Street N in front of the building.

- Sidewalks on both sides of the street between 9th Avenue and 8th Avenue are in poor condition.
- ADA accessibility
  - Accessibility on both sides of the street between 10th Avenue and 9th Avenue is considered fair. The missing section of sidewalk in front of the 900 N 3rd Street building needs to be completed.

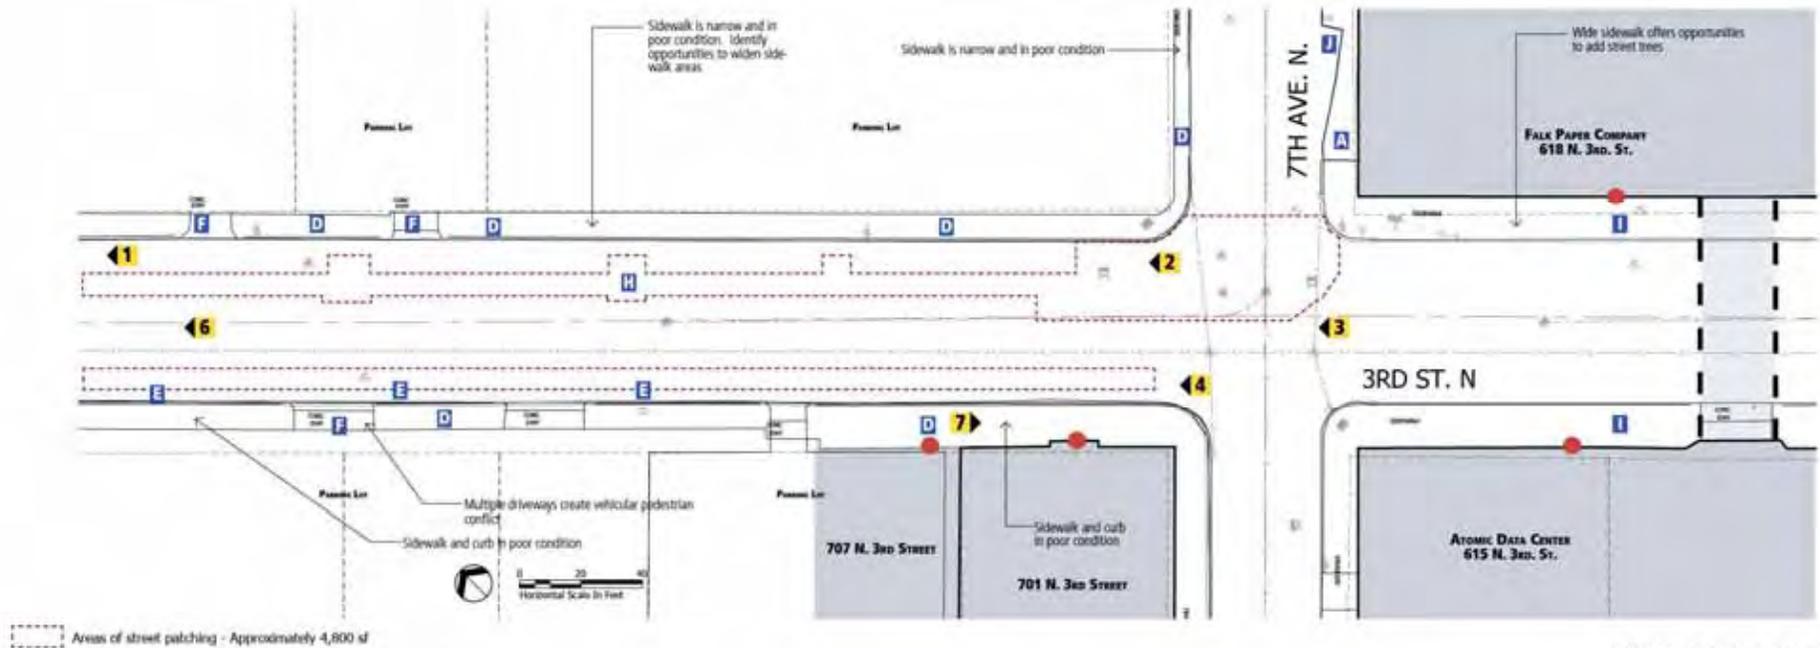
3rd Street Existing Conditions  
WAREHOUSE DISTRICT HERITAGE STREET PLAN

R.O.W. - 82.45'  
Street Width - 56'  
ADT - 1700

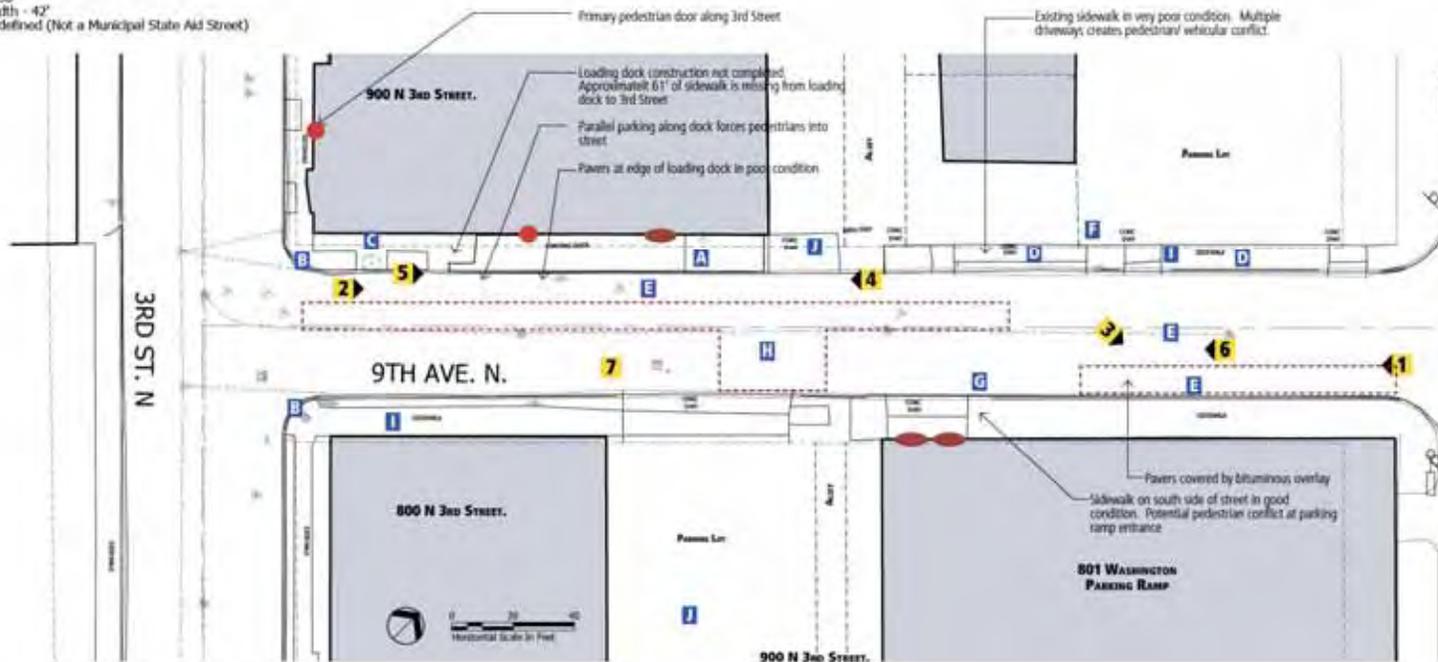
R.O.W. - 66'  
 Street Width - 42'  
 ADT - Undefined (Not a Municipal State Aid Street)

Areas of street patching - Approximately 3,375 sf

- Estimated 85% of pavement appears to be in good condition
- New continuous sidewalk on the east side of the street. Sidewalk on the west side of the street is interrupted by numerous driveways leading to parking areas.

- Existing loading dock has been modified along the 900 N. Third Street Building.
  - Loading dock construction is not completed and not ADA compliant.
- ADA accessibility

- Accessibility on the east side of the street is considered good and the west side of the street is considered poor.

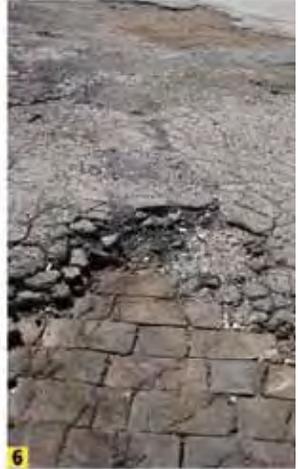
6 Extensive bituminous patching has occurred over existing wood block pavers

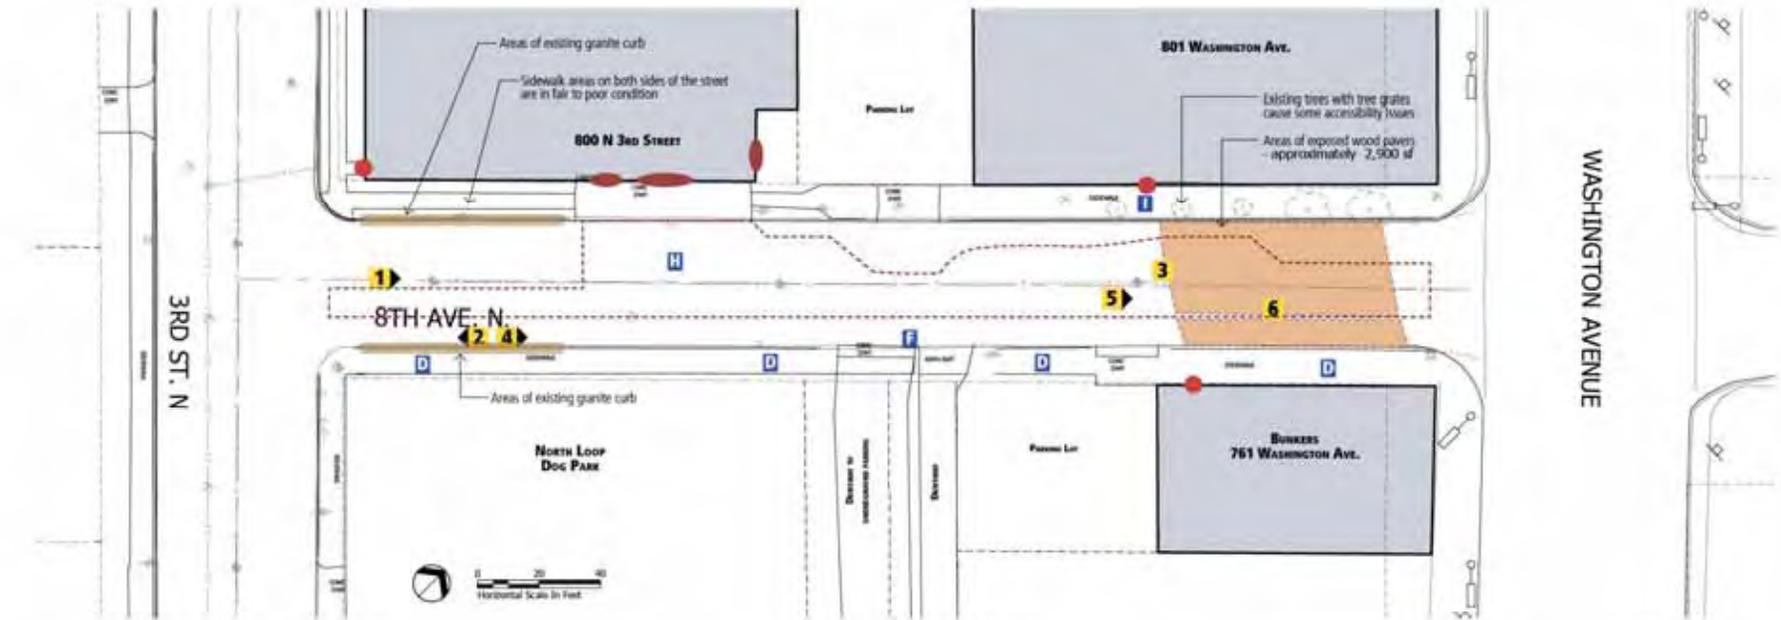
R.O.W. - 66'  
 Street Width - 42'  
 ADT - Undefined (Not a Municipal State Aid Street)

--- Areas of street patching - Approximately 7,240 sf

- Some visible areas of pavement settling that collect stormwater
  - Estimated 70% of pavement appears to be in fair to good condition
  - Existing creosote wood block pavers appear to be in good condition

- Sidewalks on both the east and west side of the street is interrupted by numerous driveways leading to parking areas.
  - Sidewalks are in poor condition based on visual analysis.

- Curbs also appear to be in poor condition. There are existing granite curbs along both sides of the street at the intersection of 3rd Street N
- Some active loading areas exist at the 800 N 3rd Street building

- ADA accessibility
  - Accessibility on the both sides of the street is considered poor.

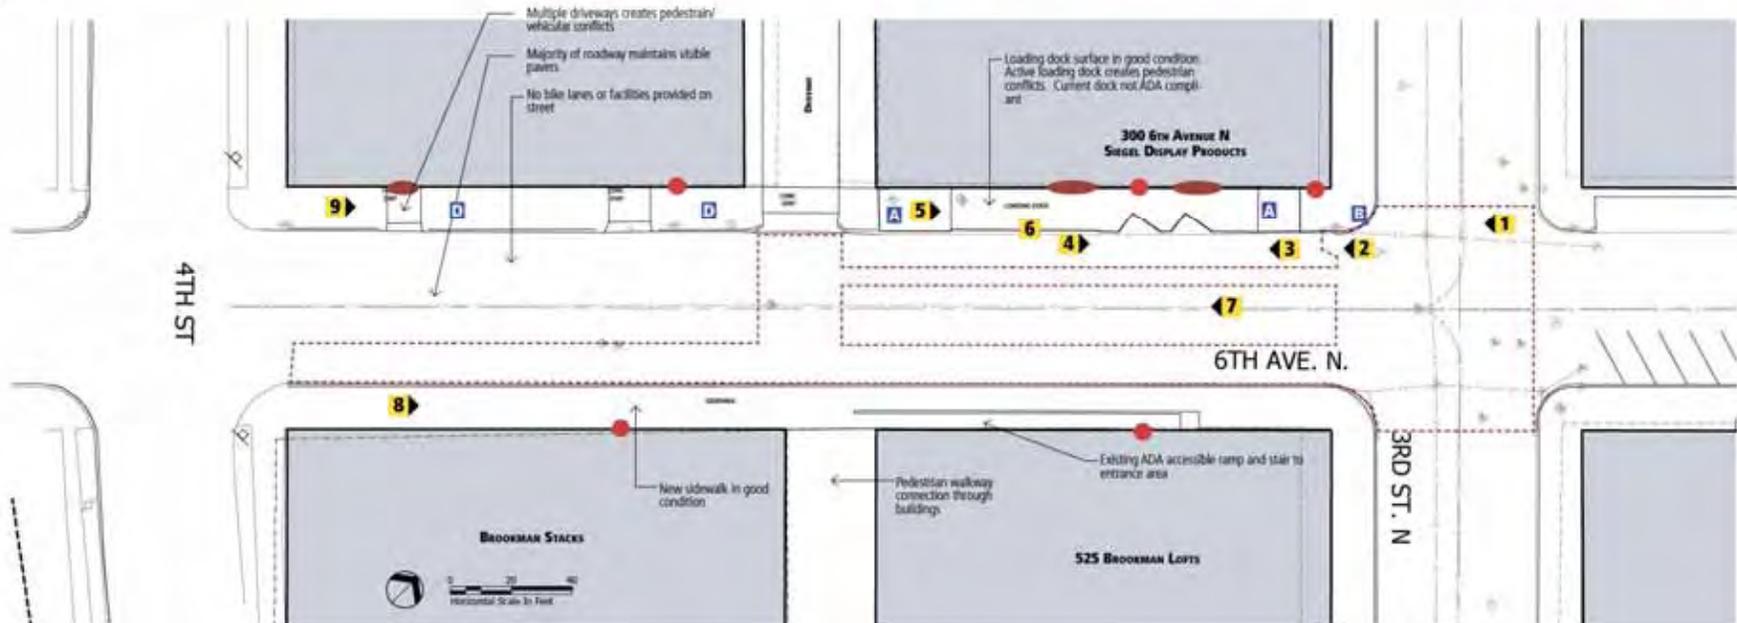
R.O.W. - 80'  
Street width - 52'  
ADT - 5600

Areas of street patching - Approximately 10,900 sf

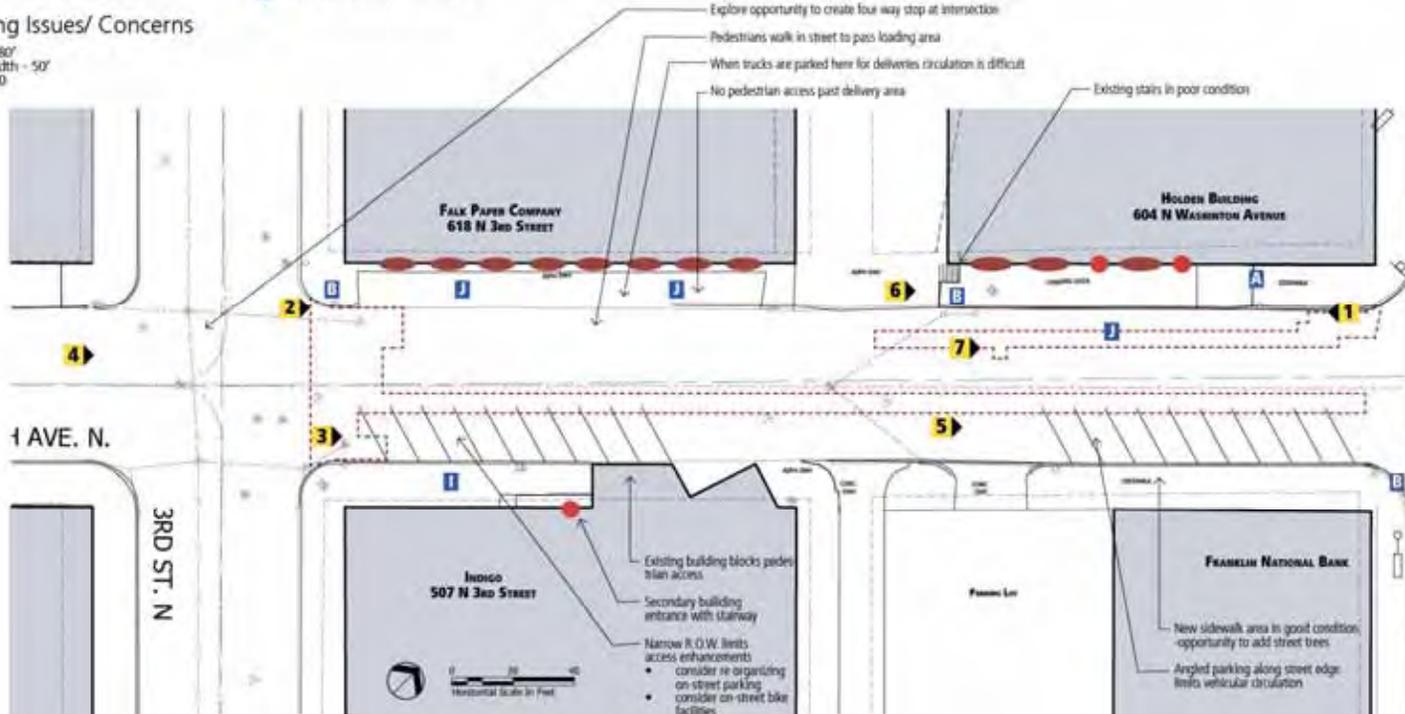
R.O.W. - 80'  
Street Width - 50'  
ADT - 5600

Areas of street patching - Approximately 4,100 sf

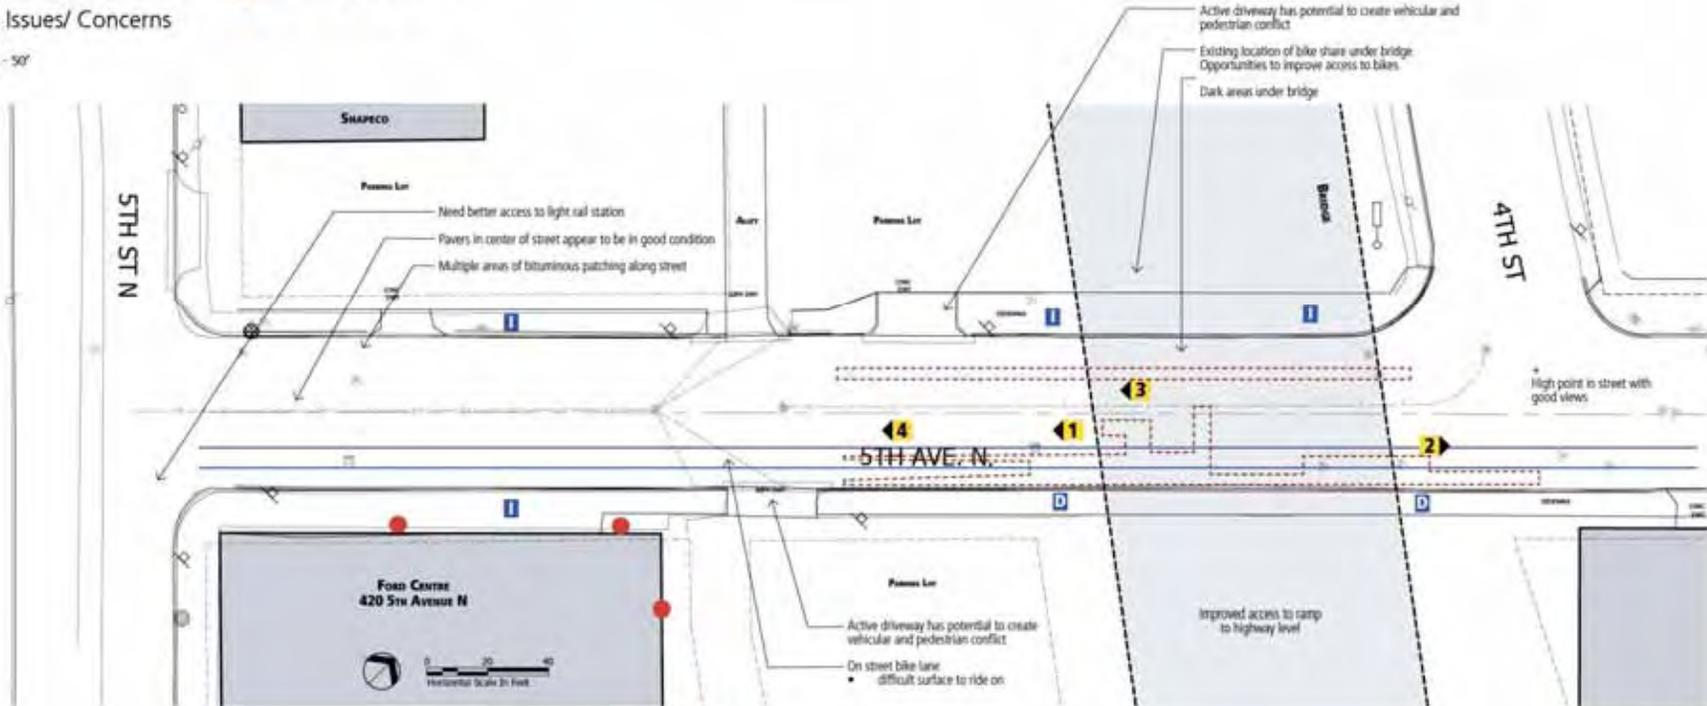
5th Avenue Existing Conditions  
**WAREHOUSE DISTRICT HERITAGE STREET PLAN**

R.O.W. - 80'  
 Street Width - 50'  
 ADT - 3800

Areas of street patching - Approximately 2,650 sf

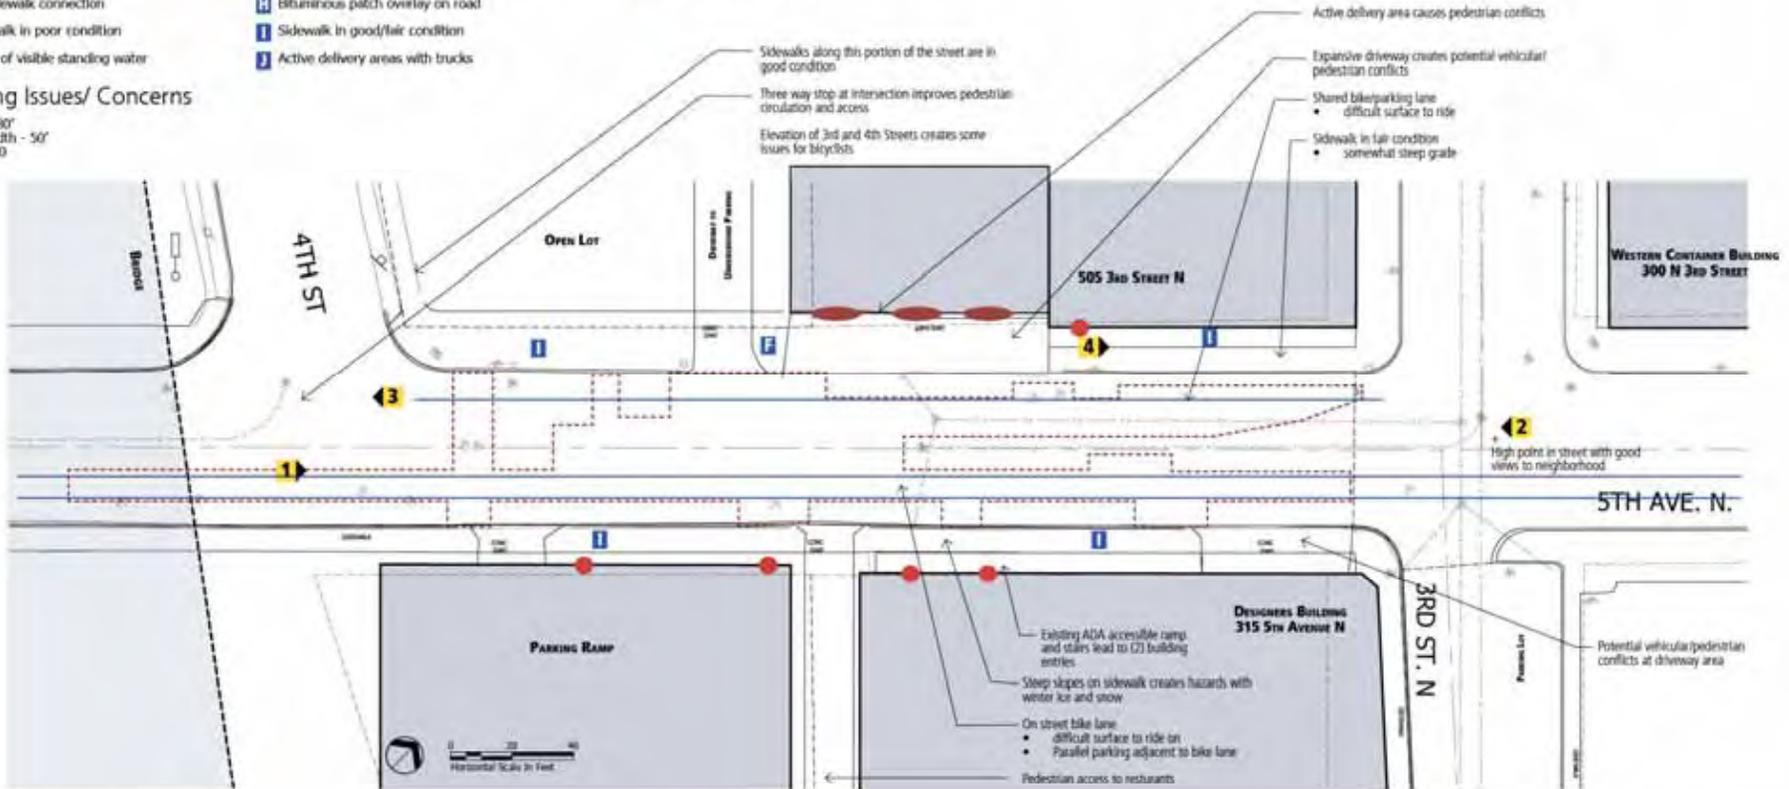
R.O.W. - 80'  
Street Width - 50'  
ADT - 3800

Areas of street patching - Approximately 10,400 sf

- Sidewalk on the east side of street is in fair condition based on visual analysis. Curbs also appear to be in fair condition.
  - Existing on-street bike lane is defined on the east side of the street and a shared bike lane exists on the west side of the street.

- ADA accessibility
  - Accessibility on both sides of the street is considered fair. Steep sidewalk slopes can cause issues in the winter months.

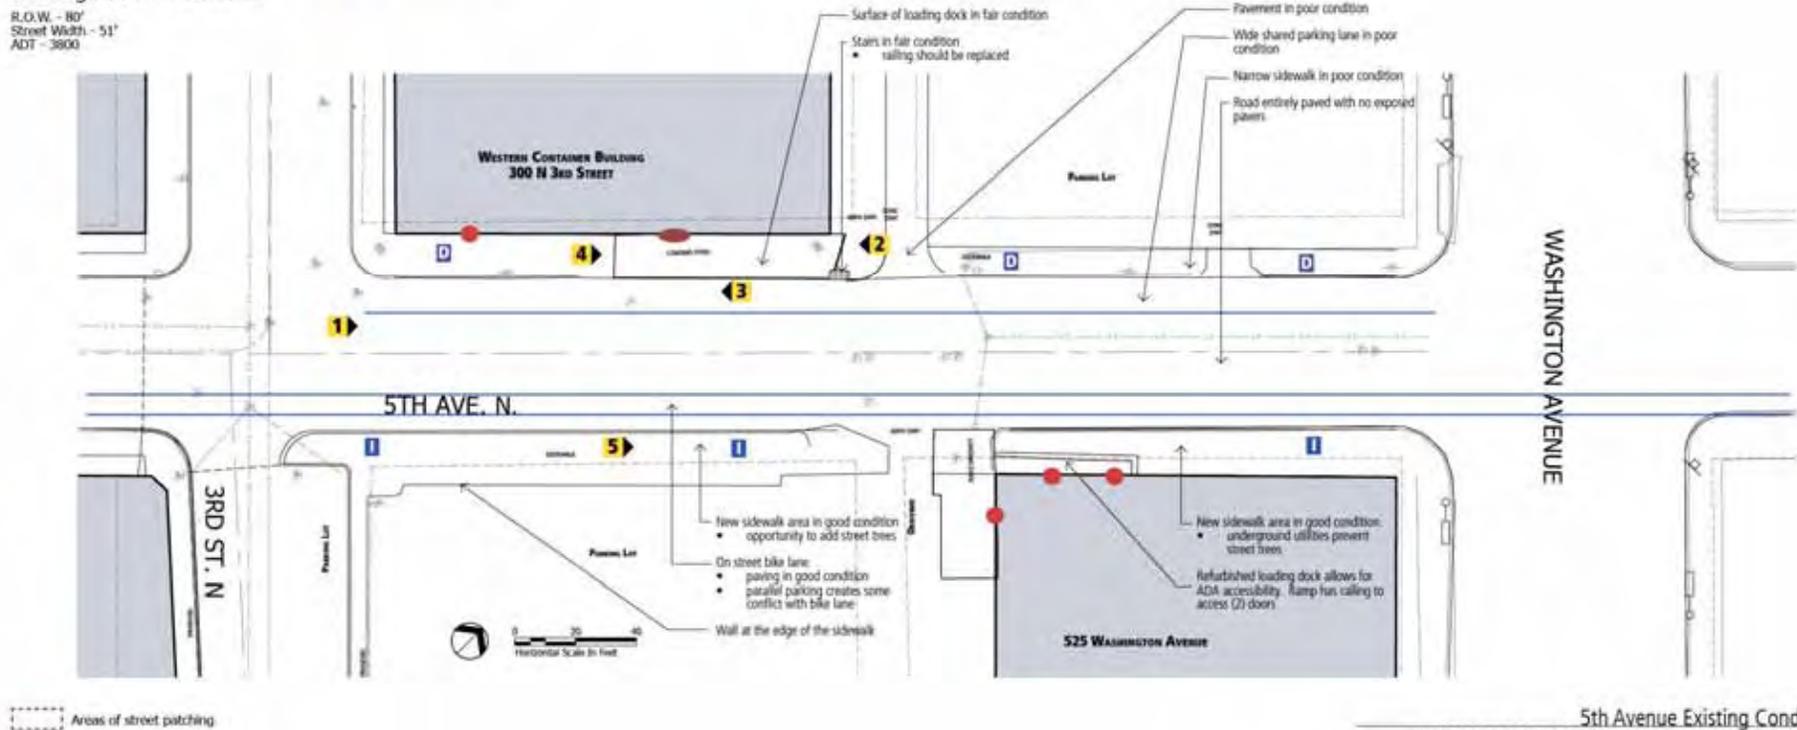
R.O.W. - 80'  
Street Width - 51'  
ADT - 3800

- Existing ROW along 5th Avenue N is 80' wide
- Current Street width is 51' wide
- 5th Avenue N is a designated MSA (Municipal State Aid) route
- ADT's for 5th Avenue are 3800

- 300 N 3rd Street building has a loading dock that appears to be in poor condition. Loading dock contains a small ramp along the south edge that is not ADA complaint and provides a stair access along the north edge. Loading dock leads to building primary entrance. Loading dock is not active.

- ADA accessibility
  - Accessibility on east side of street is good. Accessibility on west side of street is poor with existing sidewalk in poor condition and loading dock. It is common to see pedestrians walking in the street adjacent to the loading dock area.

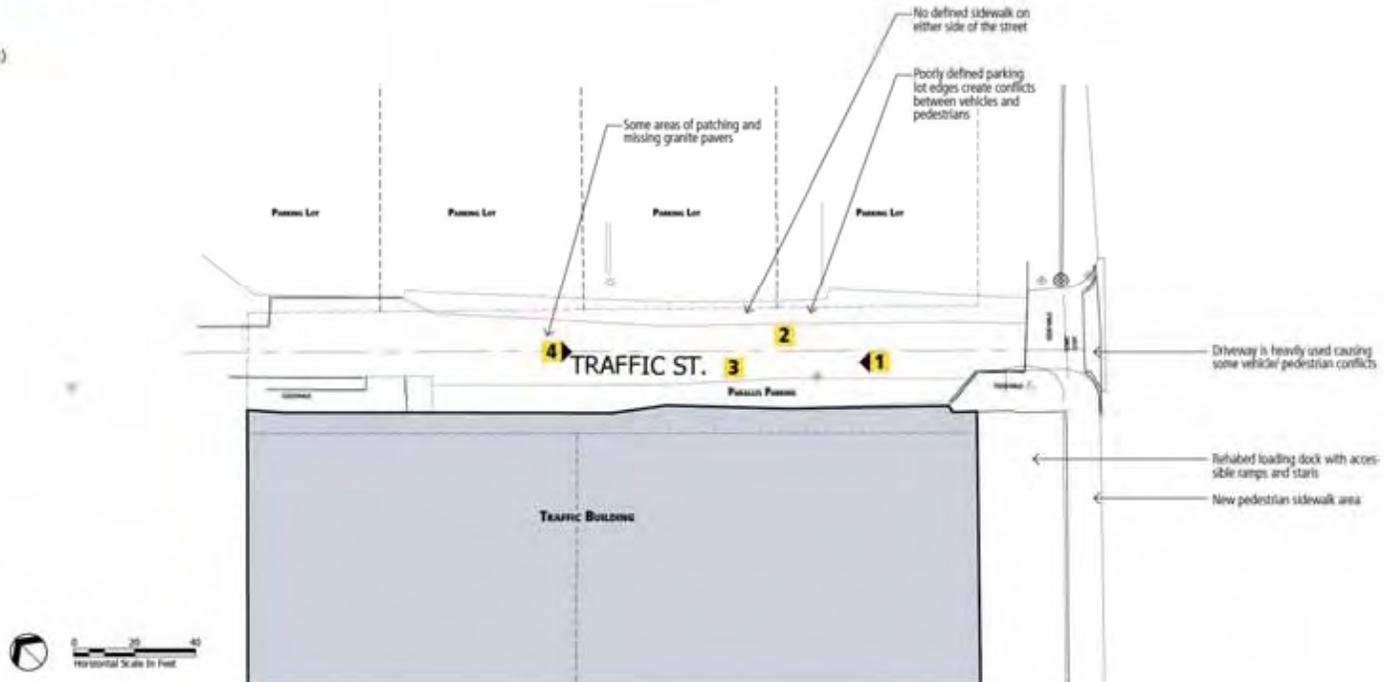
Traffic Street Existing Conditions  
**WAREHOUSE DISTRICT HERITAGE STREET PLAN**

R.O.W. - 40'  
 Street Width - Varies (22' - 25' wide)  
 ADT - Undefined (Not a Municipal State Aid Street)

- Existing ROW along Traffic Street is 40' wide
- Current Street width varies between 22' and 25' wide
- Traffic Street is not a designated MSA (Municipal State Aid) route
- There is currently on-street parking on the south side of the street and parking lots along the north side.
- Historic granite pavements are visible in the street. Historic granite paving appears to be in good condition but there are visible areas of missing pavers. Some pavement settling has also occurred.
- No sidewalks exist along either side of the street.
- ADA accessibility
  - The street is not ADA accessible.

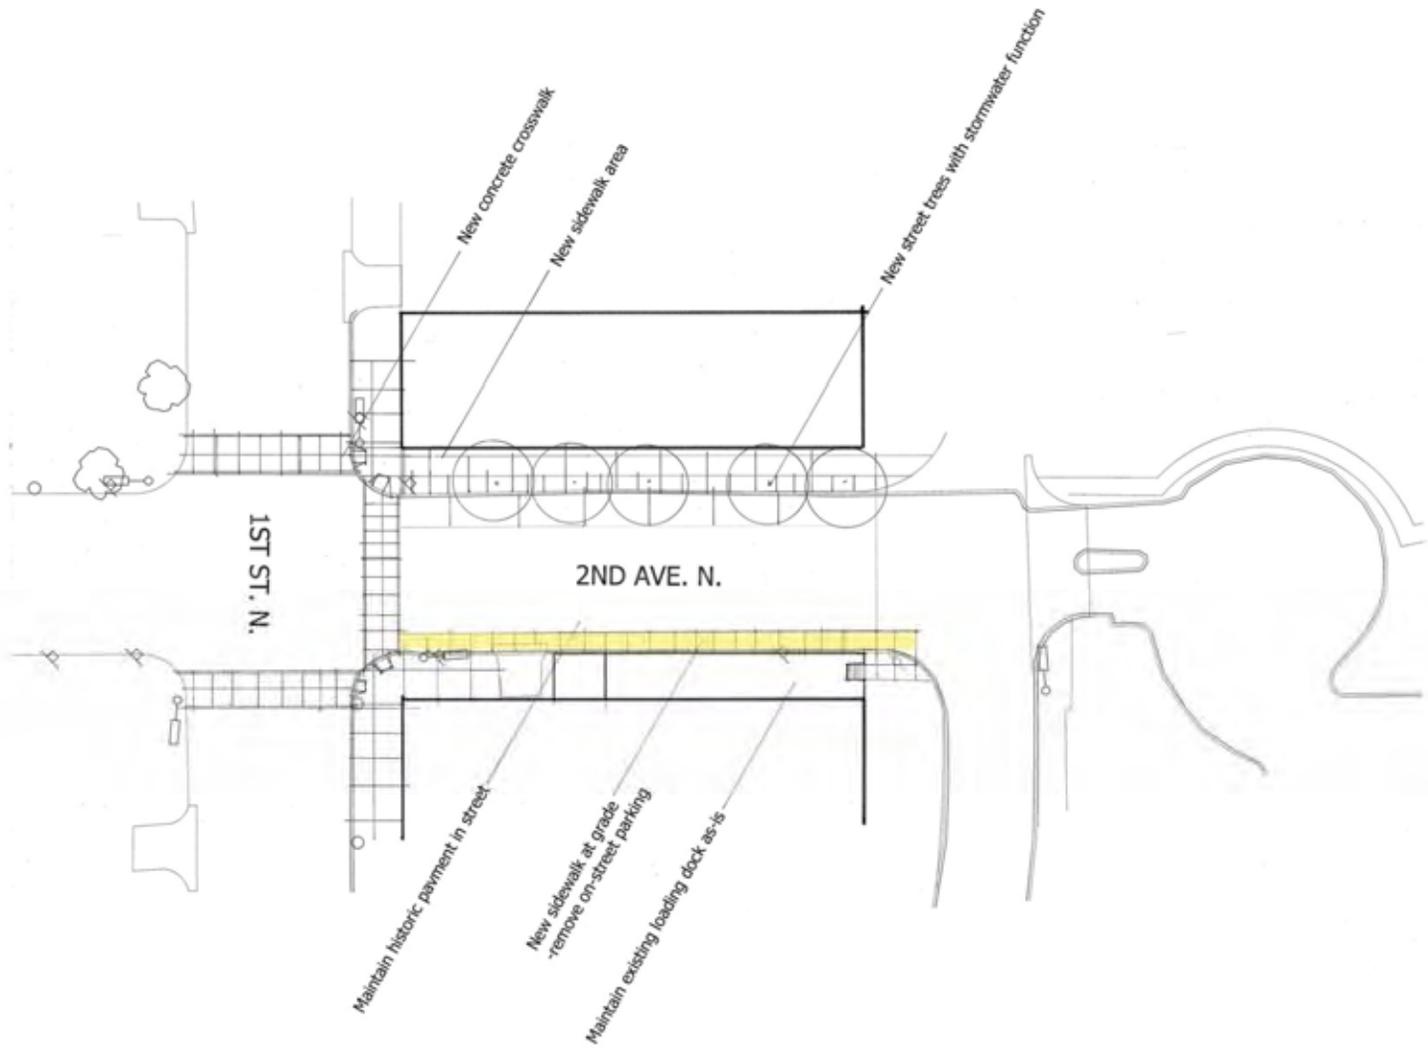
- Existing ROW along 2nd Avenue N is 80' wide
- Current Street width is 47' wide
- 1st Avenue N is a designated MSA (Municipal State Aid) route
- There is currently on-street parking on both sides of the street.

- Loading dock occurs along the SE side of the street.
  - Loading dock contains a small ramp along the south edge that is not ADA complaint and provides a stair access along the north edge. Loading dock leads to building secondary entrance.

- Loading dock is not active.
- ADA accessibility
  - Accessibility on the north side of the street is considered good
