# Framework for the Treatment of Character Defining Features for the Reactivation of the Hollywood Theater

CPED Staff Presentation to the  
Heritage Preservation Commission  
March 10, 2009

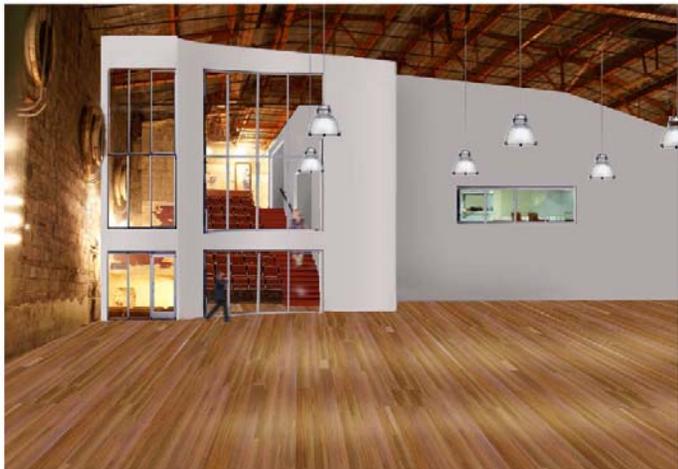
Rendering

The volume of the auditorium is intact. The plaster of the roof was removed during remediation and roof replacement- this slightly changes the feeling of the volume of the space.

The subdivision of the space can be done, however, the sense of space associated with the volume of the space and theater activity shall be conveyed in the subdivision. See below for details.
