CPED STAFF REPORT

HPC Agenda Item #3
 August 19, 2014
 BZH-28246

Property Location: 241 First Avenue North
Project Name: Lerner Building Window Replacement
Prepared By: [Lisa Steiner](#), City Planner, (612) 673-3950
Applicant: Martin Investments Limited Partnership
Project Contact: Adam Lerner
Ward: 3
Neighborhood: Downtown West
Request: To obtain after-the-fact approval for unpermitted window replacement and seek approval for the replacement of additional windows on an existing building.

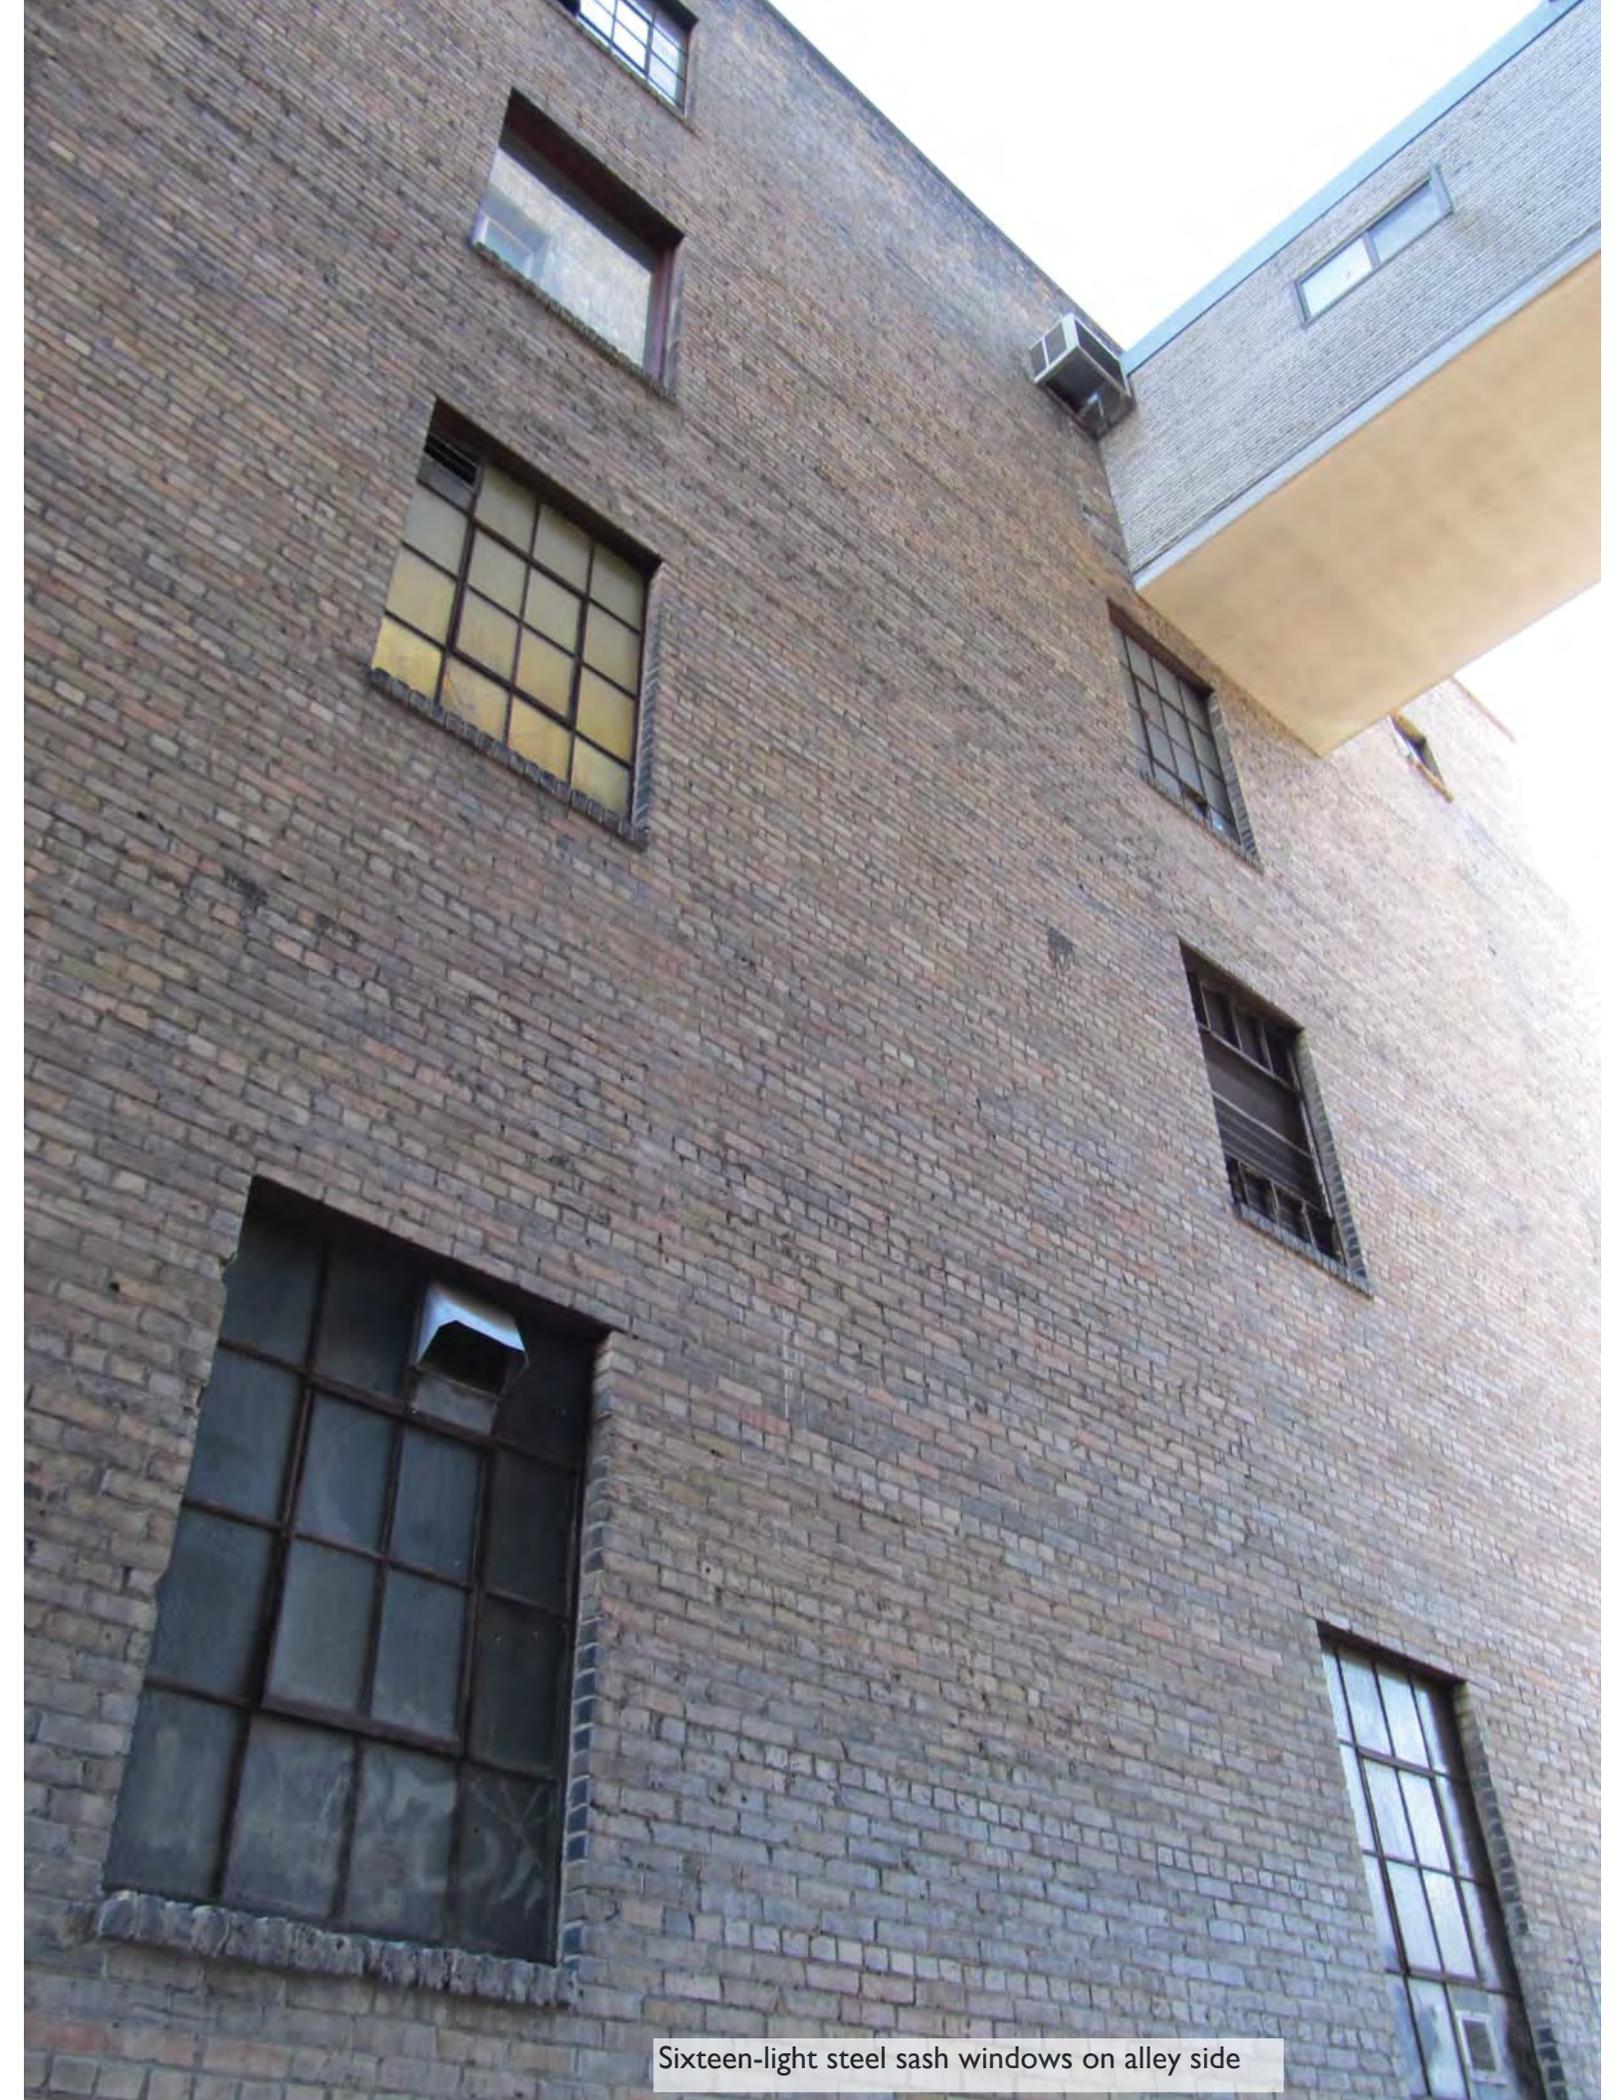
Sixteen-light steel sash windows on alley side

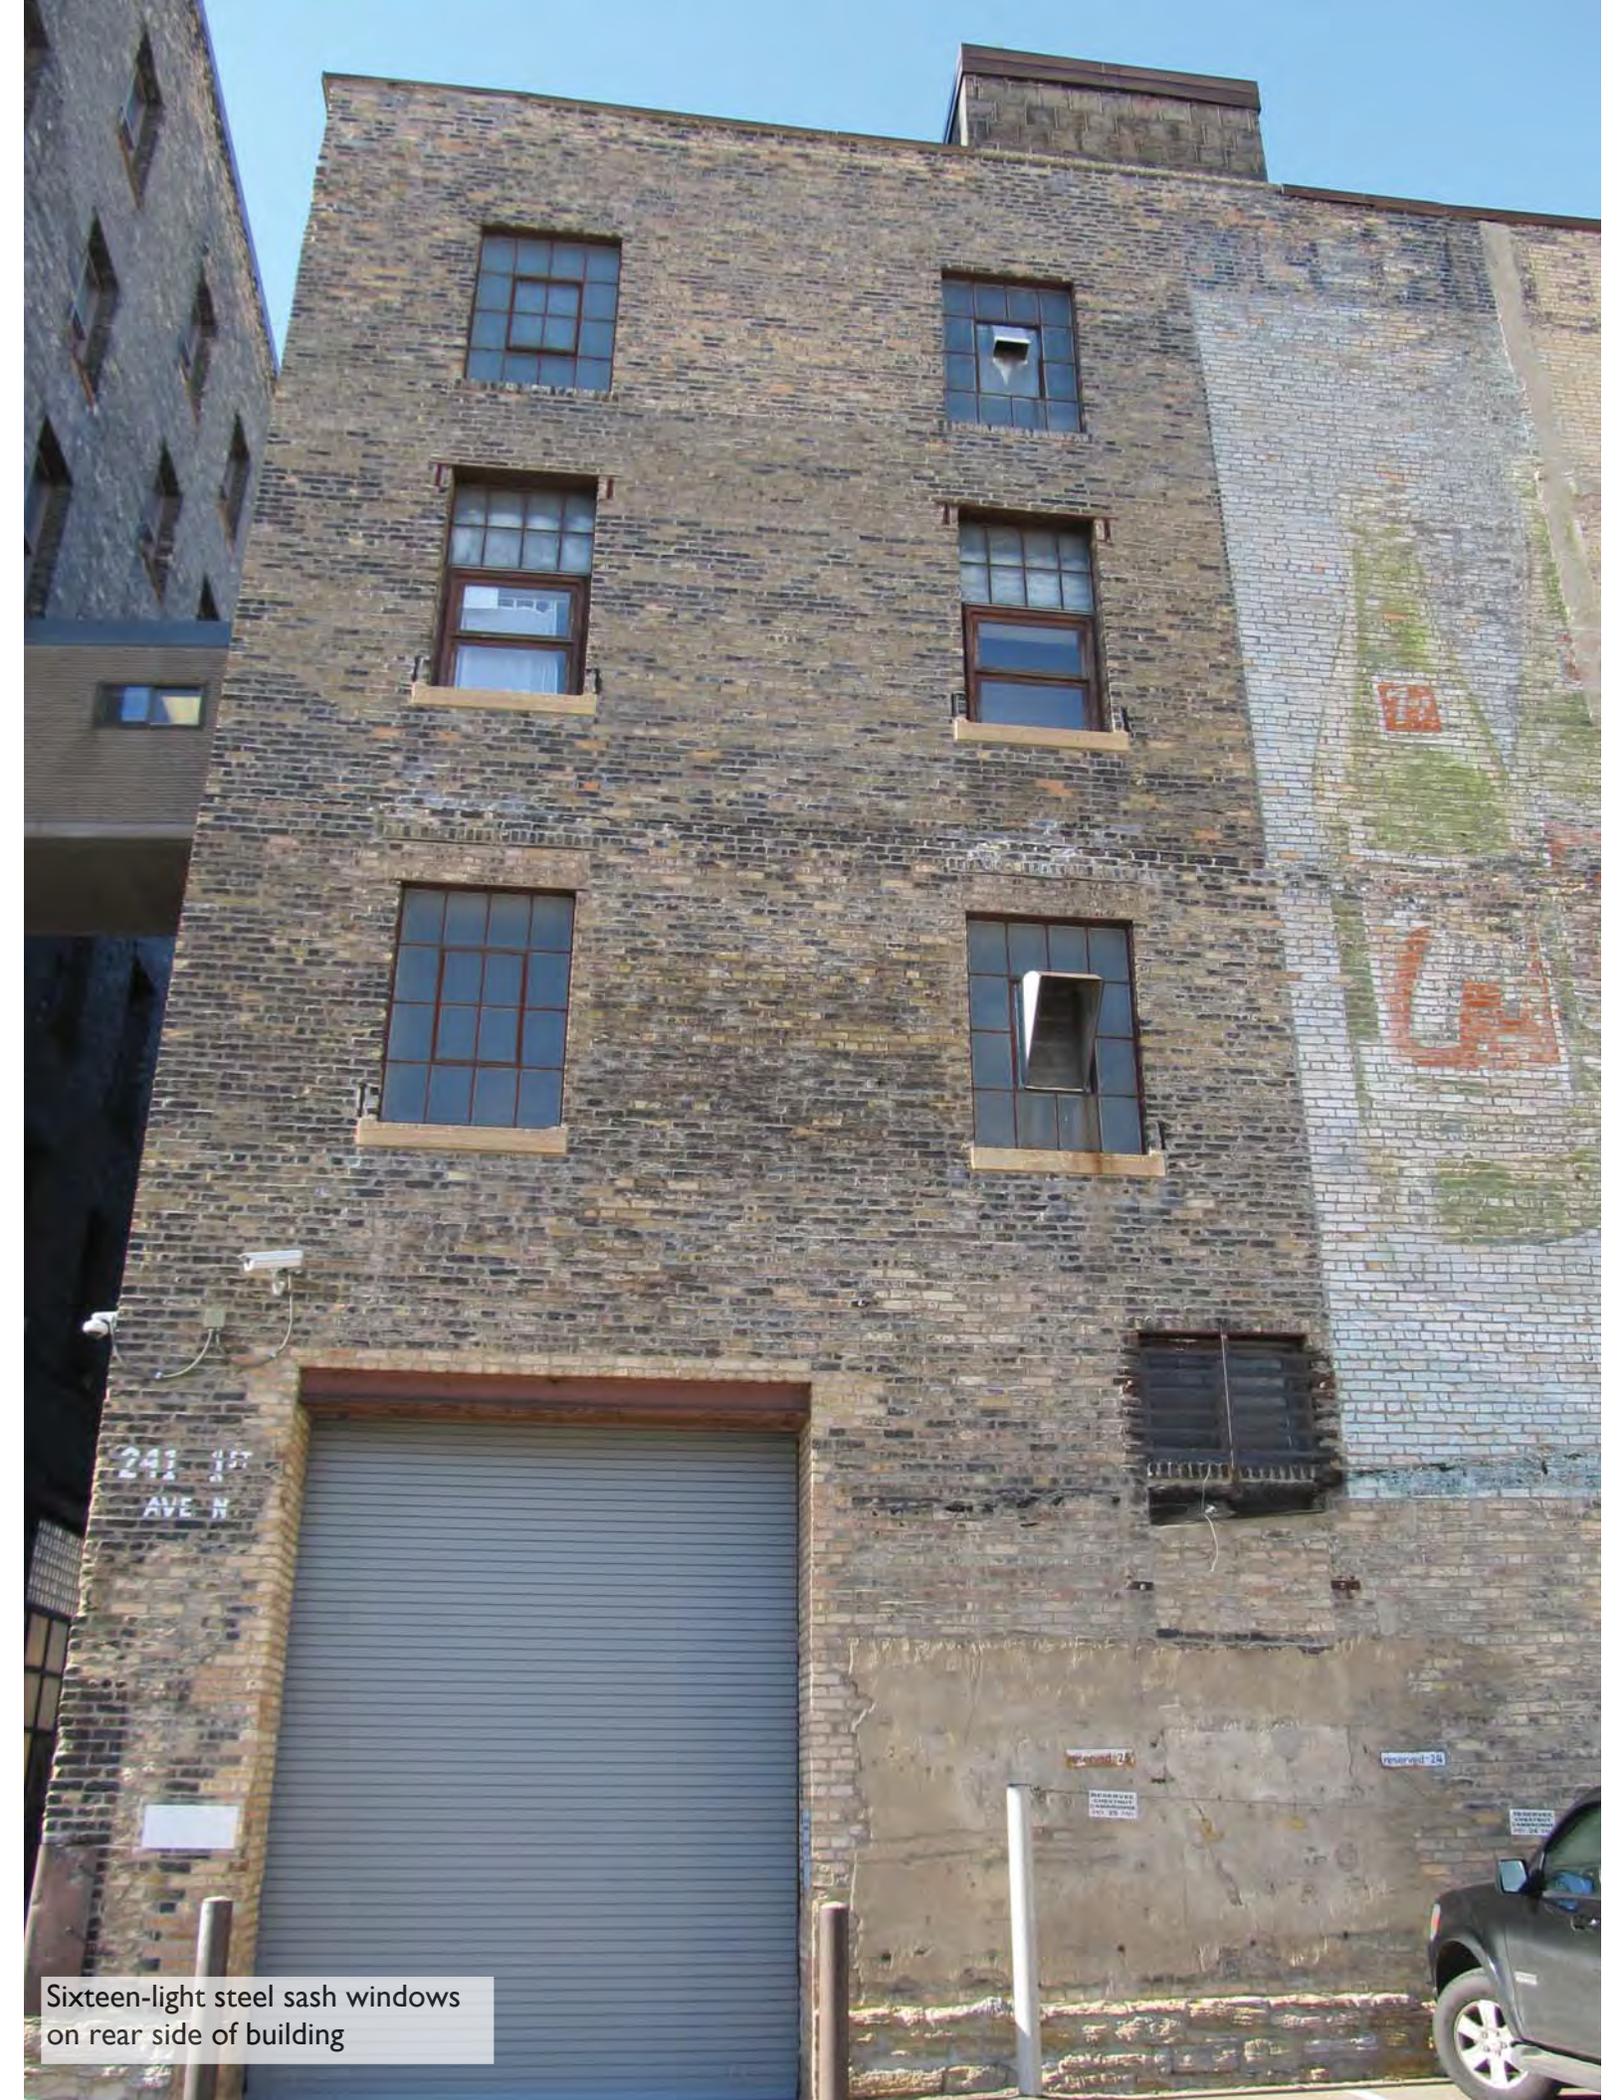
Sixteen-light steel sash windows on rear side of building

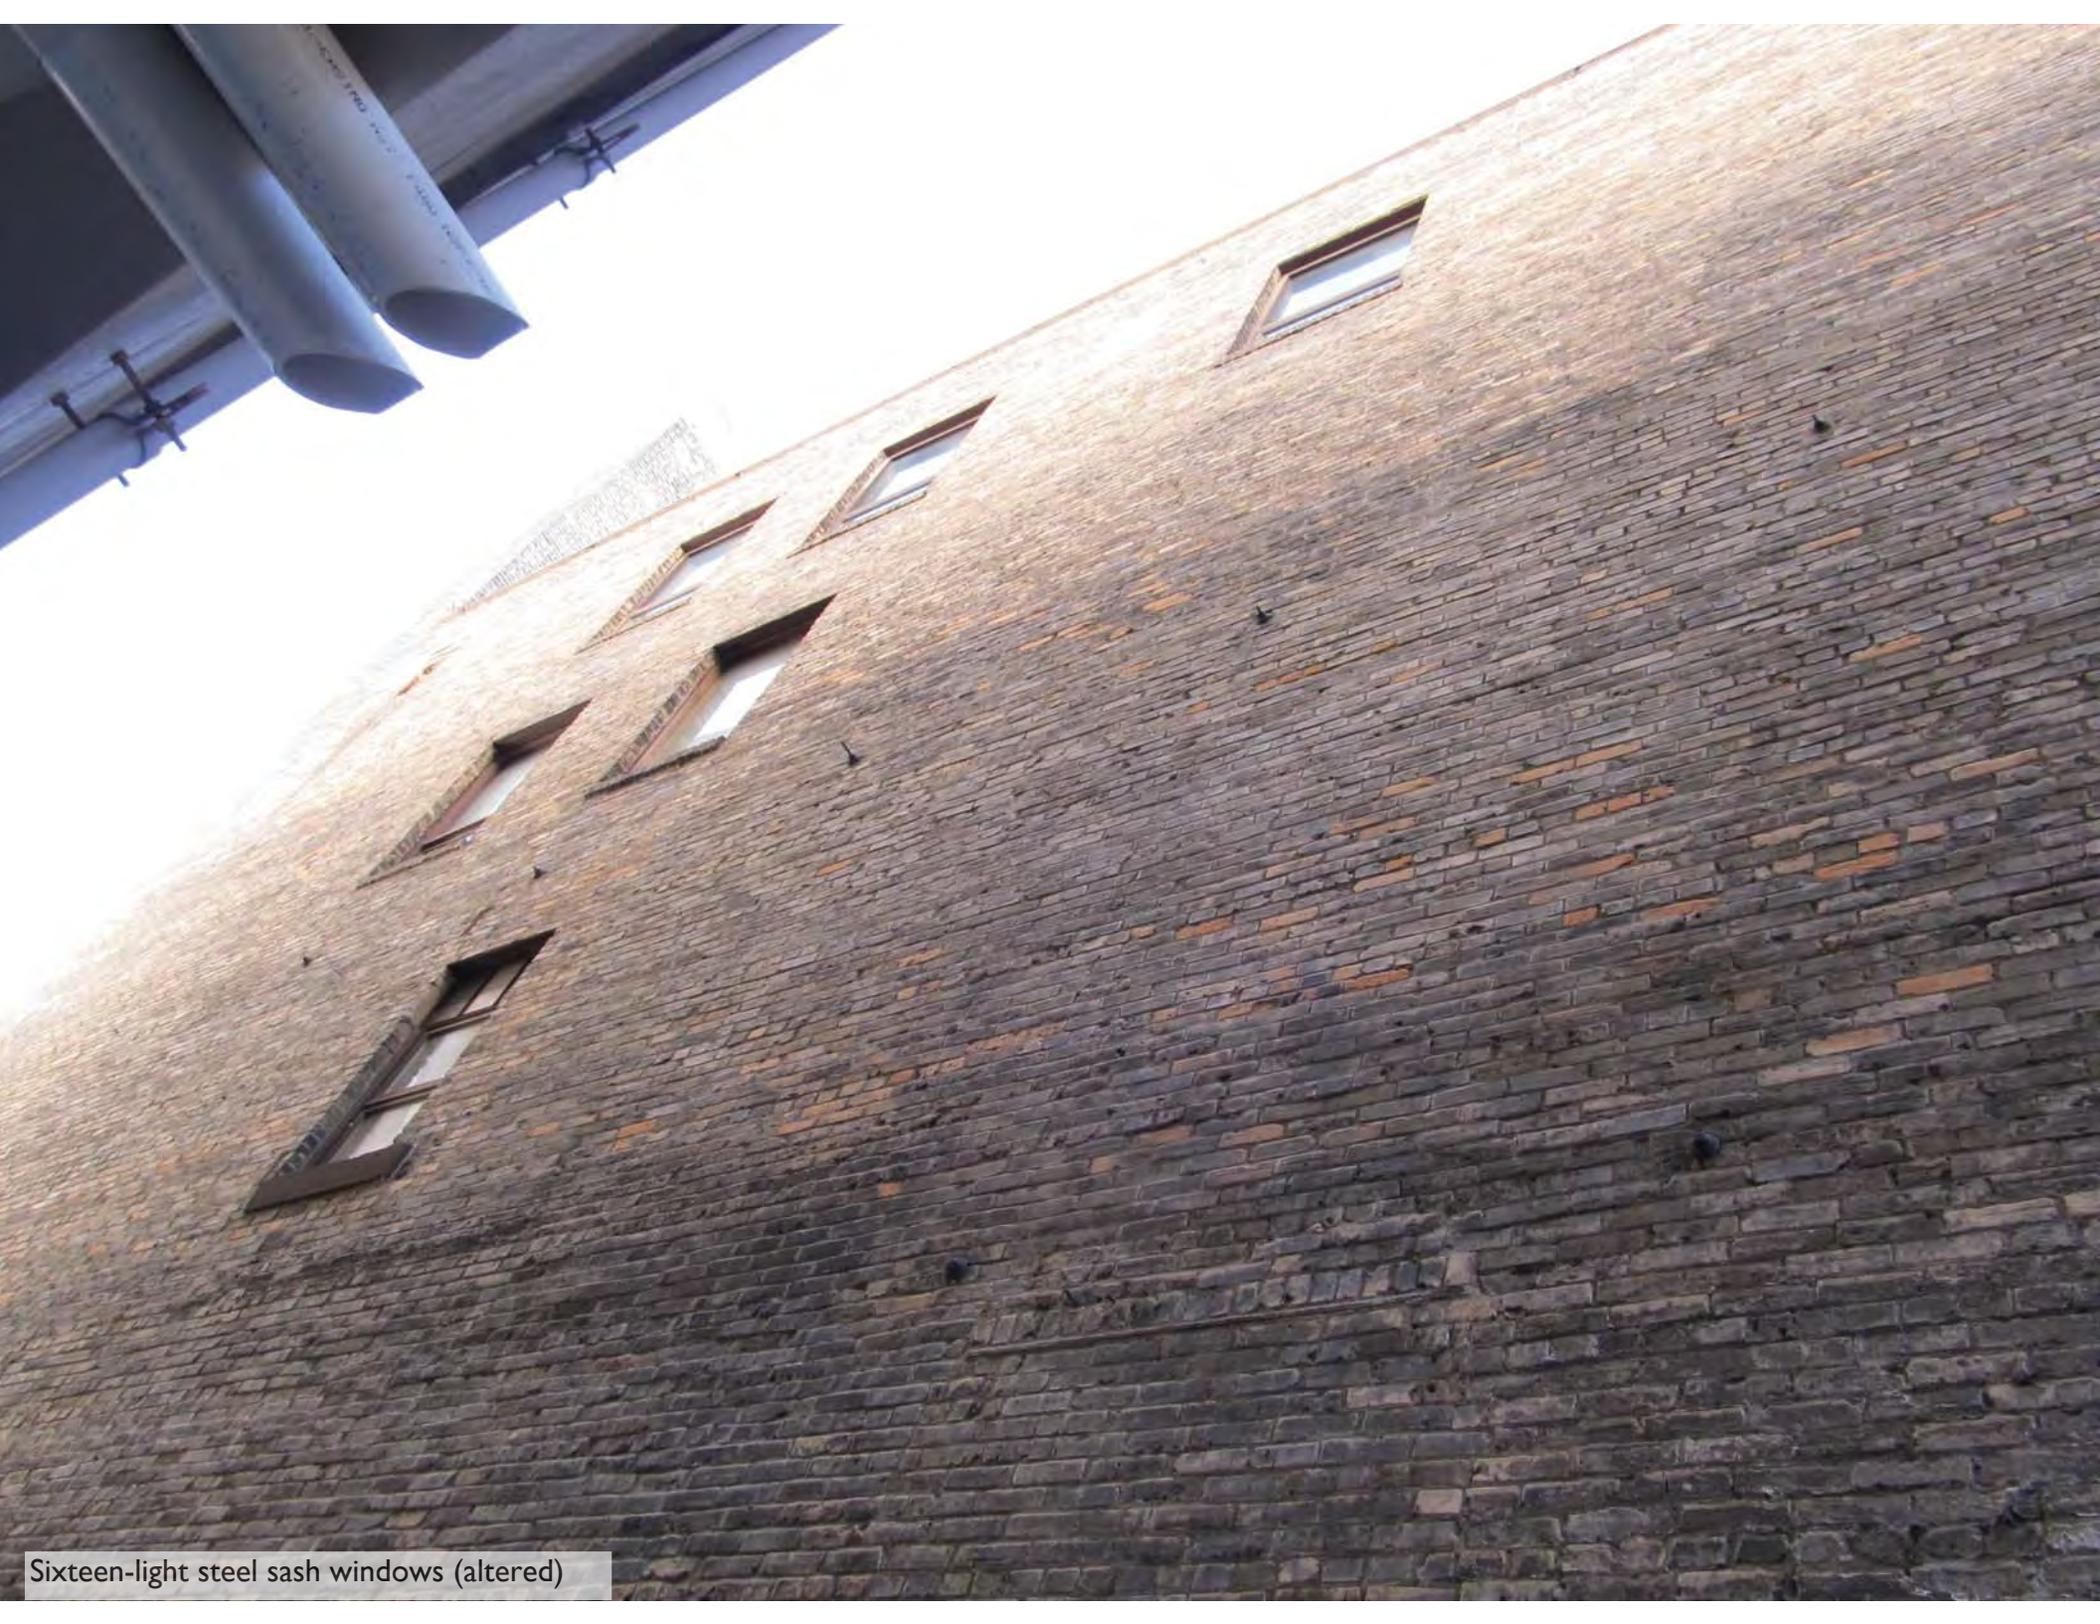
Sixteen-light steel sash windows (altered)

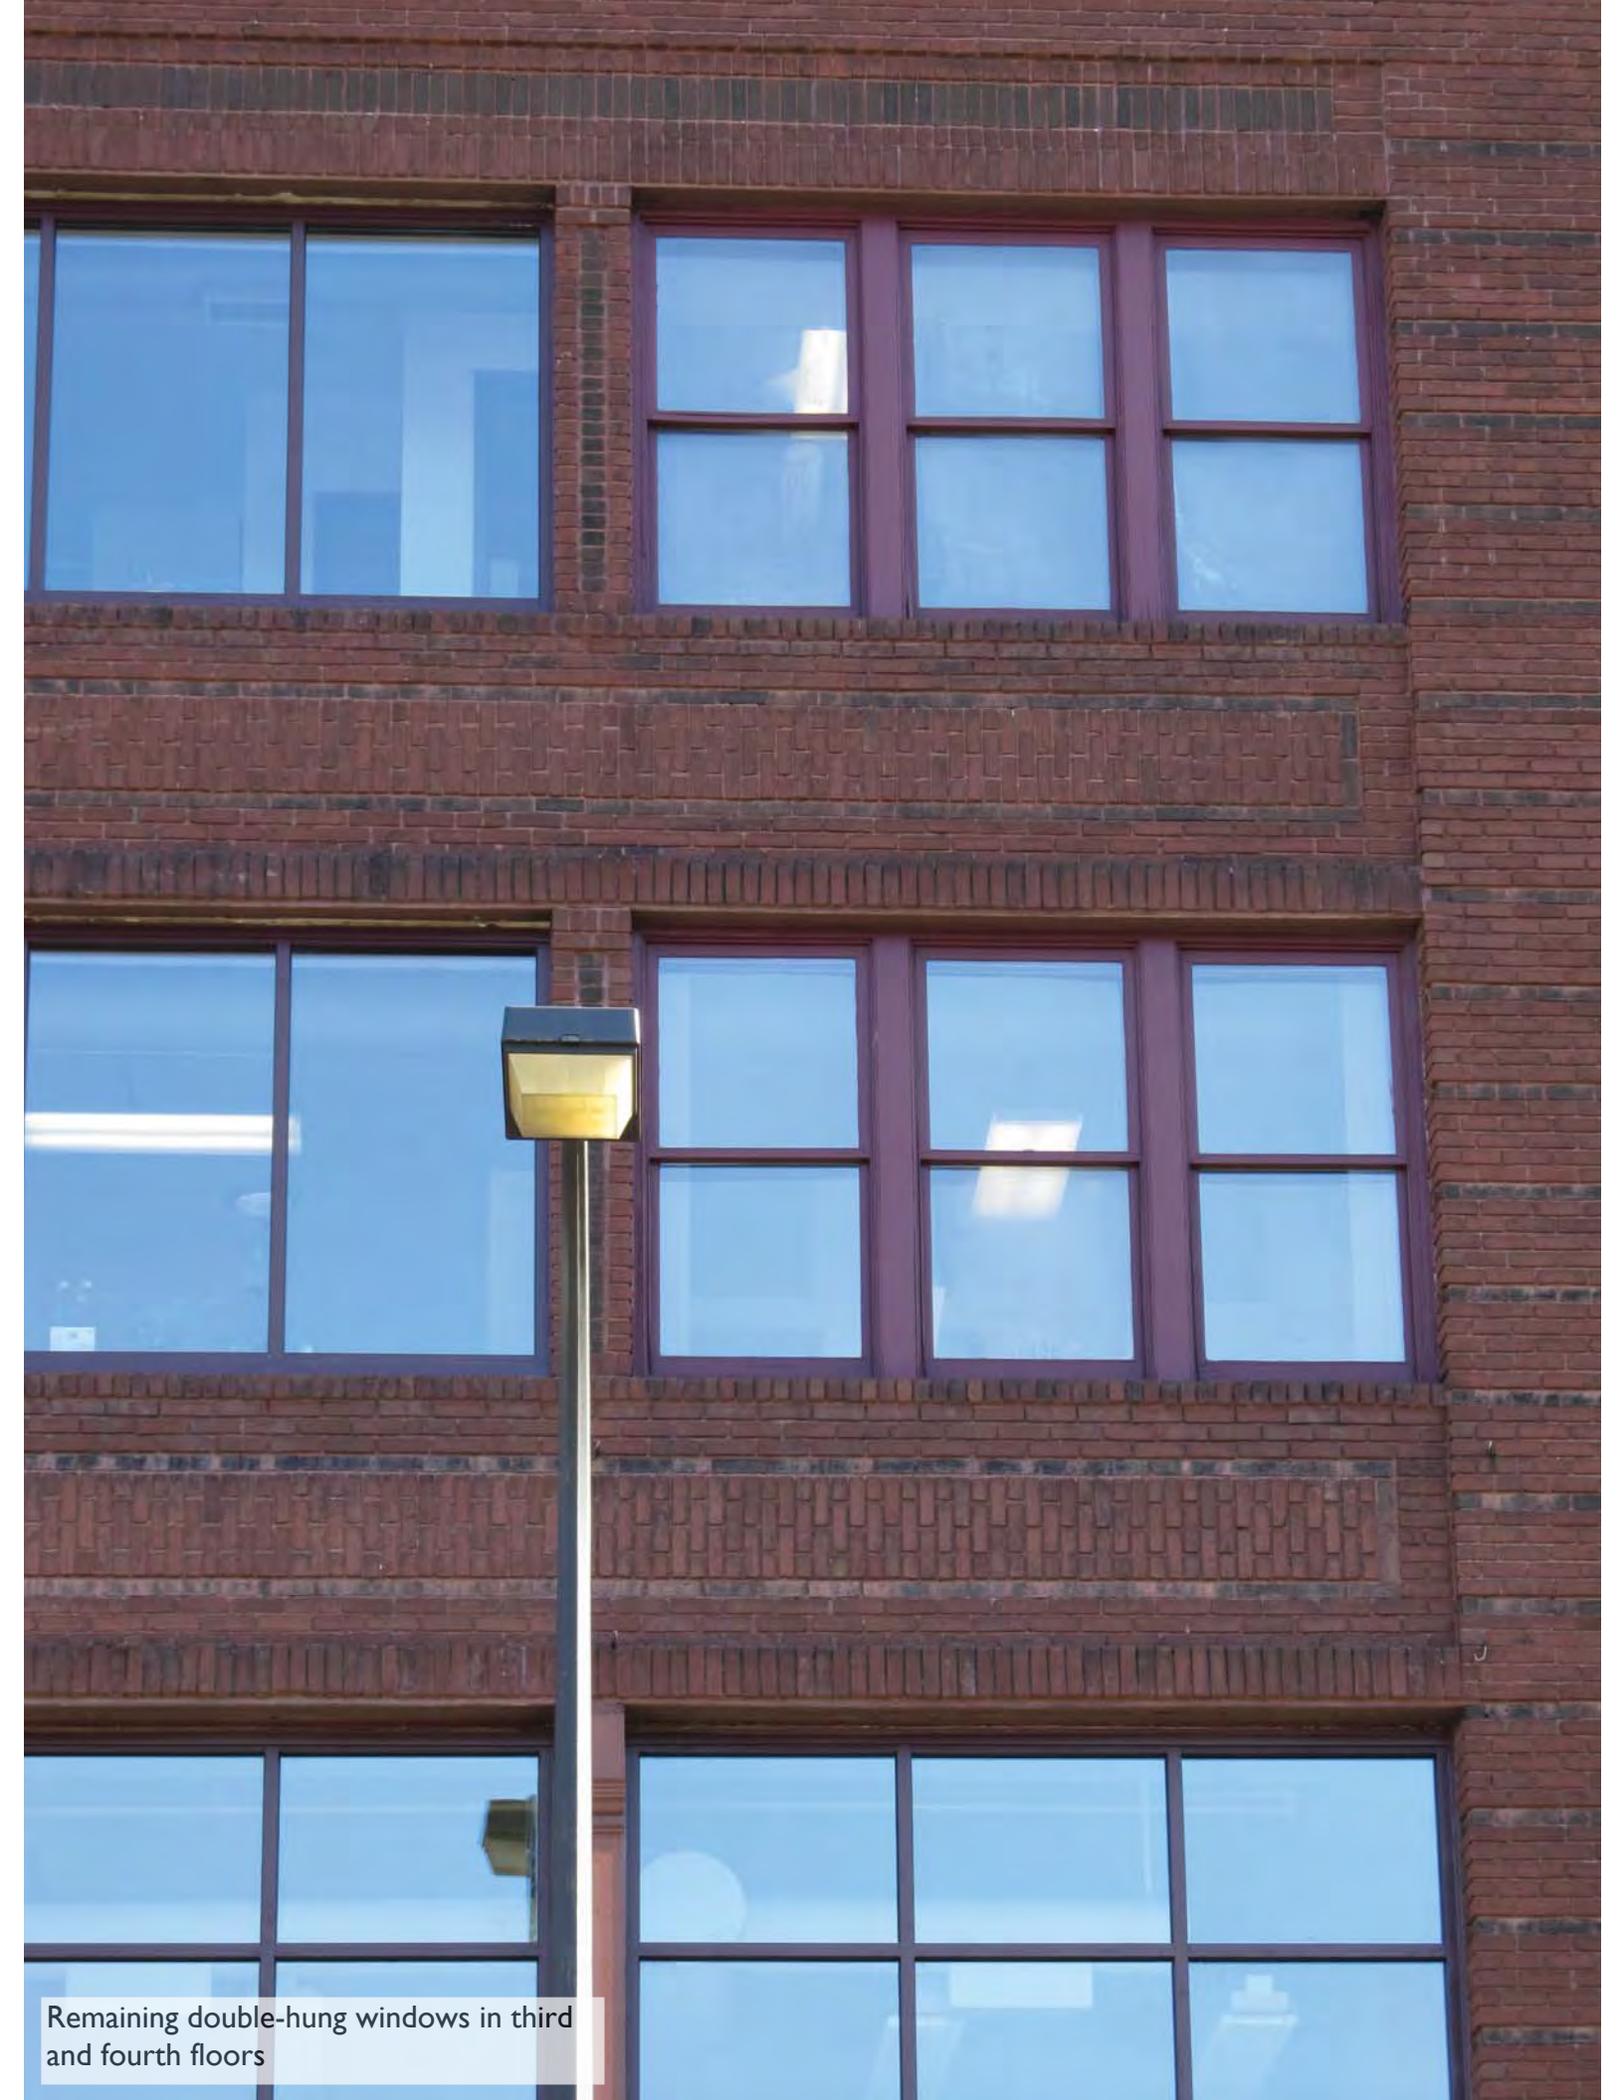
Remaining double-hung windows in third and fourth floors

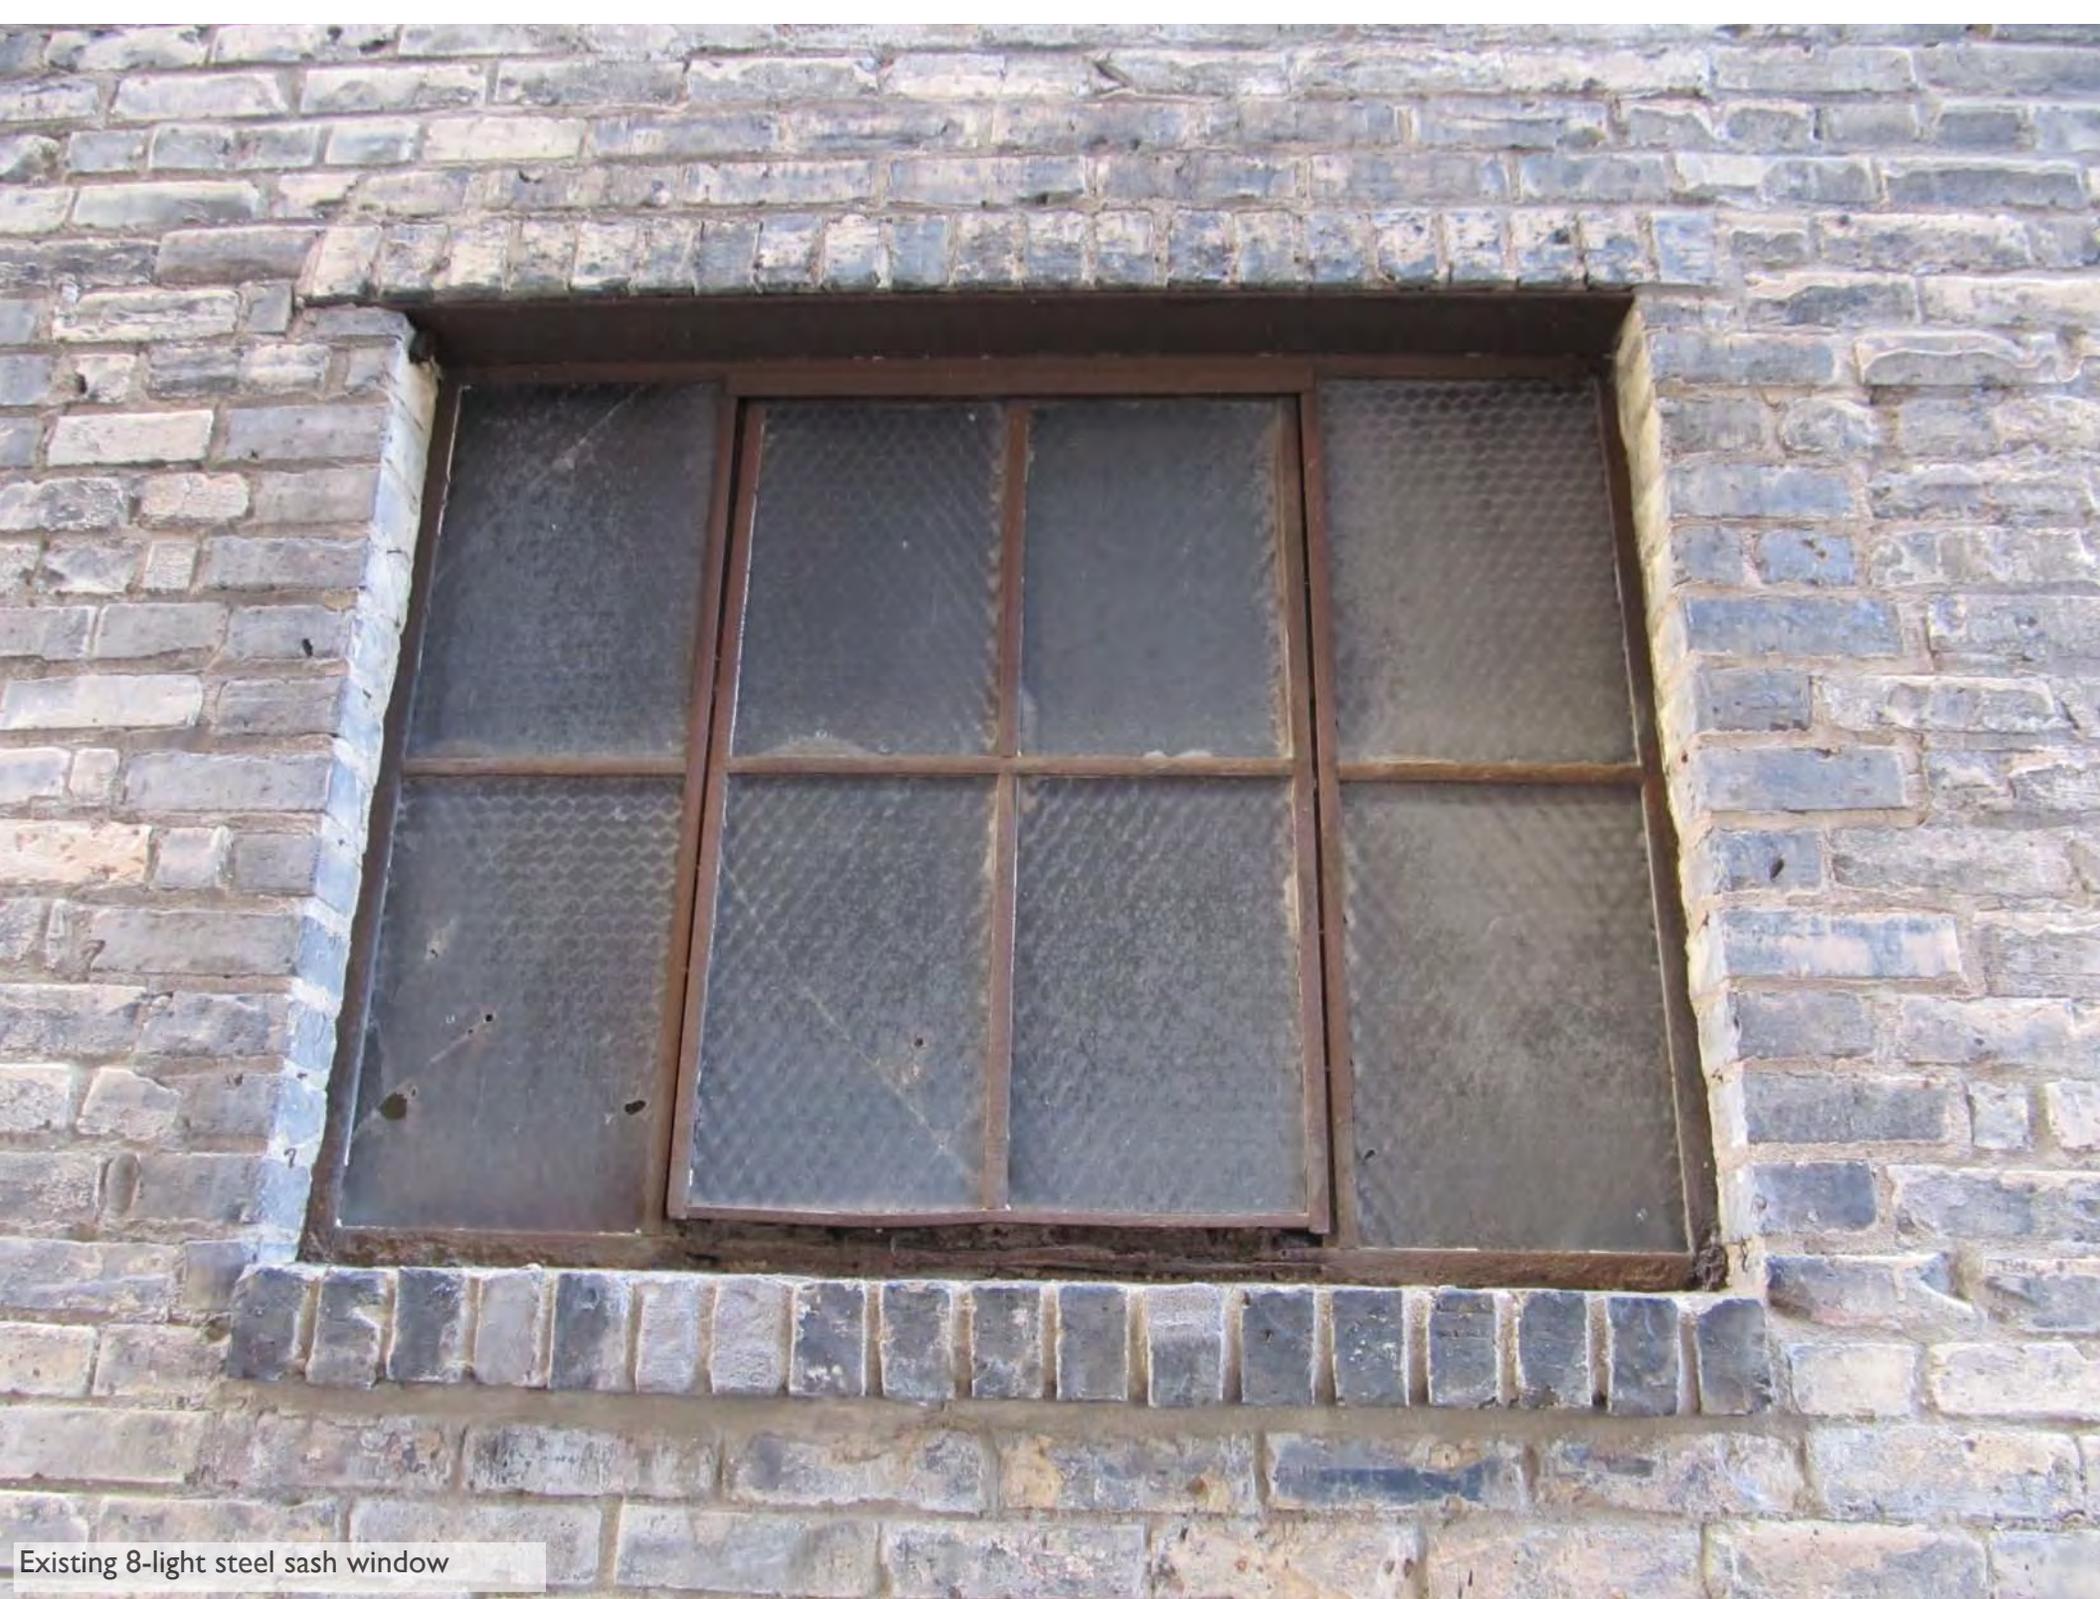
Existing 8-light steel sash window

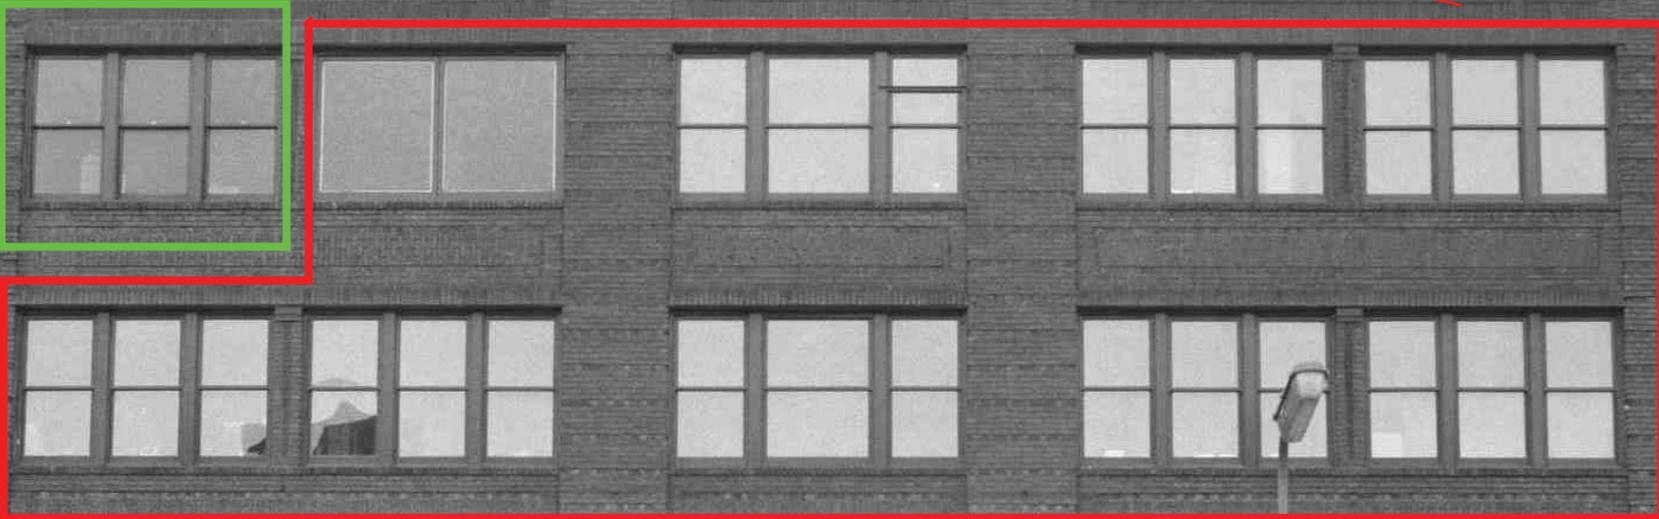
Windows assumed to have been replaced

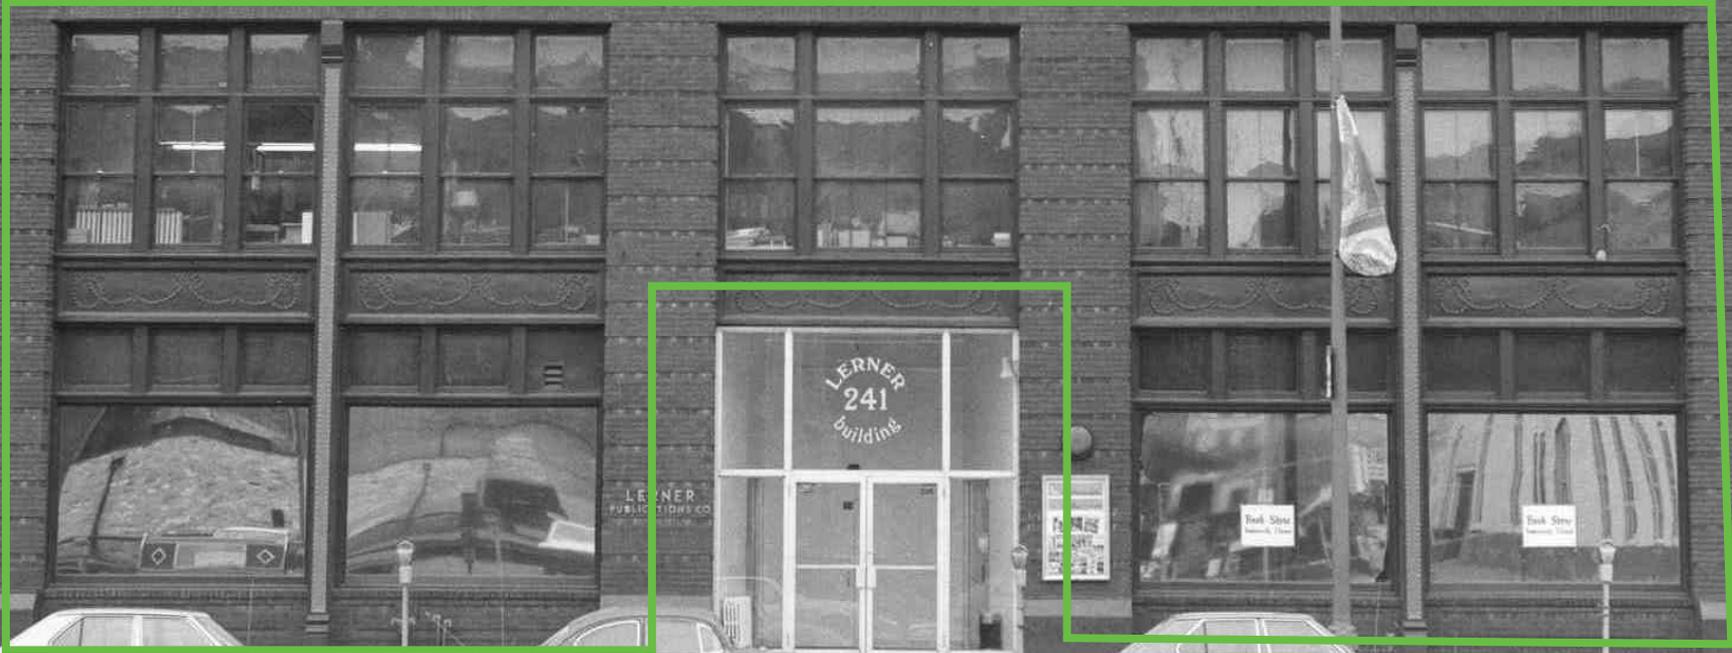
Windows believed to be original

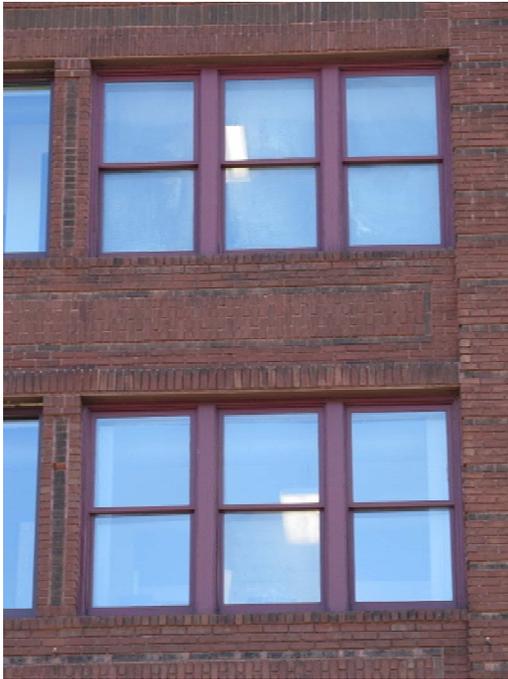
Remaining one-over-one wood frame windows

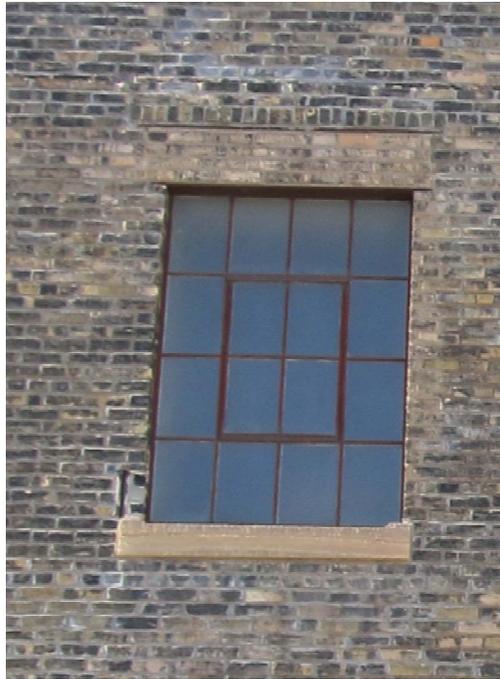
Sixteen-light steel sash windows
Window opening approx. 48" x 76"

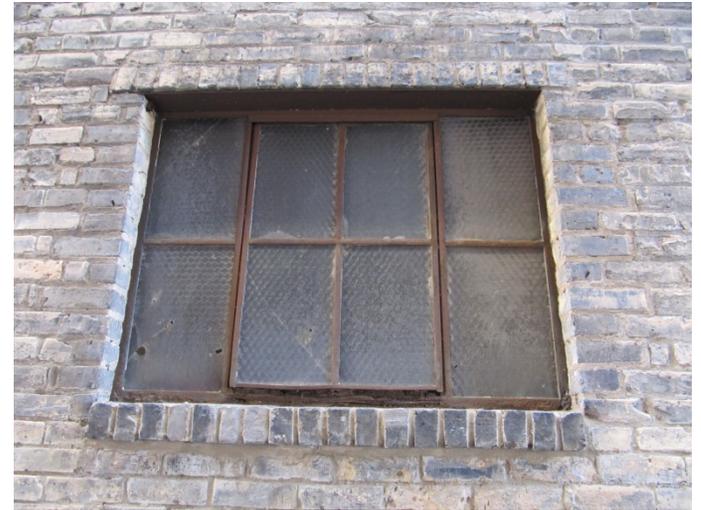
Eight-light steel sash windows
Window opening approx. 48" x 38"

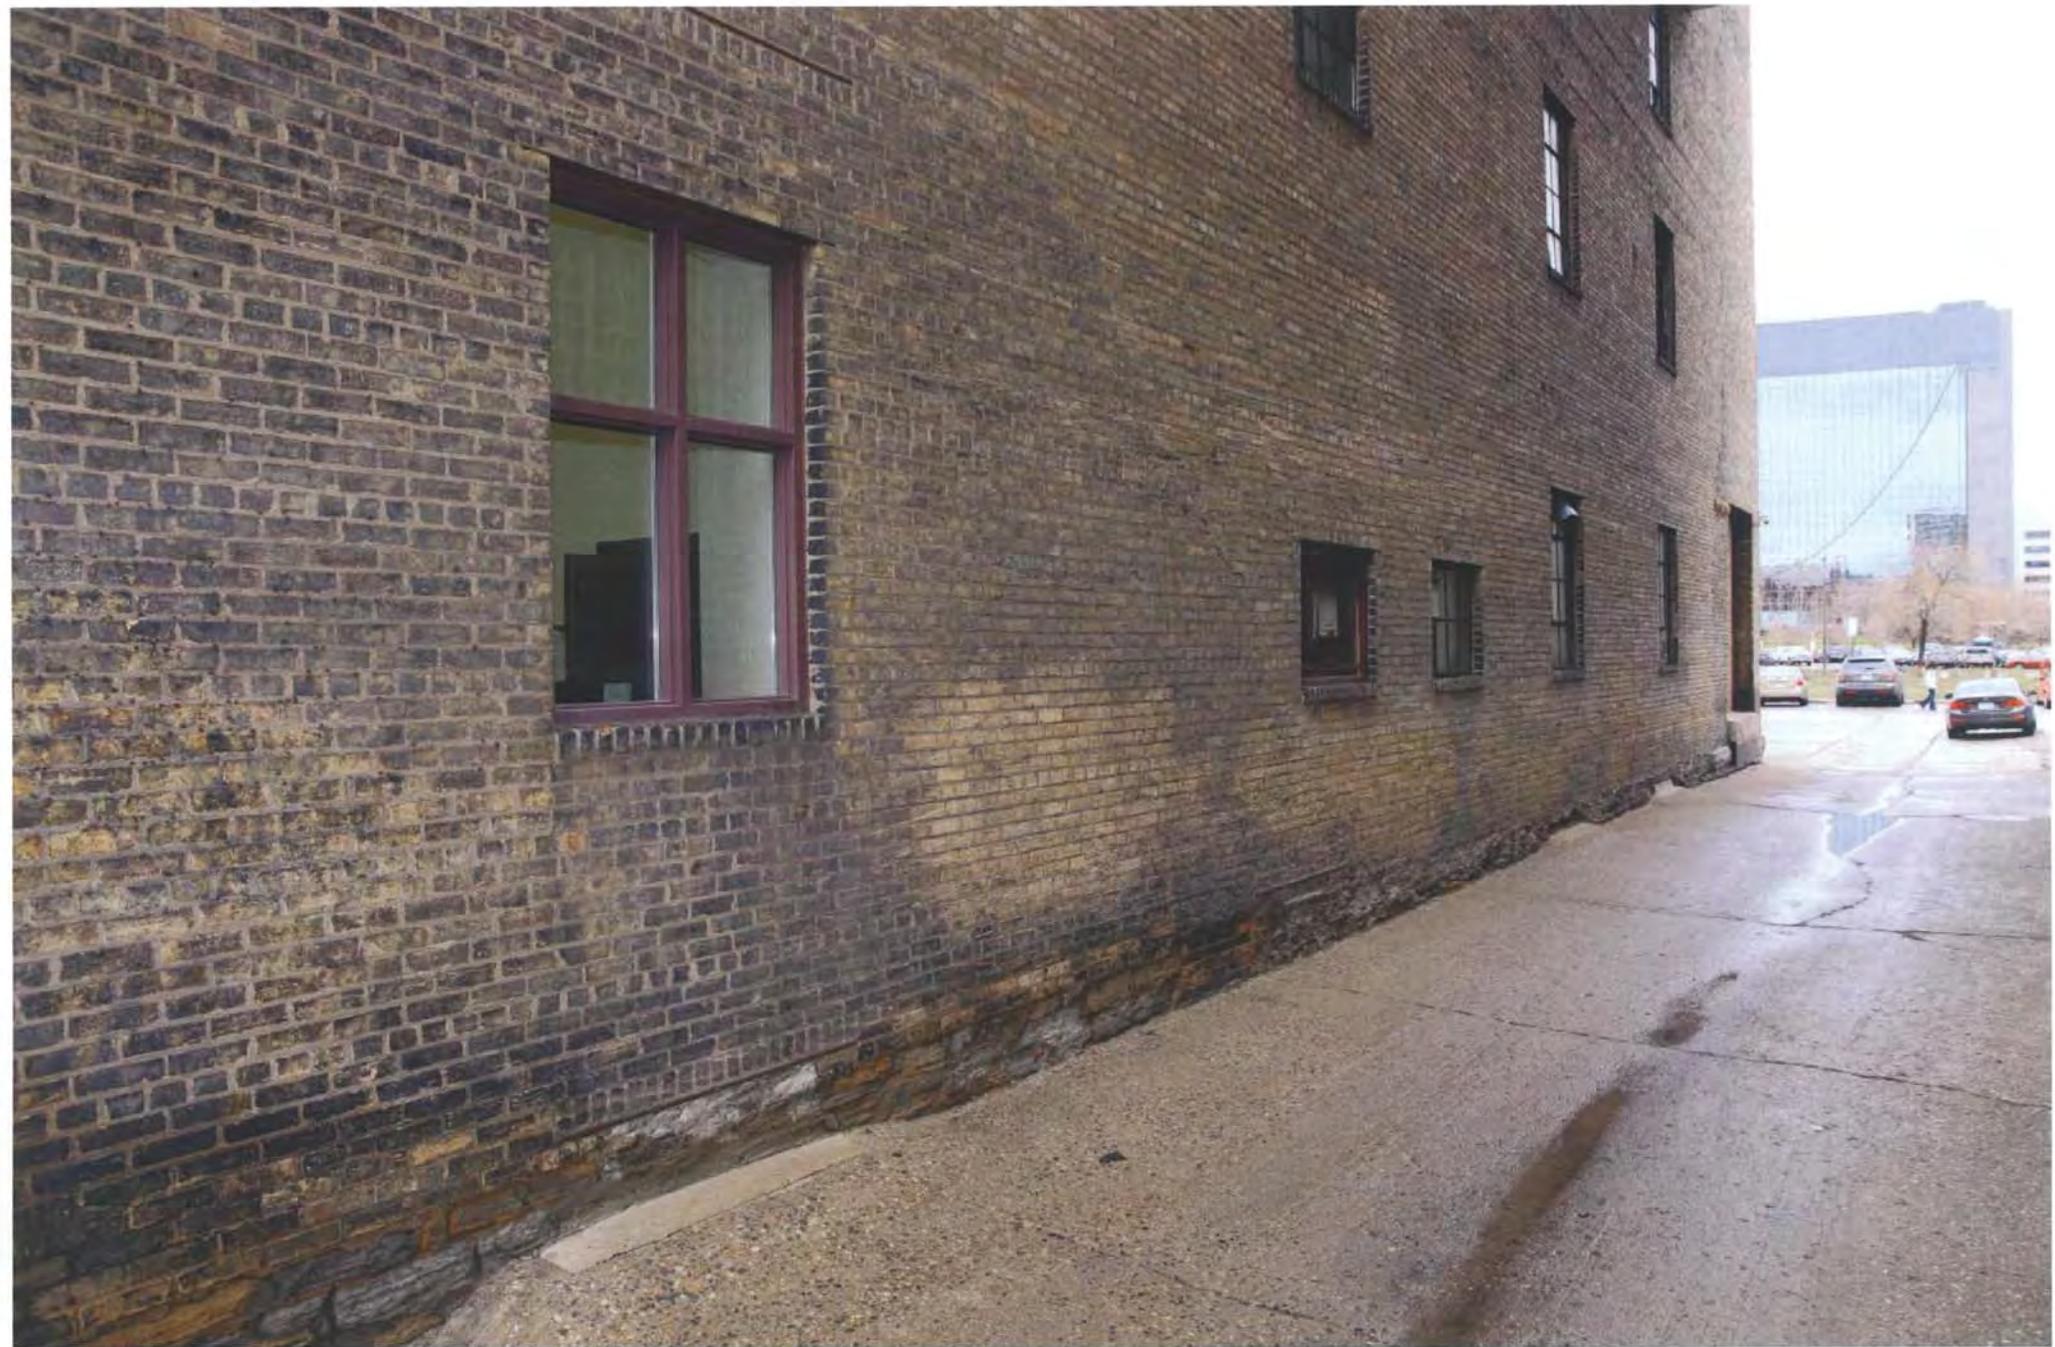
4. Southwest exterior side of building – alley view – showing a new window and old windows, Date: 4/30/2014, Looking east
