CPED STAFF REPORT

HPC Agenda Item #3
 August 19, 2014
 BZH-28246

Property Location: 241 First Avenue North
Project Name: Lerner Building Window Replacement
Prepared By: [Lisa Steiner](#), City Planner, (612) 673-3950
Applicant: Martin Investments Limited Partnership
Project Contact: Adam Lerner
Ward: 3
Neighborhood: Downtown West
Request: To obtain after-the-fact approval for unpermitted window replacement and seek approval for the replacement of additional windows on an existing building.

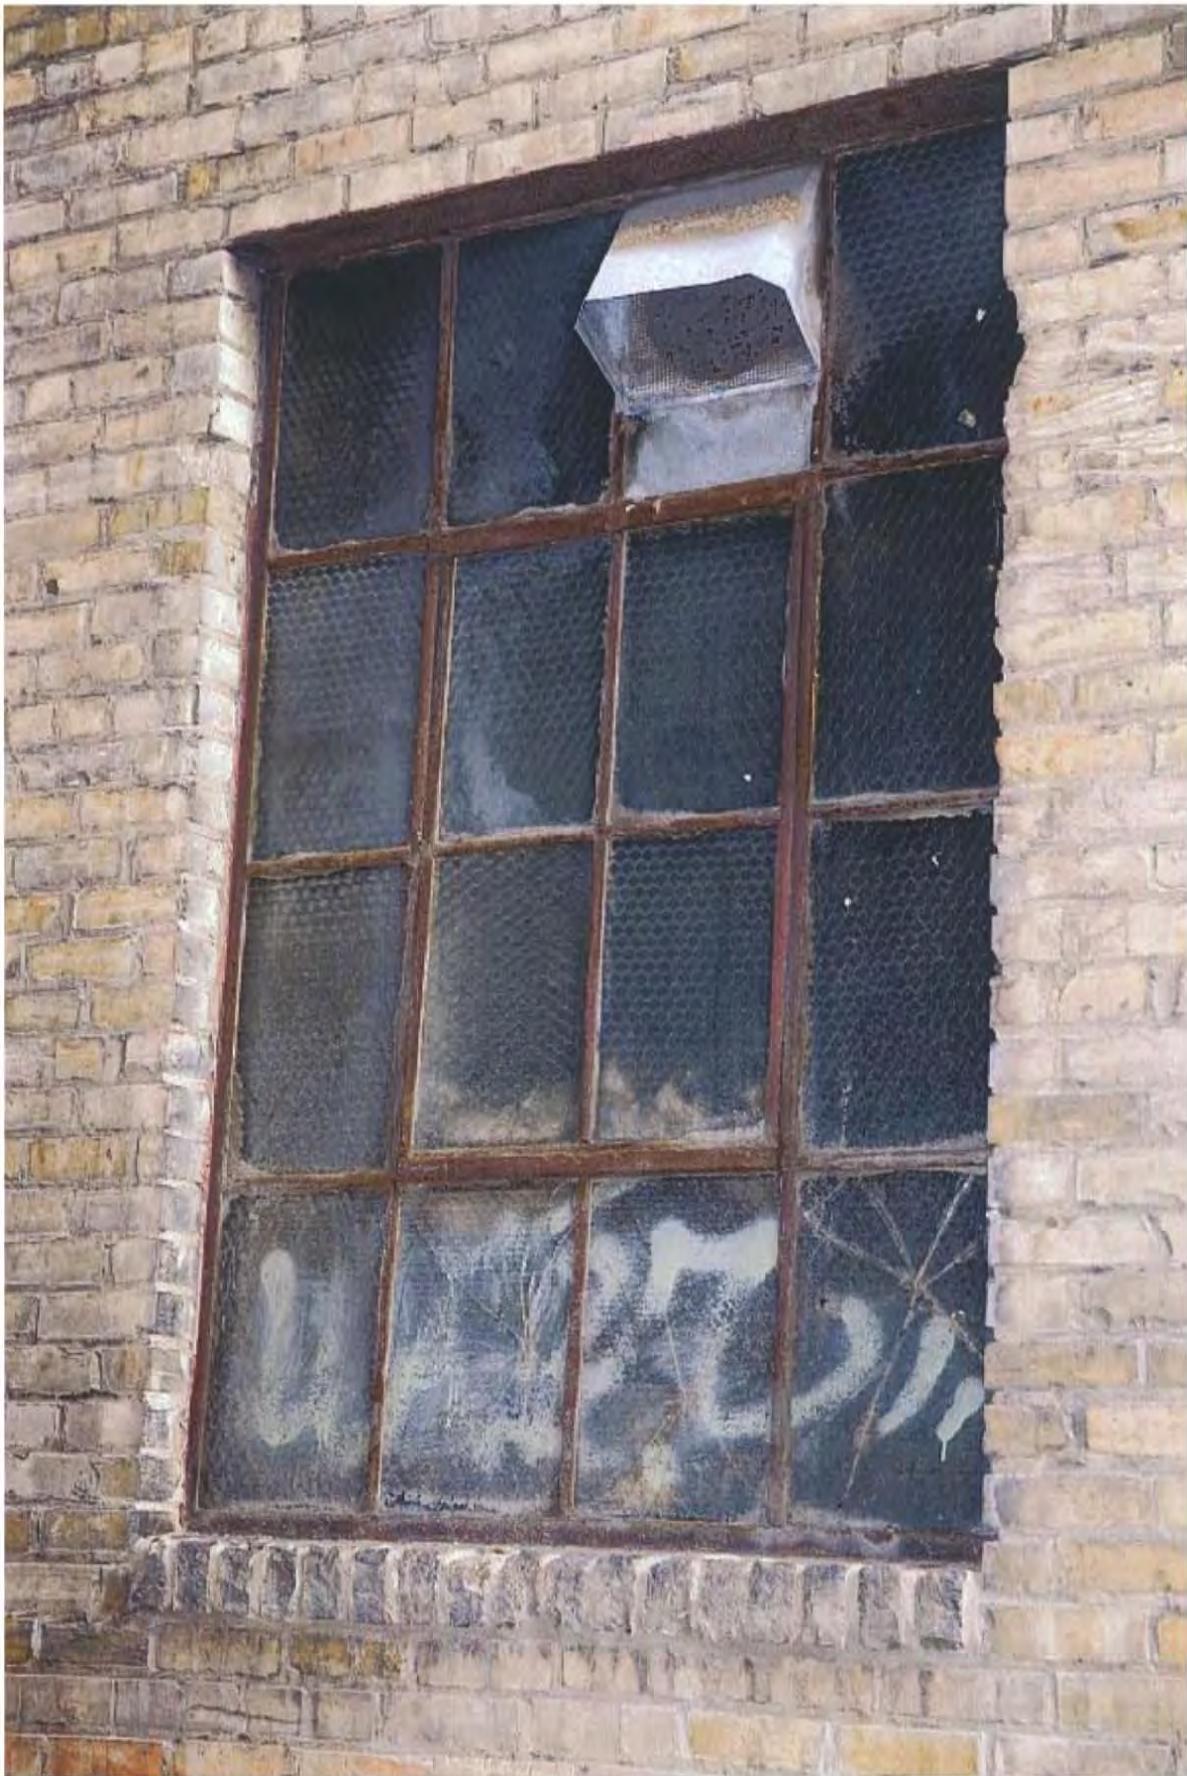
8. Exterior deteriorated loading dock window with corroded metal frame and exhaust vent on the ground floor - southwest side of building (alley side), Date: 4/11/2014, Looking north

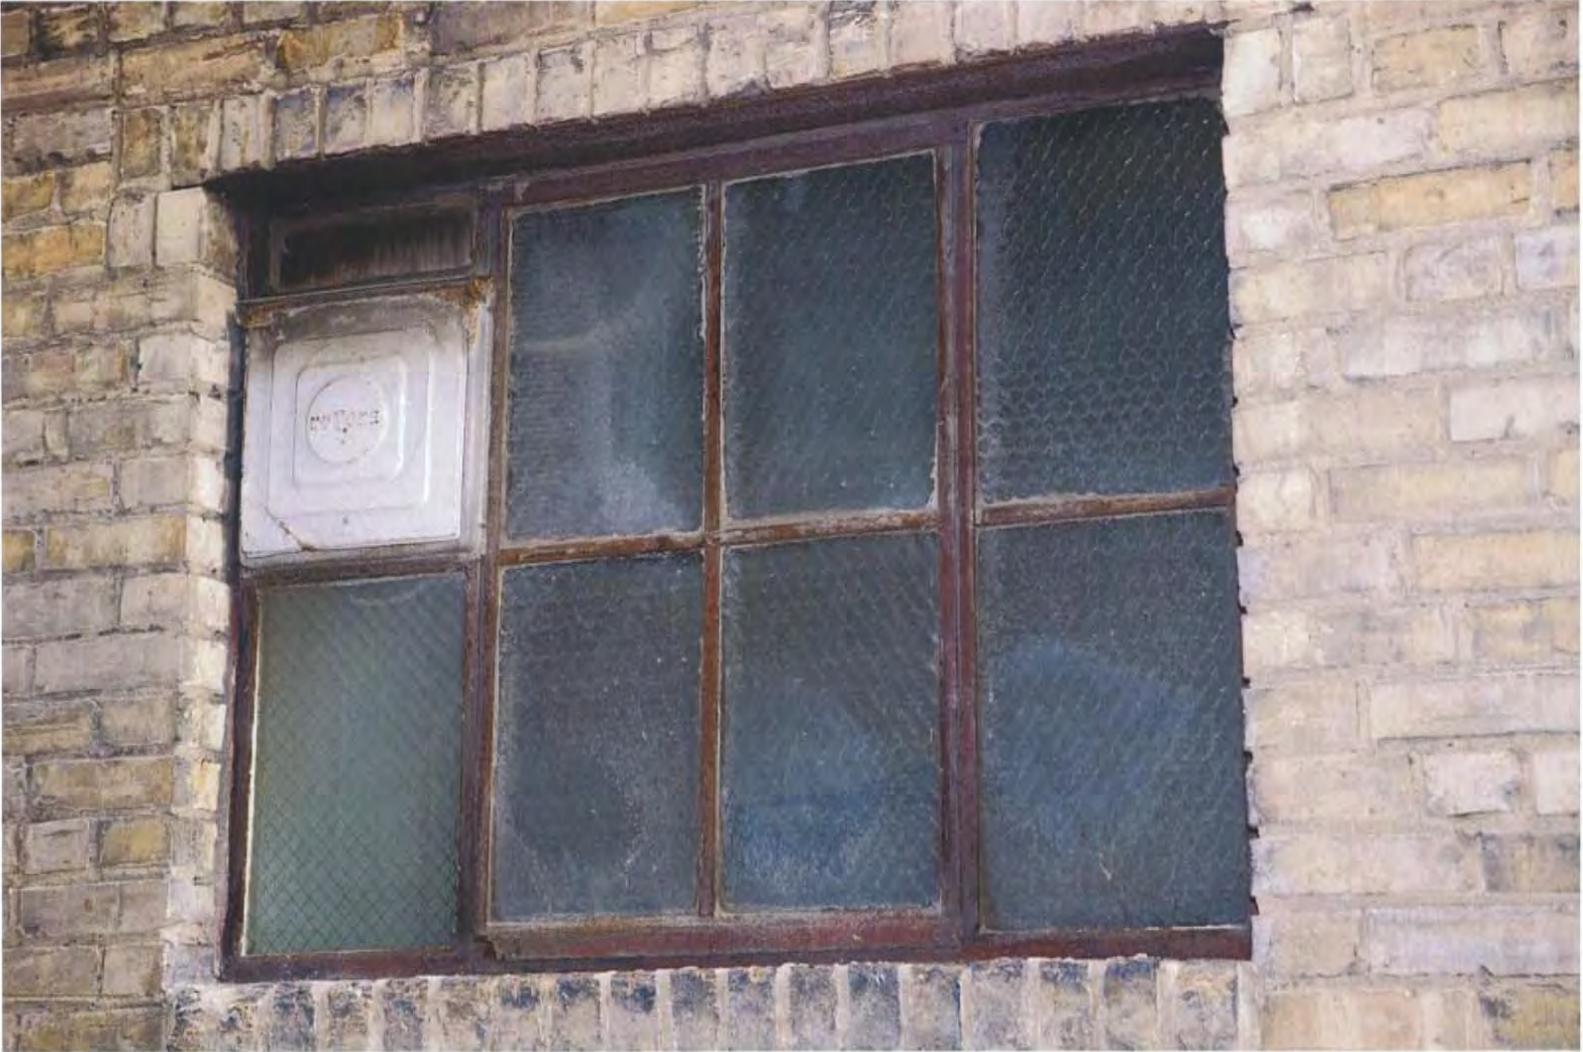
9. Exterior deteriorated men's room window with corroded metal frame and exhaust vent on the ground floor - southwest side of building (alley side), Date: 4/11/2014, Looking north

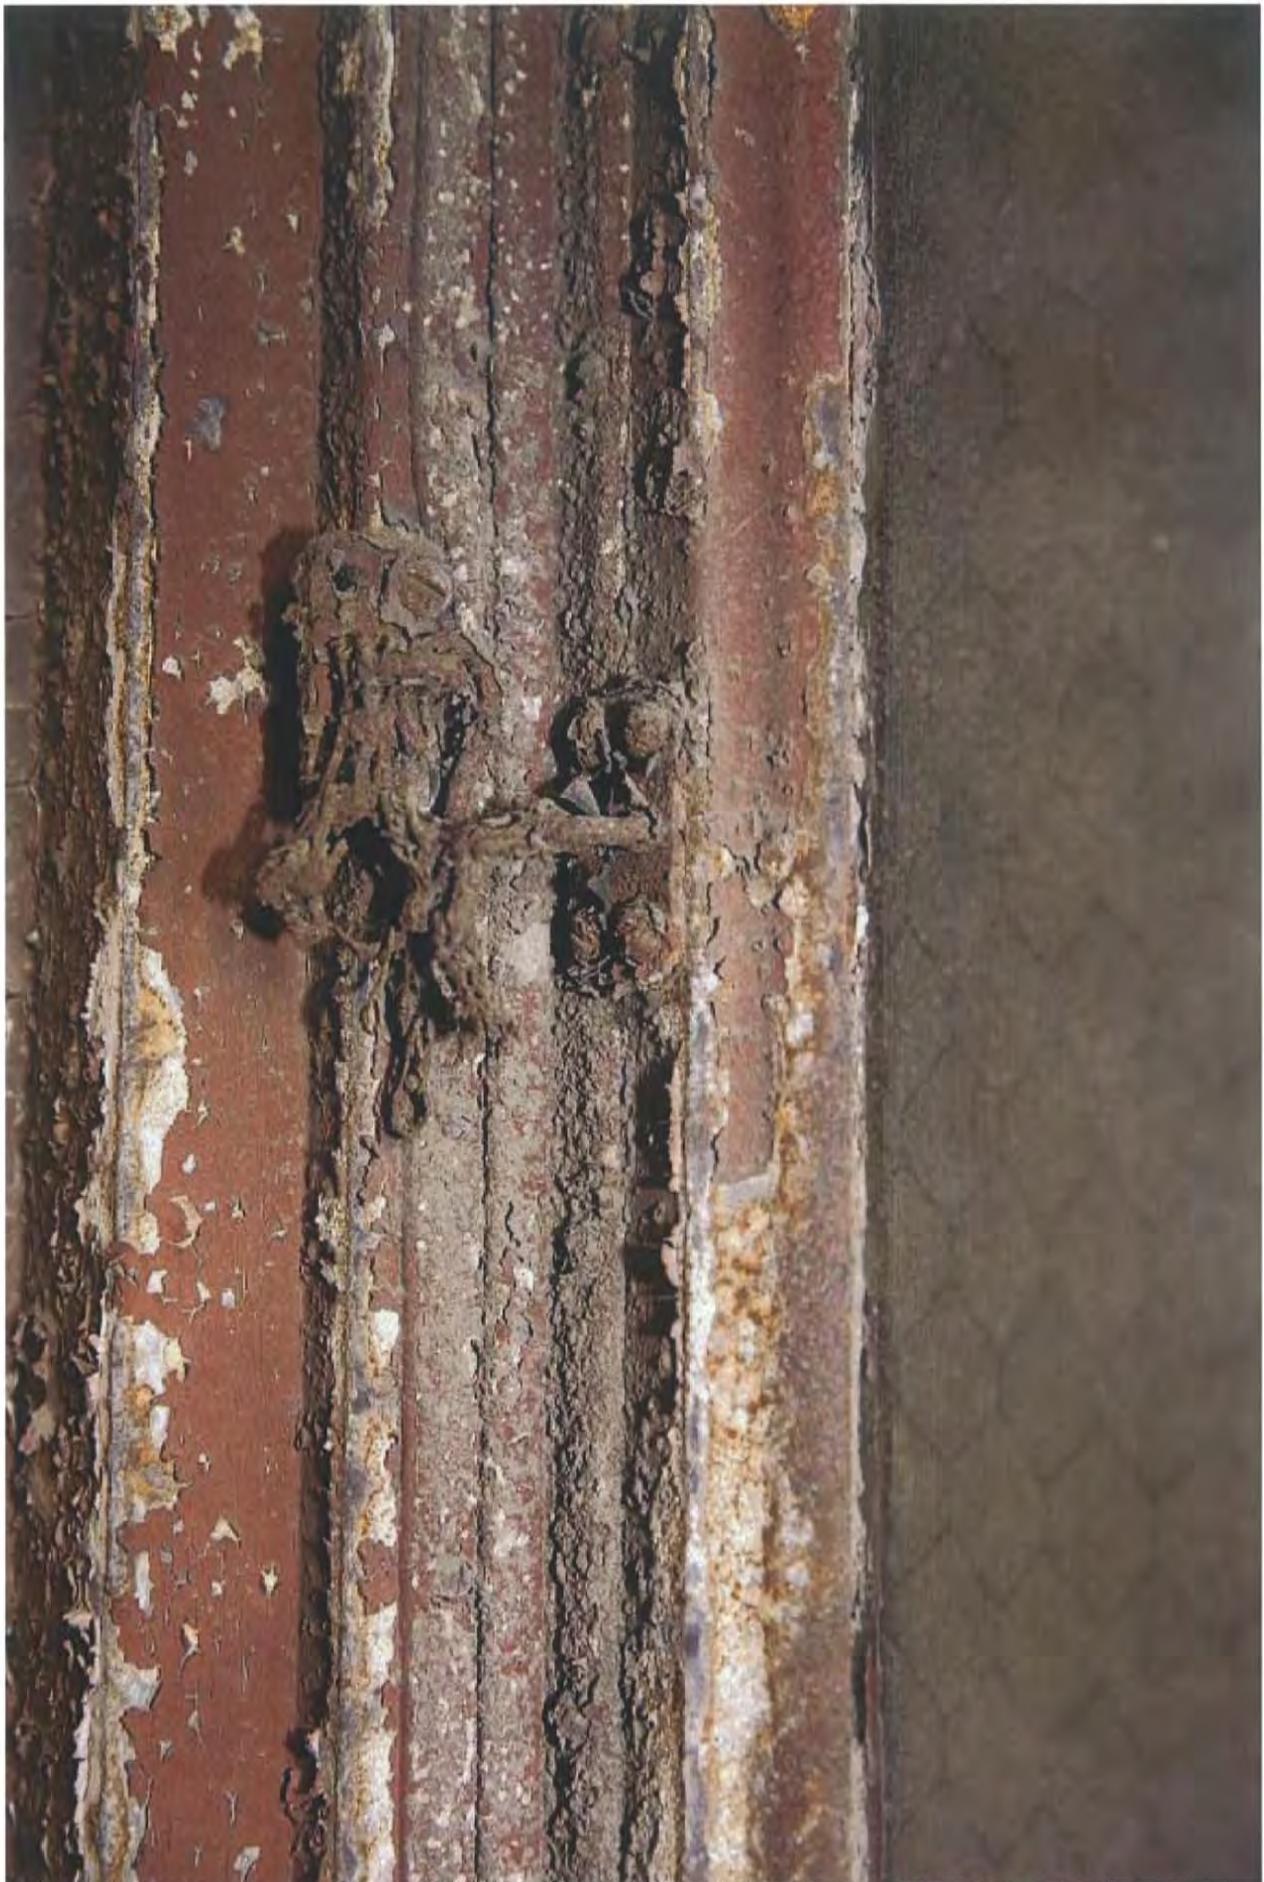
10. Close-up exterior detail of corroded and rusty metal window frame on the ground floor – southwest side of building (alley side), Date: 4/11/2014, Looking north

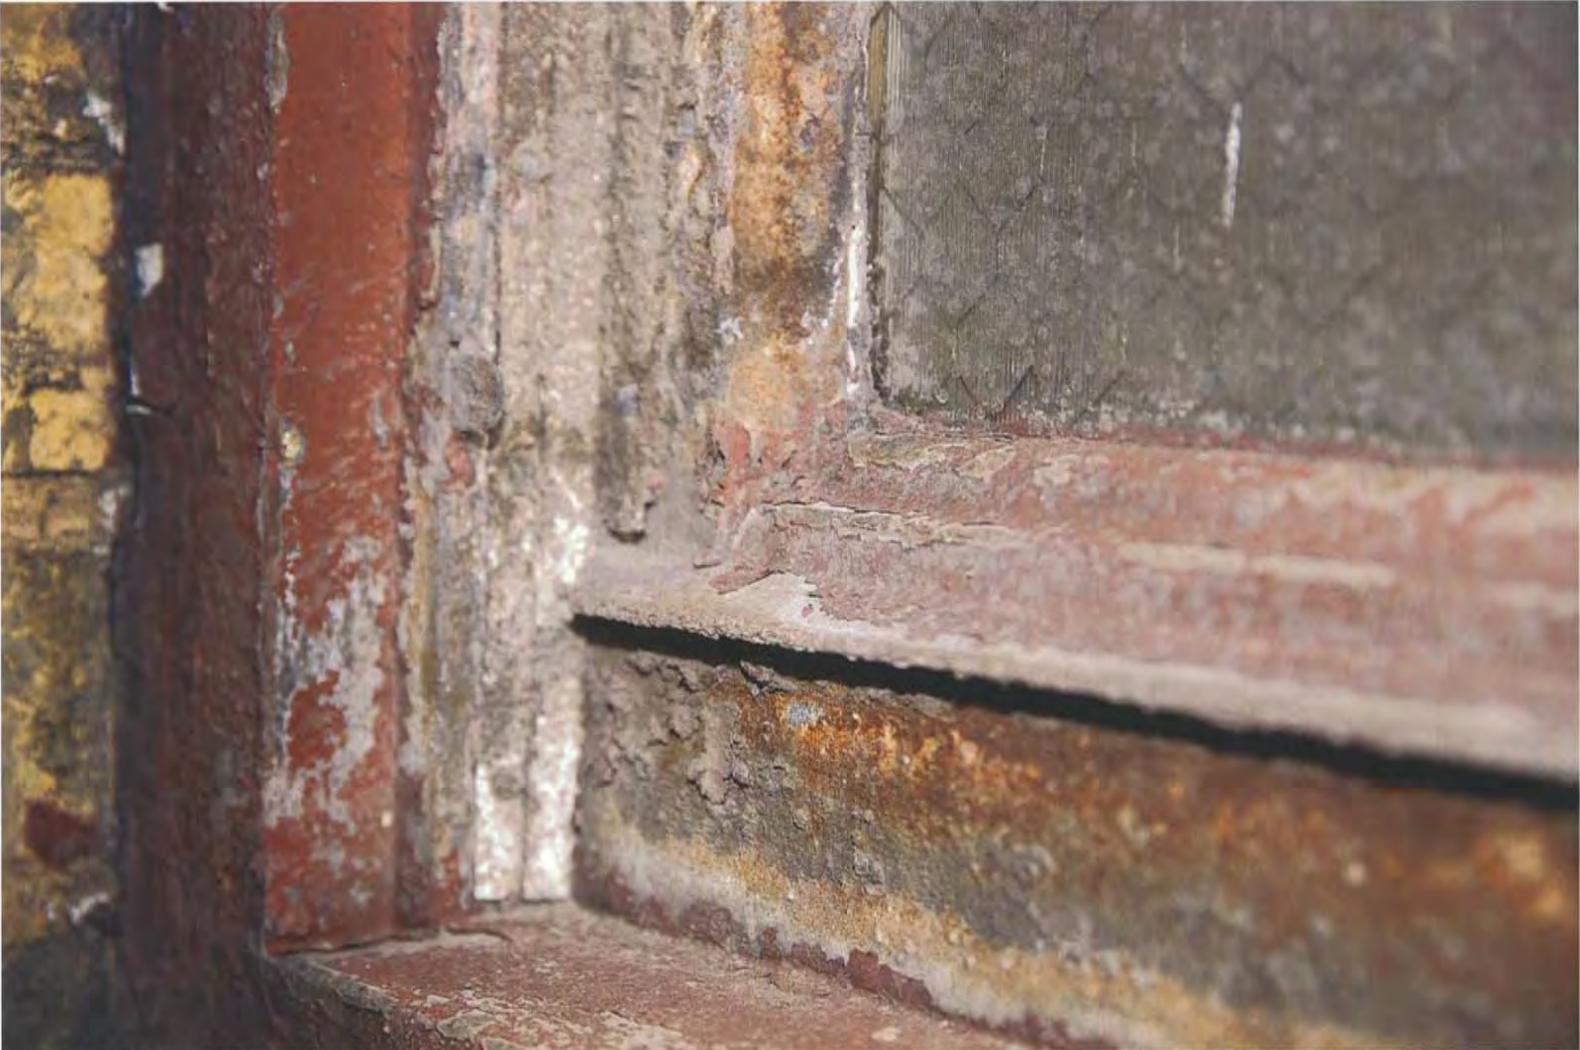
11. Close-up exterior detail of lower left hand corner of corroded and rusty metal window frame on the ground floor – southwest side of building (alley side), Date: 4/11/2014, Looking north

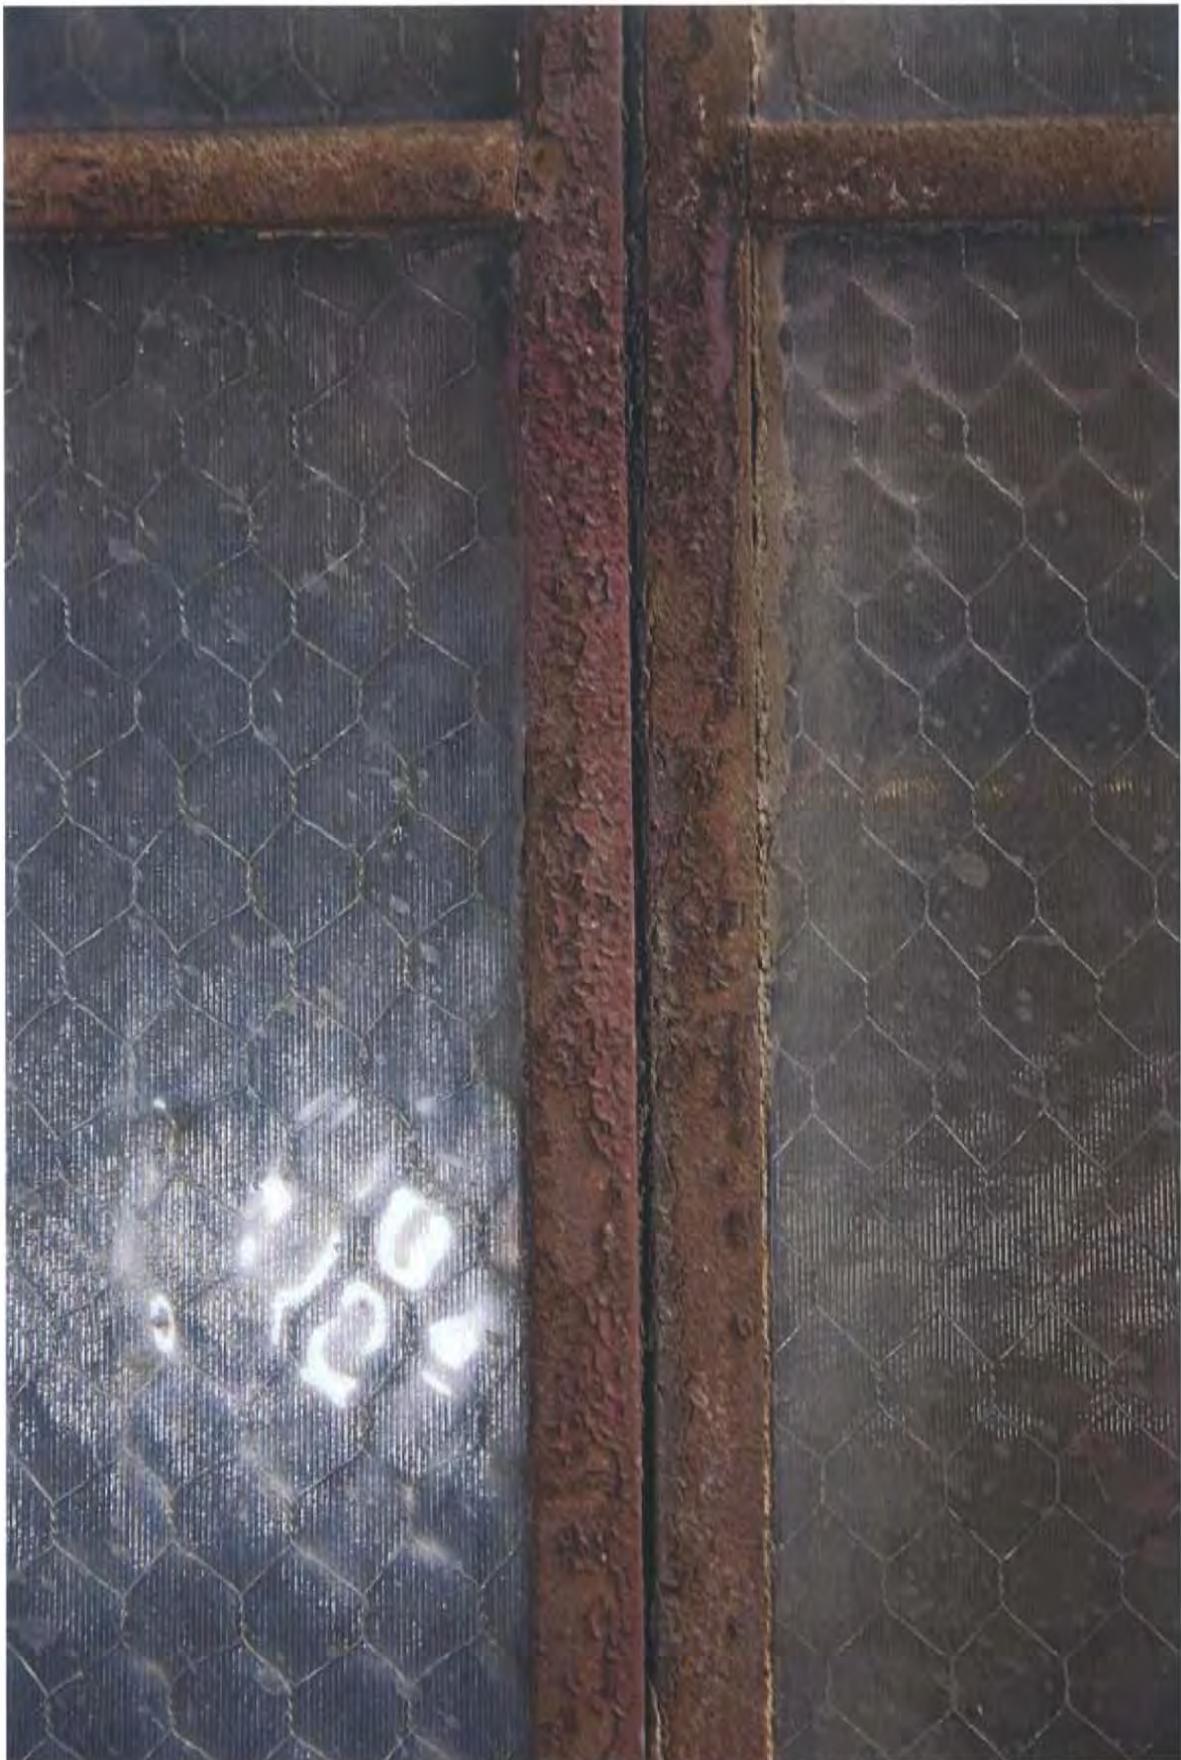
12. Close-up exterior detail of corroded and rusty metal window frame on the ground floor – southwest side of building (alley side), Date: 4/11/2014, Looking north

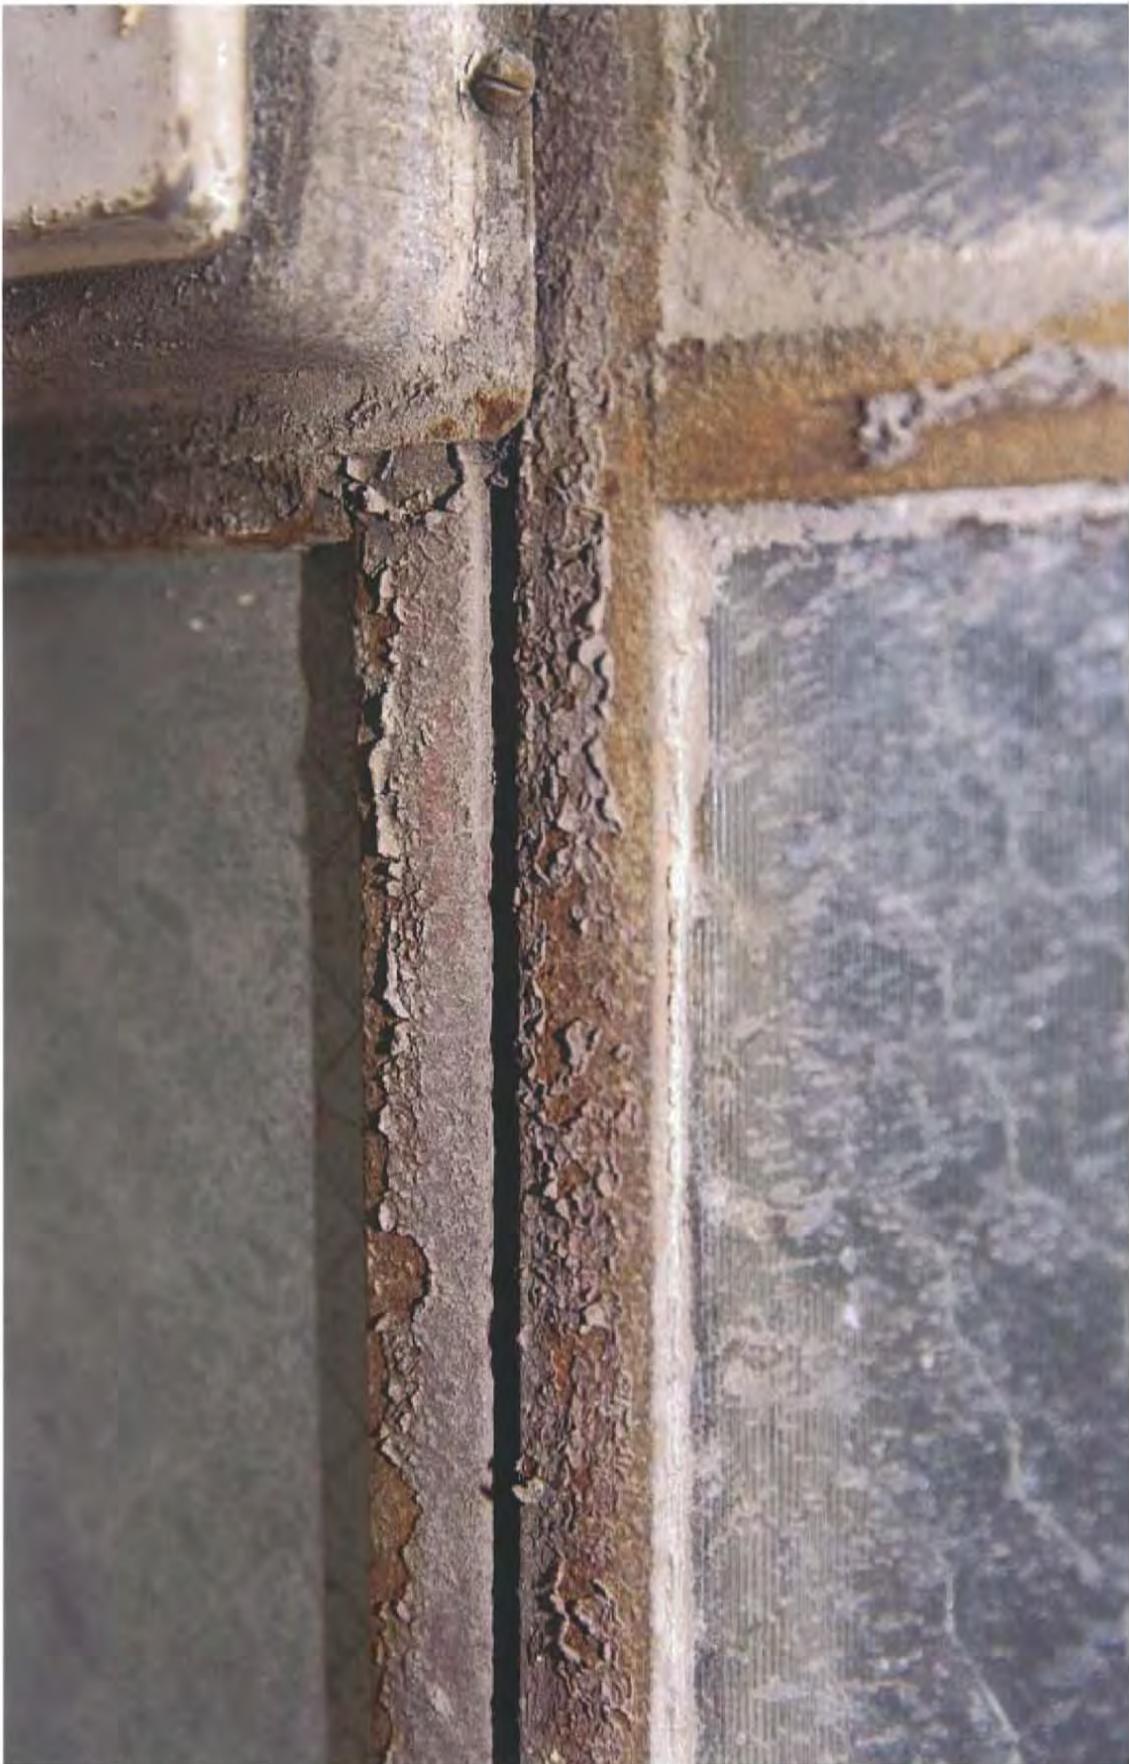
13. Close-up exterior detail of corroded and rusty metal window frame on the ground floor – southwest side of building (alley side), Date: 4/11/2014, Looking north

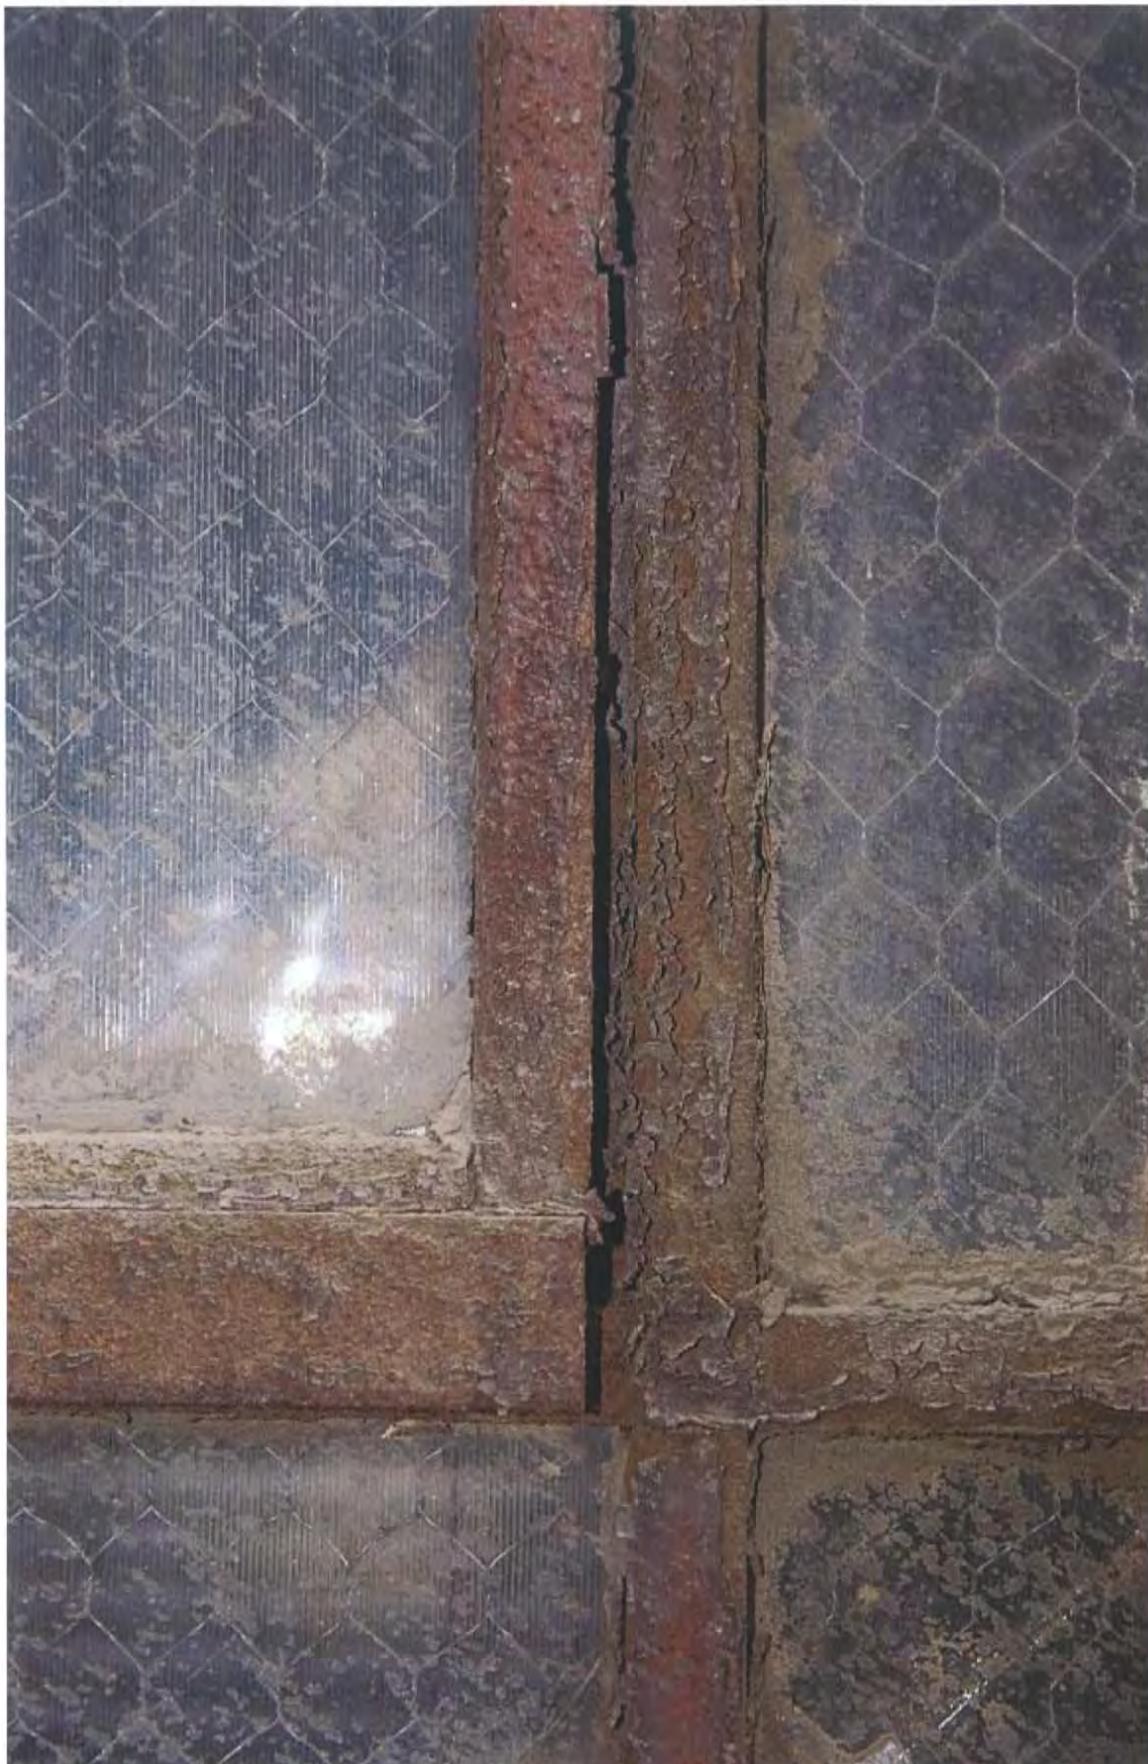
14. Close-up exterior detail of corroded and rusty metal window frame on the ground floor – southwest side of building (alley side), Date: 4/11/2014, Looking north

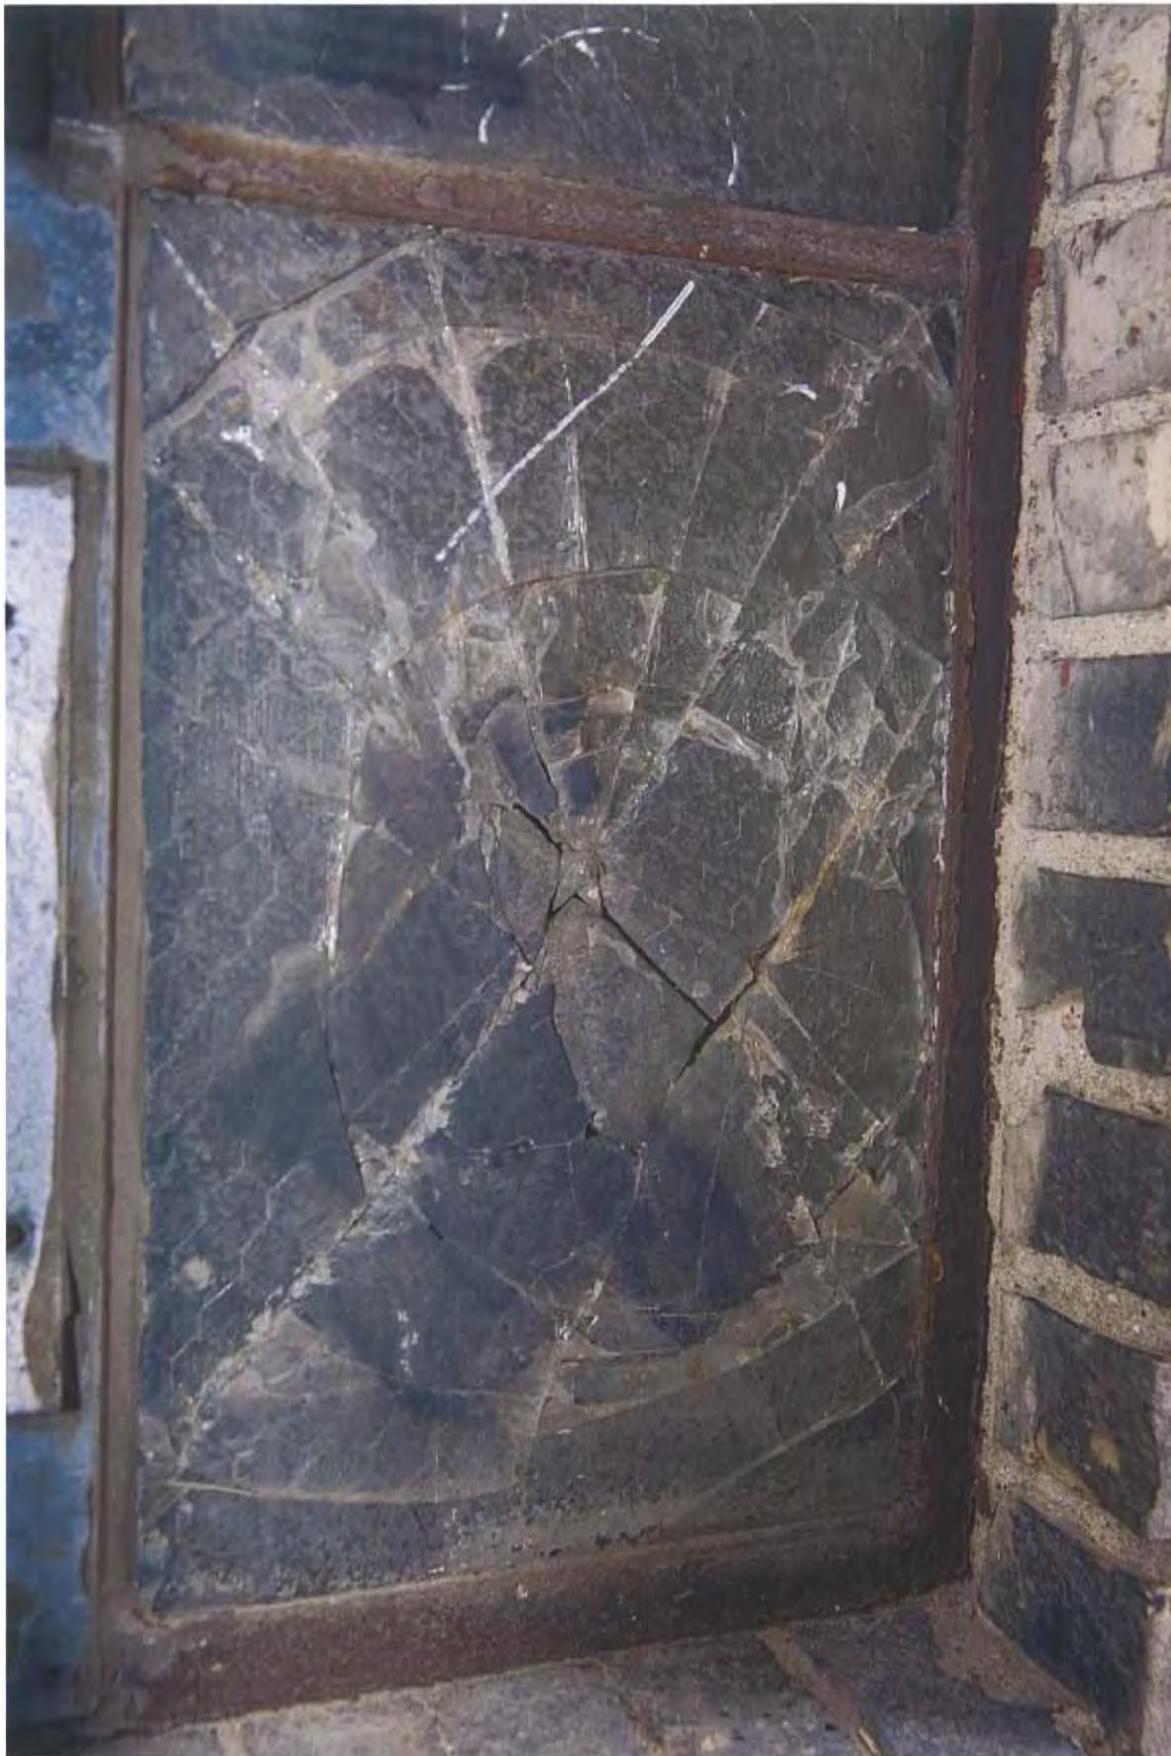
15. Close-up exterior detail of corroded and rusty metal window frame and broken safety glass on the ground floor – southwest side of building (alley side), Date: 4/11/2014, Looking north

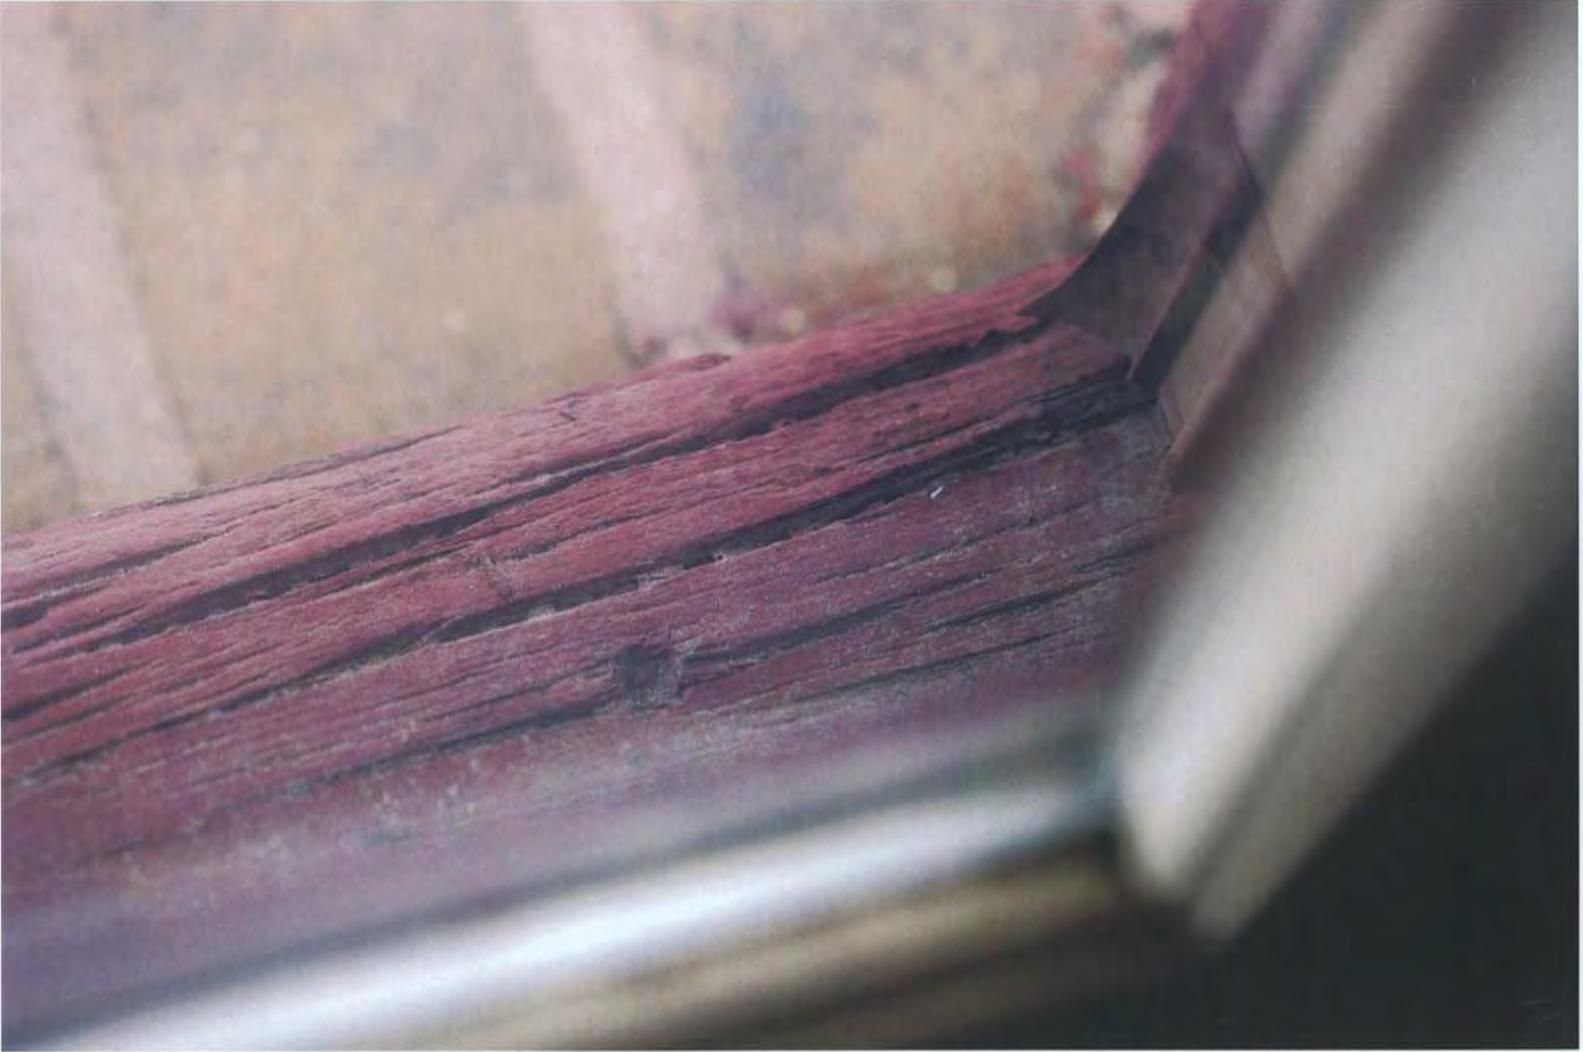
16. Close-up exterior detail of deteriorated wood window-sill on the front of building, Third (3rd) Floor, Southwest corner office, Date 4/11/2014

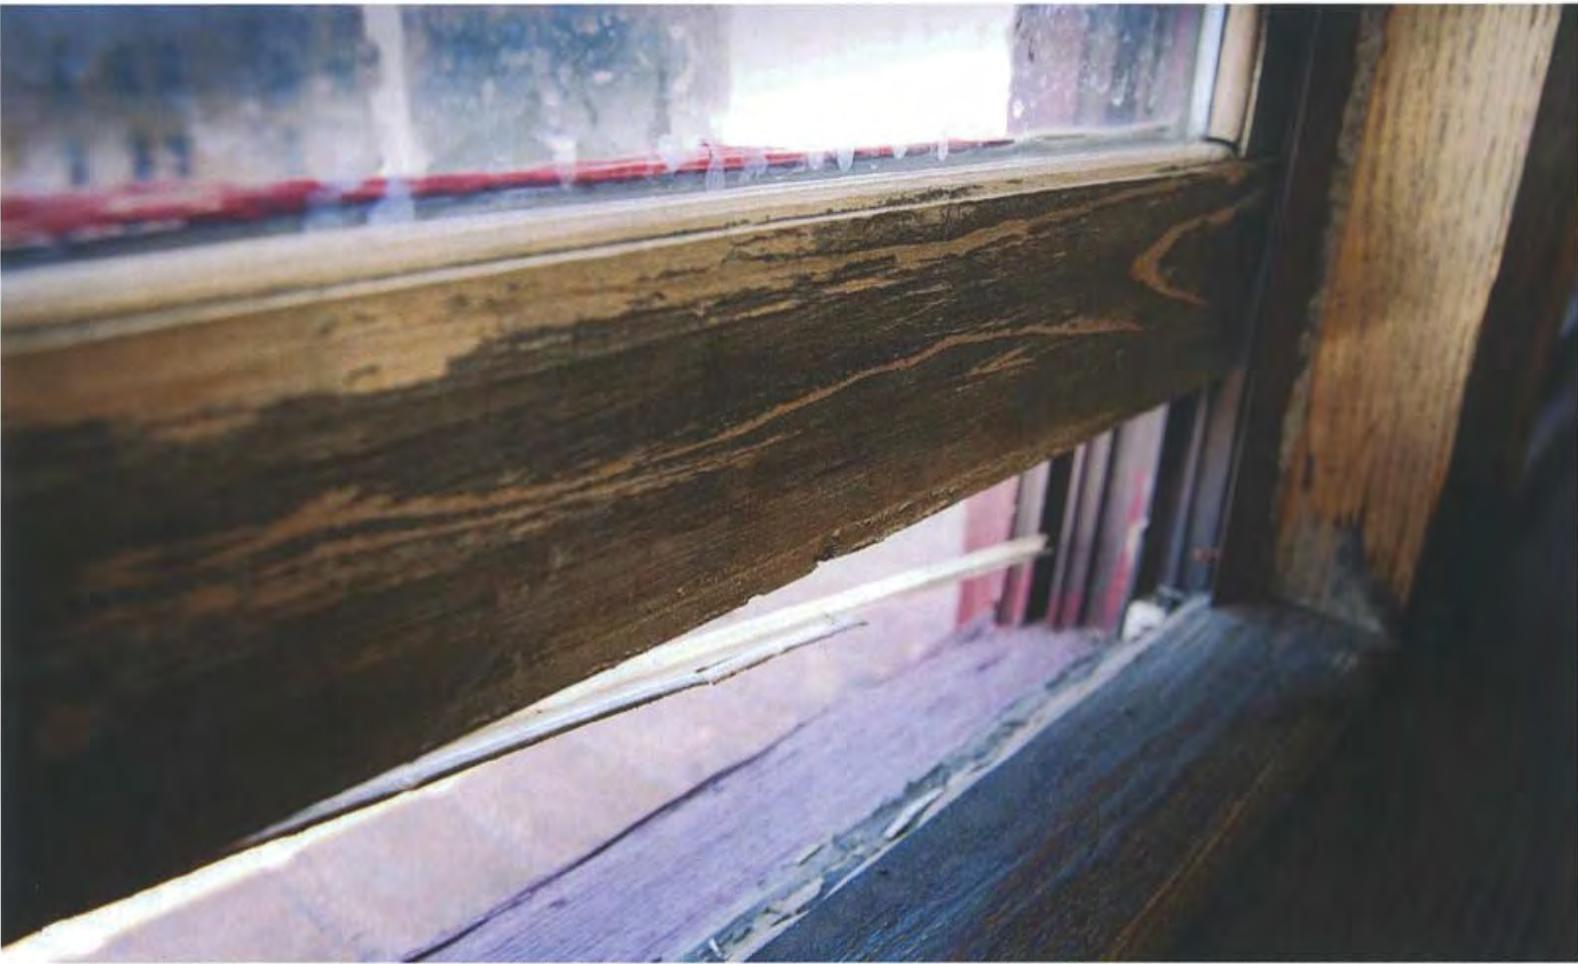
17. Close-up interior detail of deteriorated wood window frame on the front of building, Fourth (4th) Floor, Southwest corner office, Date: 4/10/2014

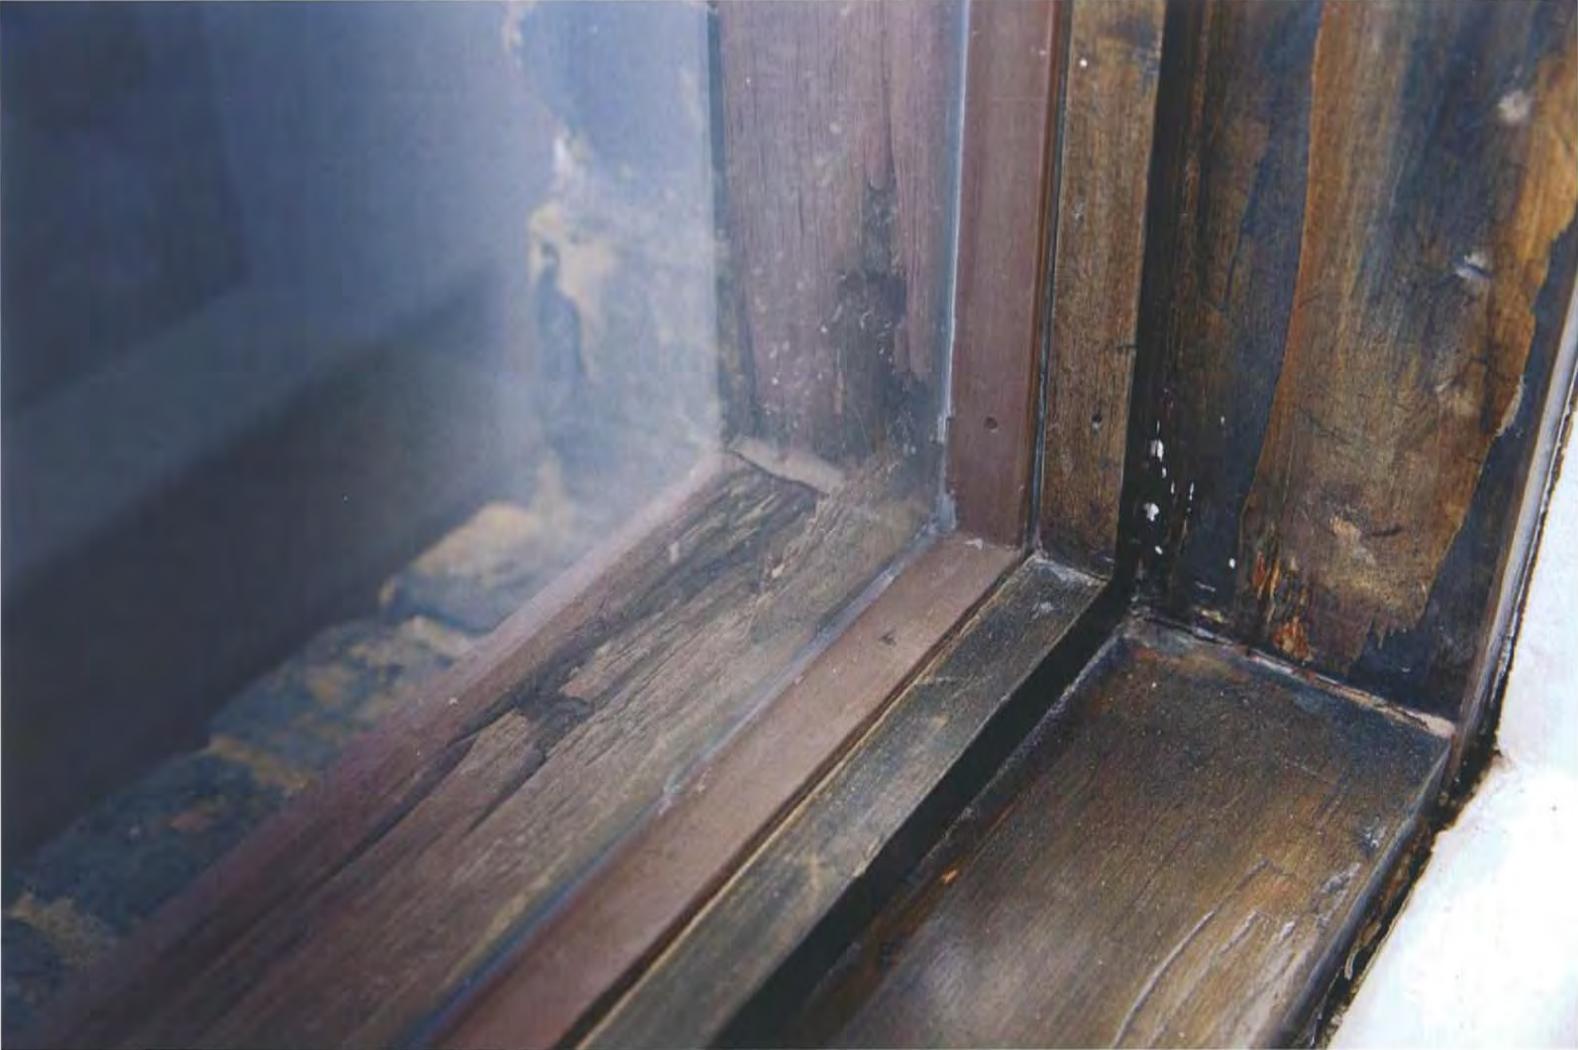
18. Close-up interior and exterior detail of deteriorated wood window-sill on the southwest side of building (alley side), Fourth (4th) Floor, Southwest corner office, Date: 4/10/2014
