CPED STAFF REPORT

HPC Agenda Item #3
 August 19, 2014
 BZH-28246

Property Location: 241 First Avenue North
Project Name: Lerner Building Window Replacement
Prepared By: [Lisa Steiner](#), City Planner, (612) 673-3950
Applicant: Martin Investments Limited Partnership
Project Contact: Adam Lerner
Ward: 3
Neighborhood: Downtown West
Request: To obtain after-the-fact approval for unpermitted window replacement and seek approval for the replacement of additional windows on an existing building.

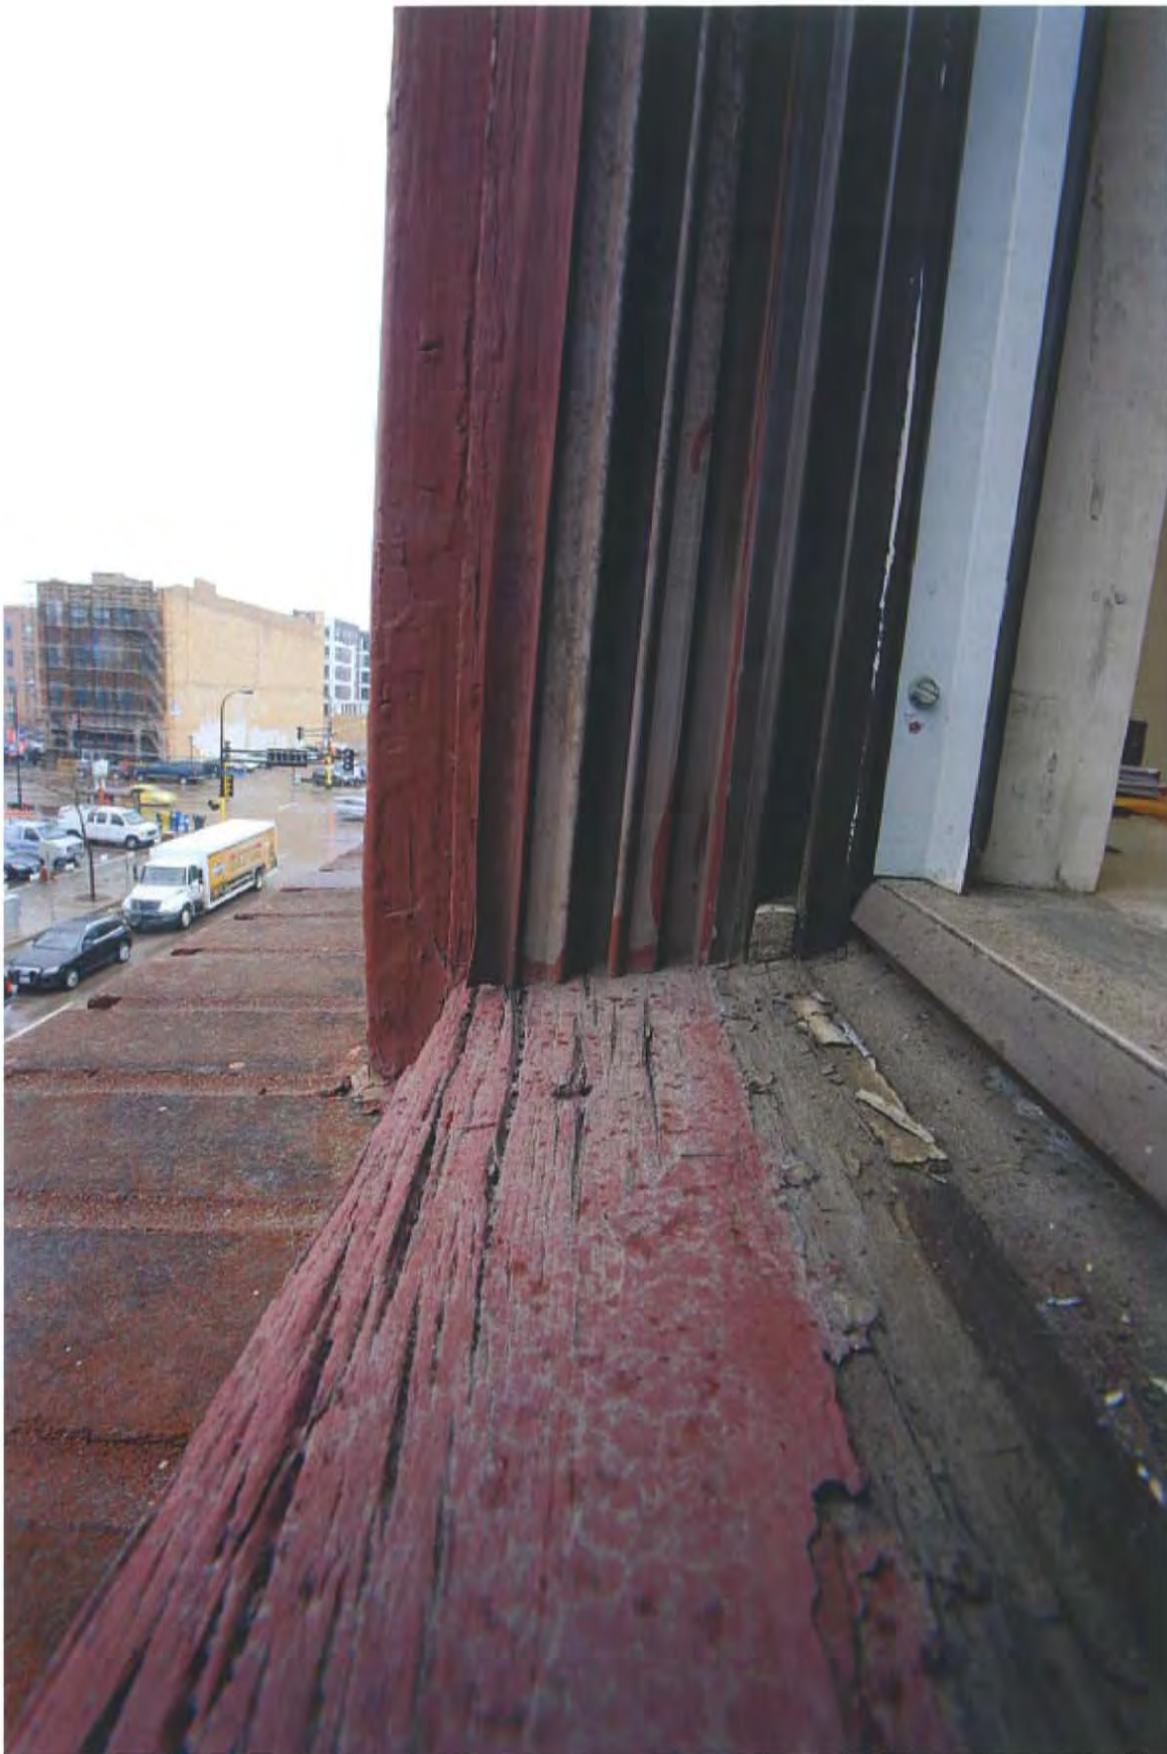
19. Close-up exterior detail of deteriorated wood window-sill on the front of building, Third (3rd) Floor, Southwest corner office, Date 4/24/2014

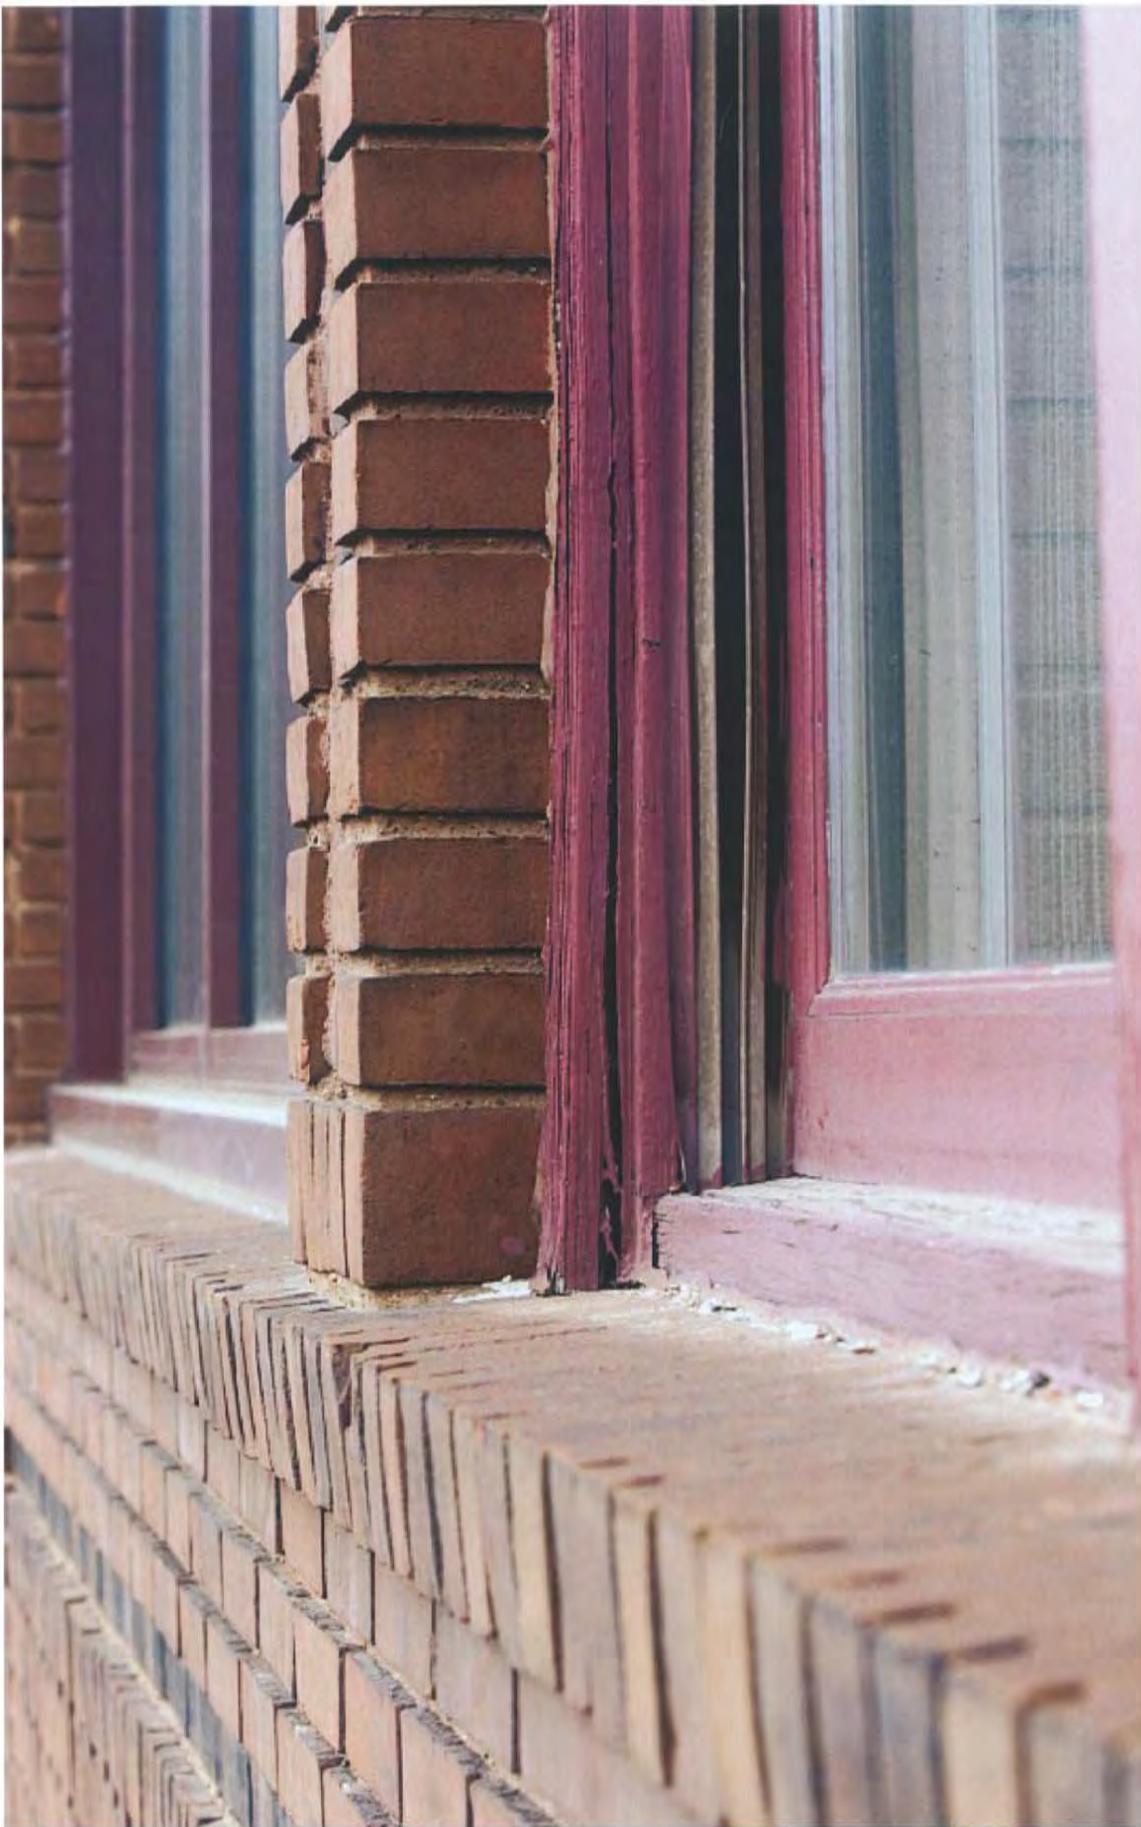
20. Close-up exterior detail of deteriorated wood window frame on the front of building Third (3rd) Floor, Southwest corner office, Date 4/24/2014

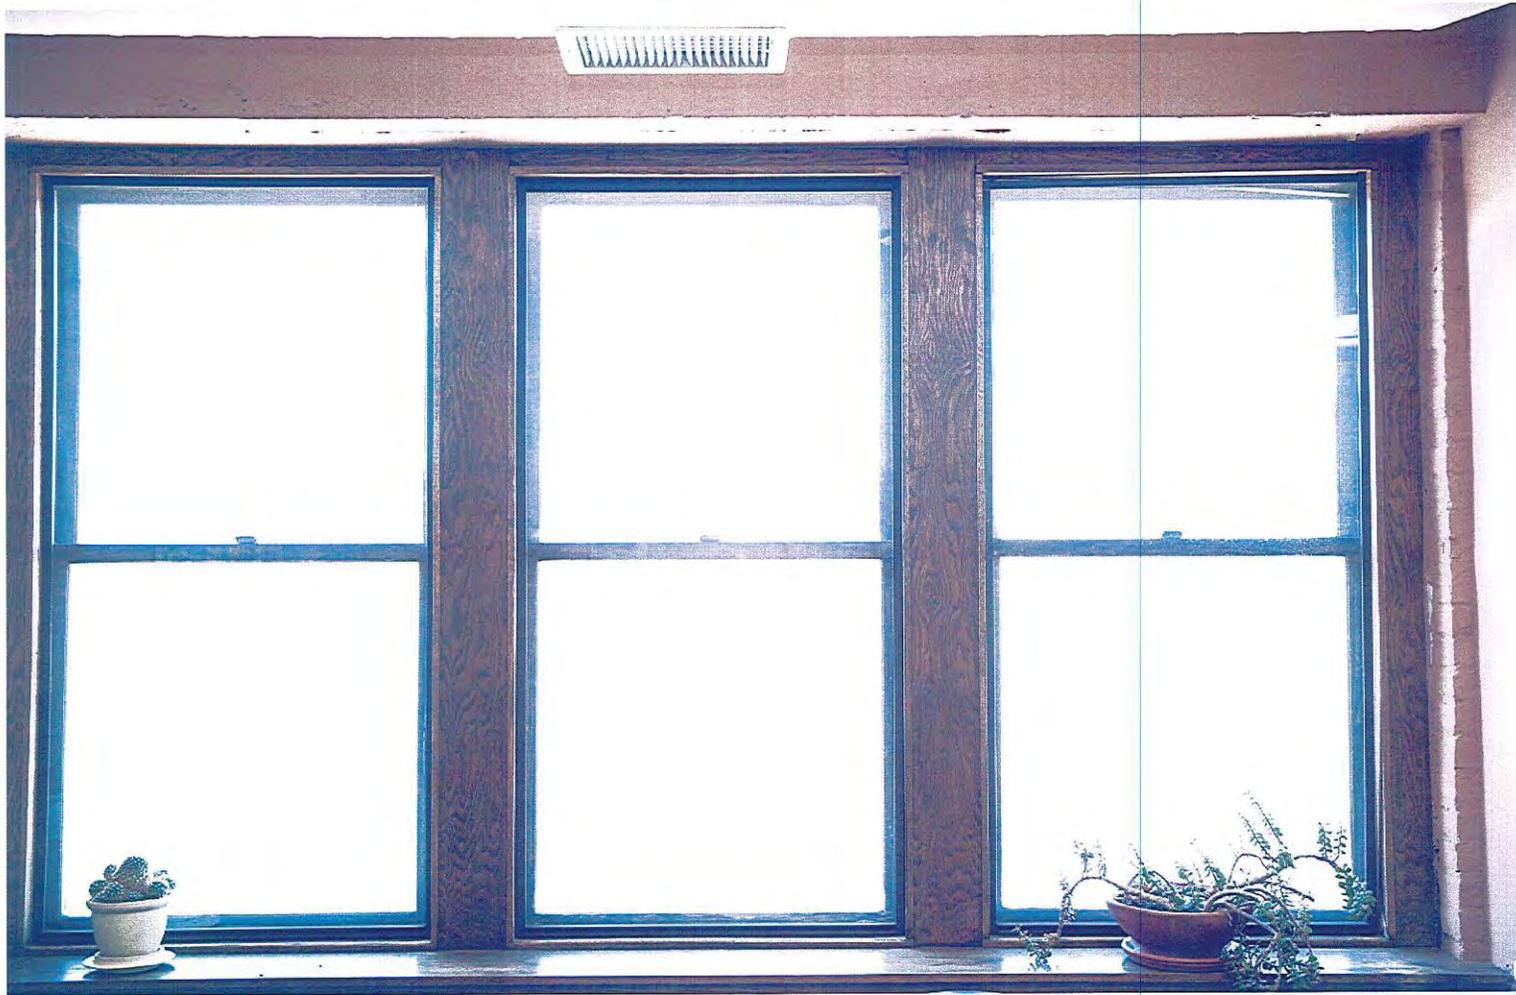
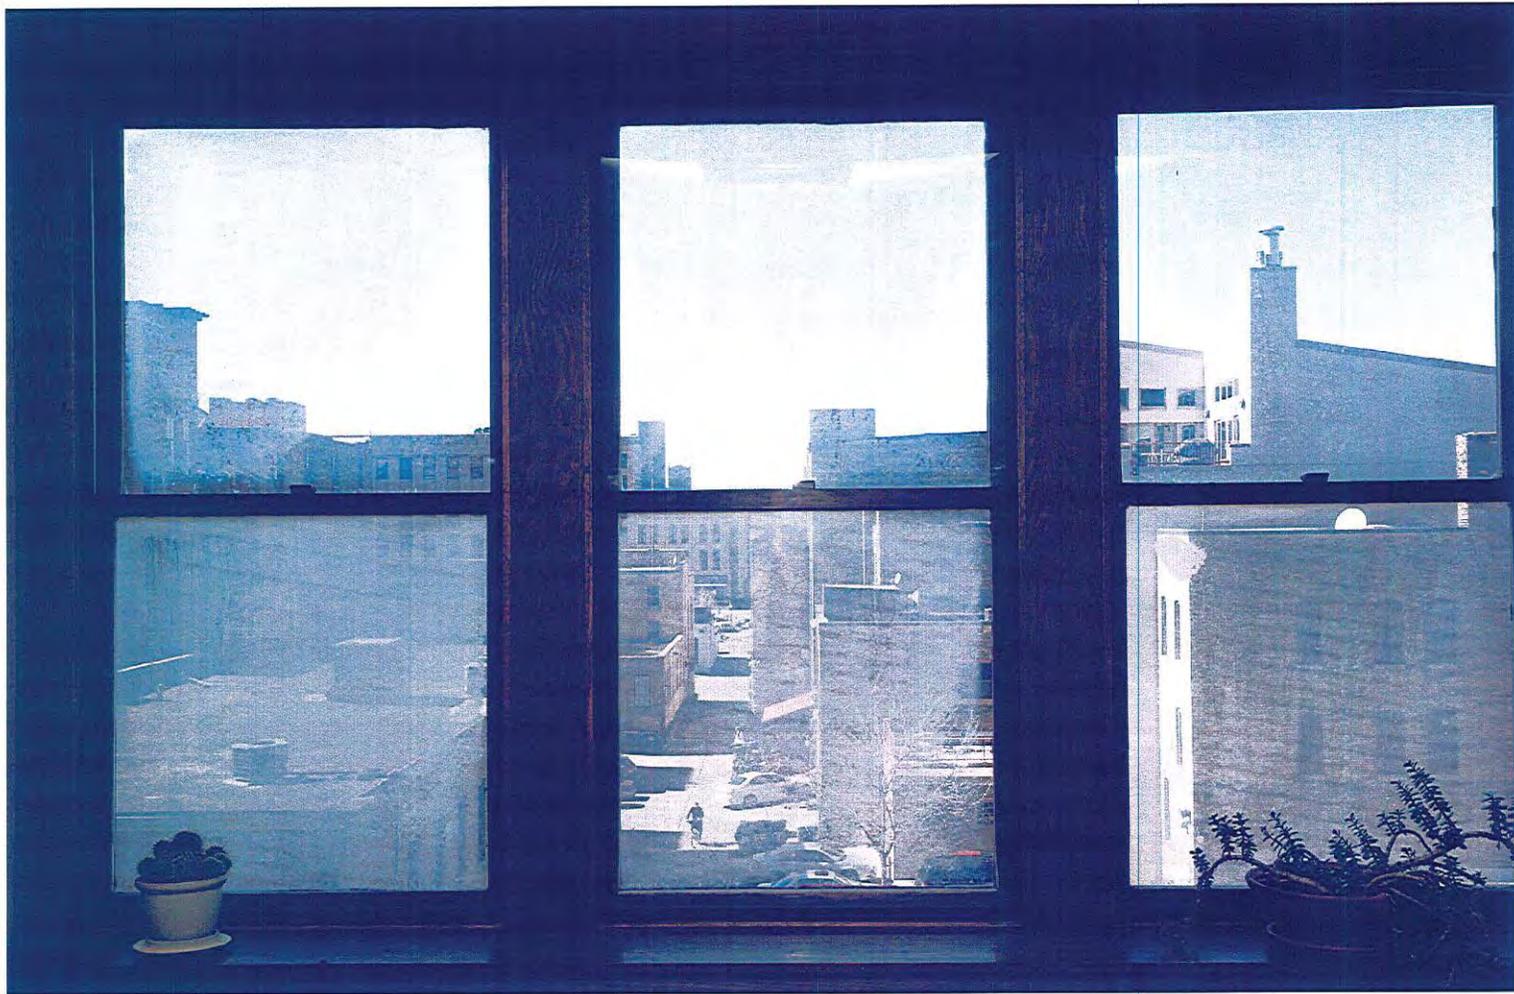
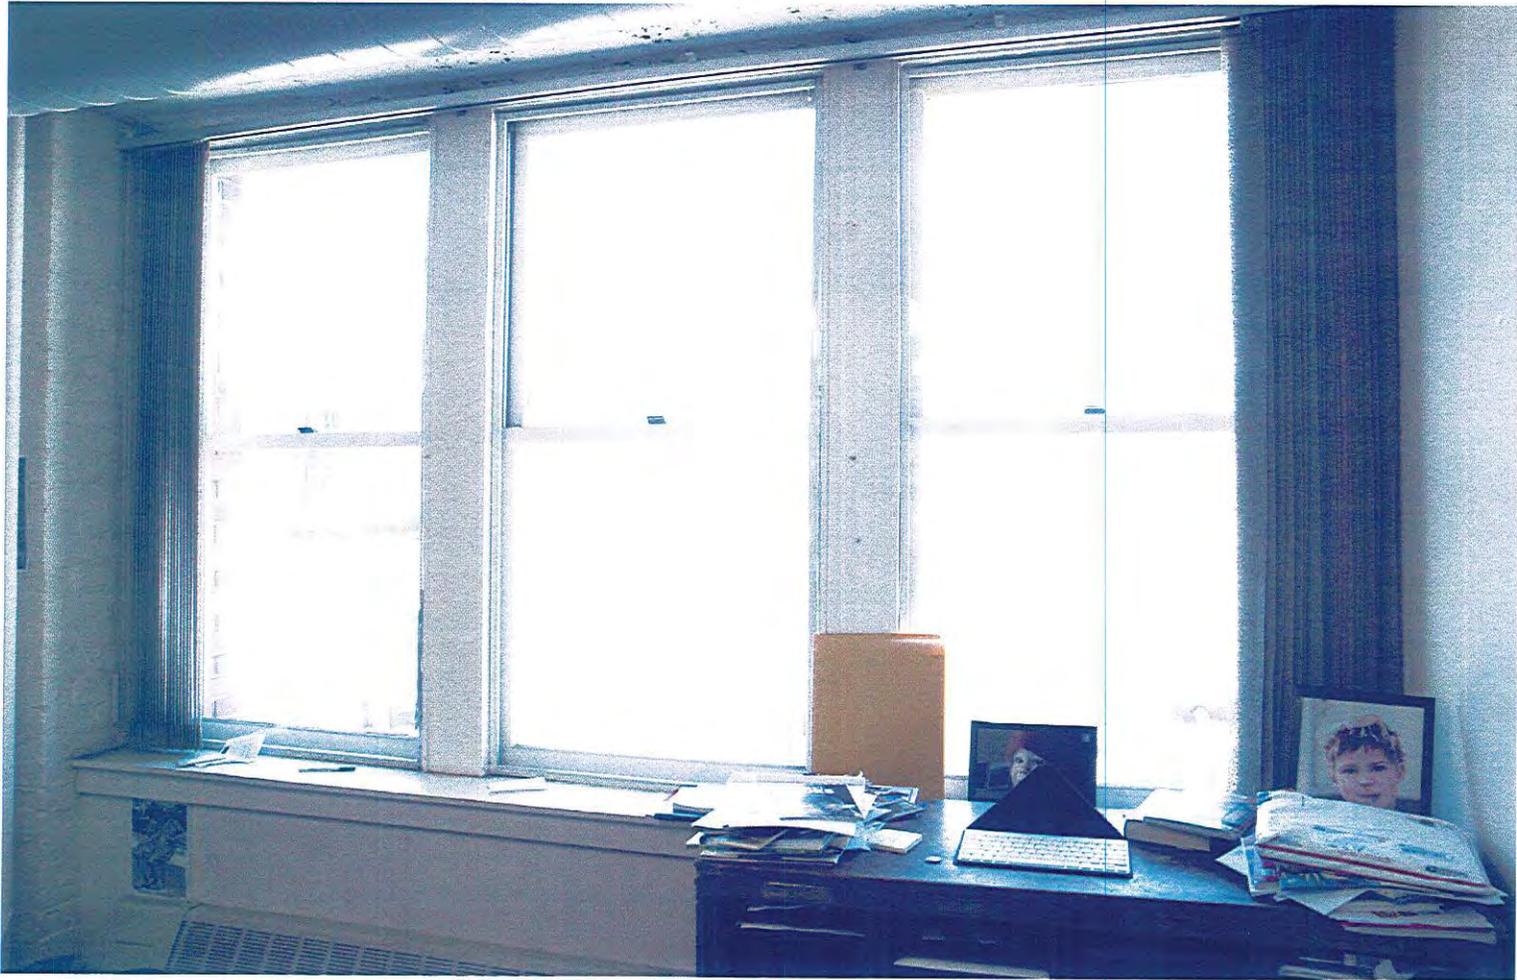
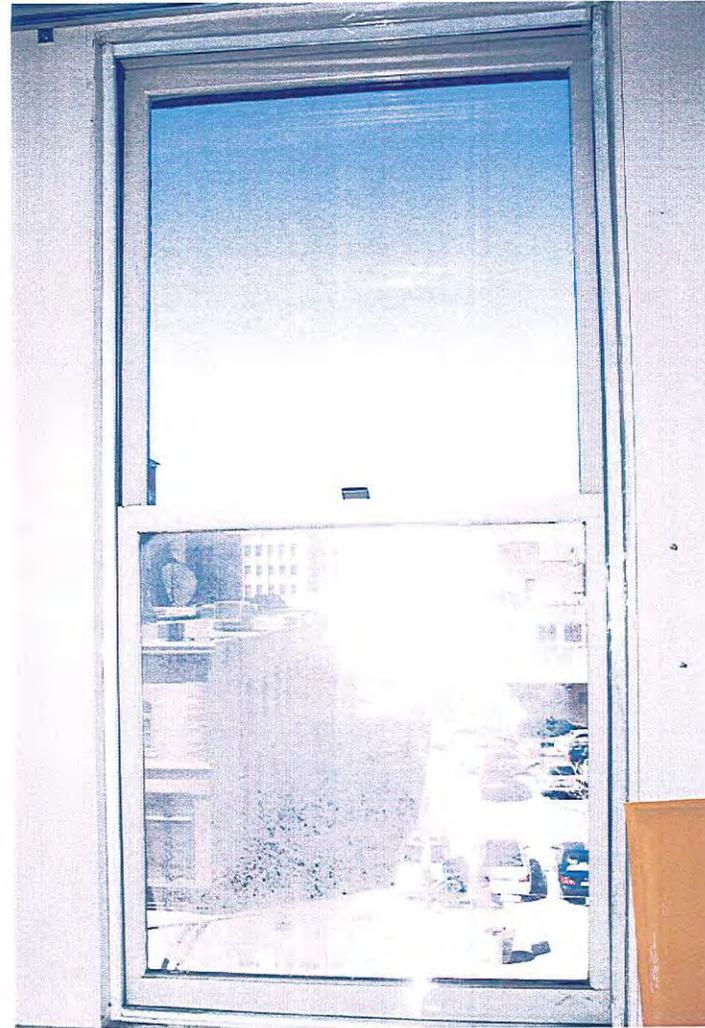
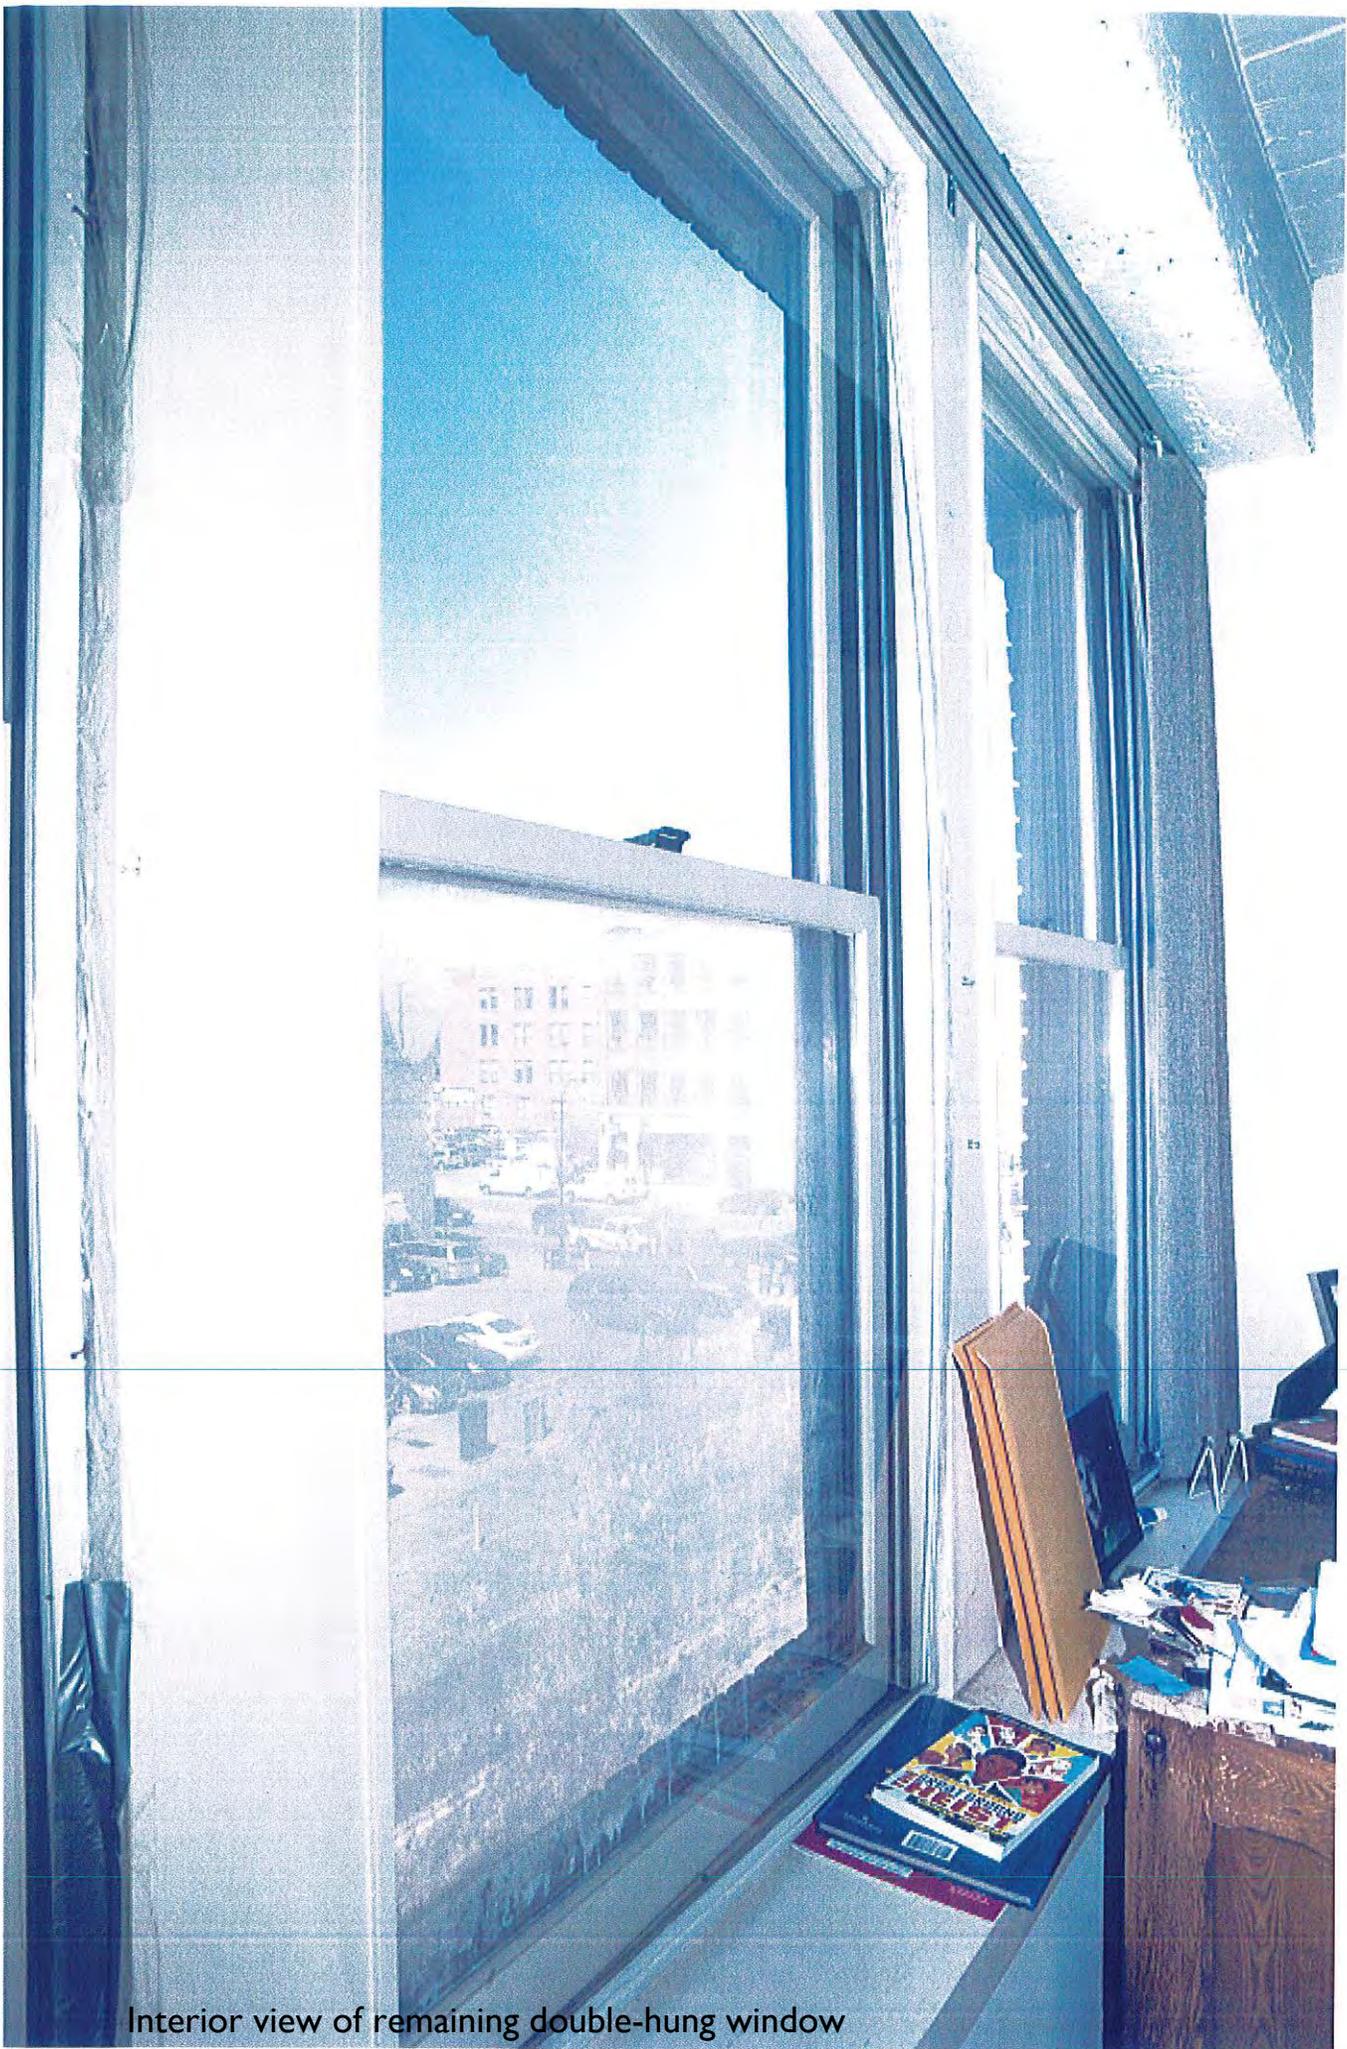
Interior view of remaining double-hung windows

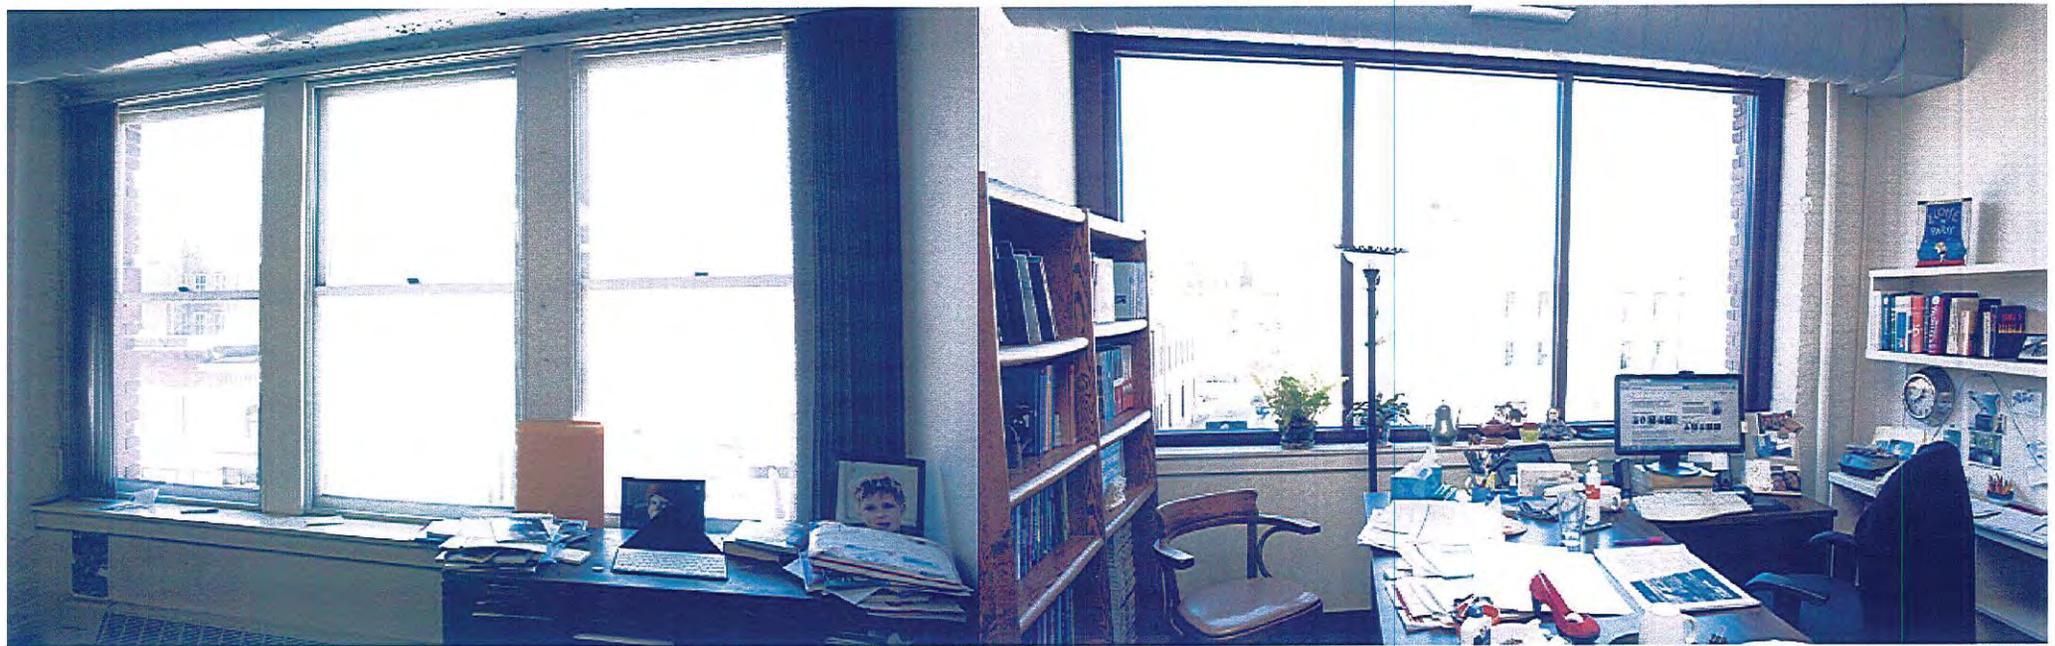
Interior comparison: remaining double-hung windows and unpermitted replacement windows

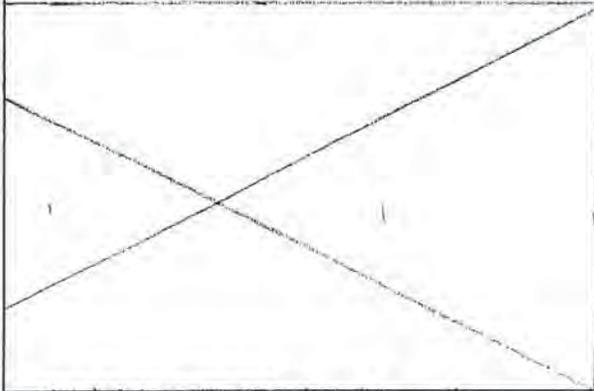
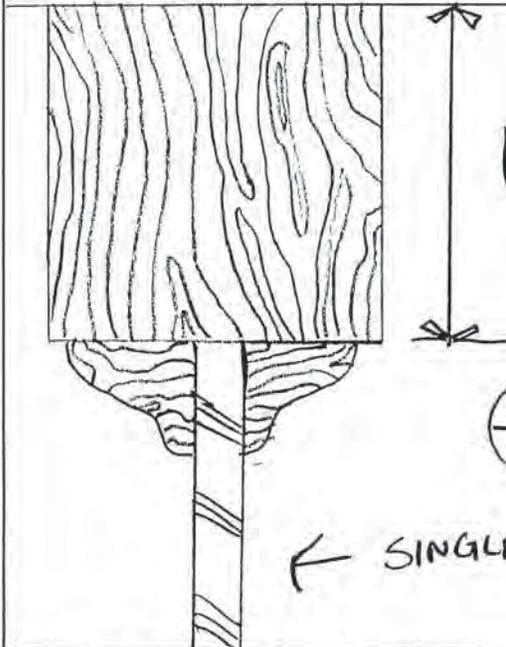
(B/5) PROPOSED HEAD PROFILE

(A/5) EXISTING HEAD PROFILE
