910 Portland Avenue South

BZH-27888

CONTINUATION SHEET-Part 1
Historic Preservation Certification Application

The Roselle
910 Portland Avenue South, Minneapolis, Hennepin, Minnesota

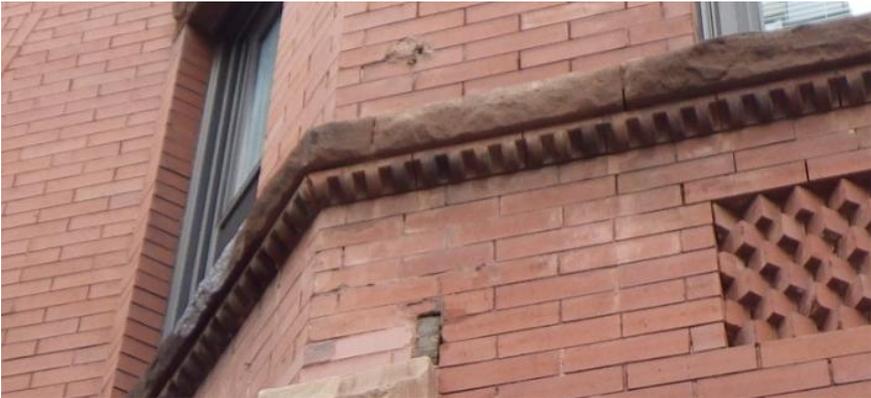
Deterioration of Exterior

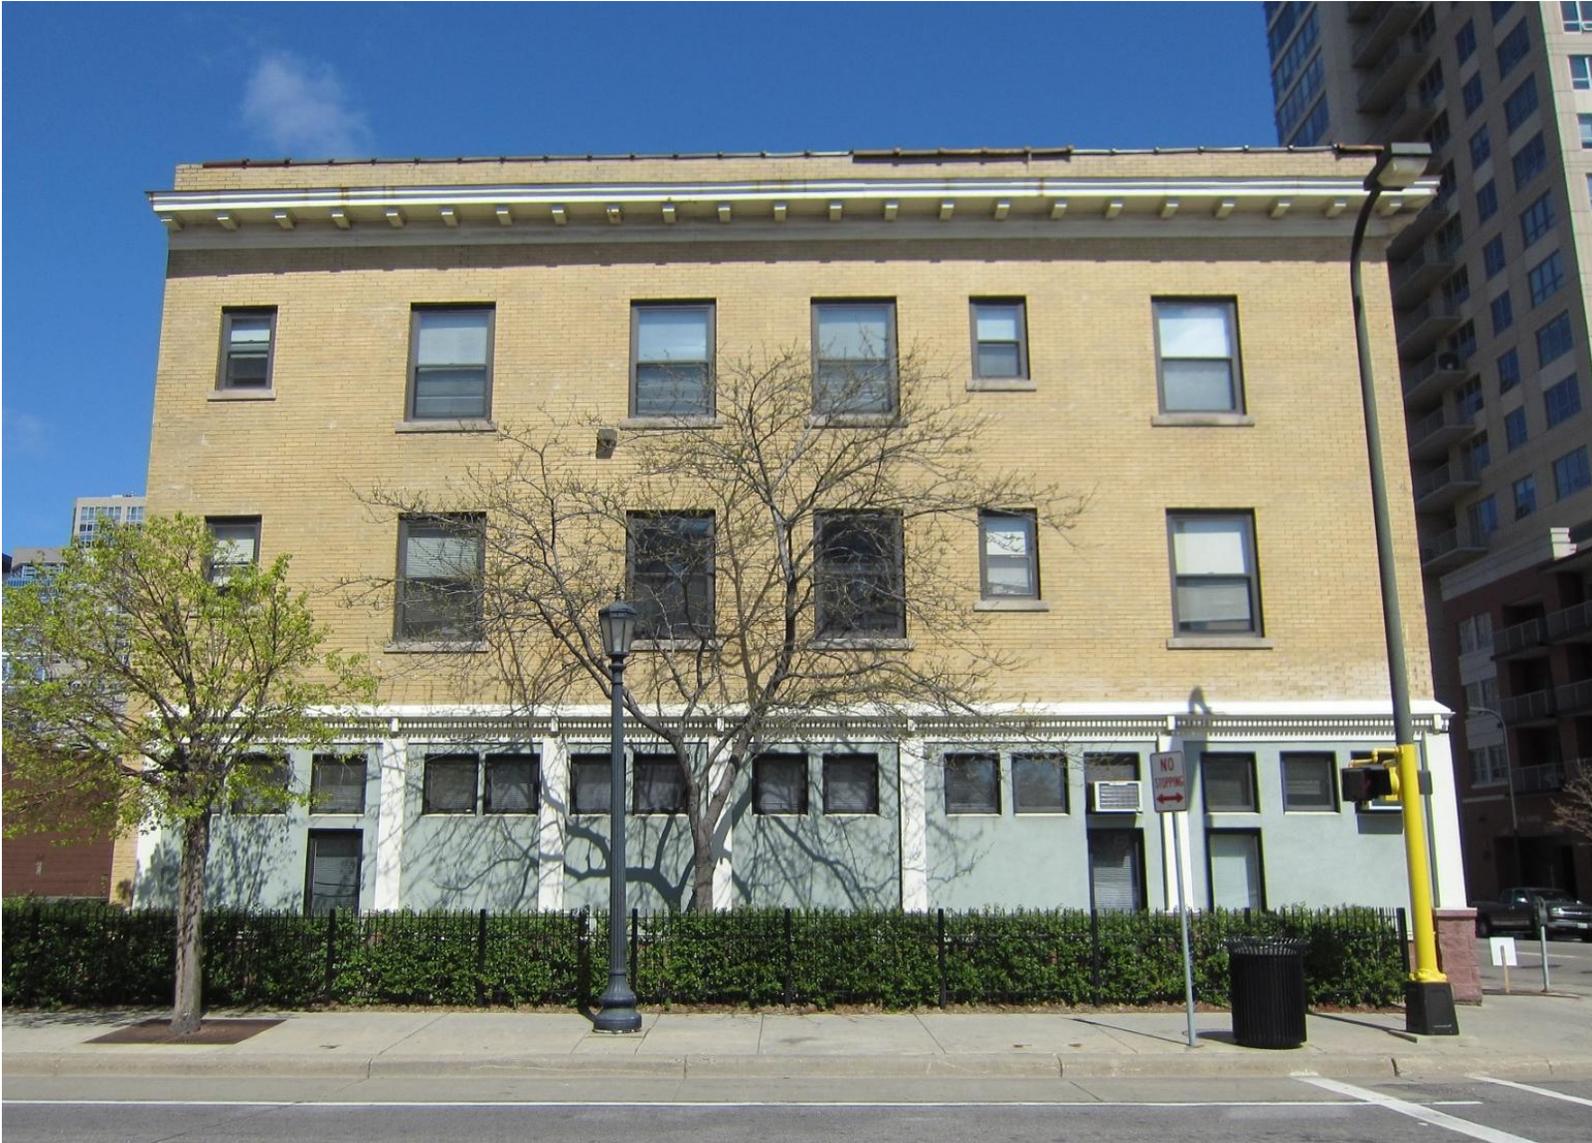
Milton- Soffit Damage

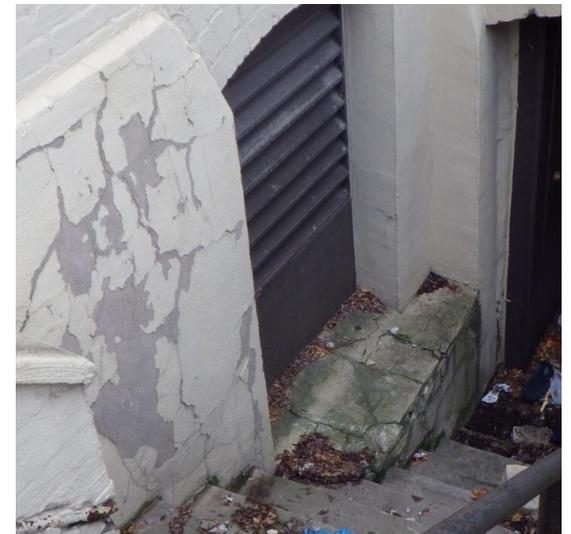
Milton- Stairway deterioration
