Pillsbury A Mill Tunnel Historic and Engineering Condition Study

Report prepared for
City of Minneapolis

May 2014

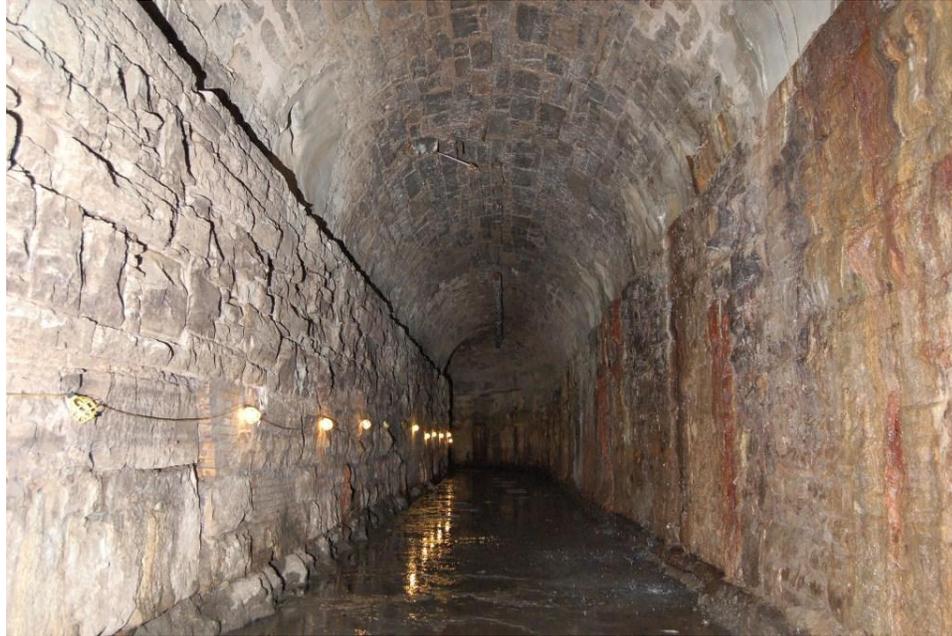
Figure 9. Circular arch roof tunnel structure.

The circular stone arch tunnel section is in fair condition overall (see Figure 9). No evidence of bulging walls or extensive cracking in the walls was observed. The main structural issues surrounding the tunnel are missing mortar, deteriorating stonework, drummy (debonded) brick infills, and groundwater infiltration. A few areas of deteriorating rock near the keystone were observed.

A related concern is the presence of a leaking watermain immediately adjacent to the tunnel from Station 4+25 to 4+80. The leaking watermain could cause piping of soil into the tunnel structure, which could locally destabilize the arch structure. The City of Minneapolis is aware of the leak and is working to repair the leaking watermain in the near future.

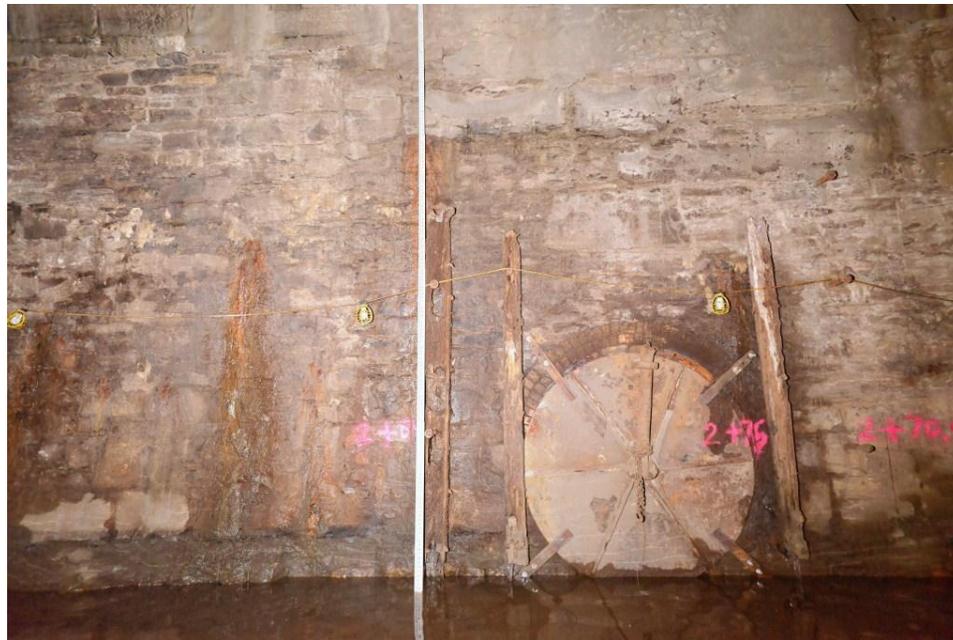
Figure 10. Phoenix headrace gate.

The river side entrance of the Phoenix headrace has been abandoned and bulkheaded, and the inland side entrance is covered by a large steel cover that is bolted to the walls (see Figure 10). The Phoenix headrace is nominally 7 feet in diameter.

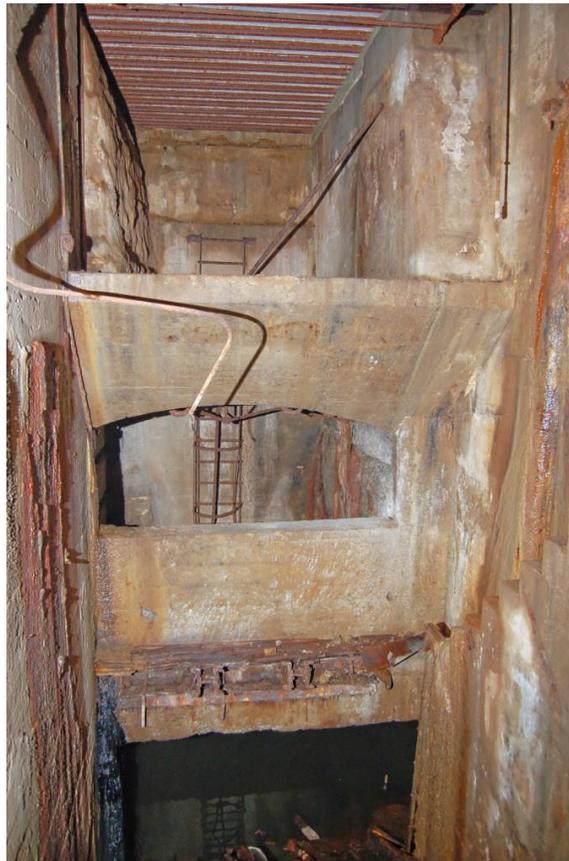
Figure 13. Upriver turbine service room.

The upriver turbine service room was only visually inspected due to the limited access into the space. The room was accessed through a hole cut in basement floor. The service room is approximately 10 feet wide and varies in height from approximately 3 to 30 feet (see Figure 13). The walls are predominantly constructed of cast-in-place concrete, with some areas of limestone exposed in the lower elevations of the service room near the drop shaft. The service room contains a number of smaller, yet notable features including:

The turbine service room base has approximately 18 inches of standing water and a significant amount of construction demolition debris.

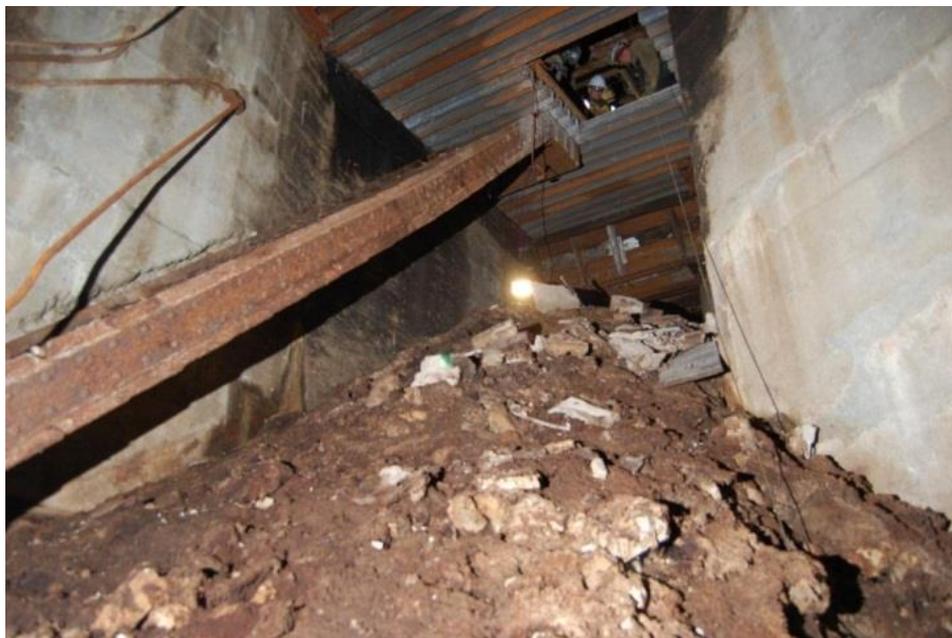
Figure 15. Downriver turbine service room.

The downriver turbine service room was only visually inspected due to the limited access into the pit. The room was accessed through a hole cut in the Pillsbury A Mill basement floor (see Figure 15). The walls are predominantly constructed of cast-in-place concrete, with some areas of exposed limestone in the lower elevations of the wall, near the lower stair landing. The roof of the service room is constructed of a galvanized metal deck and concrete. The stairs are constructed of built-up structural steel members. A structural steel pipe column is located in the southeast corner and provides support to a basement level column. Based on observations made in the downriver tailrace, it is believed that this room originally extended through the Platteville limestone formation and provided an access route to the turbine located at the tailrace level. Currently, this space has been substantially filled with building construction debris, which extends to the tailrace level.

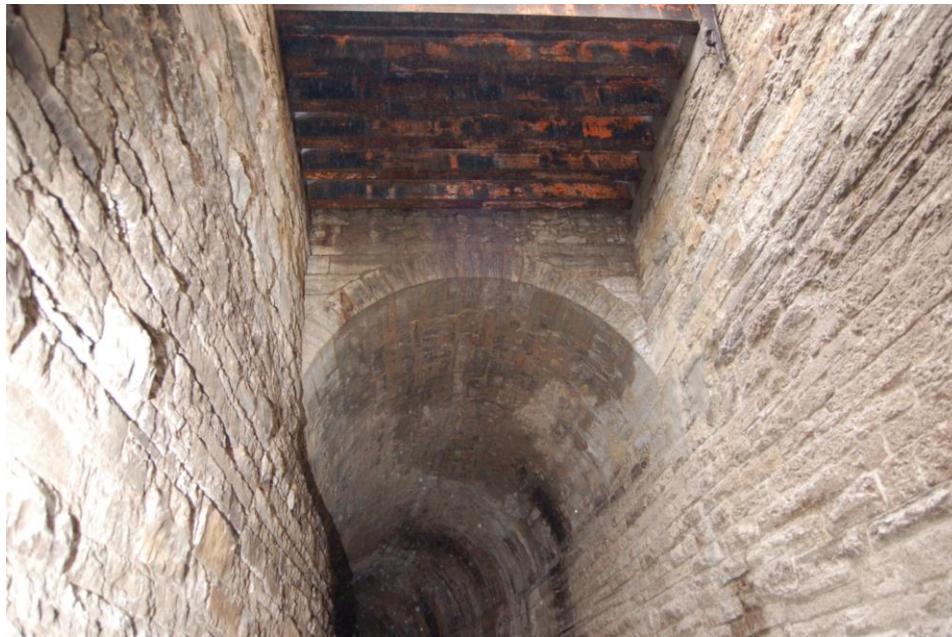
At approximately Station 1+10, the structure of the tunnel changes from a flat-ceiling with visible I-beam supports to a stone arched tunnel with a springline (see Figure 27). As noted in Section 3 of this report, the steel I-beams were added in 1949 and comprised part of a tunnel roof reinforcement to accommodate a newly approved Great Northern Railway rail spur crossing over the tunnel. In all likelihood, the addition of the I-beams did not dramatically alter the sense of space and feel in that section of the tunnel, but it is the transition from the flat-ceiling area to the stone-arched area that is most significant in this instance. The transition is significant because the downriver, flat-ceilinged end of the tunnel feels fairly massive and open, whereas the main body of the tunnel (upriver from the arch) feels more restrained and confined. This shift in *feeling* is an integral part of the tunnel and thus an important aspect of the integrity of the system.

Figure 27. Start of arch, looking upriver in tunnel.

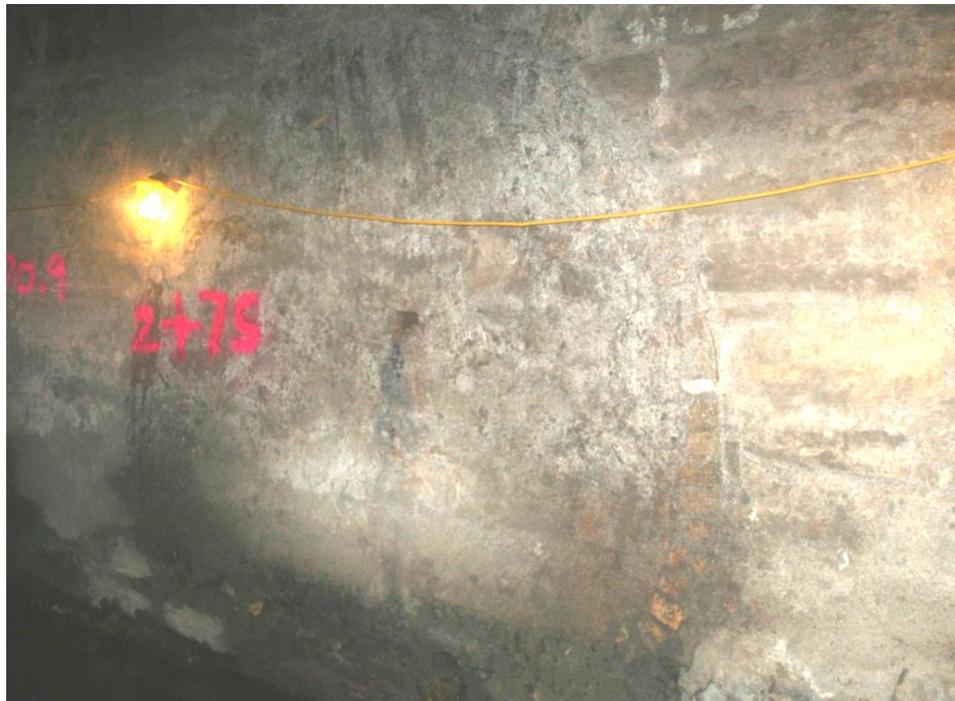
The Phoenix Mill Headrace crosses the Pillsbury A Mill tunnel at a 90-degree angle between Station 2+70.4 and Station 2+84. A large hole covered by a steel plate punctuates the inland side of the tunnel, whereas the river side of the tailrace has been bricked-in (see Figures 28, 29, and 30). This feature is important because it evidences the evolution of the tunnel system and east bank milling district. The plate covering the inland side of the Phoenix Mill Headrace has been replaced since 2010 (see Figures 31 and 32). Unfortunately, the methods used to reattach the plate to the wall do not appear to have incorporated historic techniques, using bright galvanized bolts that are not in keeping with the historic nature of the tunnel.

Figure 29. Phoenix Mill Headrace in Pillsbury A Mill tunnel's riverside wall showing filled-in area.

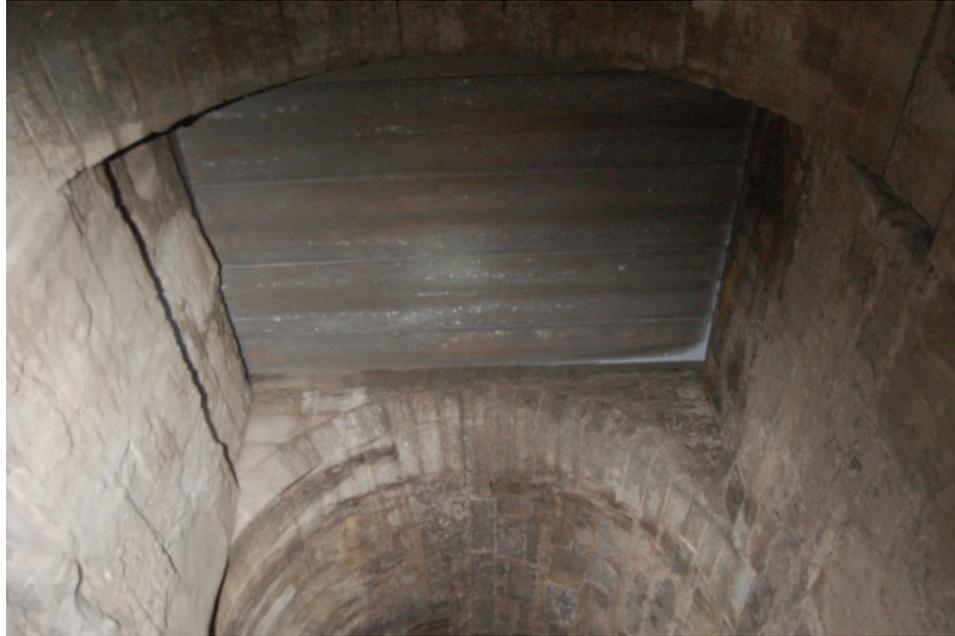
Figure 30. Ceiling structure where the Phoenix Mill tailrace intersects with the Pillsbury A Mill tunnel.

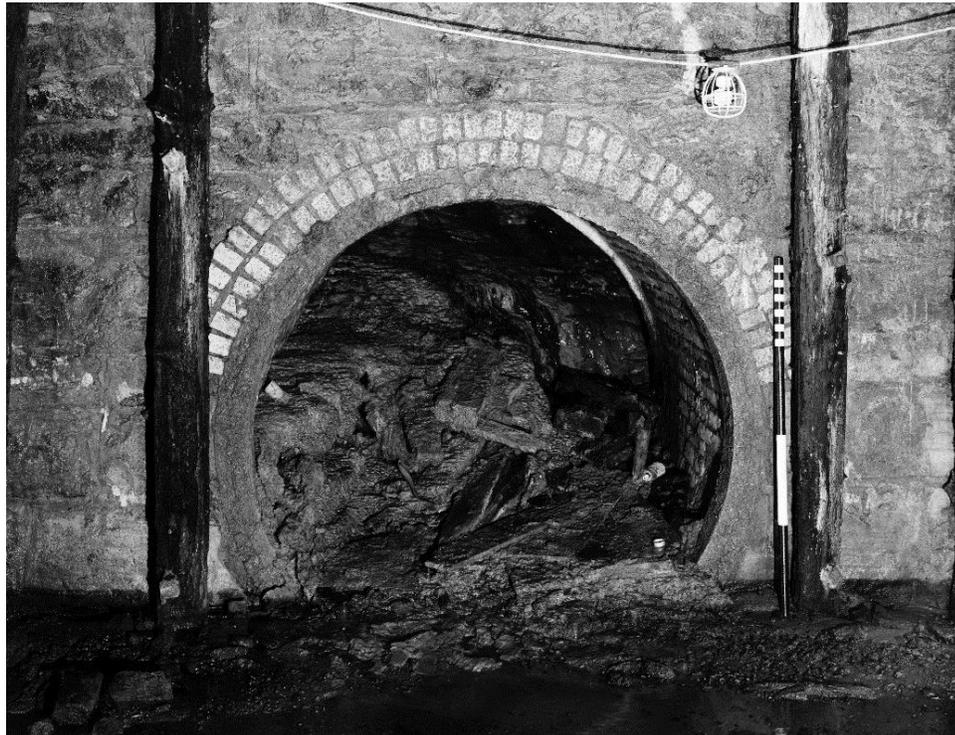
Figure 31. Photo of Phoenix tailrace in Pillsbury A Mill tunnel's inland wall in 2010.

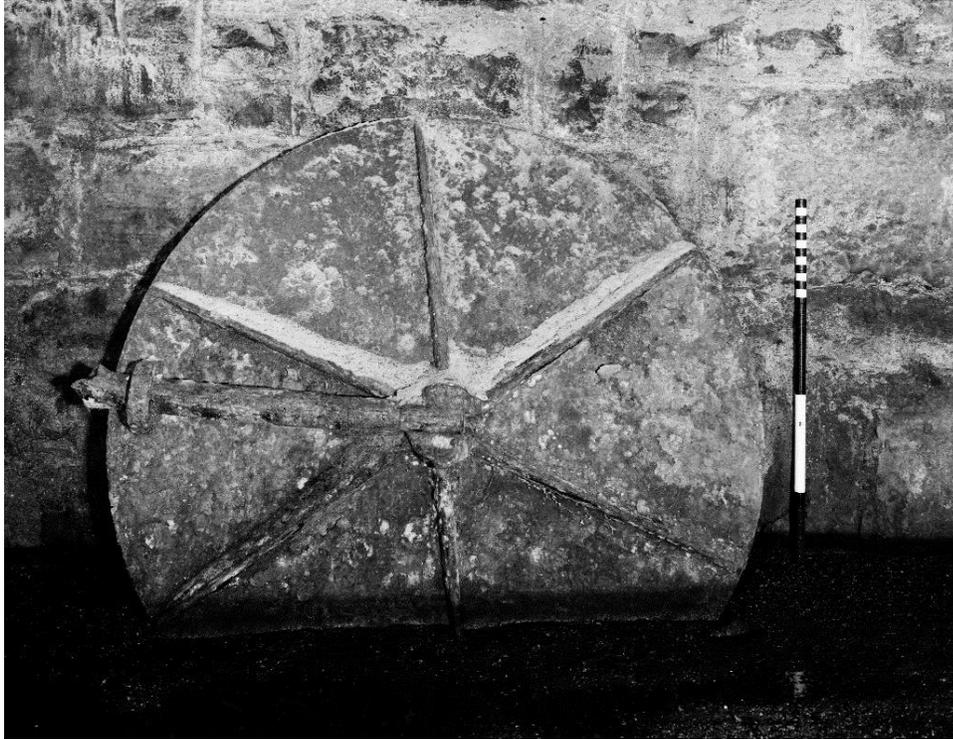
Figure 32. Plate used to cover Phoenix Mill tailrace against wall of Pillsbury tunnel in 2010.

Another example of physical alteration to the tunnel includes the covering of the Phoenix Mill headrace on the inland side of the tunnel. In 2010 the cover was detached and resting on the tunnel floor, but it has since been attached to the tunnel wall over the inland headrace opening. Although re-attaching the artifact to the canal wall might have been both necessary and appropriate, the method used is not in keeping with the feel, design or materials used in the tunnel construction and maintenance. Because modern materials were used to attach the plate to the wall, the repair does not convey the historic sense of the feature and results in an unsympathetic alteration to the tunnel.

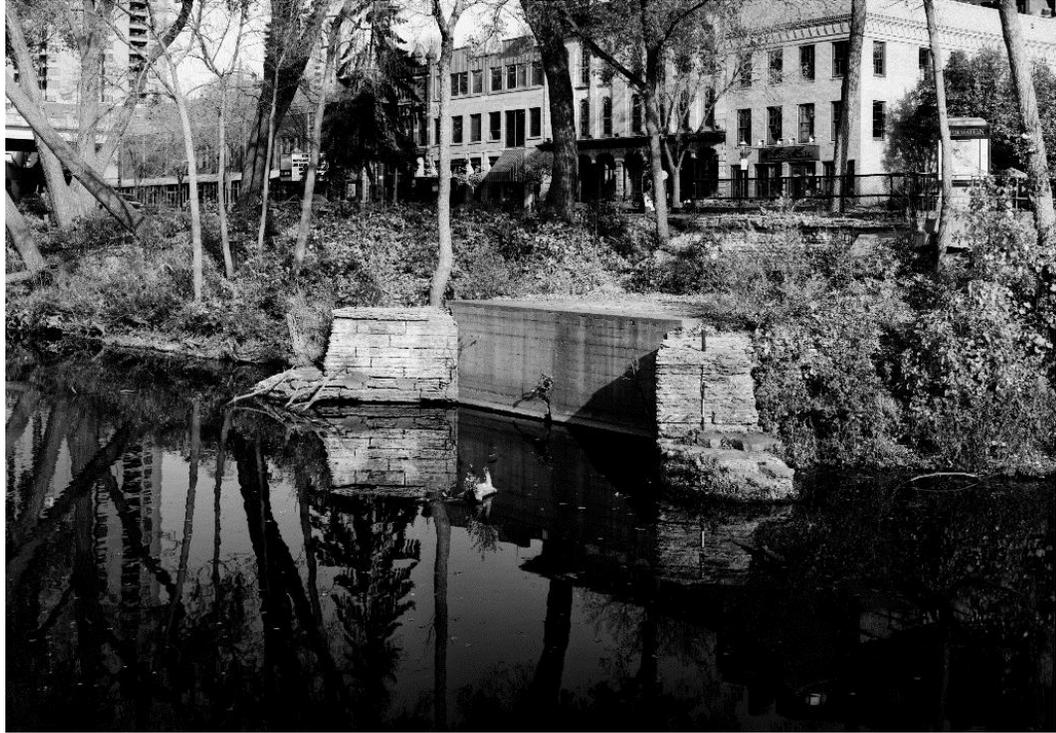
Figure 33. Exterior view of tunnel entrance in 2010.

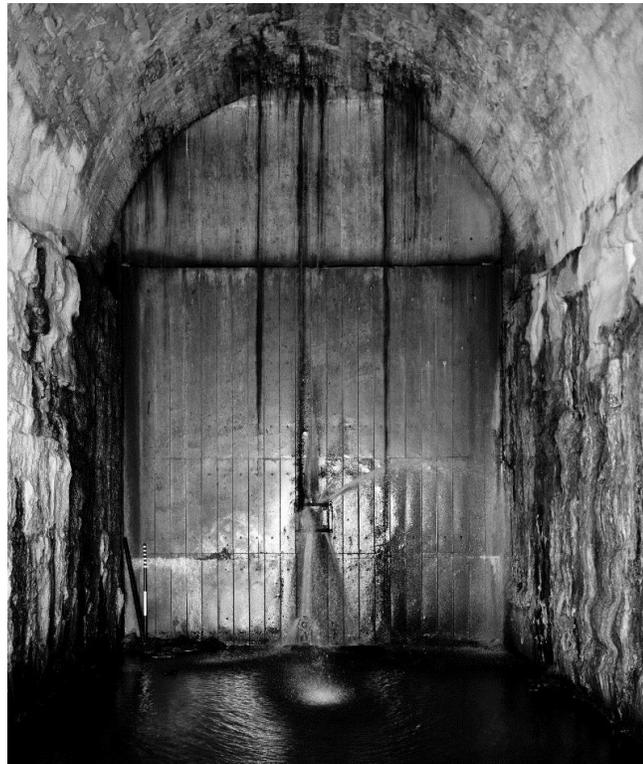
At approximately Station 5+60, the tunnel turns at a 90-degree angle from its generally north-westward trajectory to head southwest toward the river. The tunnel entrance and bulkhead are located at the upriver end of the tunnel, at Station 6+09. During its period of operation, the tunnel entrance from the Mississippi River would have been open, theoretically with only a trash rack partially covering the entrance but also with some means of shutting off water flow to allow tunnel maintenance and repair (see Figure 33). Currently, a large concrete bulkhead over the opening prevents water from freely entering the tunnel. A small opening in the center of the bulkhead present in 2010 allowed water into the tunnel (see Figure 34). The opening has since been sealed (see Figure 35).

Figure 34. Interior view of tunnel entrance and bulkhead in 2010.

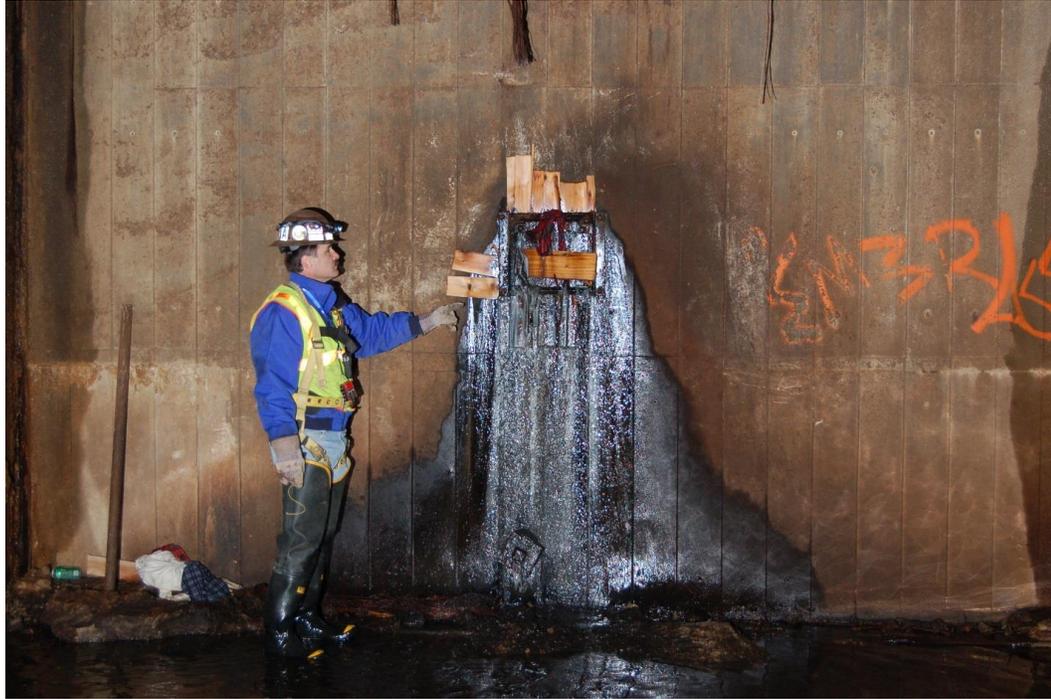
Figure 35. Sealed opening in center of bulkhead.

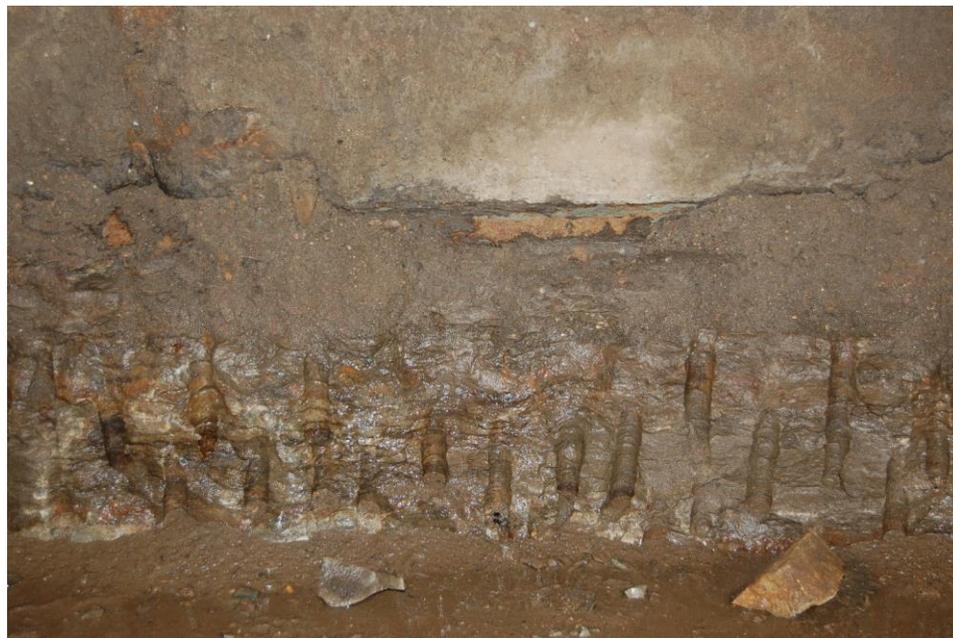
Figure 37. Drill holes at floor level.

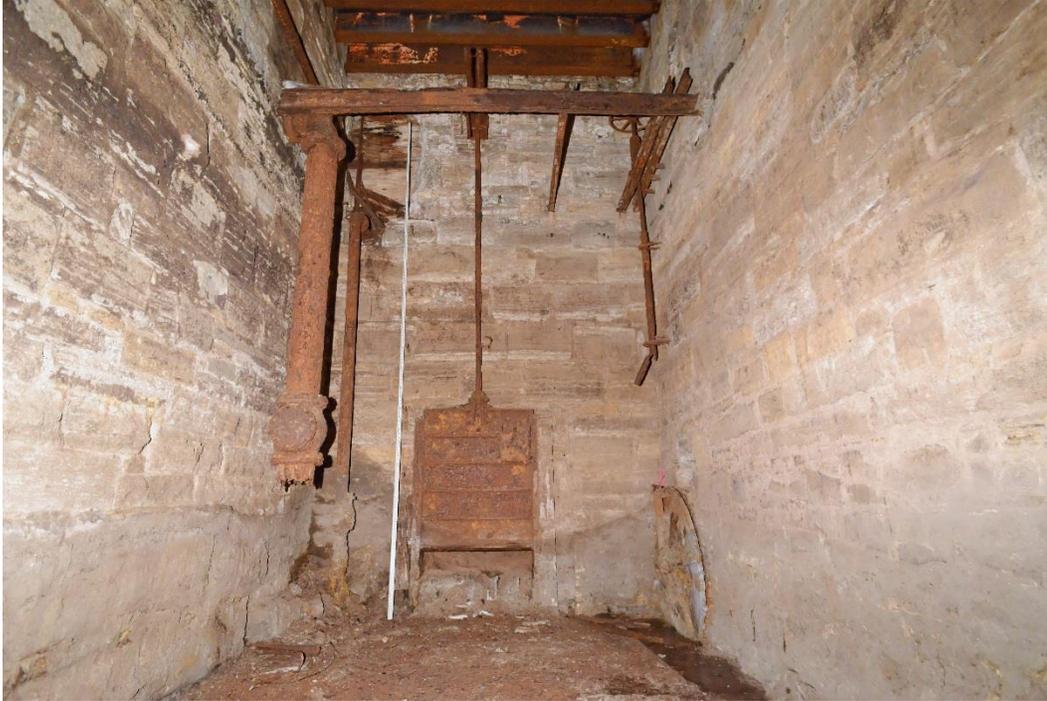
Photo 1. Downstream endwall showing headrace bypass (right), and machine shop headrace gate structure.

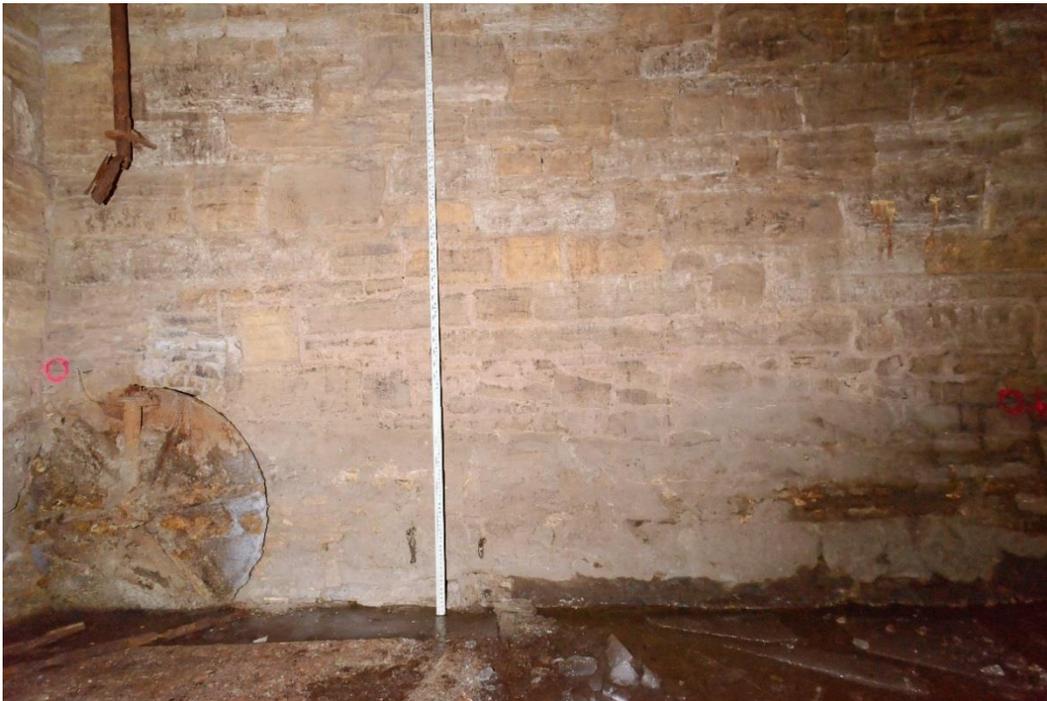
Photo 2. Headrace bypass along river side wall at Station 0+02.

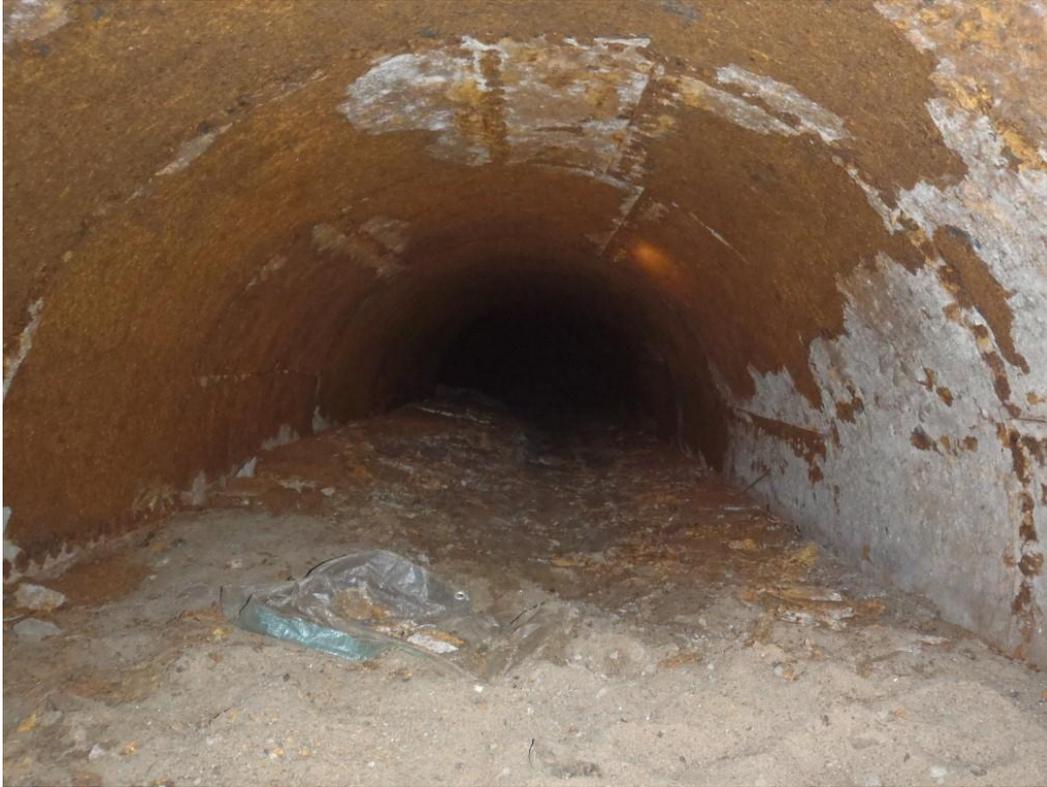
Photo 3. View inside abandoned machine shop headrace.

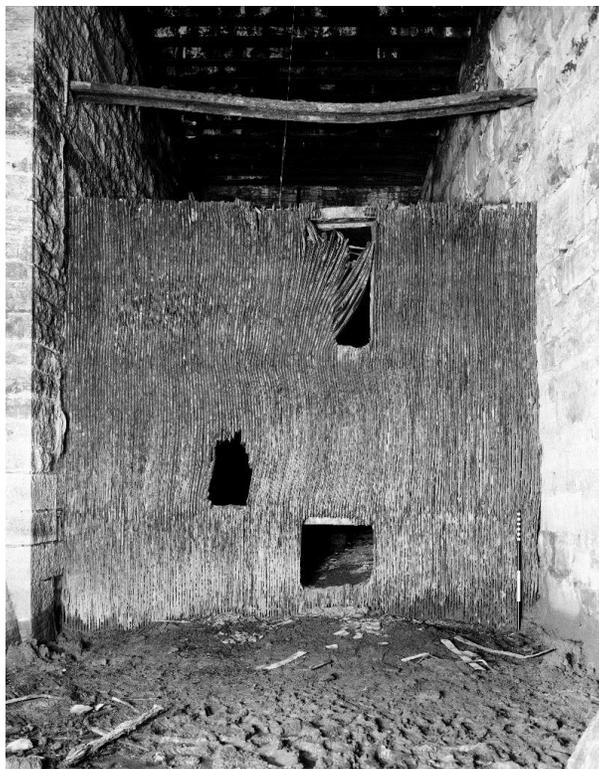
Photo 4. Trash screen at Station 0+38 in 2010 before it was removed, looking downstream.

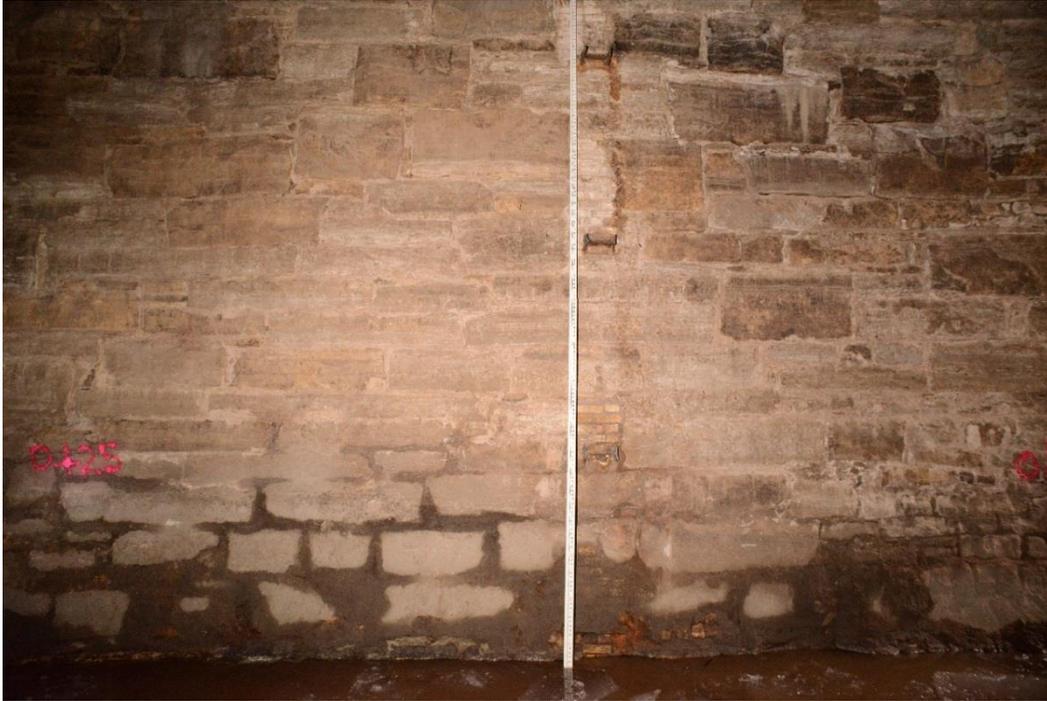
Photo 5. I-beam remnants of cross-tunnel trash screen.

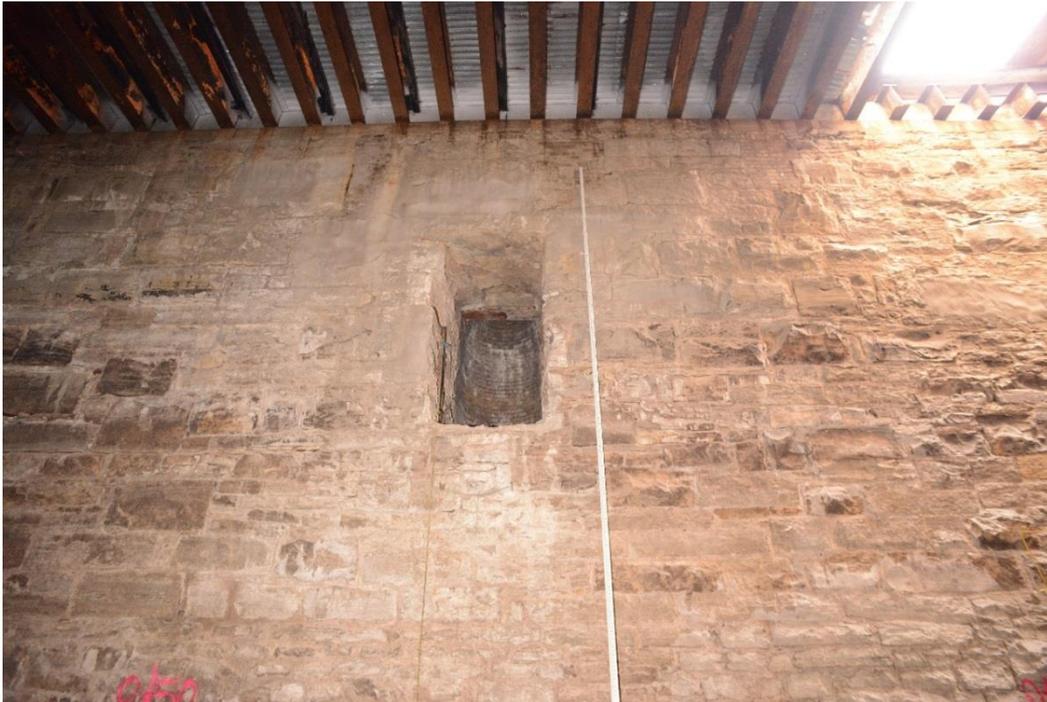
Photo 6. Catch basin lead through the river side wall at Station 0+57.

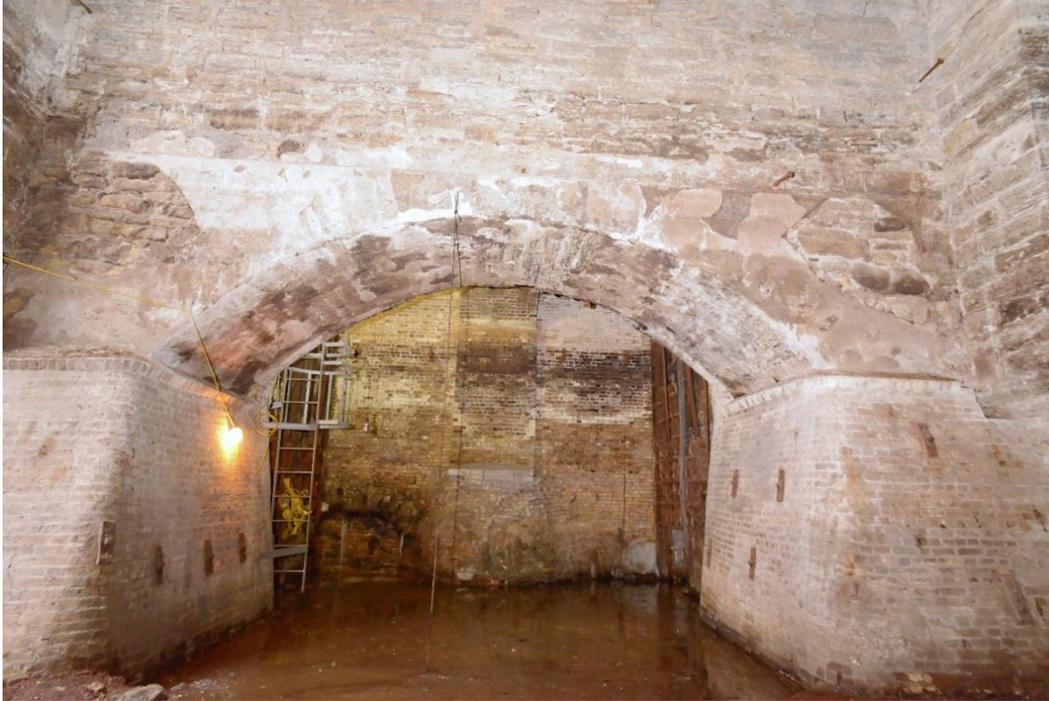
Photo 7. Inland side foundation wall arch into forebay.

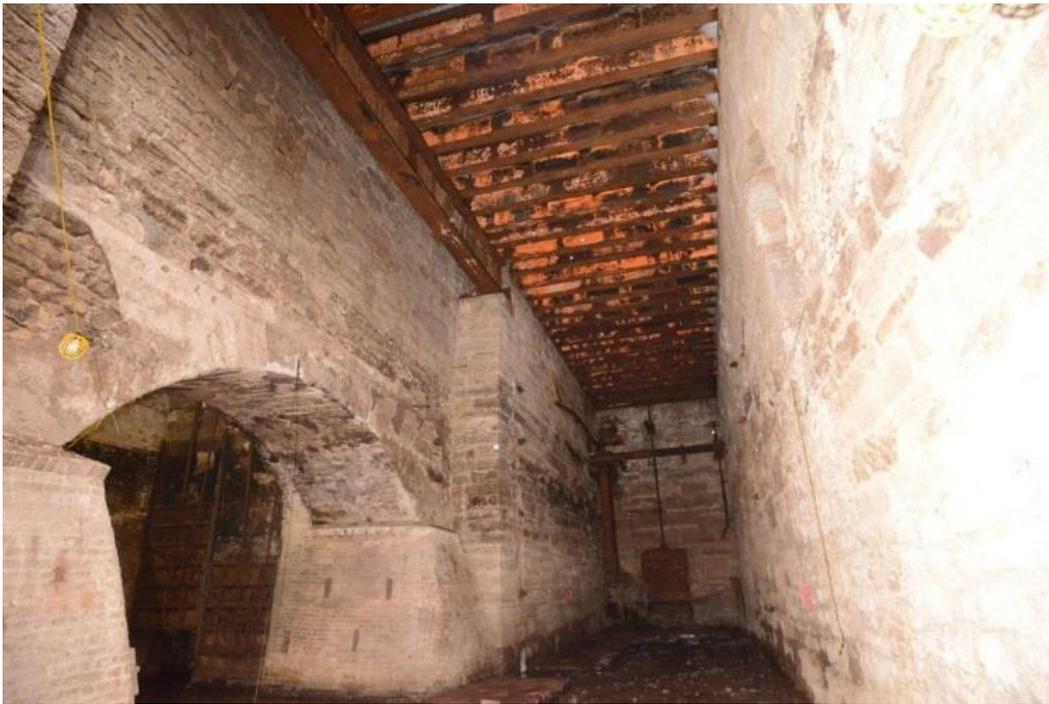
Photo 8. Overview of downstream tunnel section.

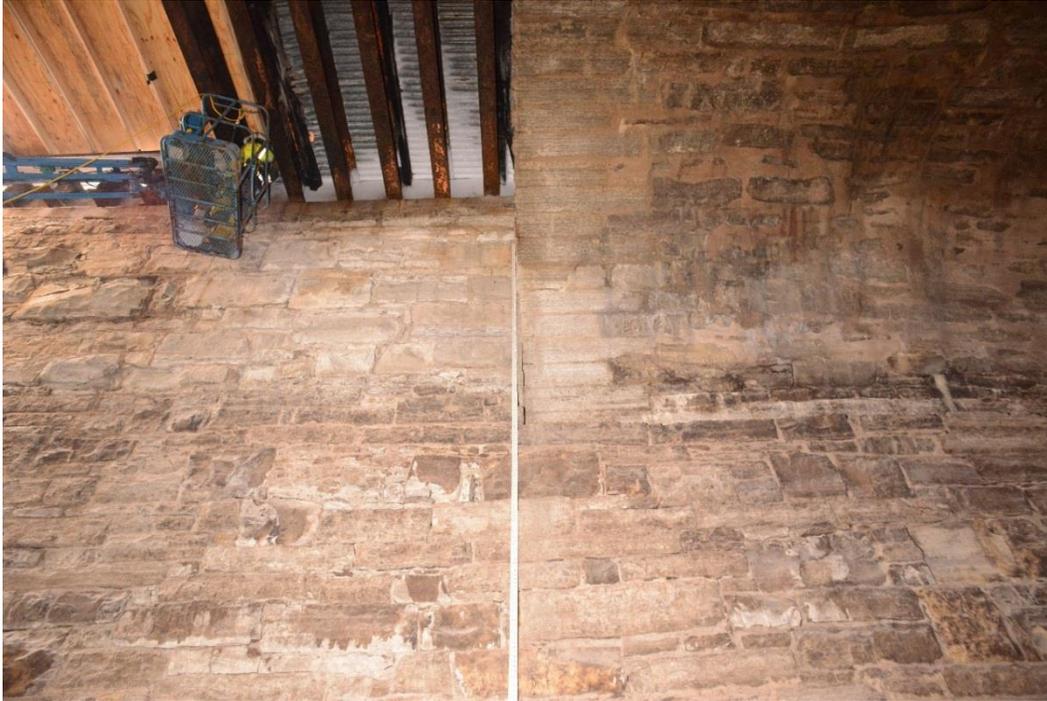
Photo 13. Transition at Station 1+12 from rectangular tunnel to arched tunnel.

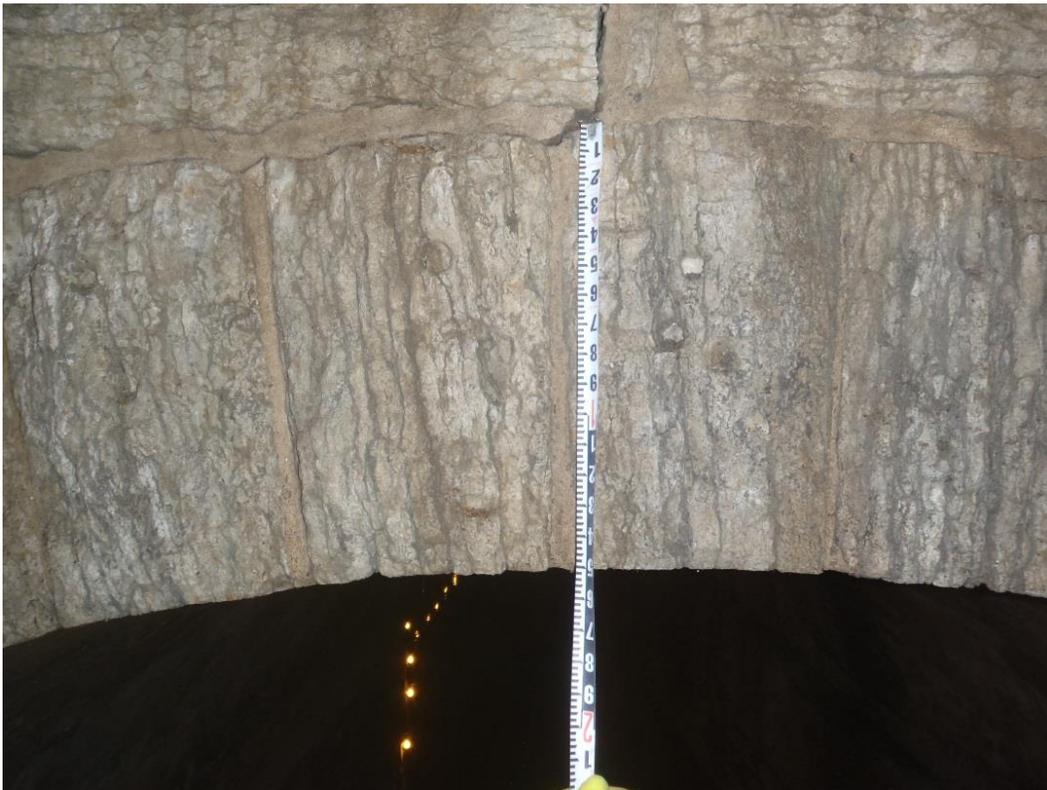
Photo 14. Close-up of the crown at the transition zone to rectangular tunnel.

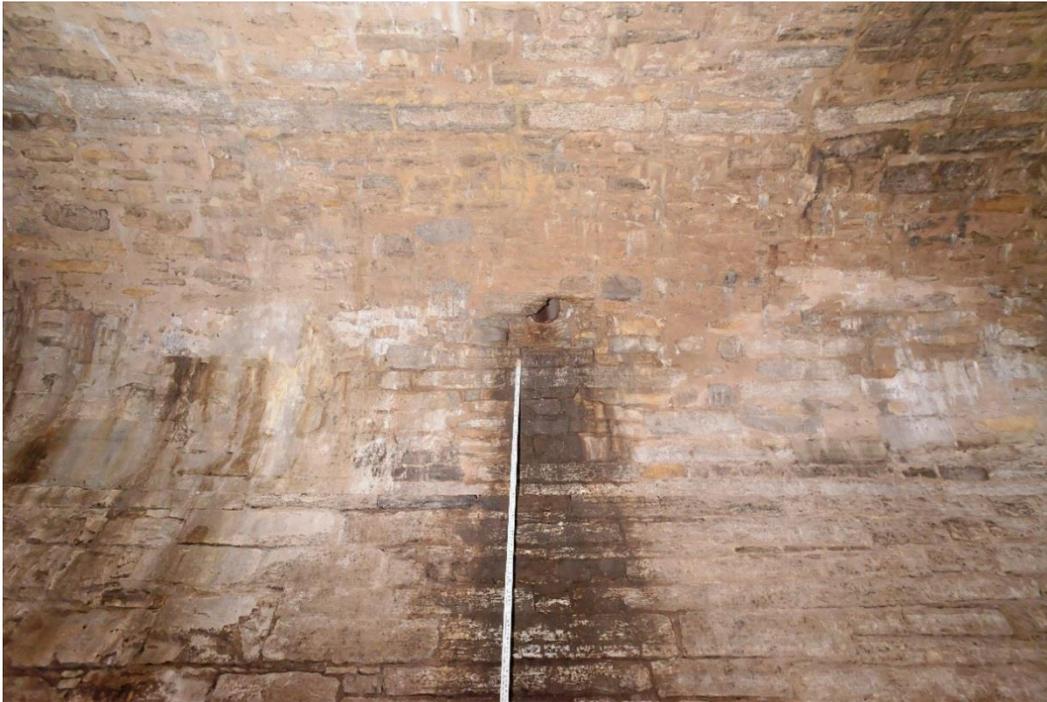
Photo 16. Catch basin connection at Station 1+35 on inland side wall.

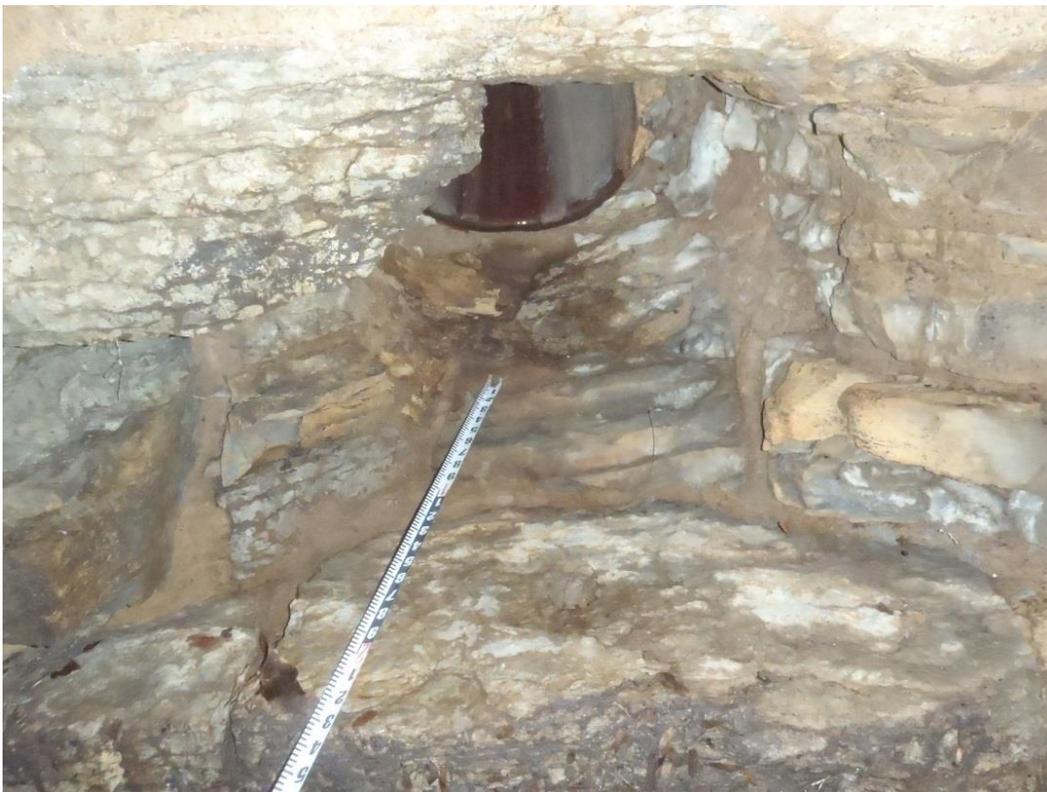
Photo 18. Close up of catch basin at Station 1+35.

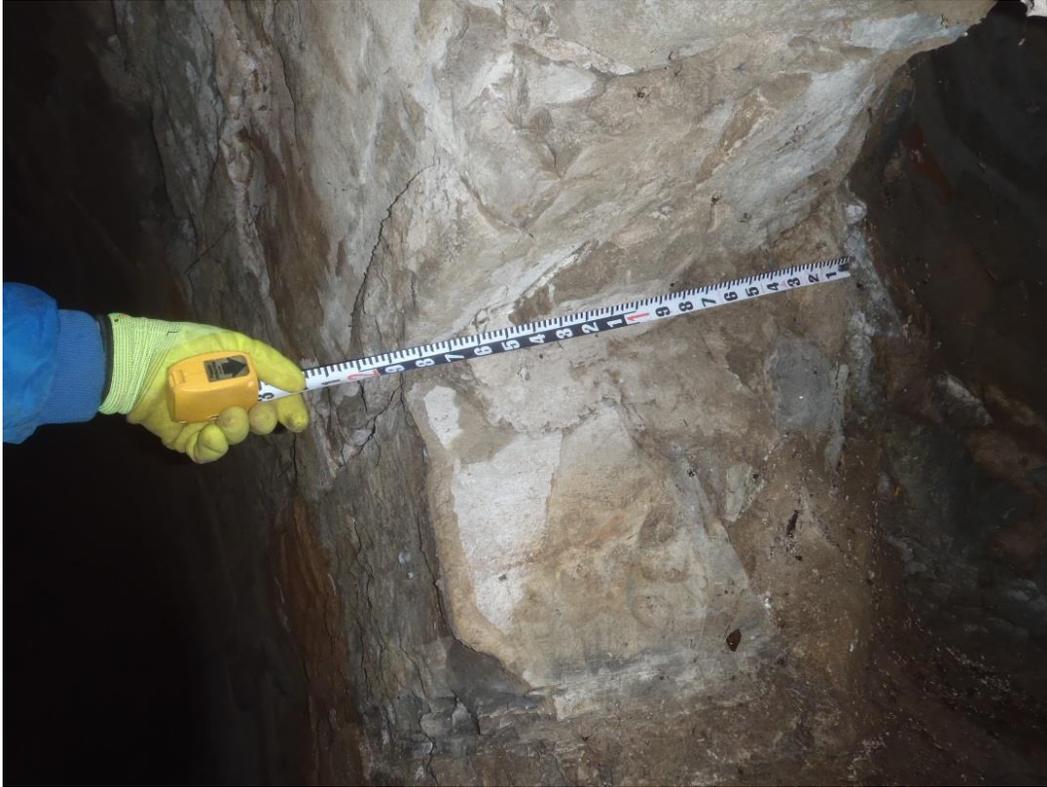
Photo 19. Close-up showing wall thickness at catch basin Station 1+86.

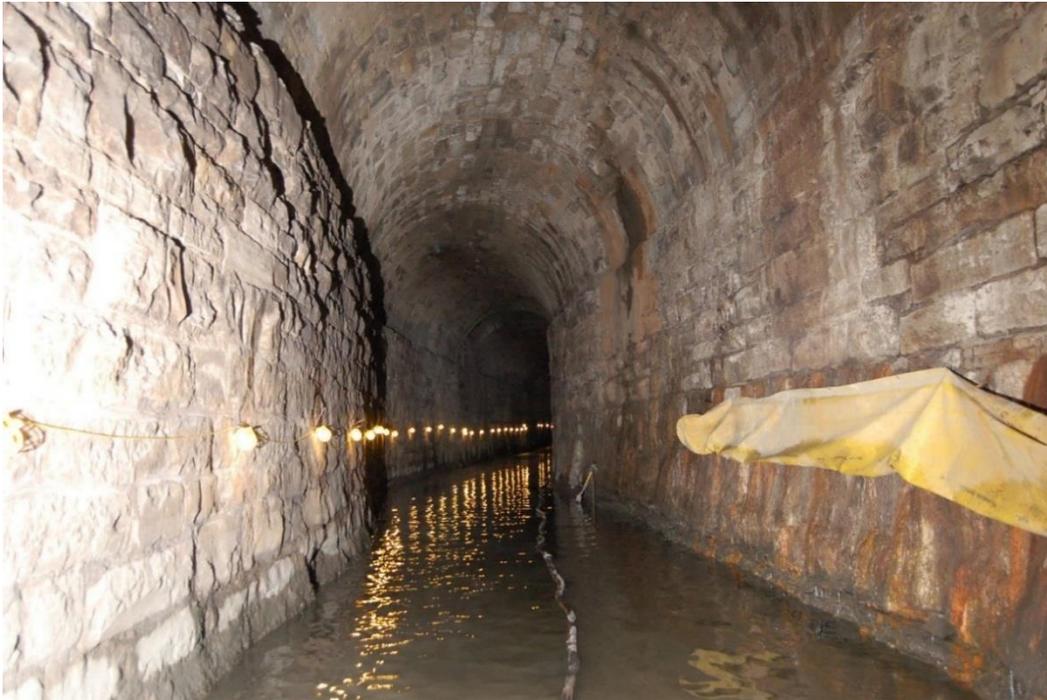
Photo 21. S-curve in arched tunnel. Picture taken from Station 1+75 looking upstream.

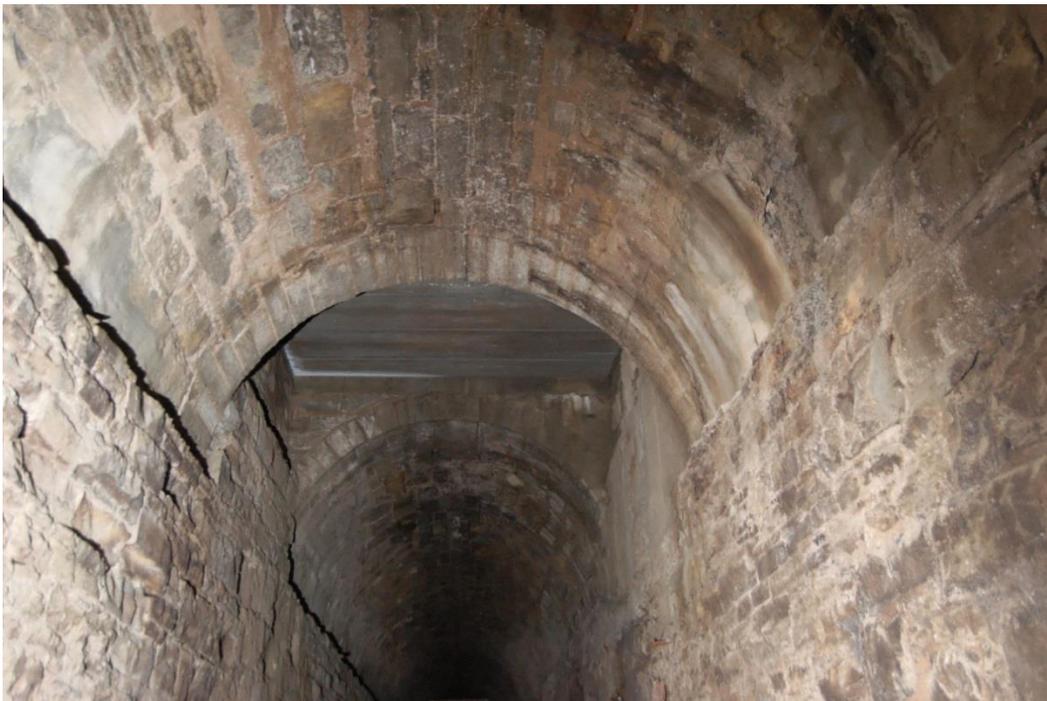
Photo 22. Precast roof section change over Phoenix headrace at Station 2+75.

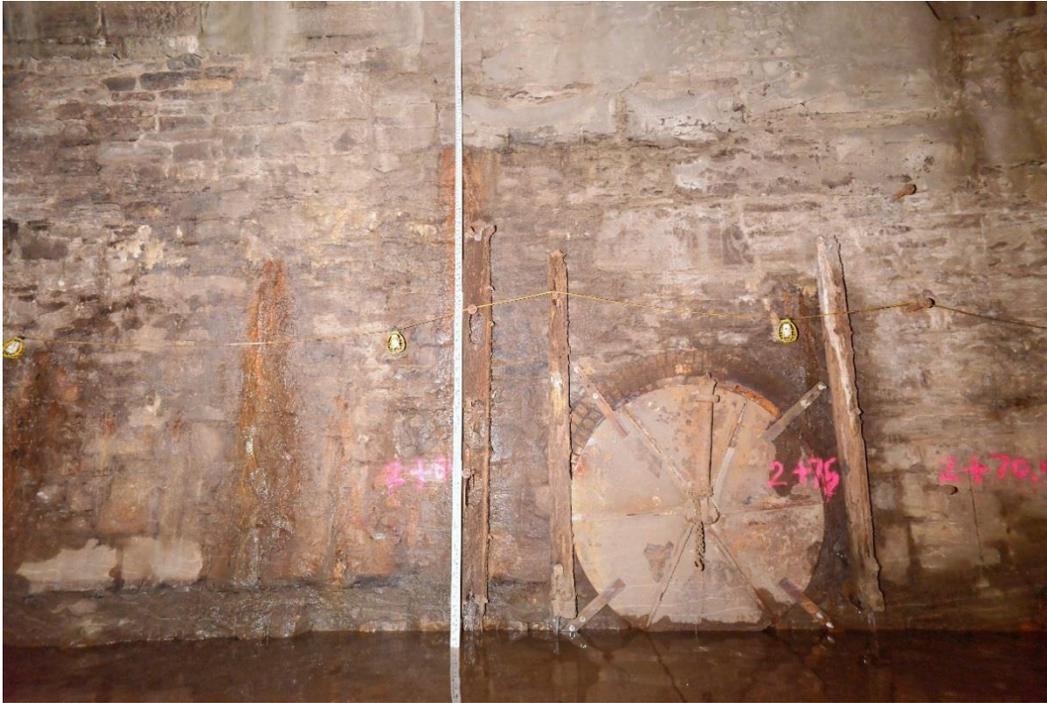
Photo 23. Inland side wall of Phoenix headrace intersection.

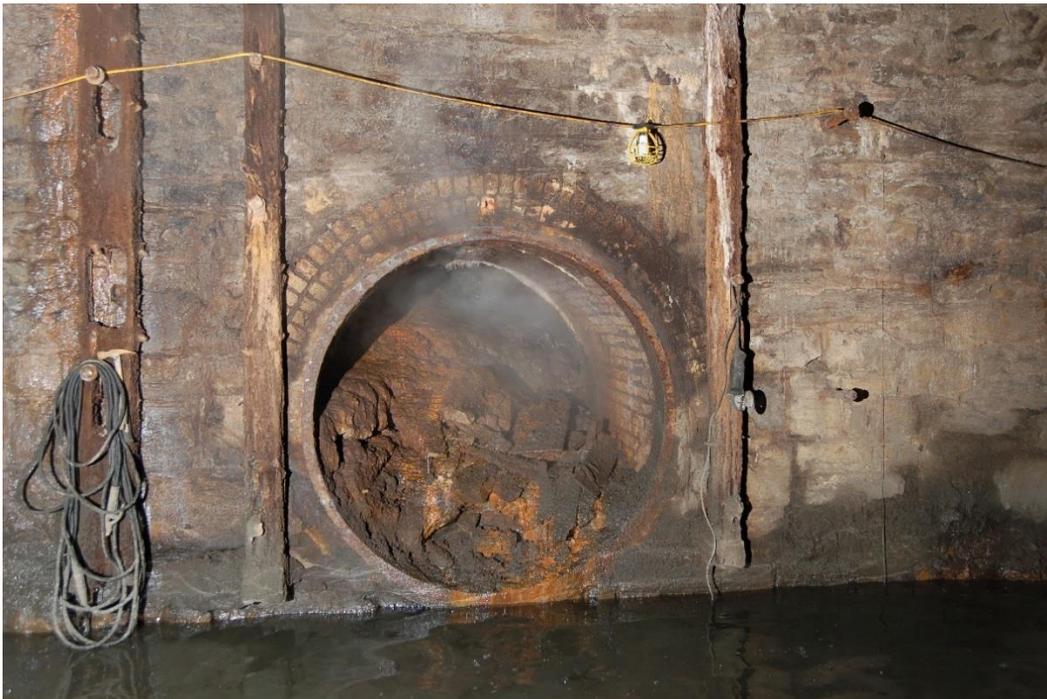
Photo 24. Inland side wall of Phoenix headrace intersection before steel gate cover placement.
