Pillsbury A Mill Tunnel Historic and Engineering Condition Study

Report prepared for
City of Minneapolis

May 2014

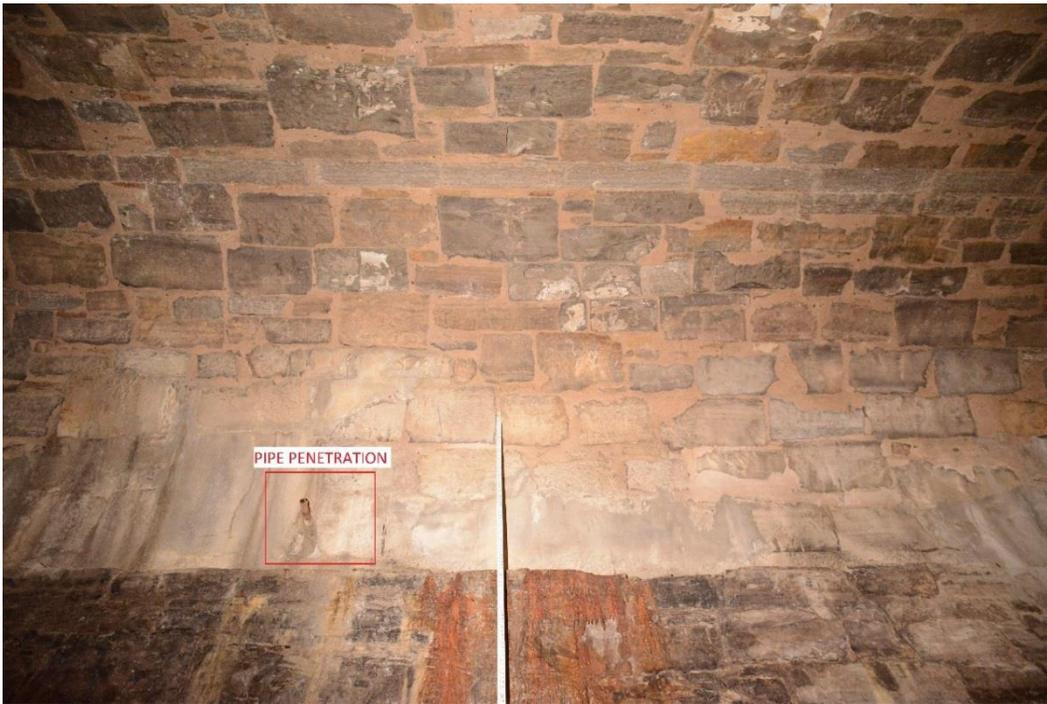
Photo 28. 2-inch pipe penetration at Station 3+45.

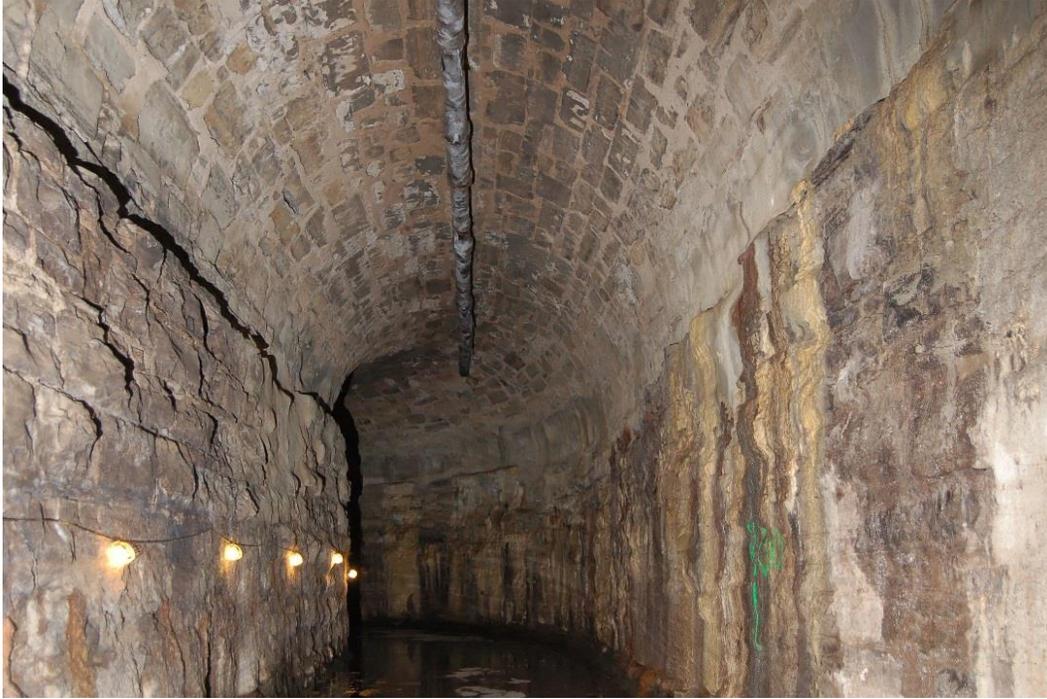
Photo 33. Looking upstream from STA 4+97 towards 90-degree bend.

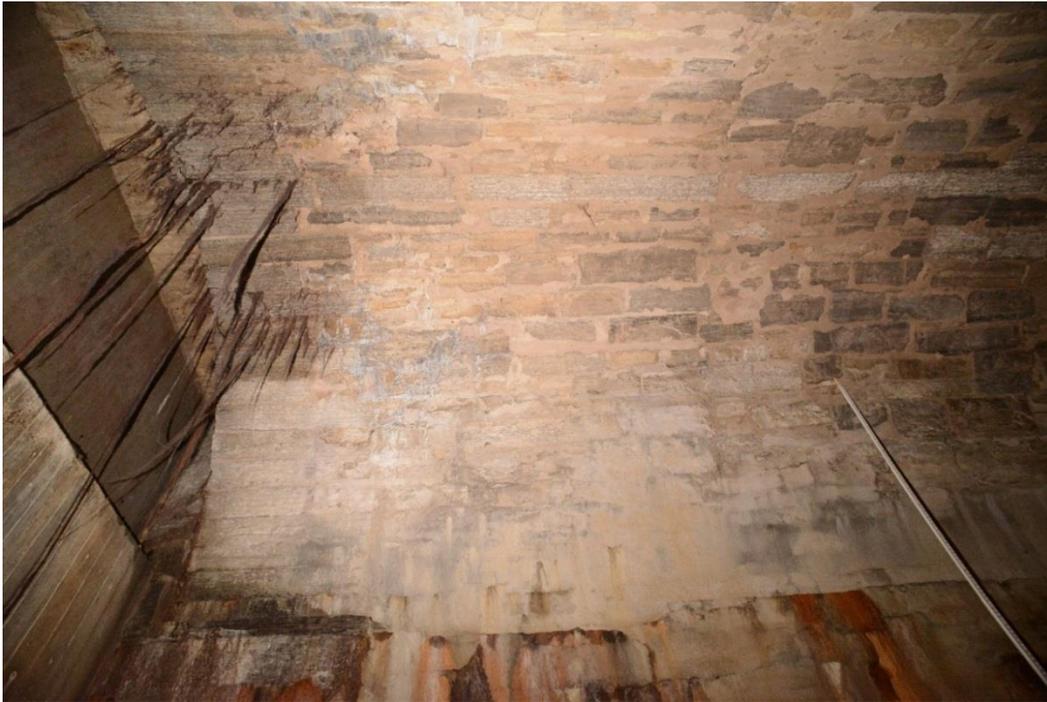
Photo 36. Roots penetrating through arch roof in front of bulkhead.

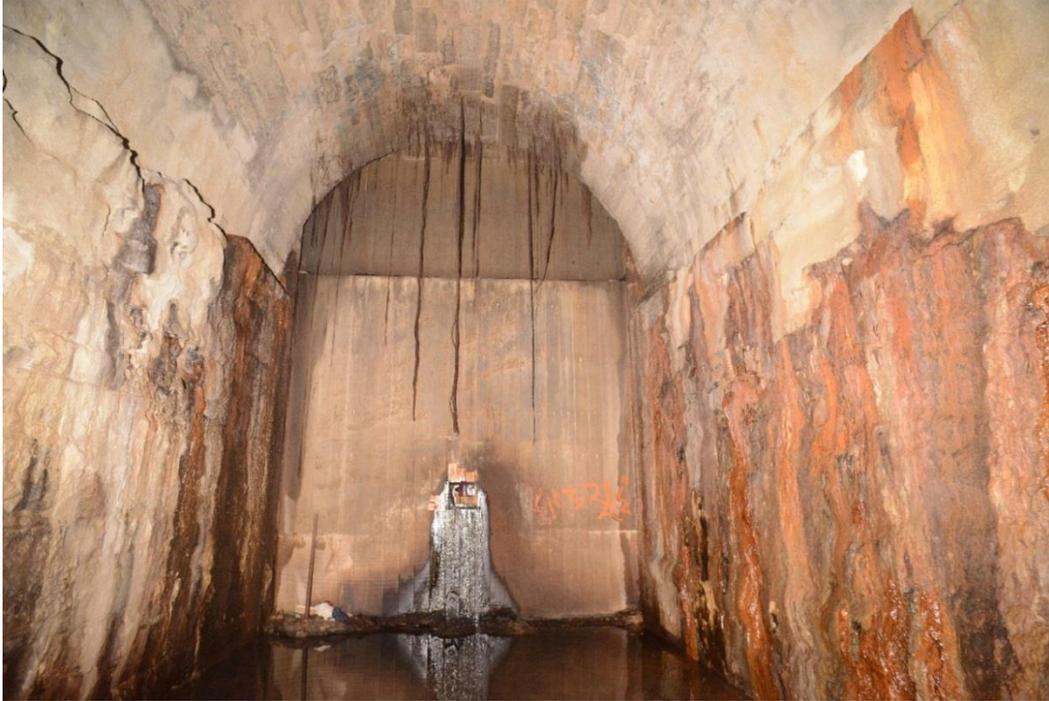
Photo 37. Headrace bulkhead.

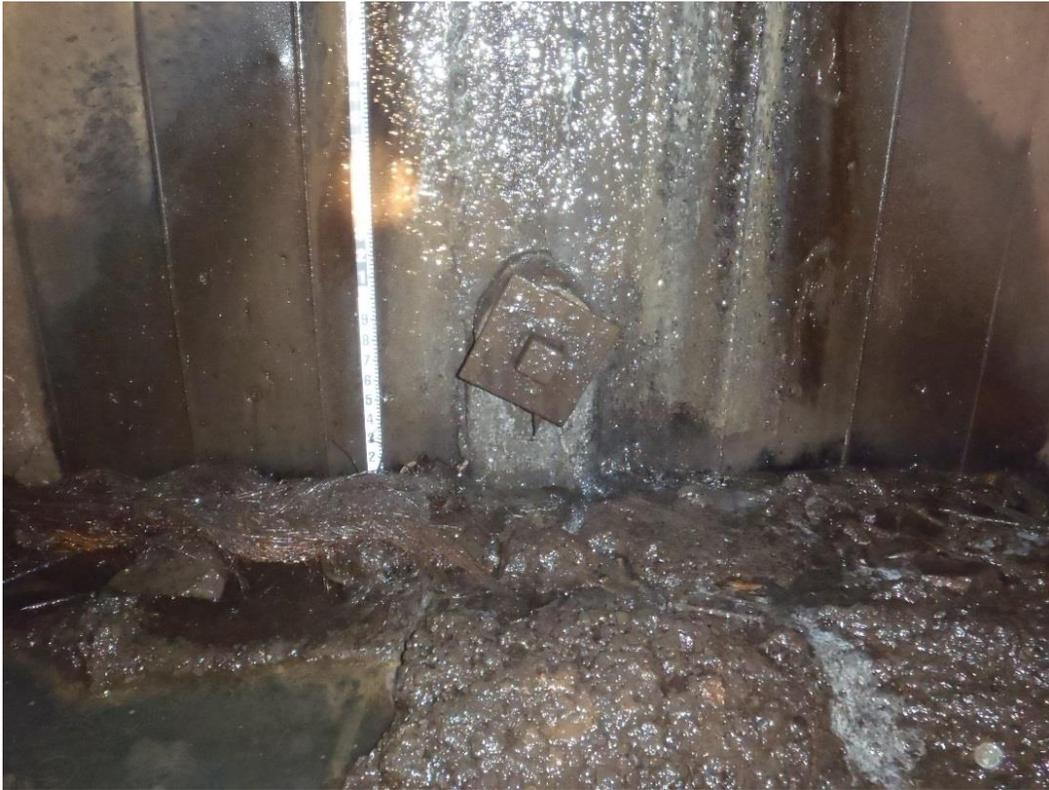
Photo 38. 8-inch pipe on headrace bulkhead.

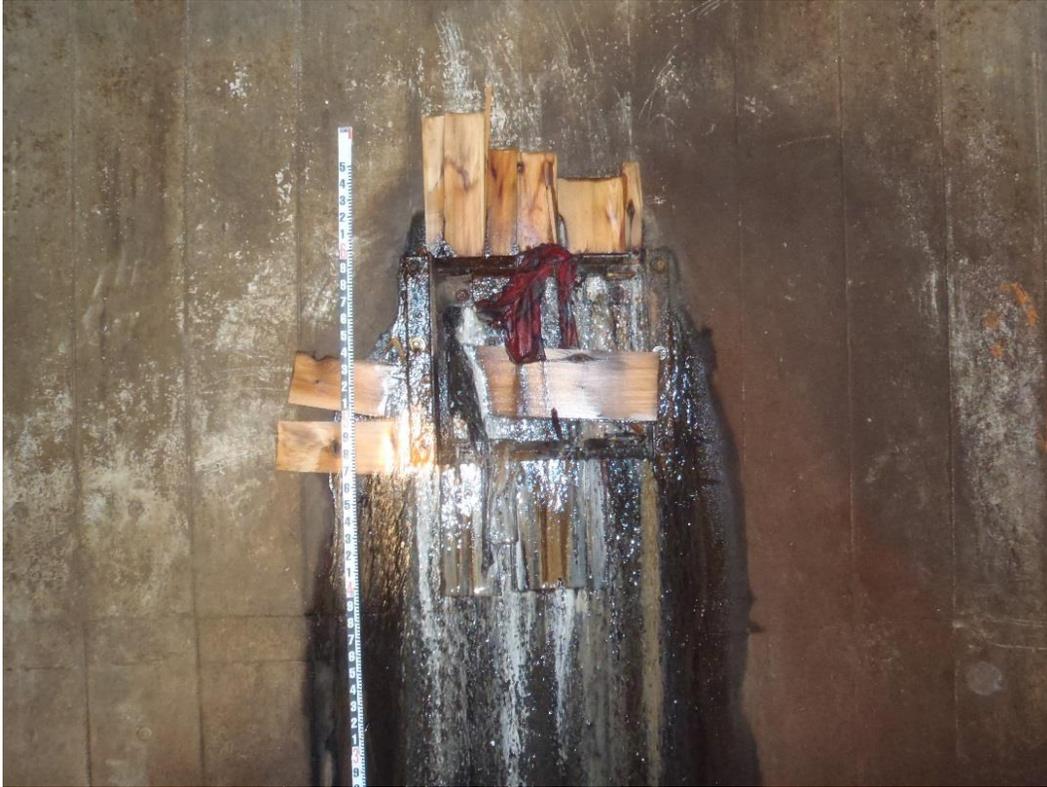
Photo 39. 1-foot by 1-foot steel sliding gate on headrace bulkhead.

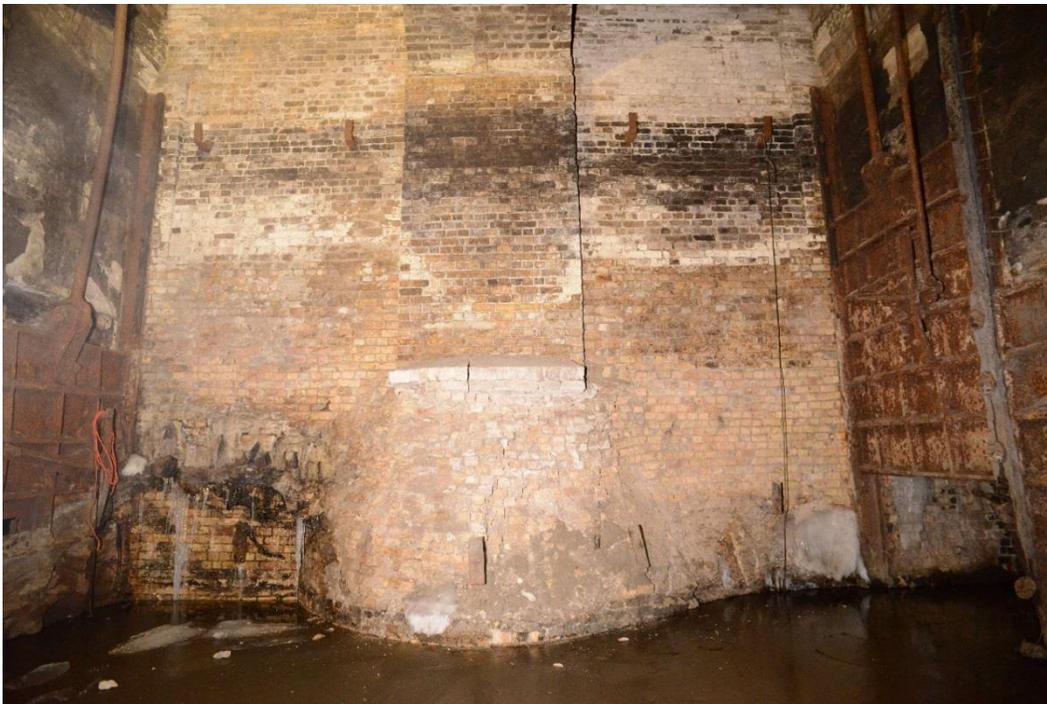
Photo 40. Forebay inland side wall.

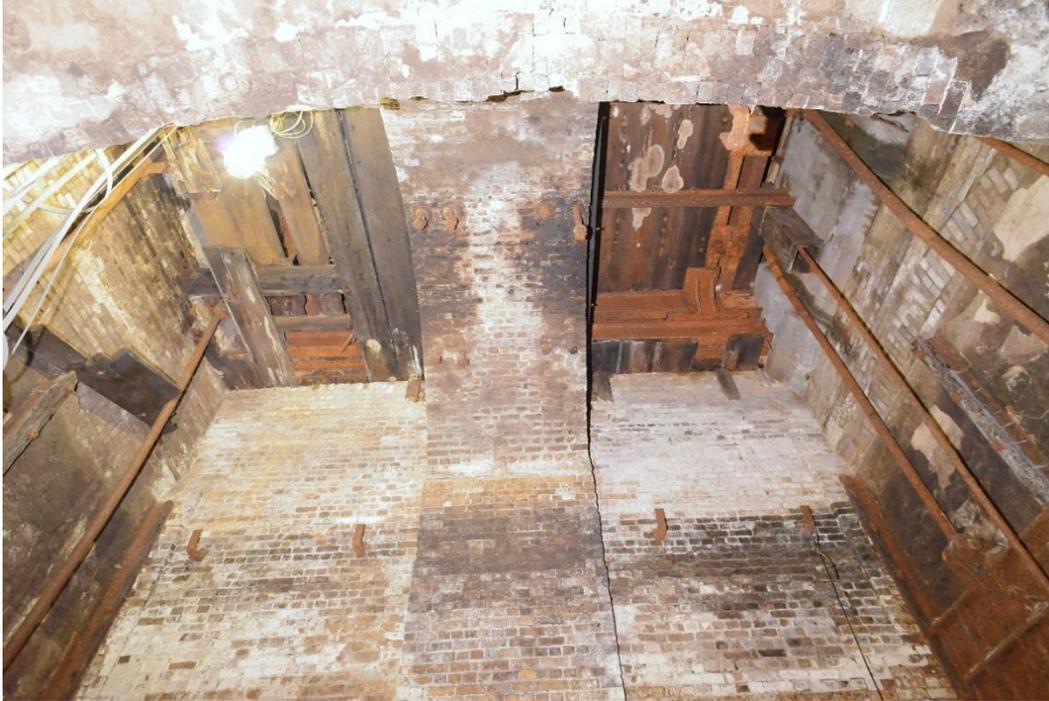
Photo 41. Forebay brick arch and timber roof.

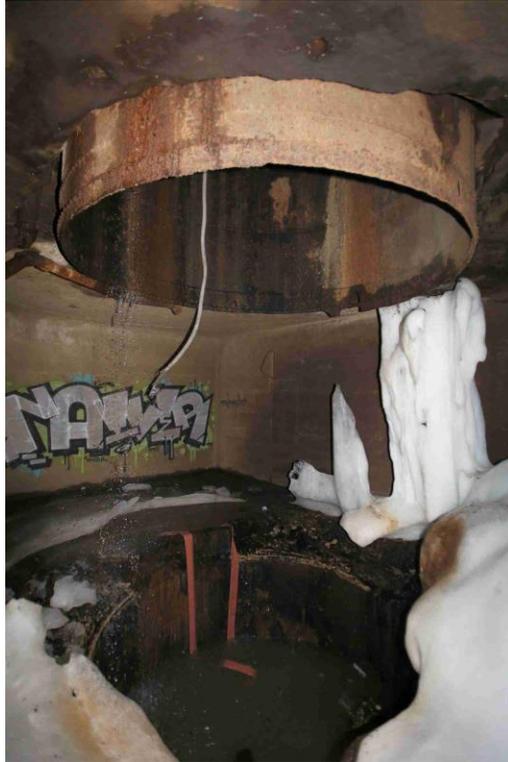
Photo 45. Downriver dropshaft in tailrace, view from tailrace service room. White formations visible in photo are ice.

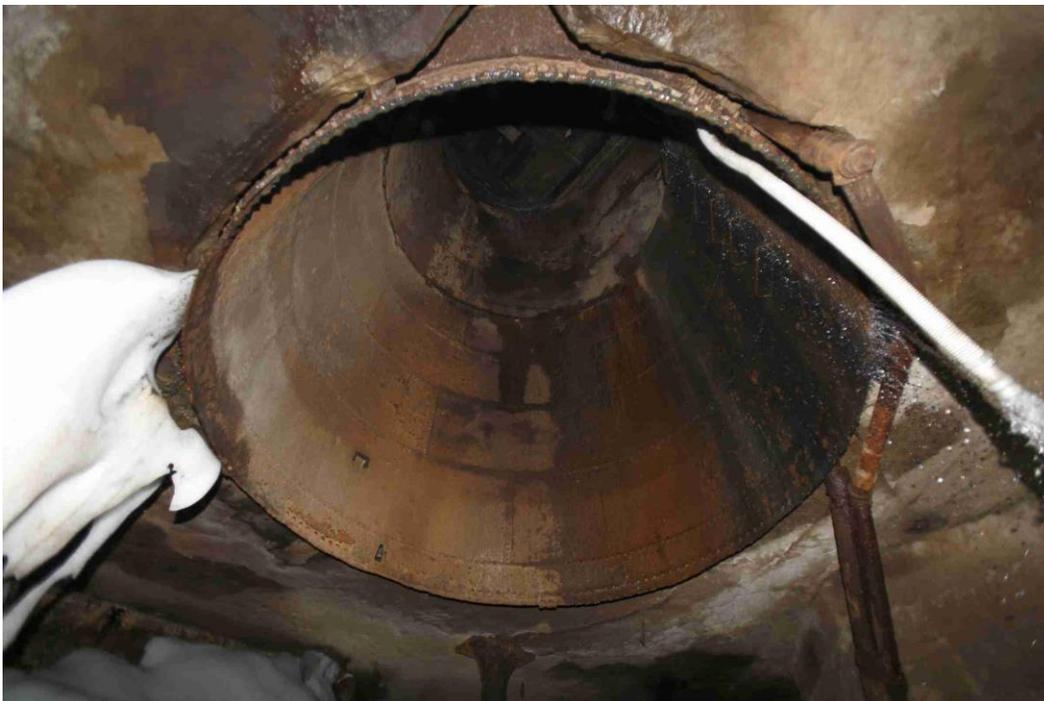
Photo 46. View from tailrace looking up downriver dropshaft. White formations visible in photo are ice.

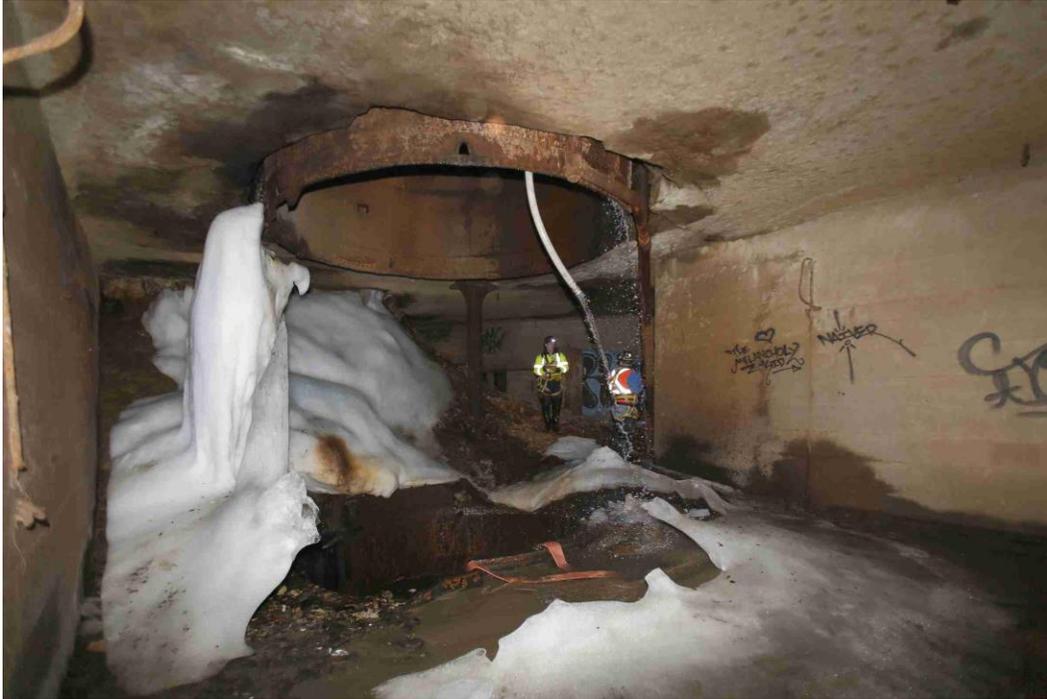
Photo 47. View from the NW corner of the downriver tailrace. White formations visible in photo are ice.

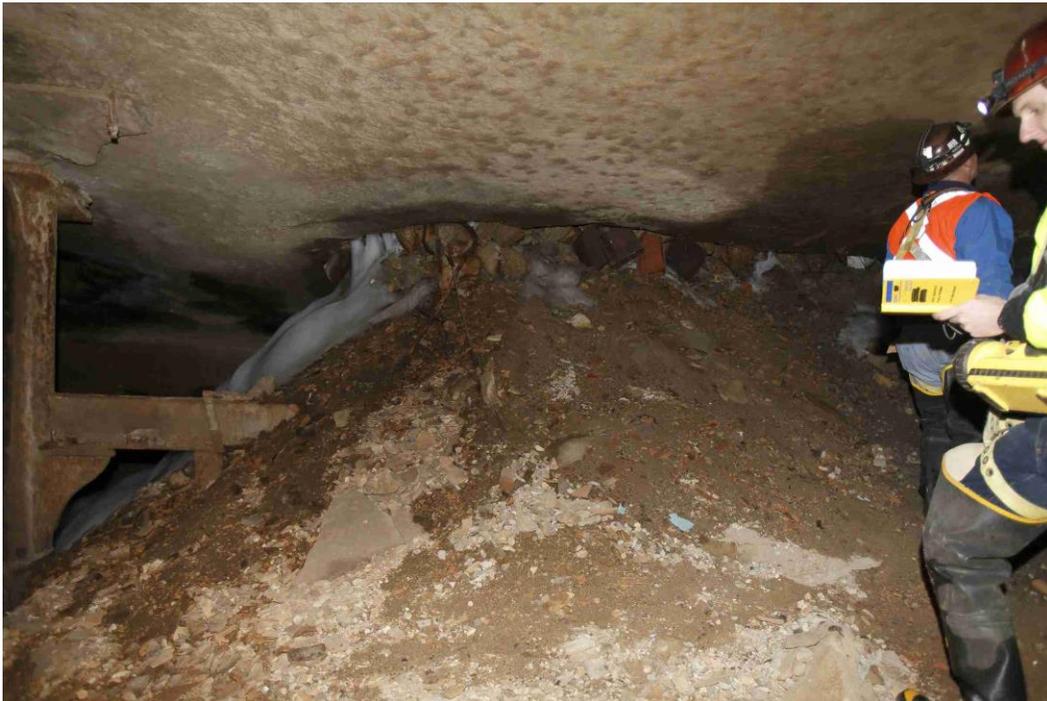
Photo 48. Debris pile coming from hole in downriver turbine service room. White formations visible in photo are ice.

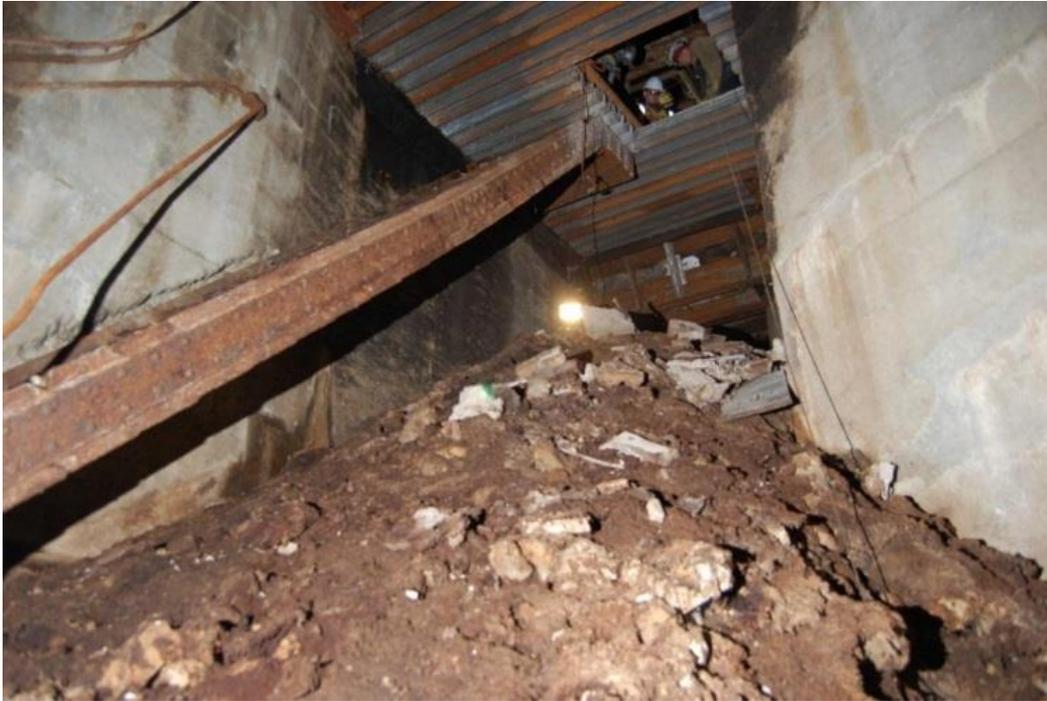
Photo 49. Downstream turbine service room.

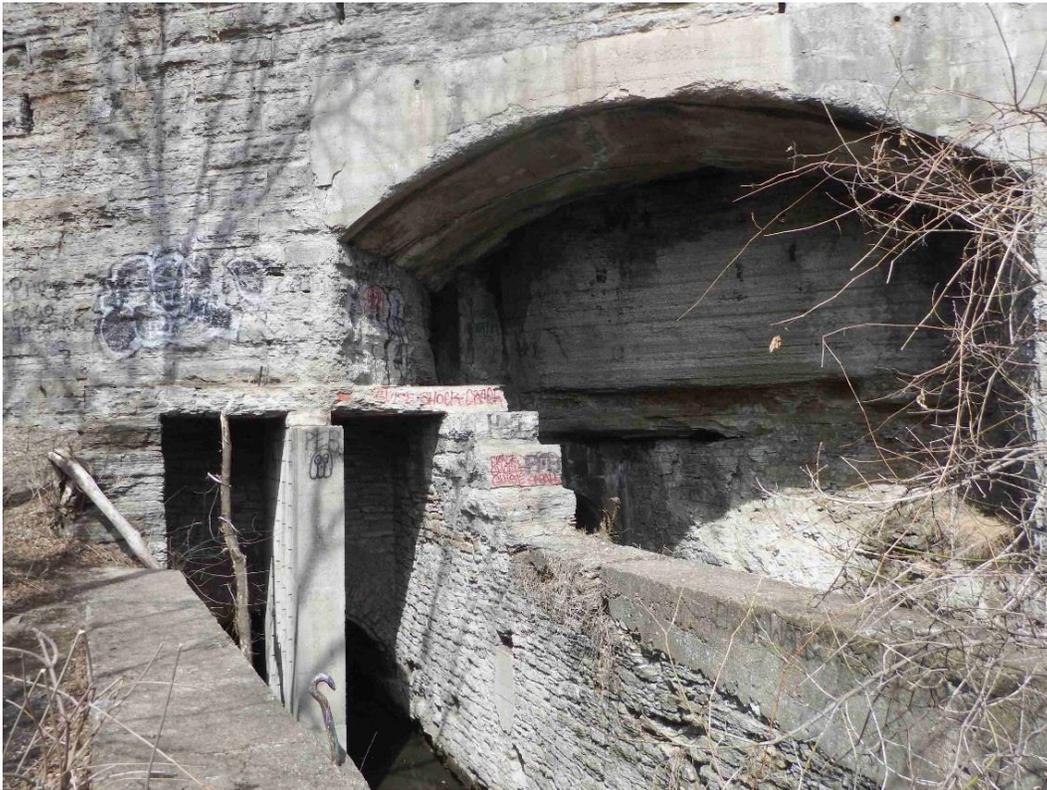
Photo 50. Downriver tailrace portal.

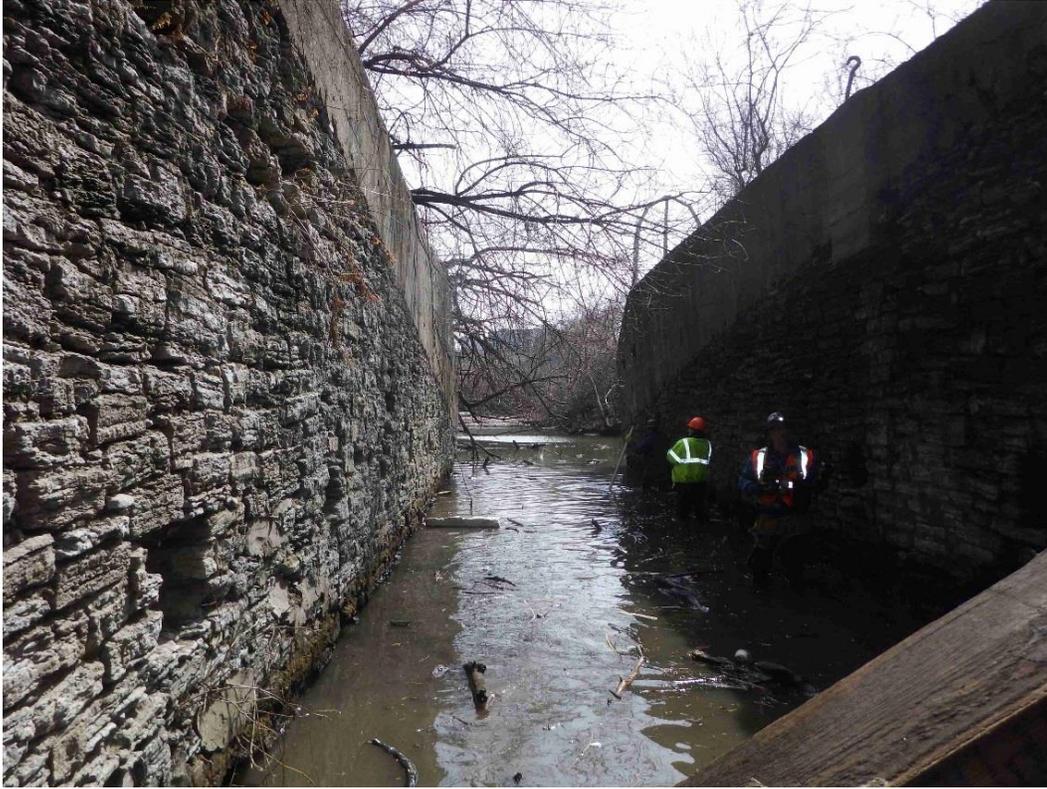
Photo 51. Downriver portal – looking towards Mississippi River from southwest channel.

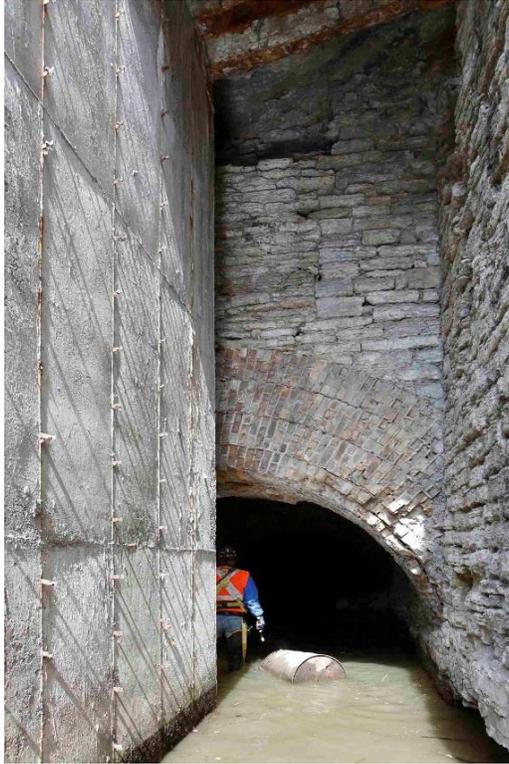
Photo 53. Arch at the entrance of the downriver tailrace southwest channel.

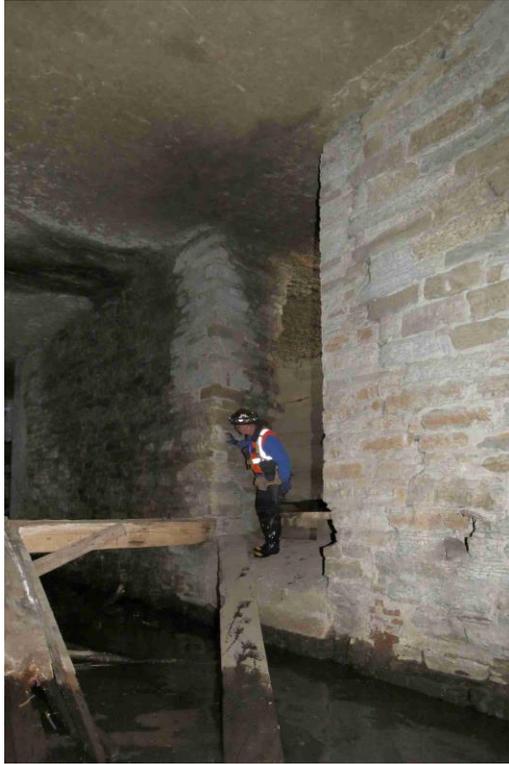
Photo 55. Downriver tailrace – penetration in interior stone masonry dividing wall.

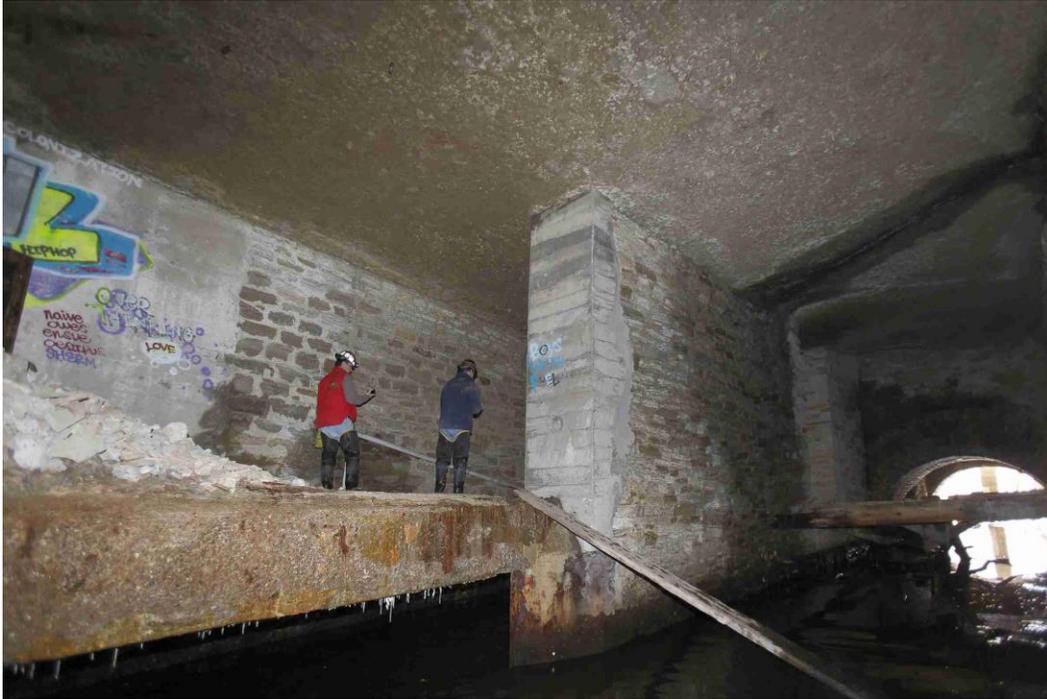
Photo 57. Southeast corner of the southwest downriver tailrace channel looking out towards the river.

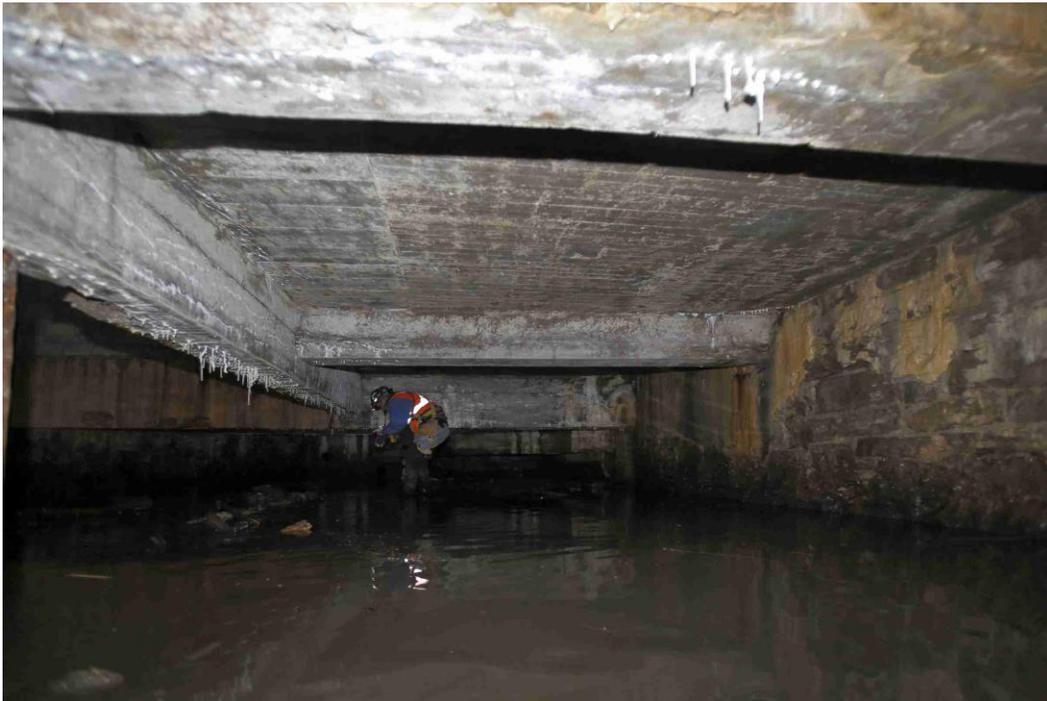
Photo 58. View beneath elevated platform structure in downstream tailrace.

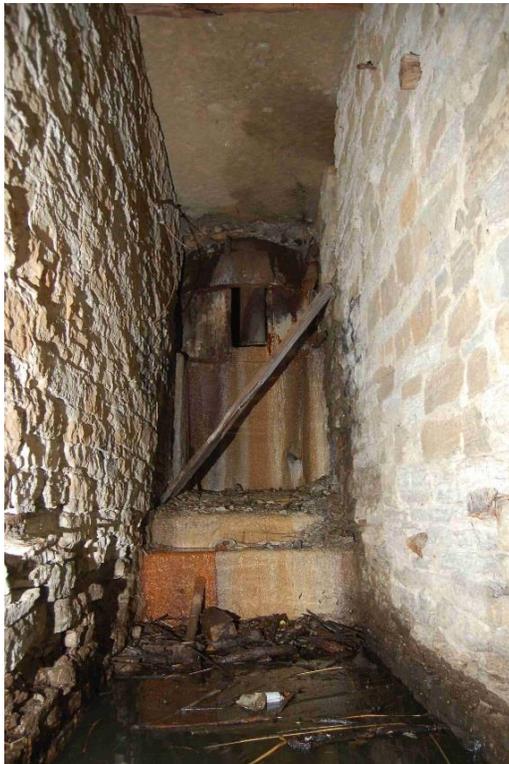
Photo 60. Machine shop dropshaft as seen from Machine shop tailrace tunnel.

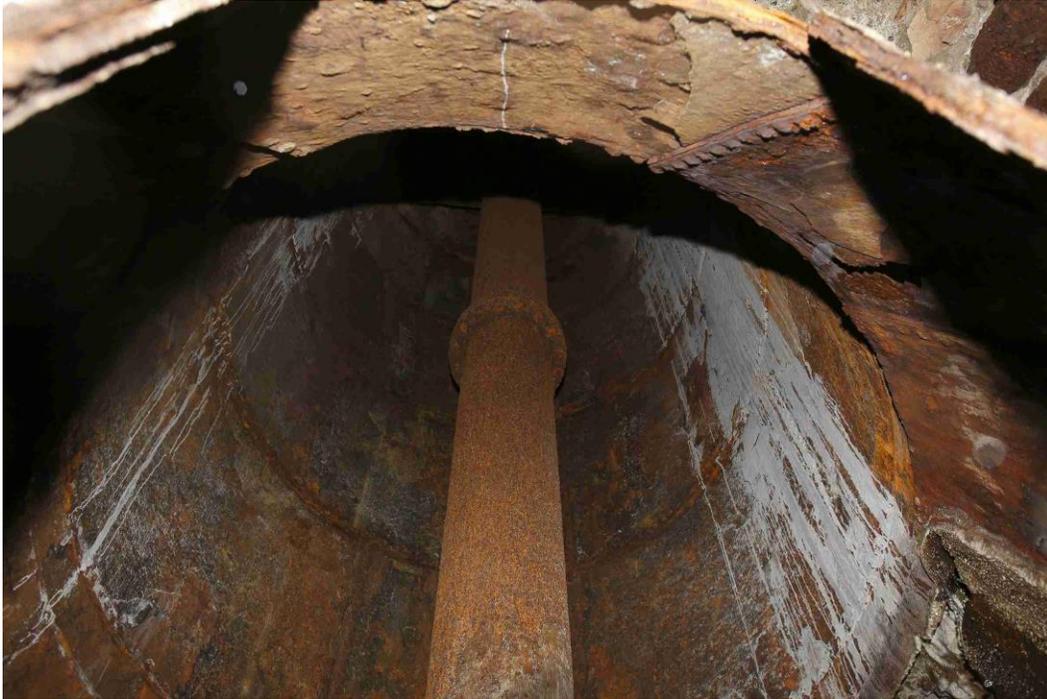
Photo 61. View looking up the Machine shop dropshaft.

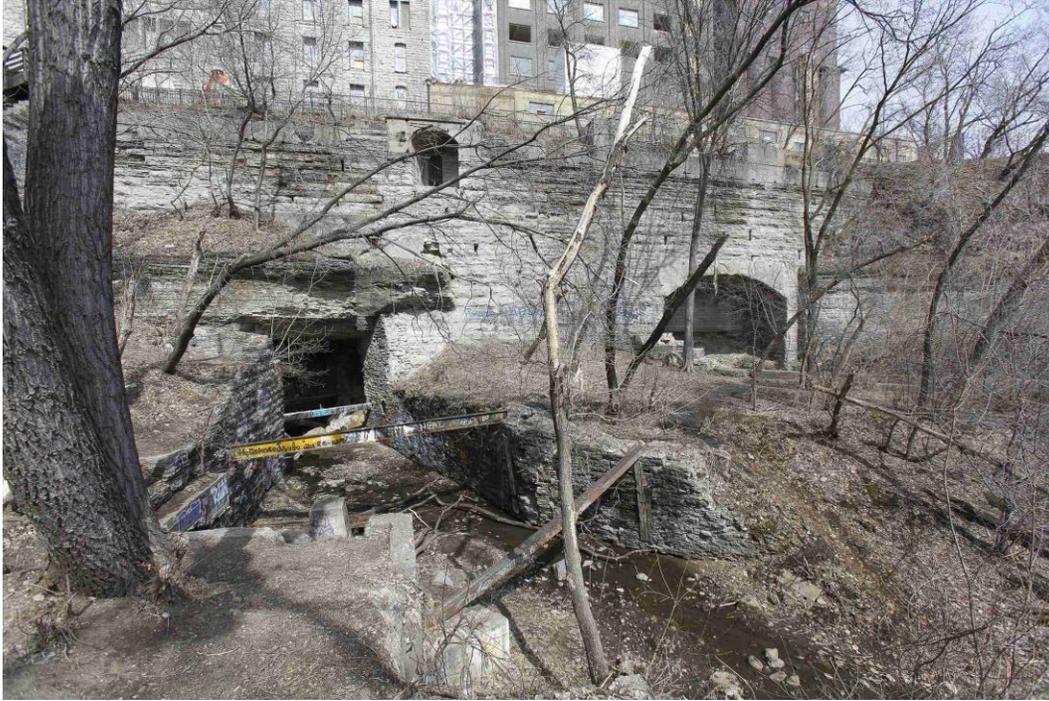
Photo 63. Upriver and Downriver tailrace portals.
