# CPED STAFF REPORT

HPC Agenda Item #1  
 August 19, 2014  
 BZH-28149

*Property Location:* 400 2<sup>nd</sup> Street Southeast  
*Project Name:* Pillsbury “A” Mill Machine Shop Rehabilitation  
*Prepared By:* [John Smoley](#), Ph.D., Senior City Planner, (612) 673-2830  
*Applicant:* Schaffer Richardson  
*Project Contact:* Amanda Janzen  
*Ward:* 3  
*Neighborhood:* Marcy Holmes  
*Request:* To rehabilitate the Pillsbury “A” Mill Machine Shop for a new office use  
*Required Applications:*

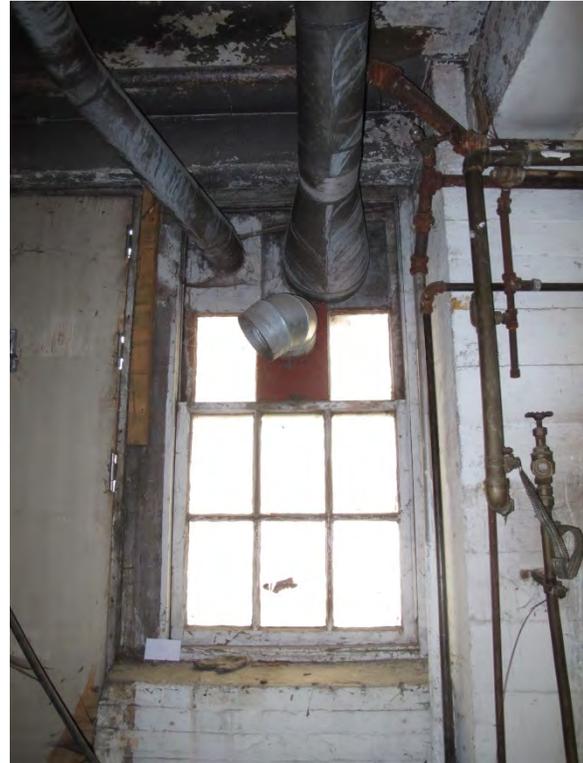
Frame and sash show rot at exterior. Upper sash heavily has been modified for mechanical penetration. Lower 6" of sash stop at right jamb is damaged.

*Note: Windows 001 through 010 are in generally poor condition, presumably due to their proximity to the sidewalk and resulting winter salt treatments and rain splash.*

Window 001 interior

**WINDOW 001 - Indicated to be replaced**

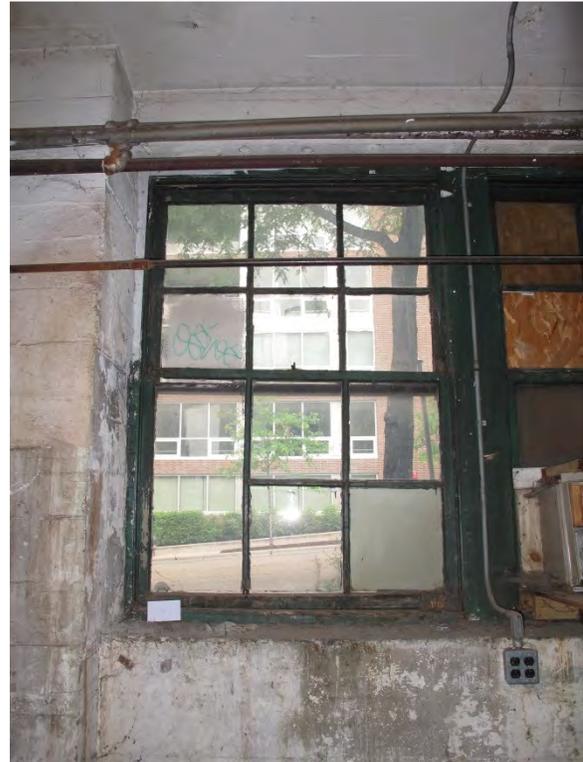
*Note: Windows 001 through 010 are in generally poor condition, presumably due to their proximity to the sidewalk and resulting winter salt treatments and rain splash.*

*Window 002 interior*

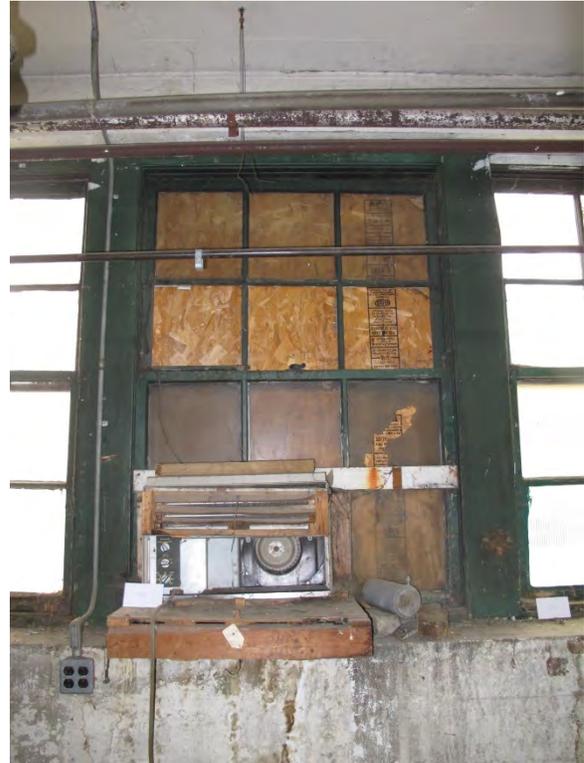
Frame and sash show rot at exterior. Frame and lower sash have been heavily modified for A/C unit.

*Note: Windows 001 through 010 are in generally poor condition, presumably due to their proximity to the sidewalk and resulting winter salt treatments and rain splash.*

*Window 003 interior*

**WINDOW 003 - Indicated to be replaced**

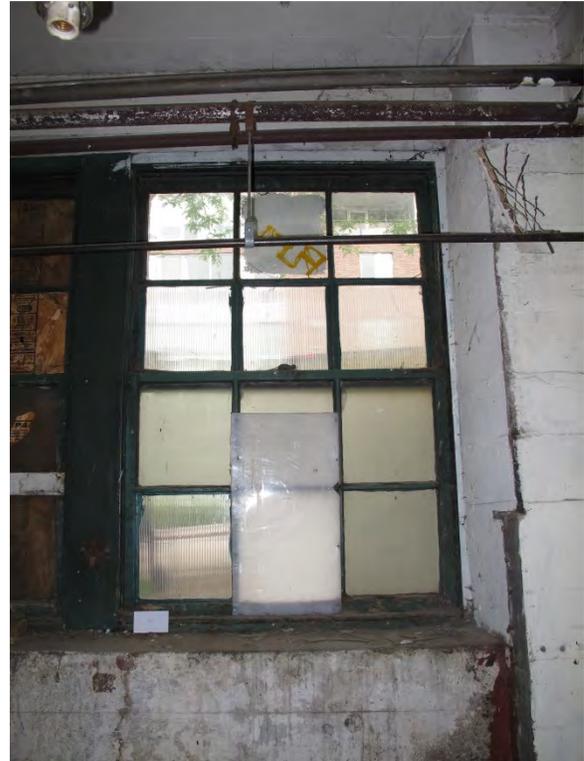
Sash stops at left and right jambs are broken.

*Note: Windows 001 through 010 are in generally poor condition, presumably due to their proximity to the sidewalk and resulting winter salt treatments and rain splash.*

*Window 004 interior*

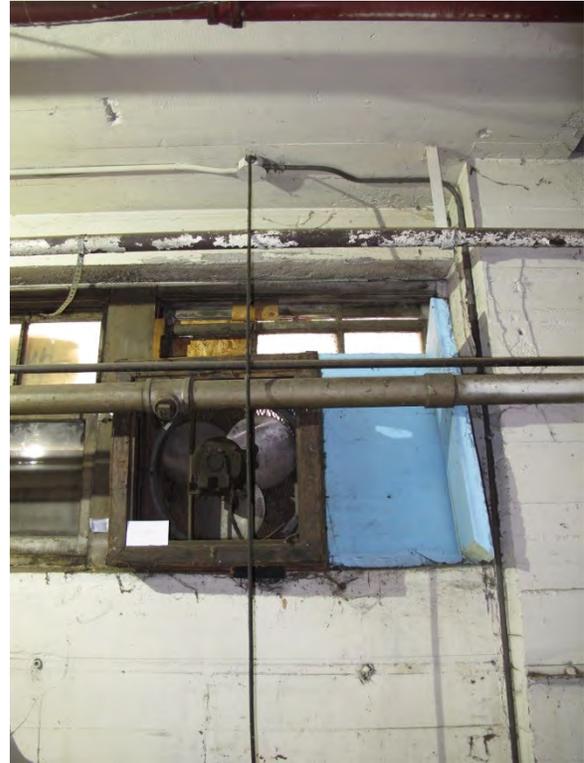
Frame and sash show rot at exterior. Lower sash has been heavily modified for ventilation equipment.

*Note: Windows 001 through 010 are in generally poor condition, presumably due to their proximity to the sidewalk and resulting winter salt treatments and rain splash.*

Window 005 interior

**WINDOW 005 - Indicated to be replaced**

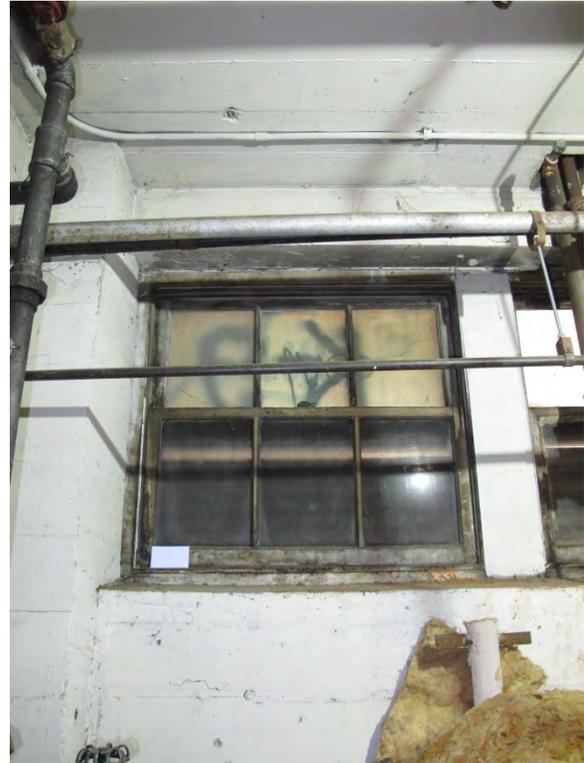
Frame and sash show rot at exterior. Wood louvers have been added at exterior of lower sash. Sash stops at right and left jambs are missing.

*Note: Windows 001 through 010 are in generally poor condition, presumably due to their proximity to the sidewalk and resulting winter salt treatments and rain splash.*

Window 006 interior

**WINDOW 006 - Indicated to be replaced**

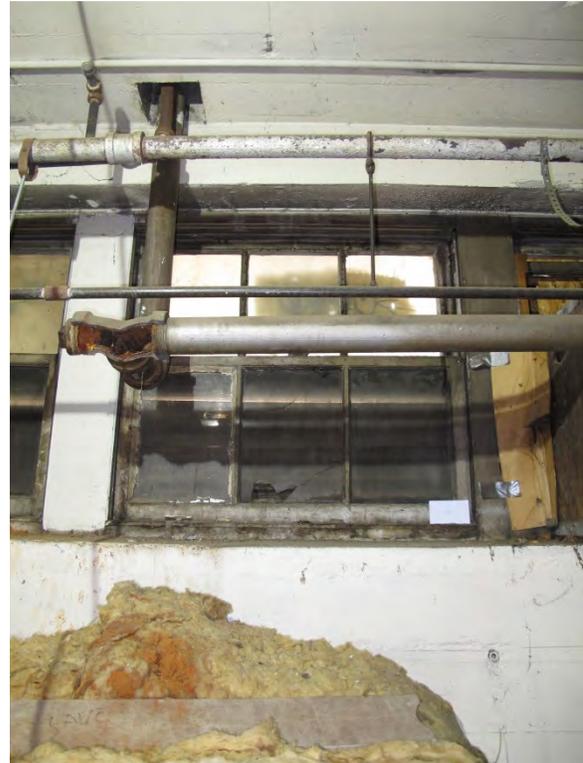
Frame and sash show rot at exterior. Wood louvers have been added at exterior of lower sash.

*Note: Windows 001 through 010 are in generally poor condition, presumably due to their proximity to the sidewalk and resulting winter salt treatments and rain splash.*

*Window 007 interior*

**WINDOW 007 - Indicated to be replaced**

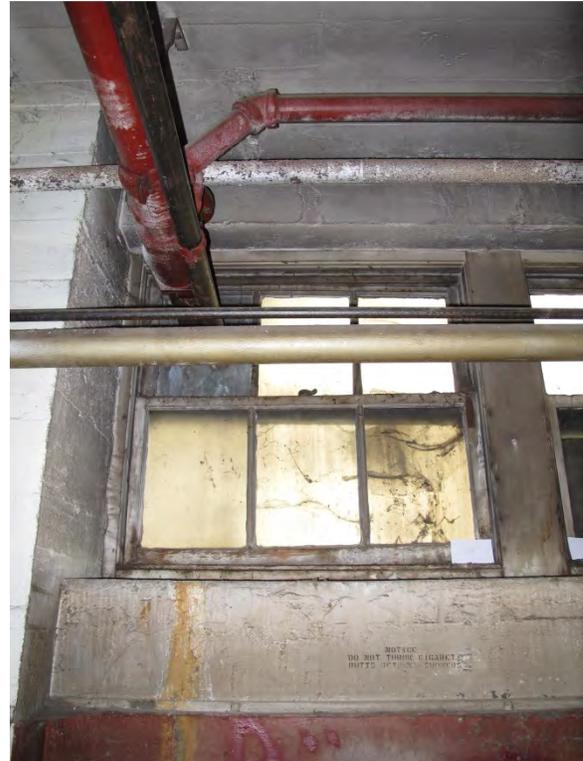
Frame and sash show rot at exterior. Upper sash has been modified for pipe penetrations.

*Note: Windows 001 through 010 are in generally poor condition, presumably due to their proximity to the sidewalk and resulting winter salt treatments and rain splash.*

*Window 008 interior*

**WINDOW 008 - Indicated to be replaced**

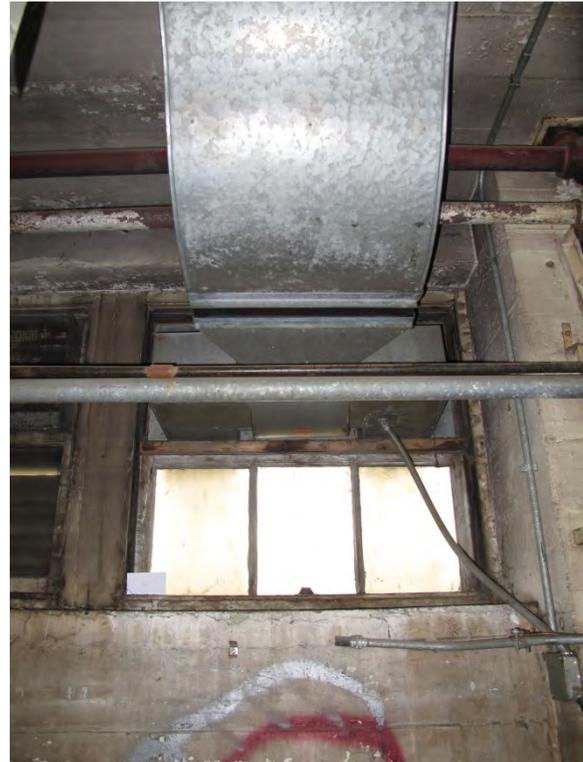
Frame and sash show rot at exterior. Upper sash has been removed for mechanical penetrations. Sash stops at right and left jambs missing.

*Note: Windows 001 through 010 are in generally poor condition, presumably due to their proximity to the sidewalk and resulting winter salt treatments and rain splash.*

*Window 010 interior*

**WINDOW 010 - Indicated to be replaced**

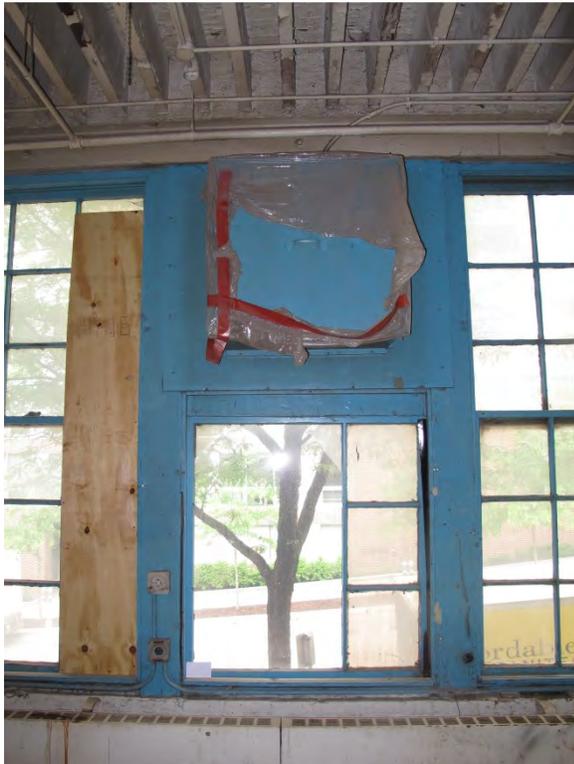
*Window 105 interior*

Frame and upper sash have been modified for ventilation equipment. Muntins at lower sash have been modified.

**WINDOW 105 - Indicated to be replaced**

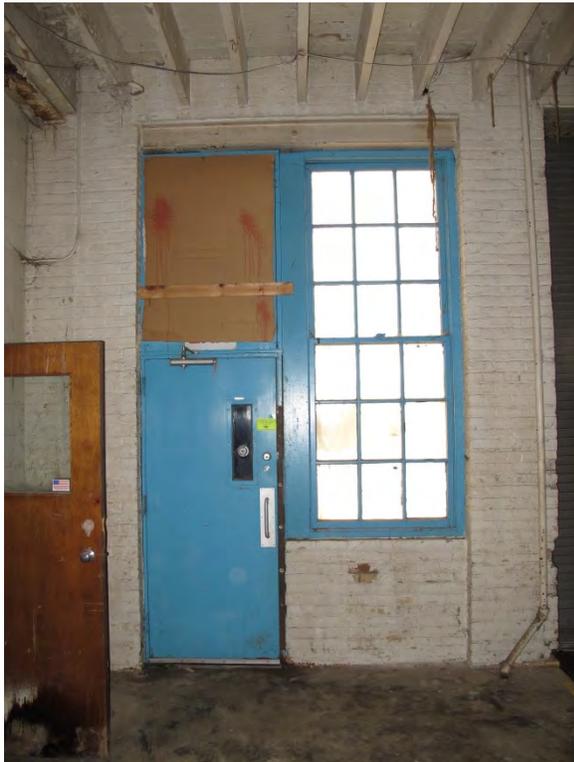
*Window 125 interior*

Lower 2' of sash stop at left jamb is damaged but intact.

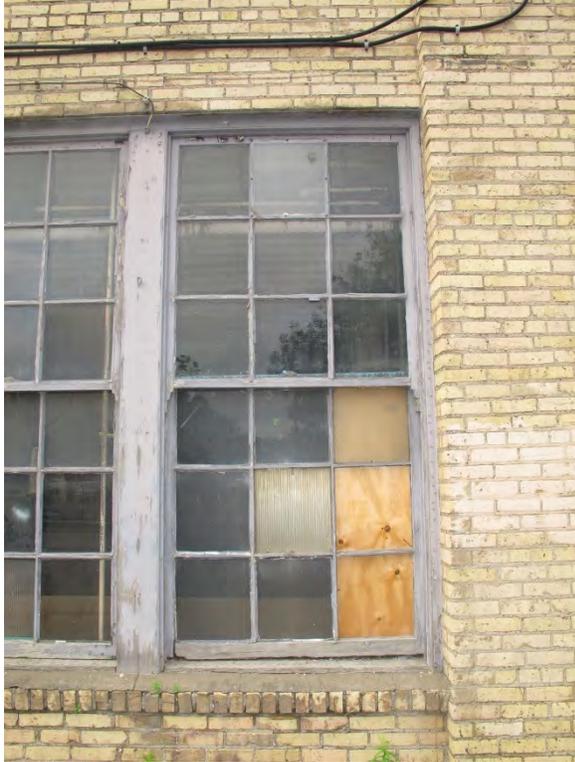
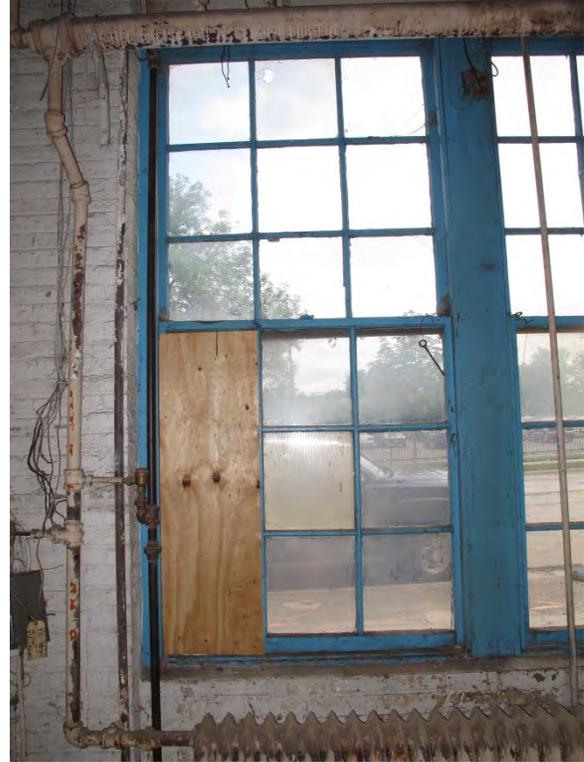
Bottom rail of lower sash is severely rotten and detached.

*Window 130 exterior*

*Window 130 interior*

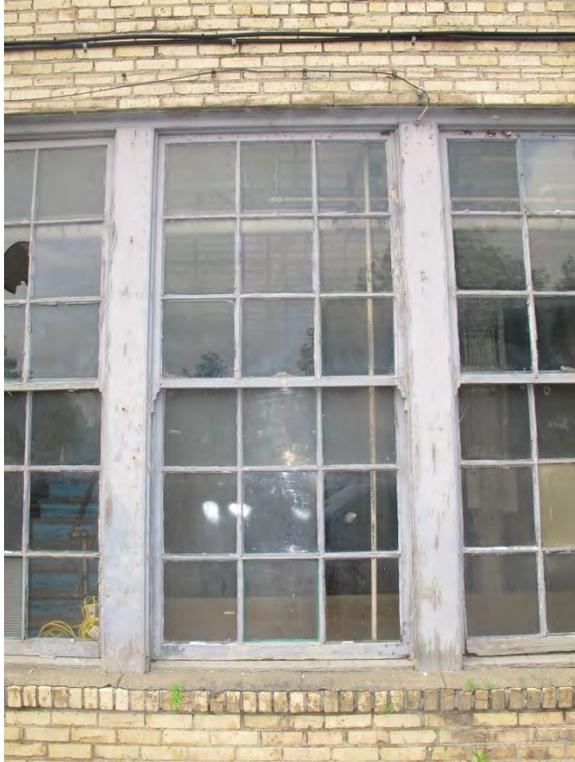
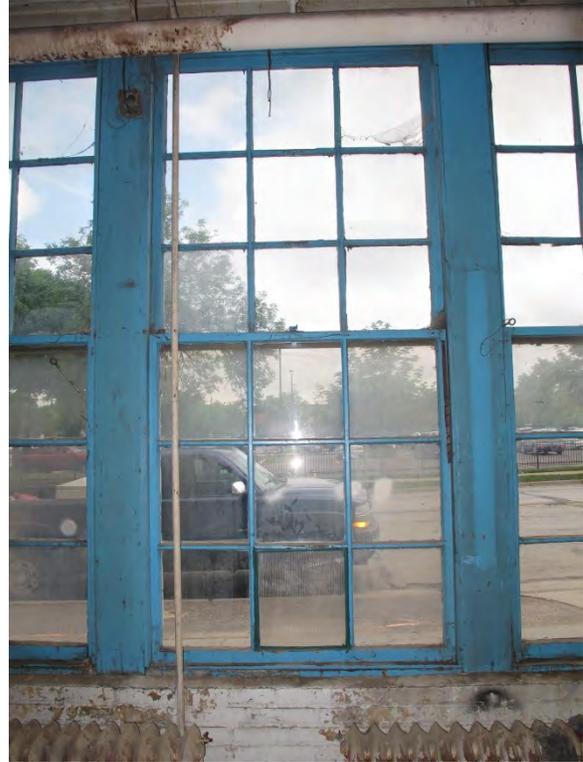
Bottom rail of lower sash is severely rotten and reinforced with steel gussets.

*Window 131 exterior*

*Window 131 interior*

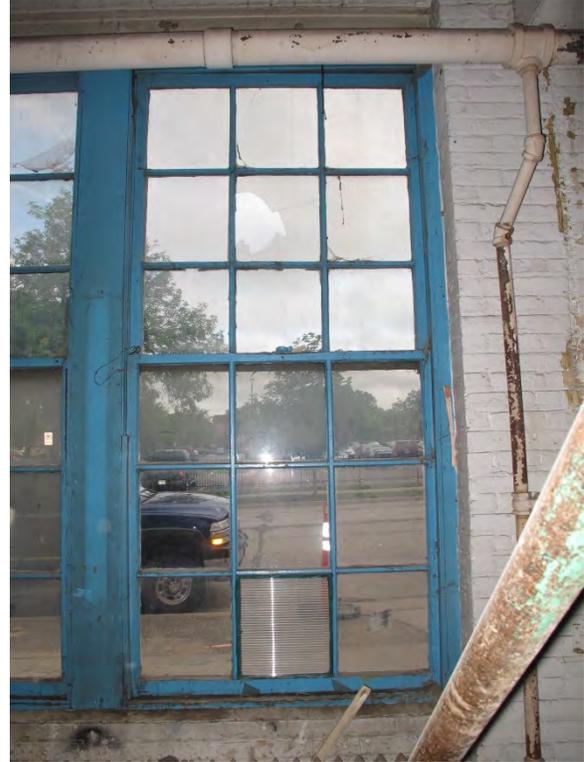
*Window 132 interior*

Portion of sash stop at left jamb has been replaced and is mismatched.

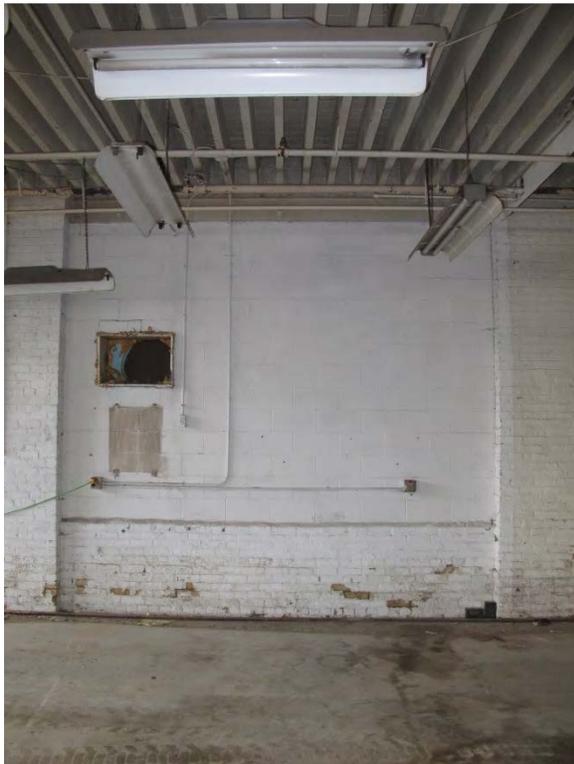
Windows have been removed and openings have been infilled with CMU masonry.

*Opening at Window 142, 143, 144  
(Windows 137 - 156 similar)*

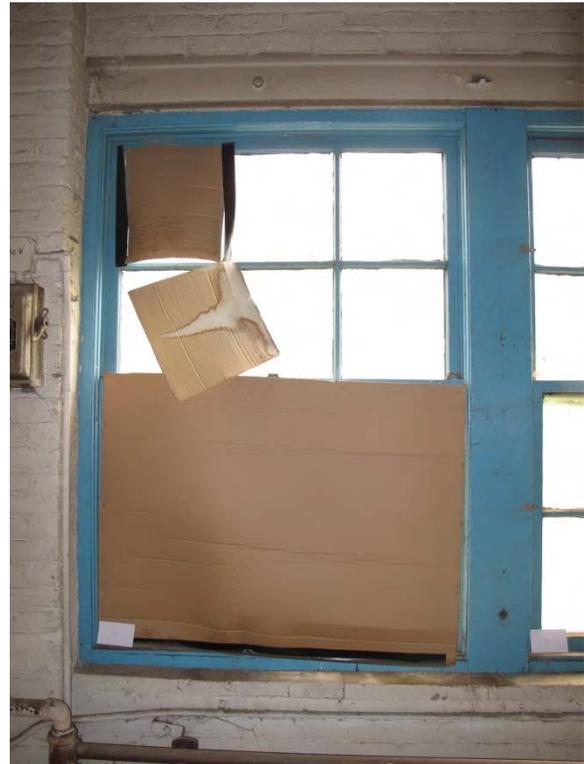
*Window 204 interior*

Bottom rail of lower sash is rotten through. Lower 12" of sash stops at both jambs are rotten.

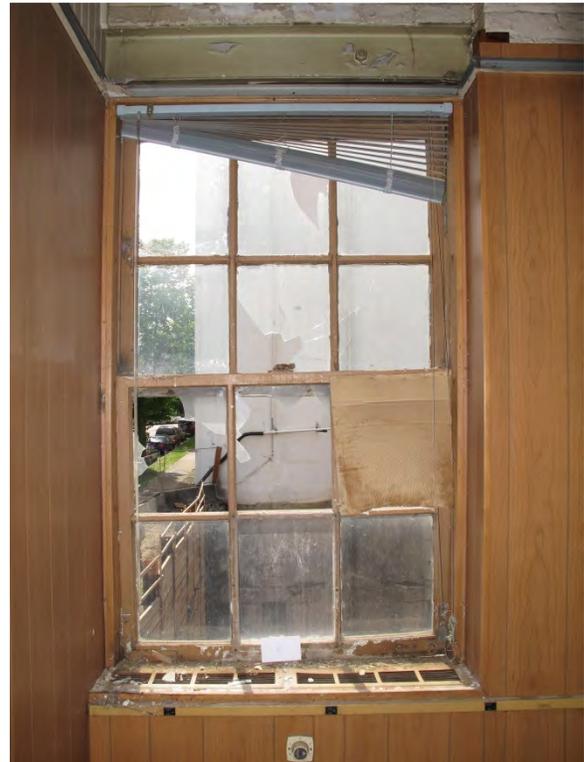
*Window 240 interior*

Bottom rail of lower sash is rotten and has been reinforced with steel gussets.

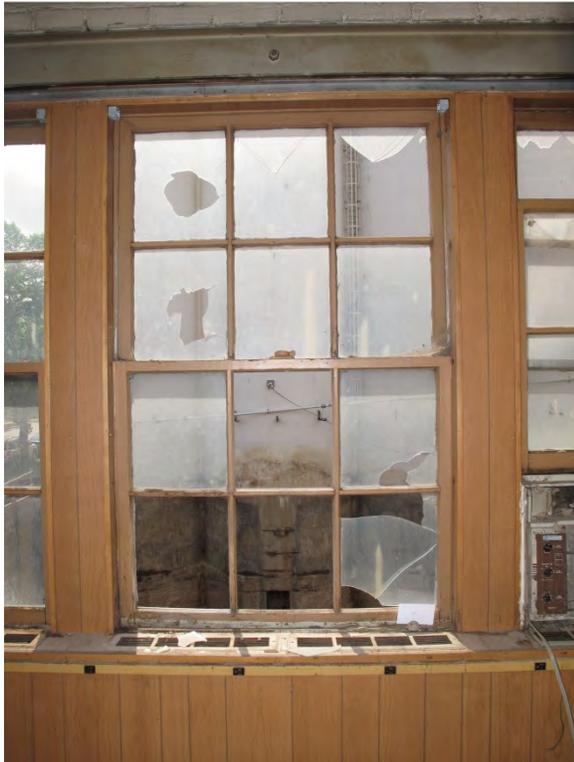
*Window 245 interior*

Bottom sash is rotten and warped.

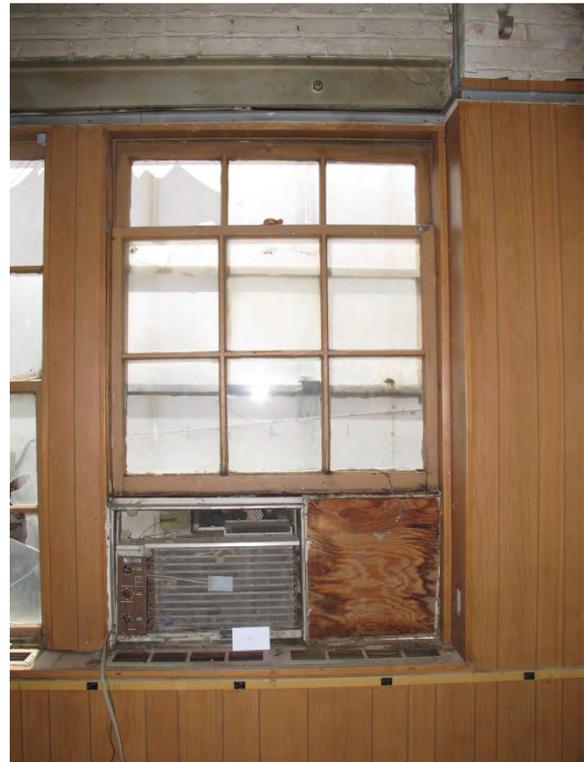
*Window 246 interior*

Sash stops at both jambs have been modified for A/C unit.

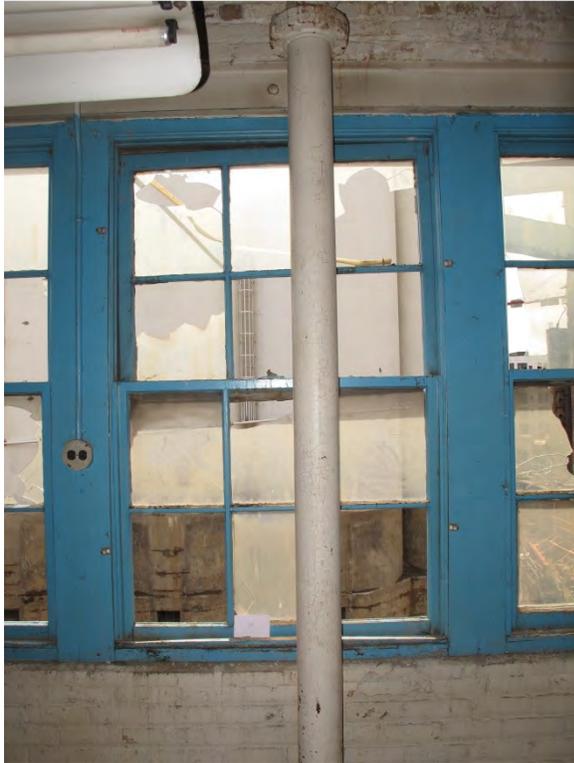
*Window 248 interior*

Interior stool is warped.

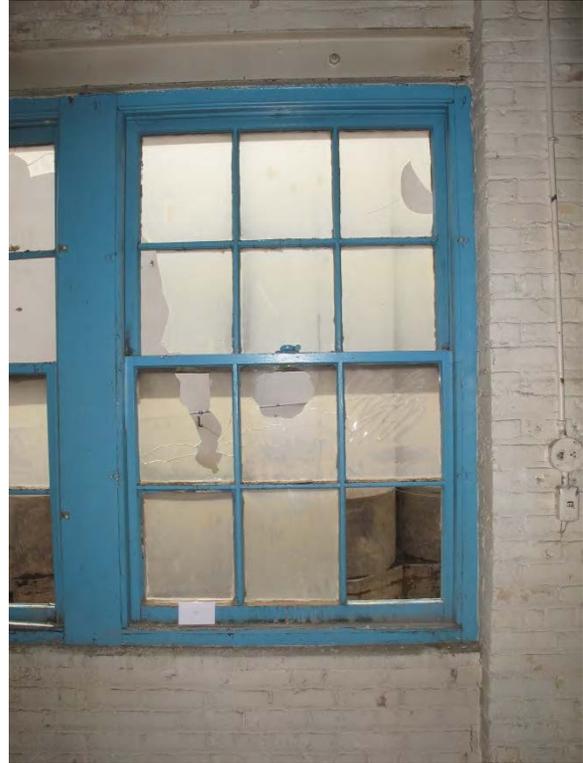
*Window 249 interior*

Interior stool is splintered.

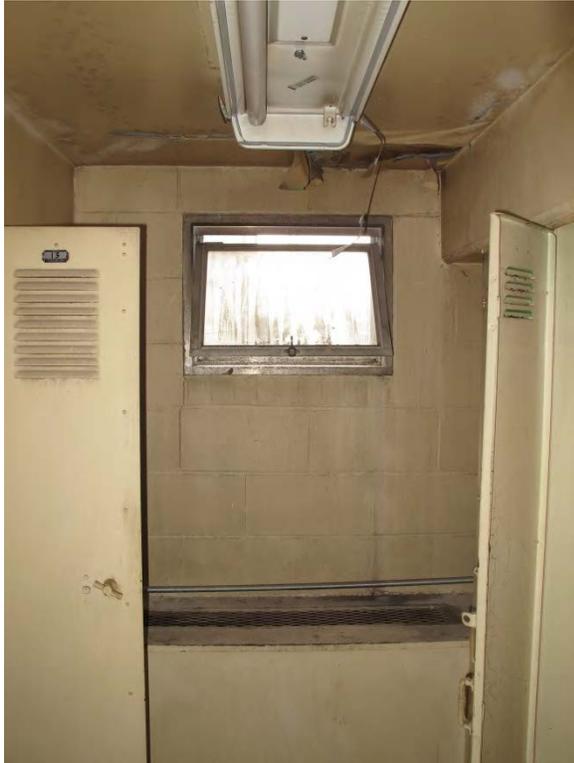
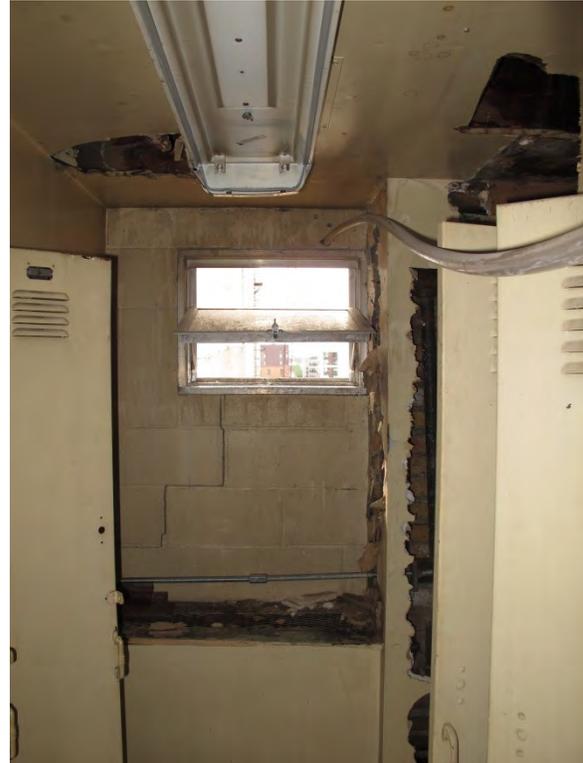
Windows have been removed and openings have been infilled with CMU masonry with small awning windows.

*Window 256 interior*

*Window 258 interior*

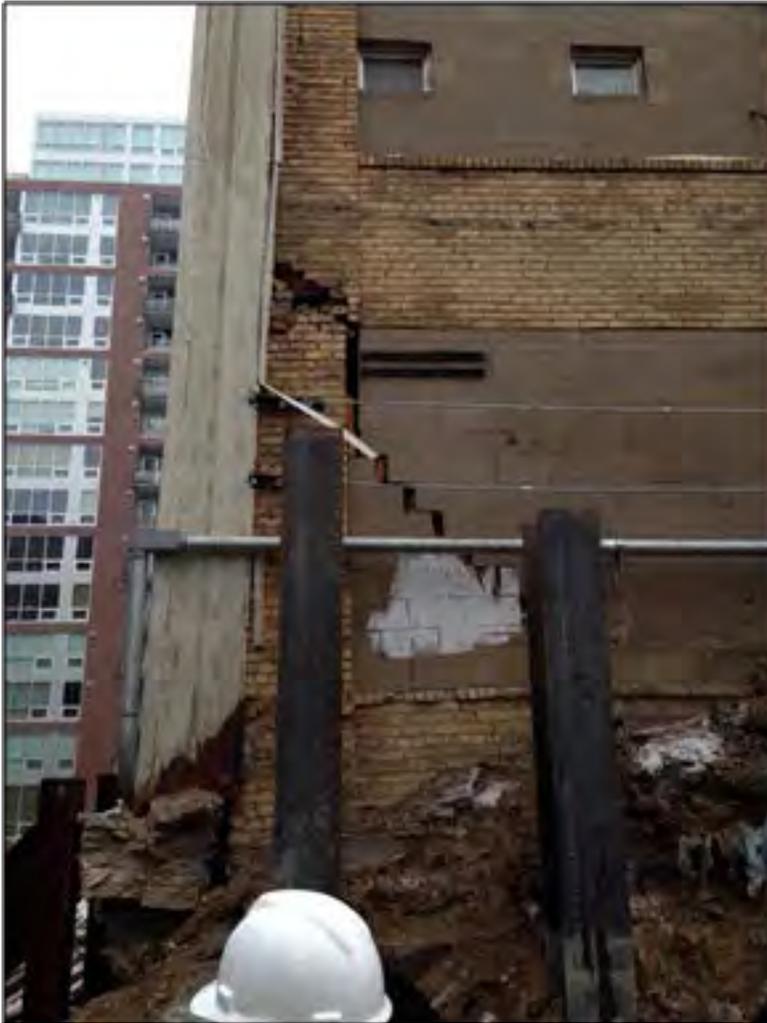
Southeast corner to be stabilized and restored.

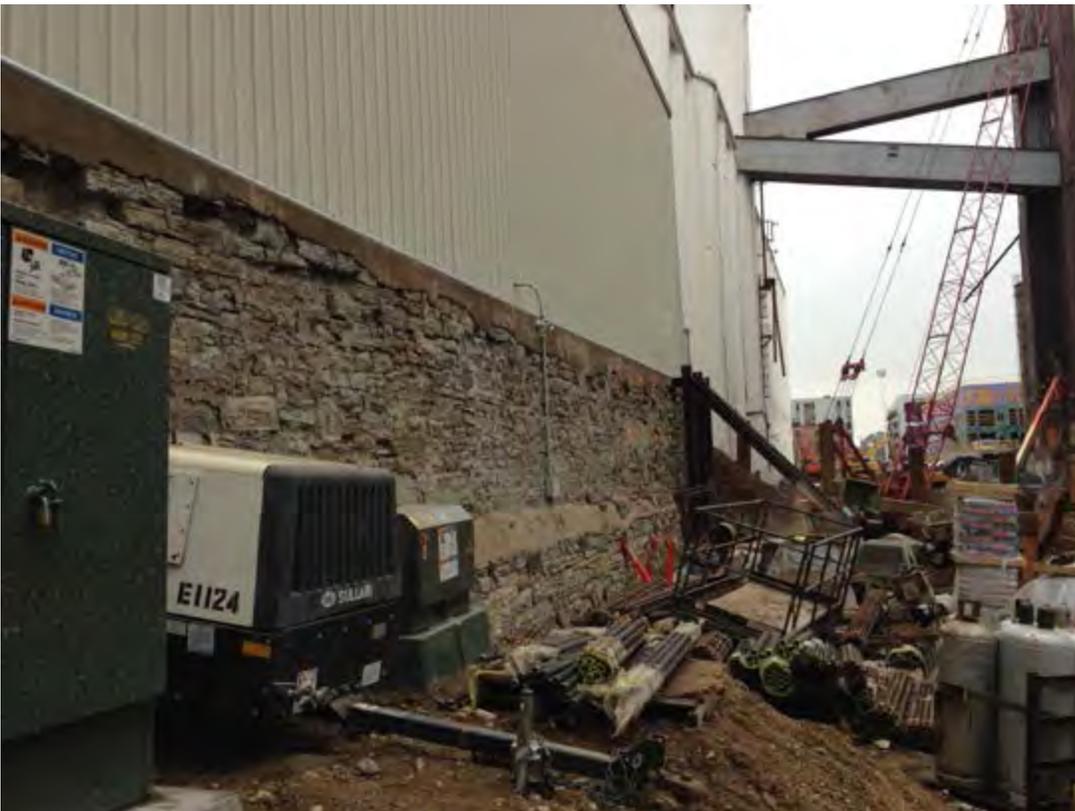
Three existing steel braces to remain for southeast corner stabilization.

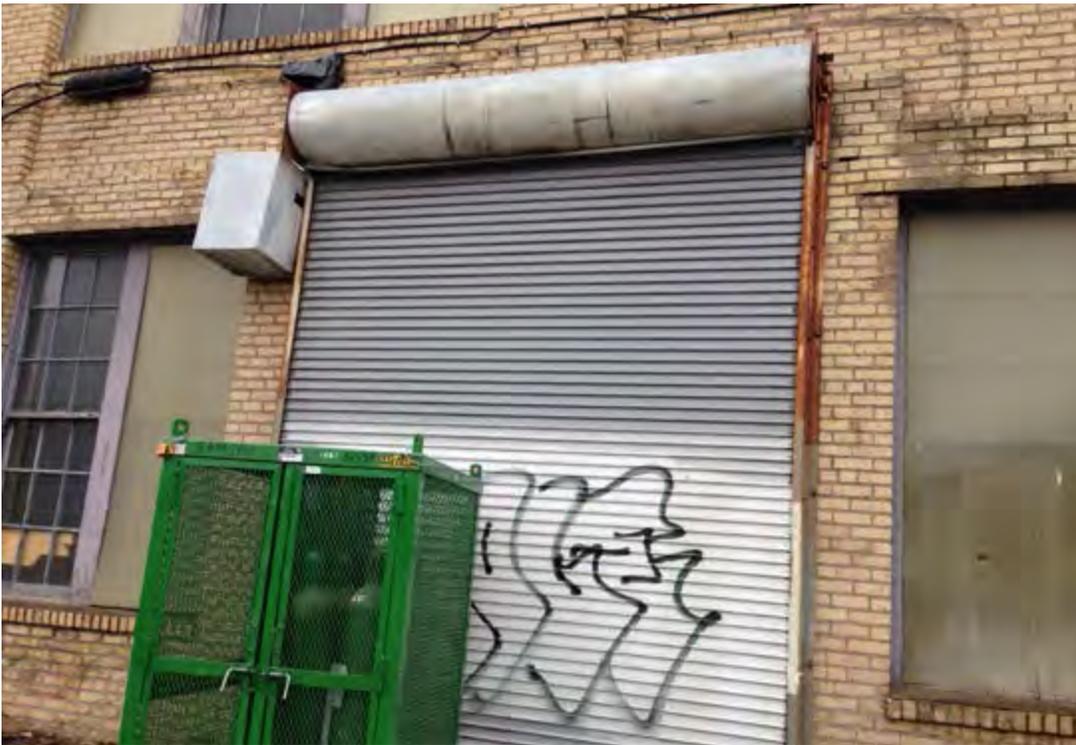
North elevation: west garage door to be removed.

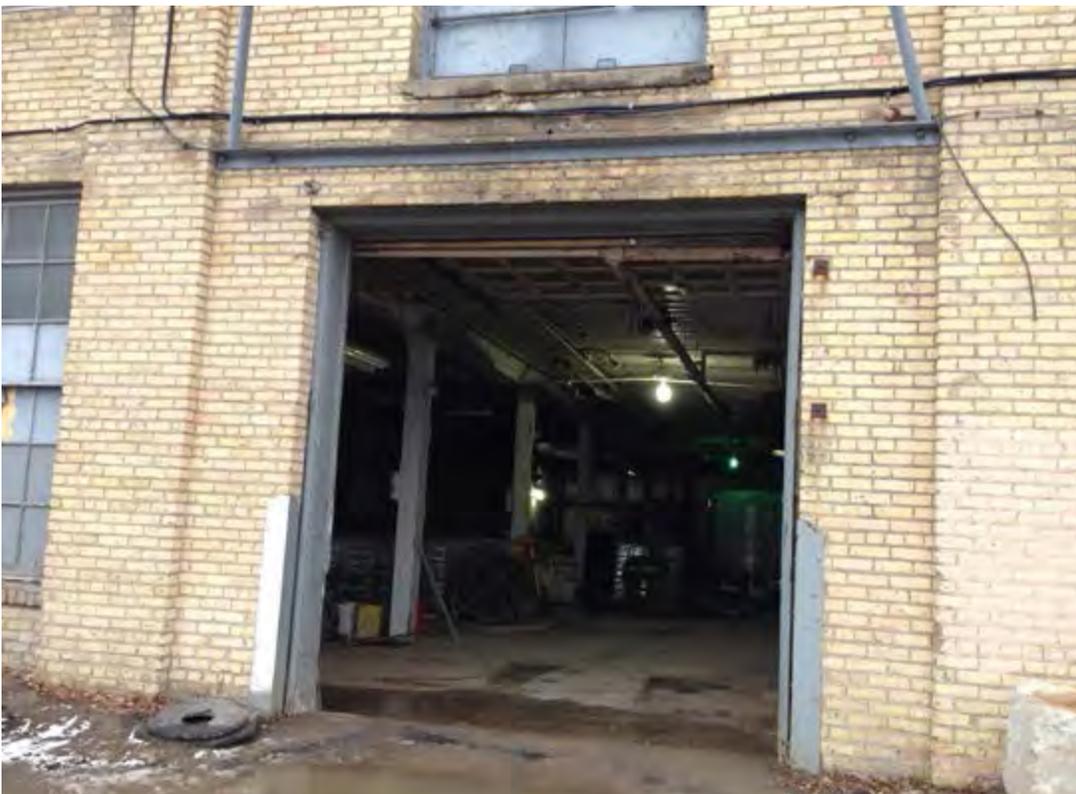
North elevation: east garage door to be removed.

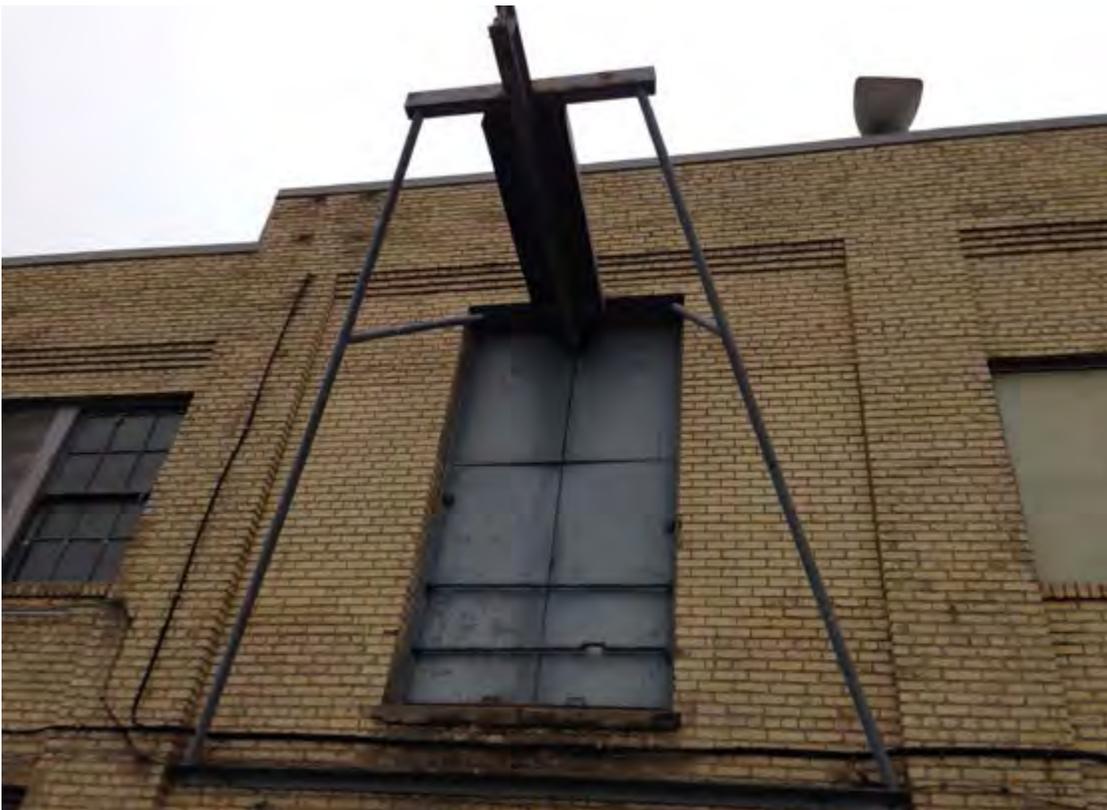
North elevation: door above east garage door to be removed. Braces to

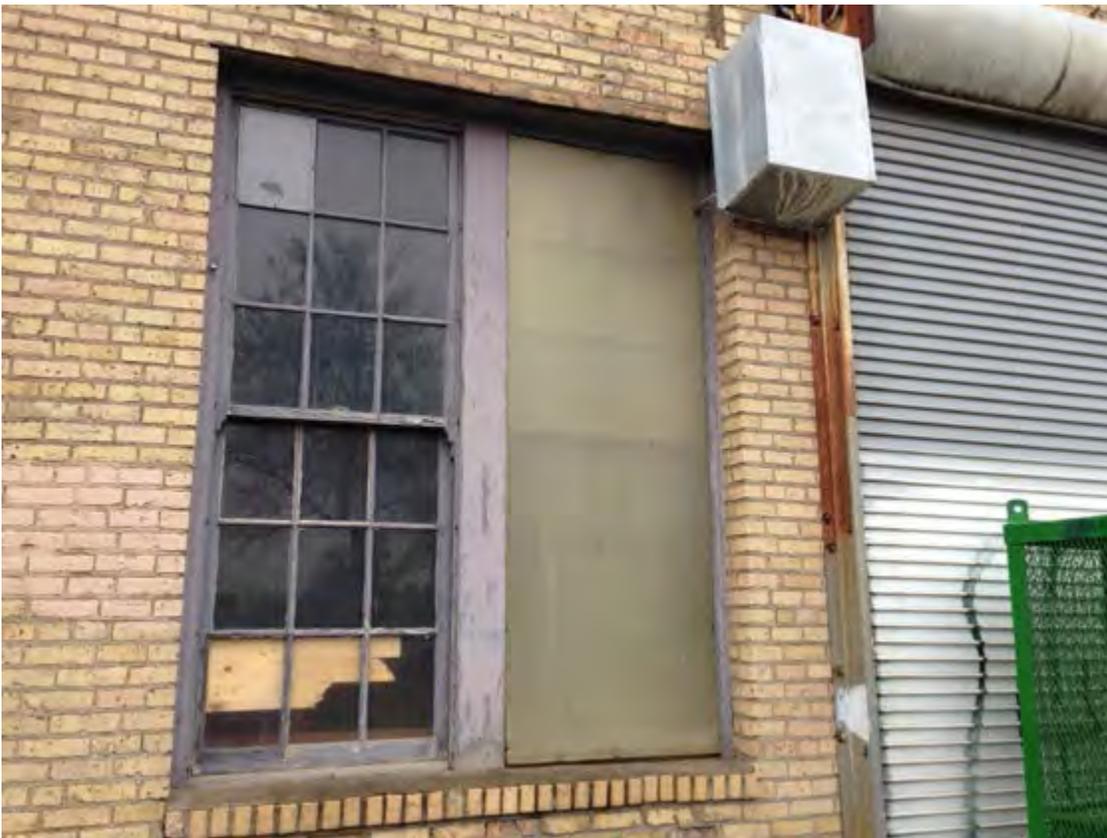
North elevation: window above door to be replaced and window east of door to be refurbished.

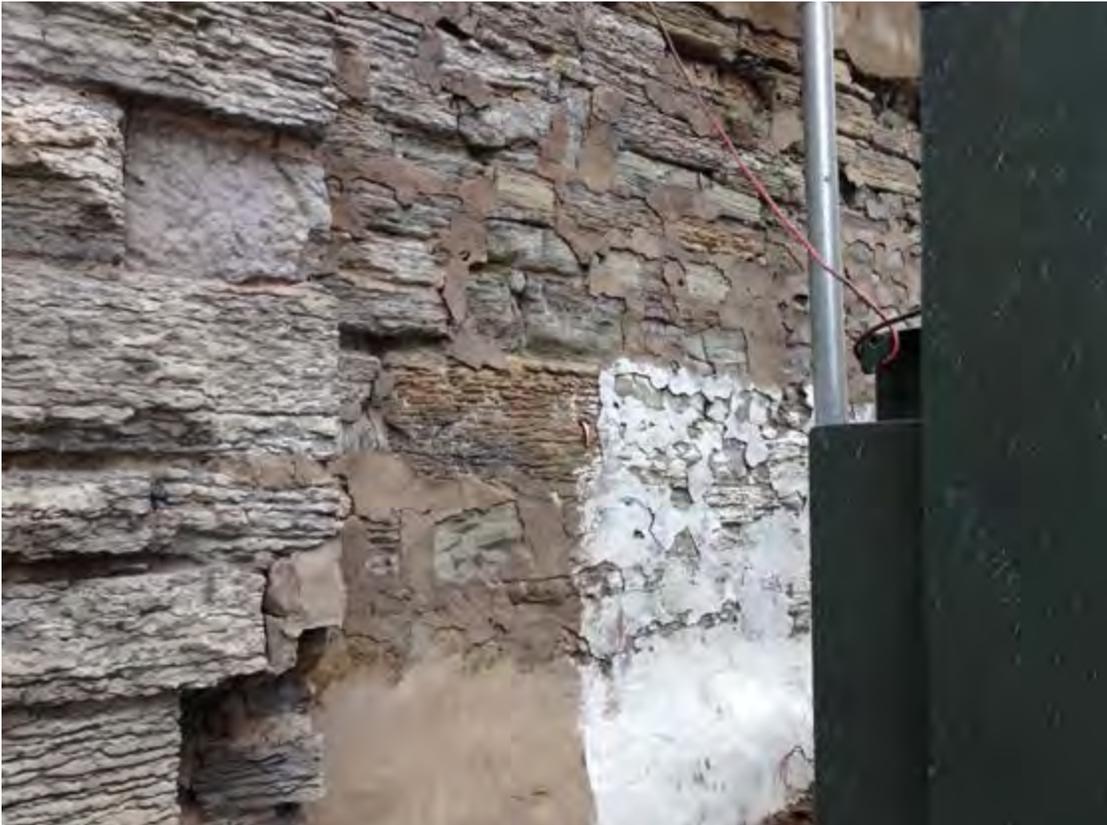
South elevation:  
repoint south limestone  
foundation. Insert  
five new windows in  
foundation.

- 2). The foundation on the South wall must be retained intact, as it is the only portion of the former wall remaining. Plans for new window openings in this portion of the wall must be removed from the scope of work.

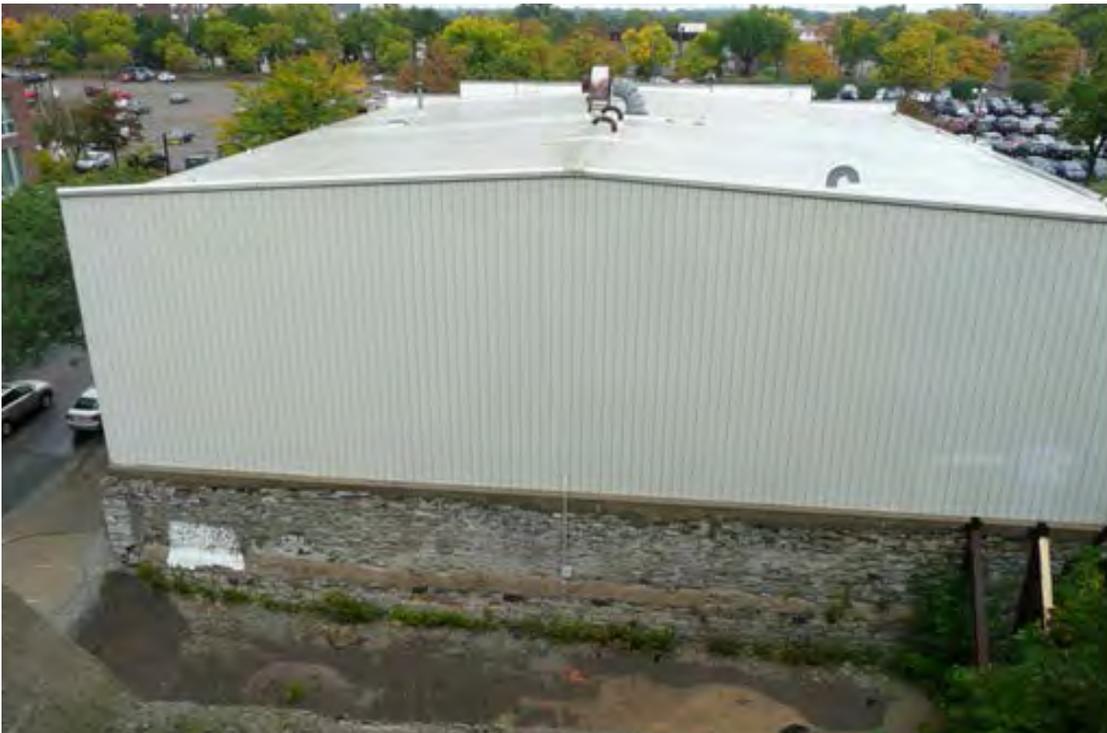
South elevation: metal  
siding to be removed  
and replaced with  
glass and aluminum  
curtainwall. Replace  
roof and place  
mechanical equipment  
on roof.

- 1). Cladding on the South Elevation must be compatible in material and design to the historic building and the historic district. The existing cladding may be retained, or, if replaced, it must be a masonry wall (brick or stucco). Plans must be revised and approved by SHPO and NPS prior to construction.

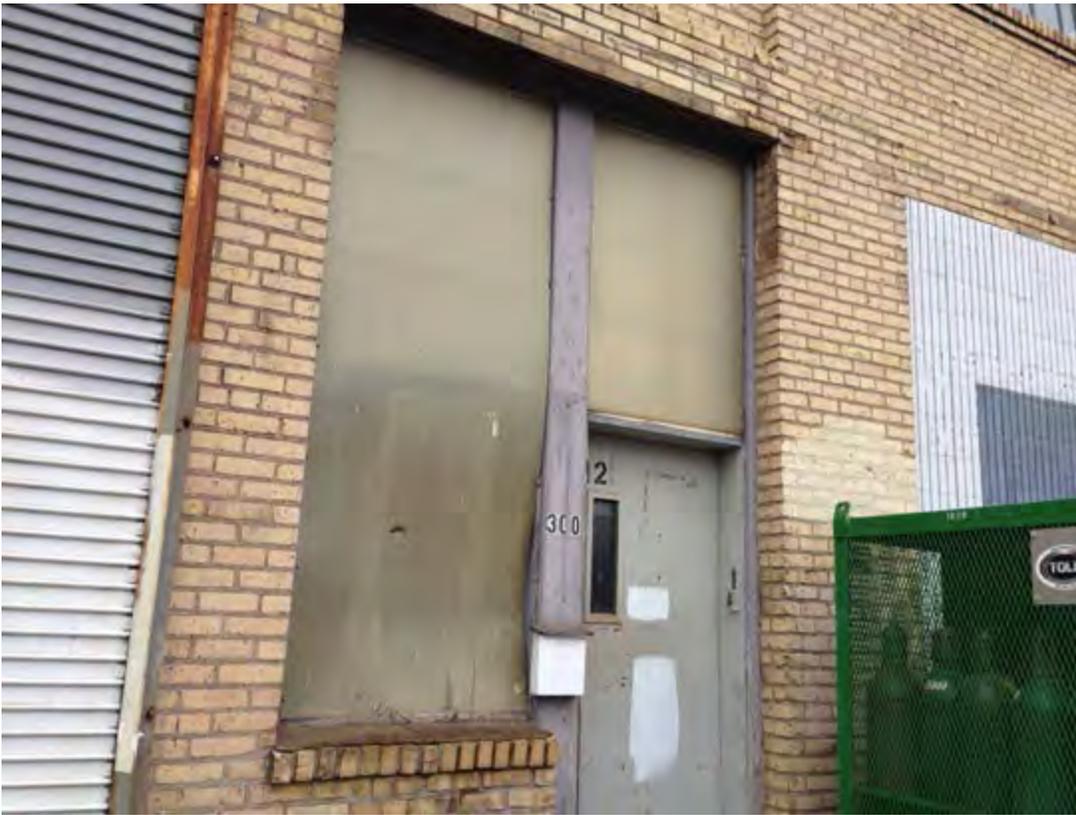
North elevation: window above door to be replaced and window east of door to be refurbished.

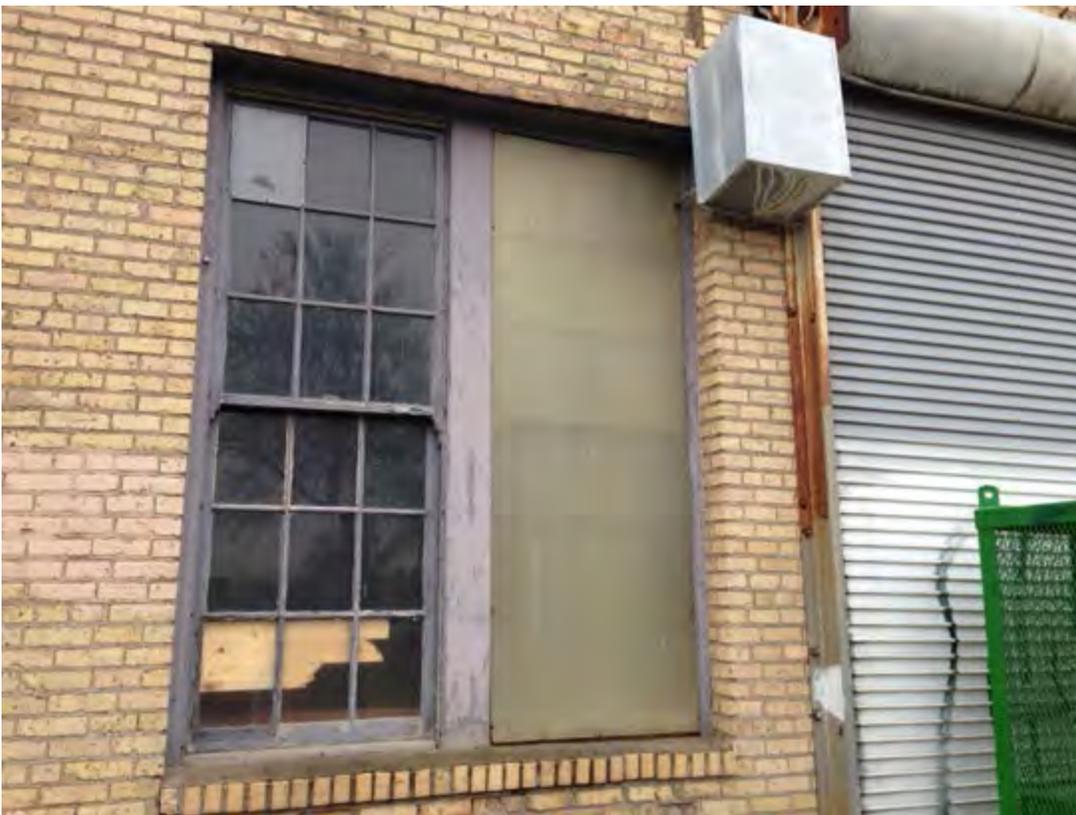
North elevation: window east of west garage door to be refurbished.

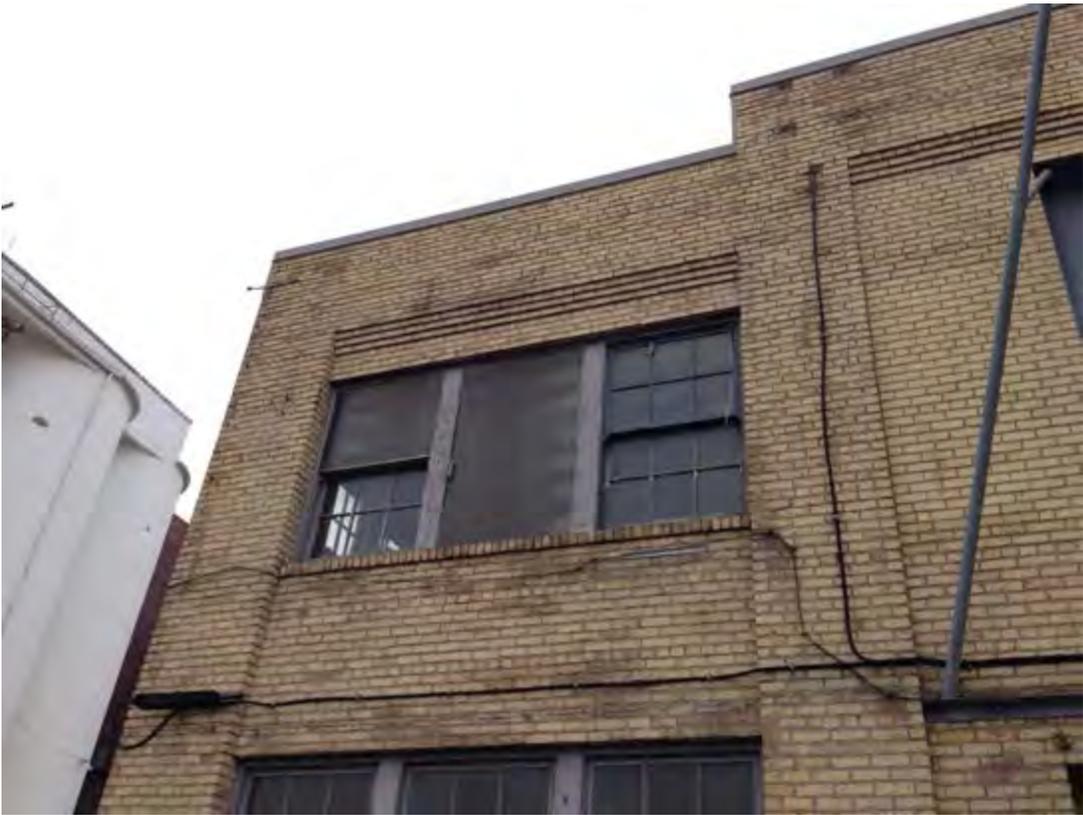
North elevation: second story east windows to be refurbished.

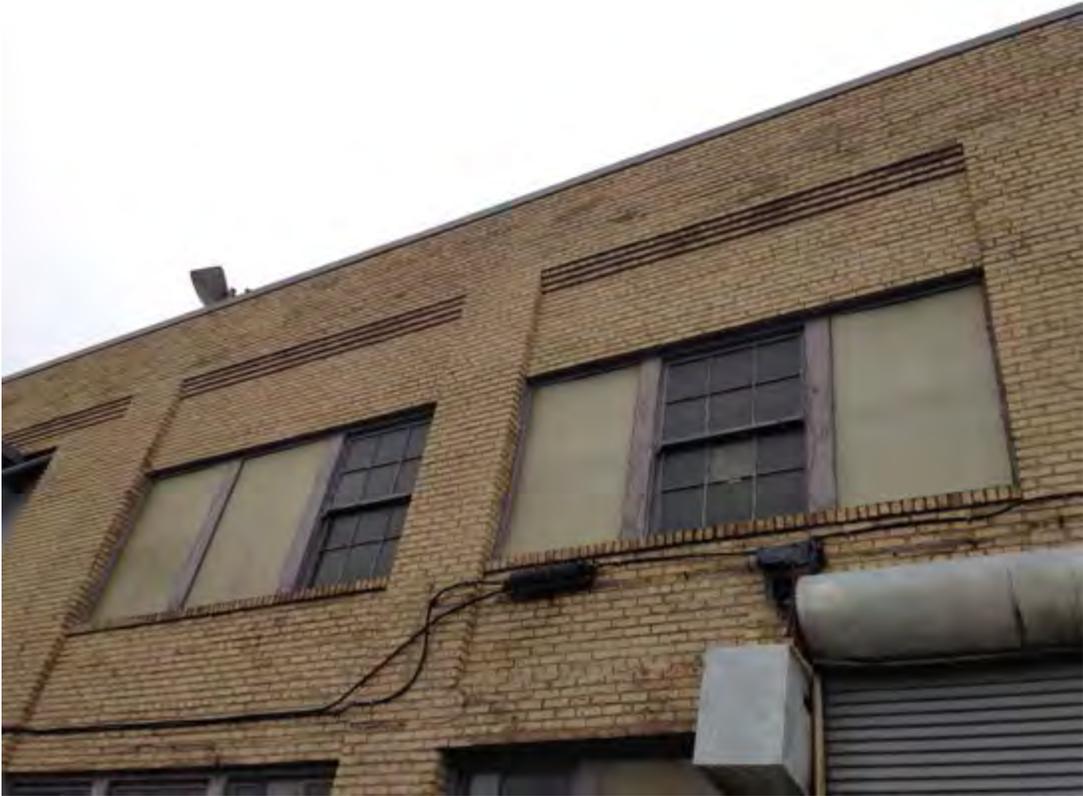
North elevation: second story windows to be refurbished.
