# CPED STAFF REPORT

HPC Agenda Item #1  
 August 19, 2014  
 BZH-28149

*Property Location:* 400 2<sup>nd</sup> Street Southeast  
*Project Name:* Pillsbury “A” Mill Machine Shop Rehabilitation  
*Prepared By:* [John Smoley](#), Ph.D., Senior City Planner, (612) 673-2830  
*Applicant:* Schaffer Richardson  
*Project Contact:* Amanda Janzen  
*Ward:* 3  
*Neighborhood:* Marcy Holmes  
*Request:* To rehabilitate the Pillsbury “A” Mill Machine Shop for a new office use  
*Required Applications:*

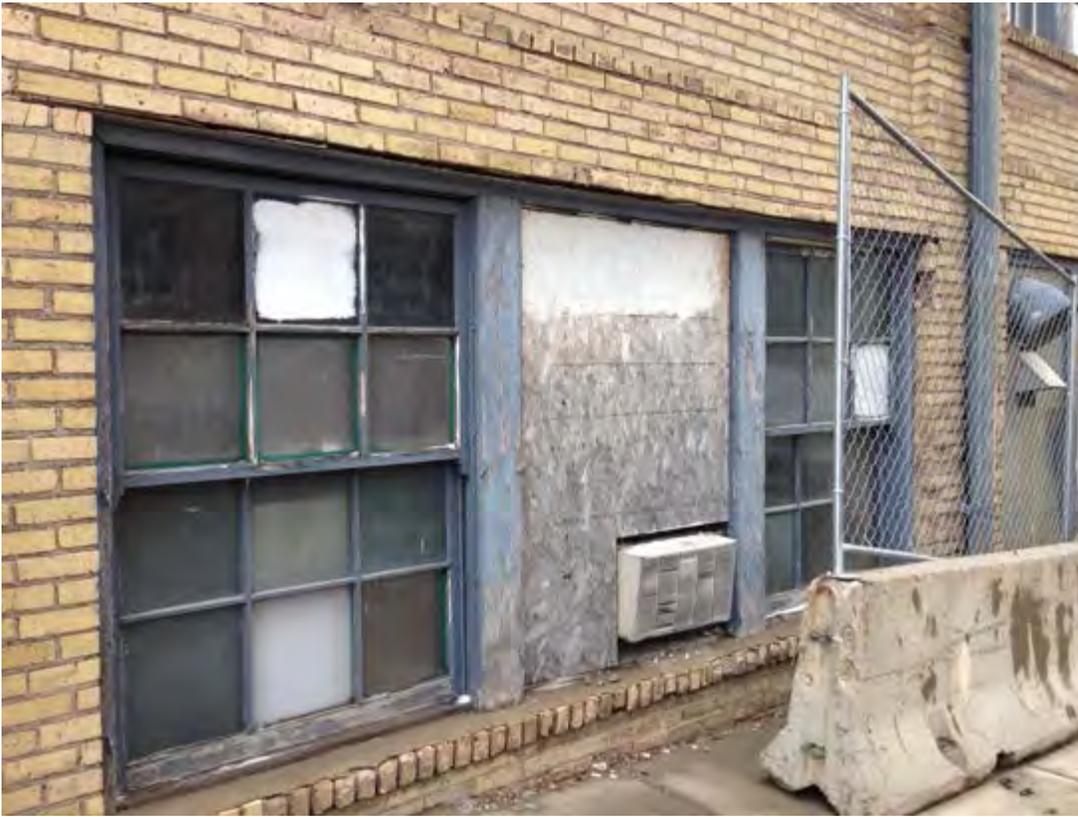
West elevation:  
basement story, fourth  
bay from south to be  
replaced.

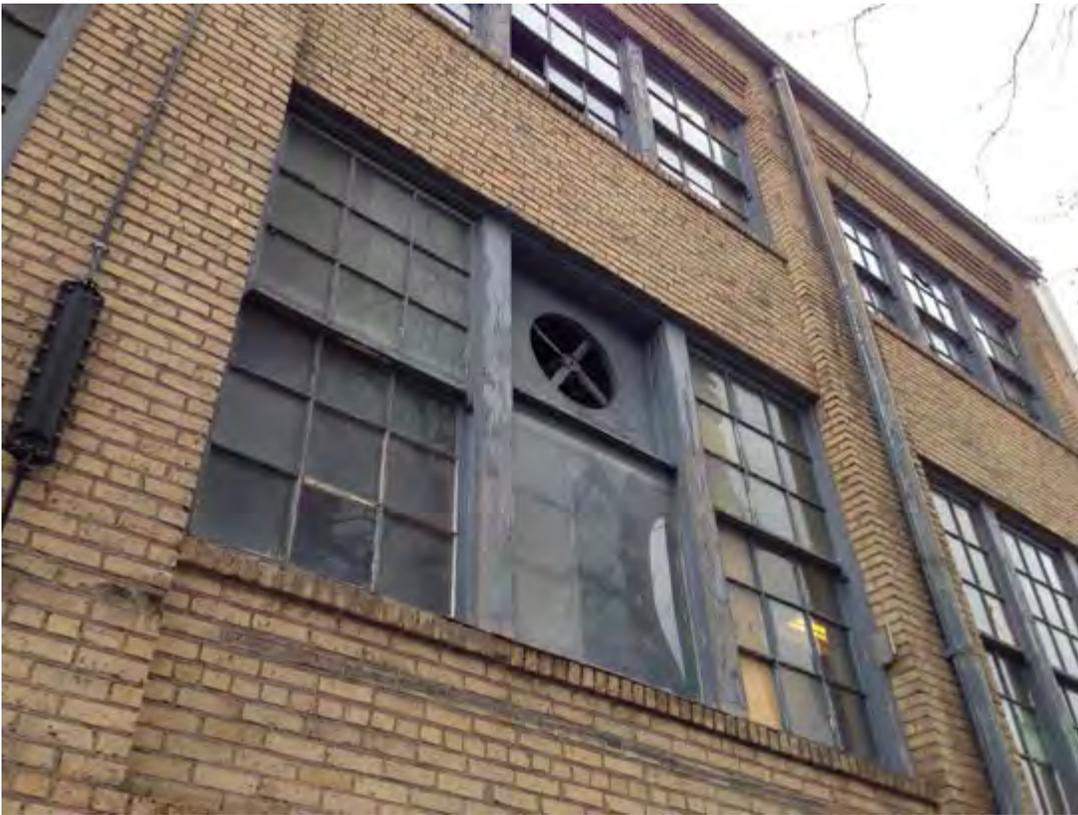
West elevation: central  
window on first story,  
second bay from south  
to be replaced. Two  
other windows to be  
refurbished.

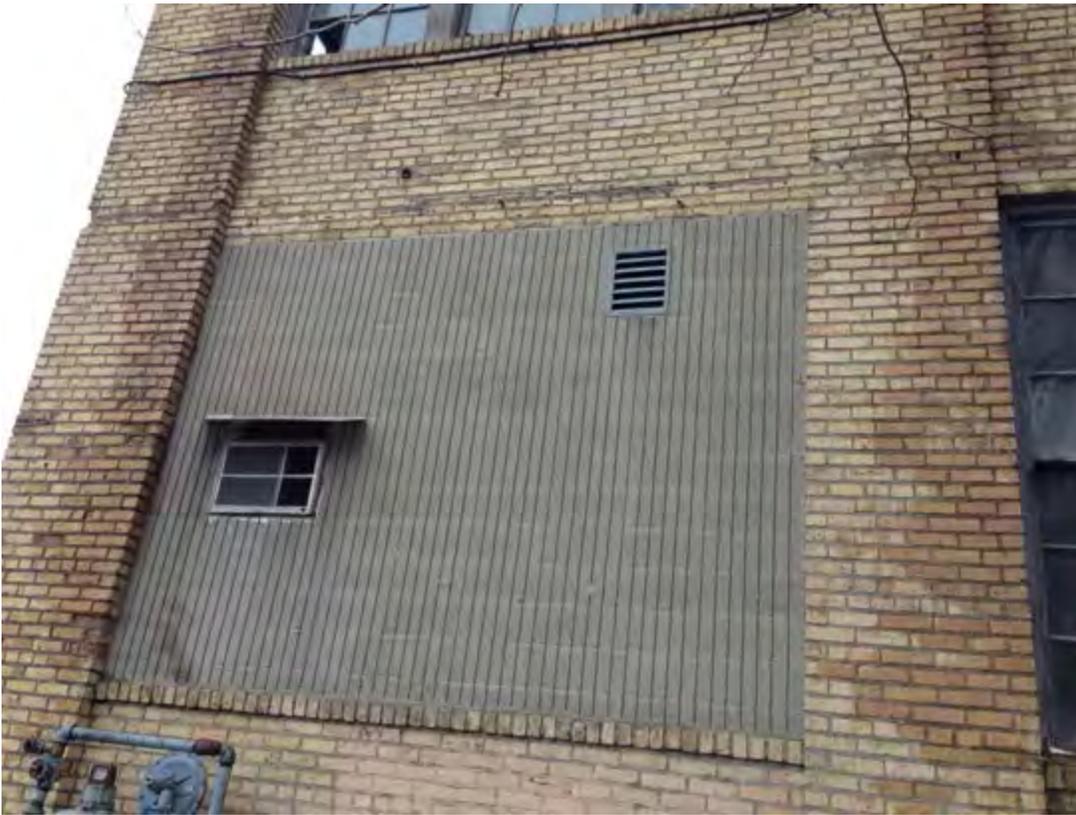
West elevation:  
concrete infill on first  
story, first bay from  
north to be removed  
and replaced with new  
windows.

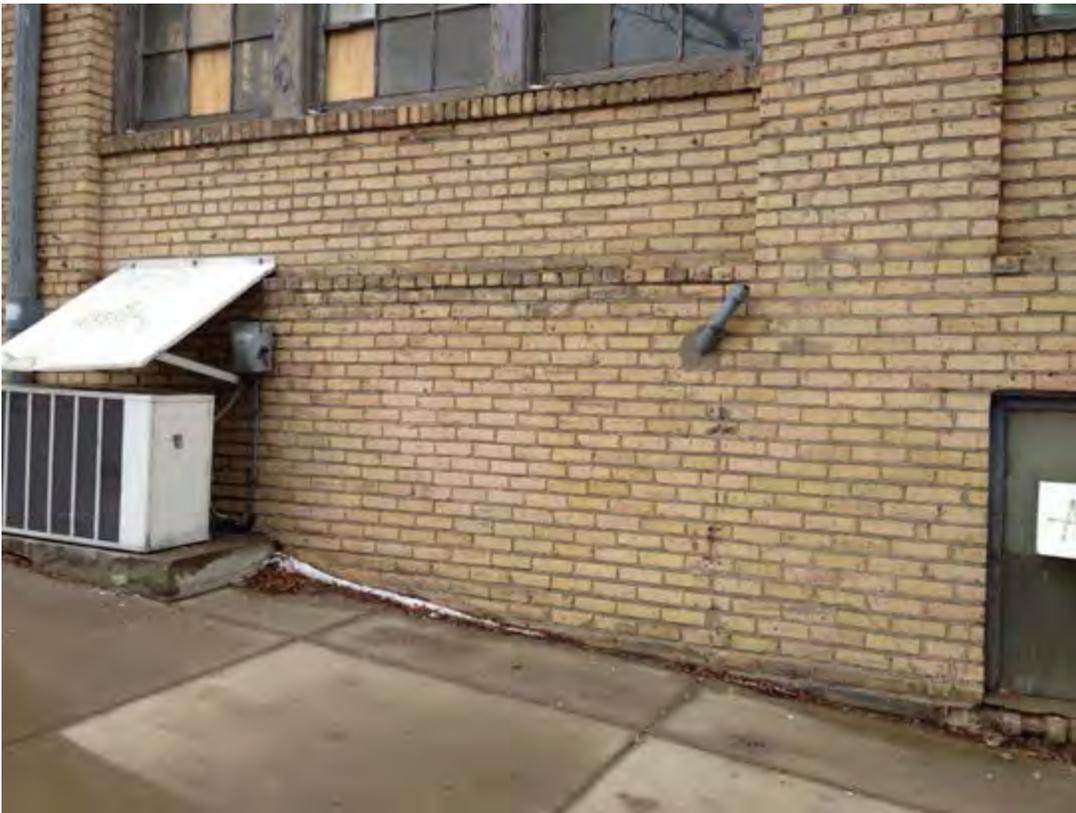
West elevation: create  
new window opening  
with new windows at  
basement story, first  
bay from north.

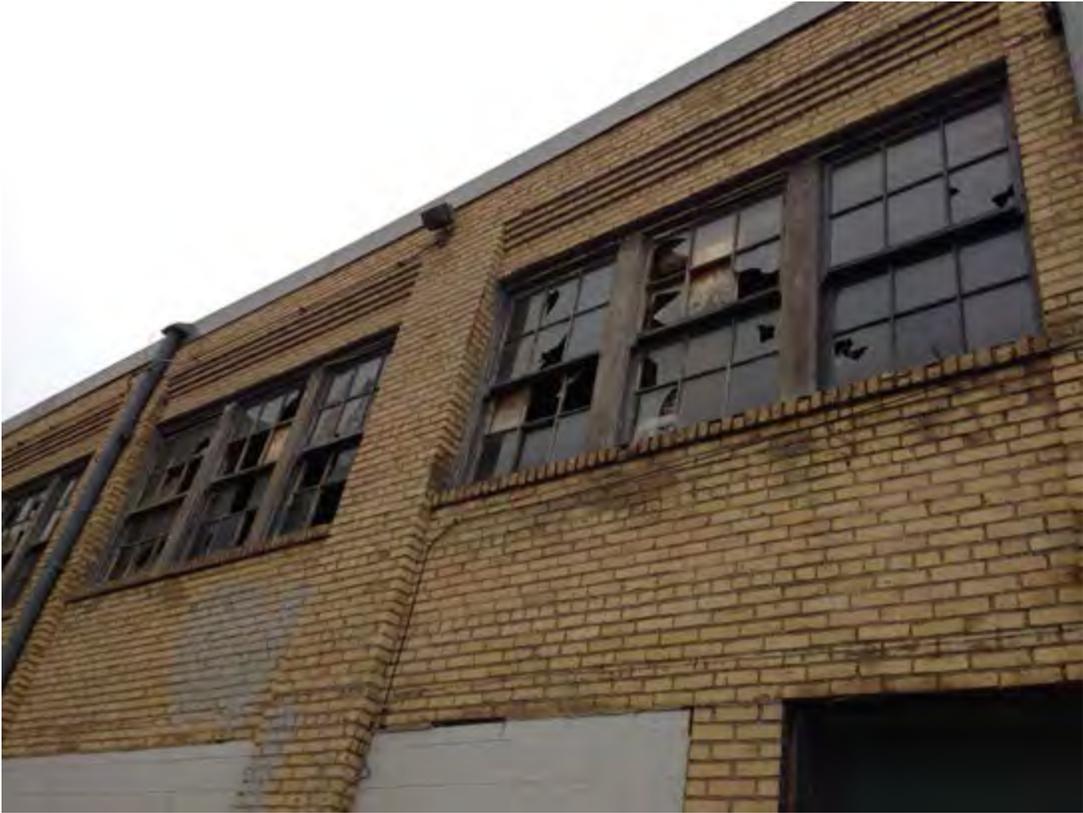
East elevation: second story windows to be refurbished.

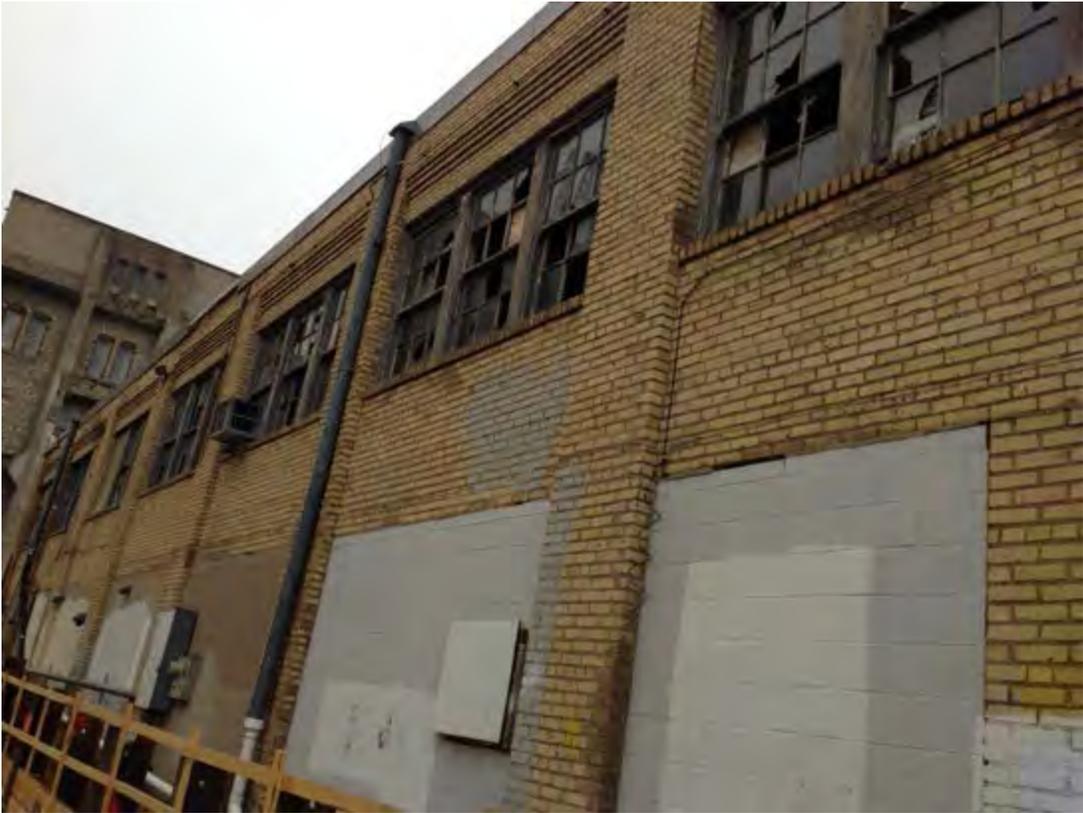
East elevation: concrete infills on first story to be removed and replaced with new windows.

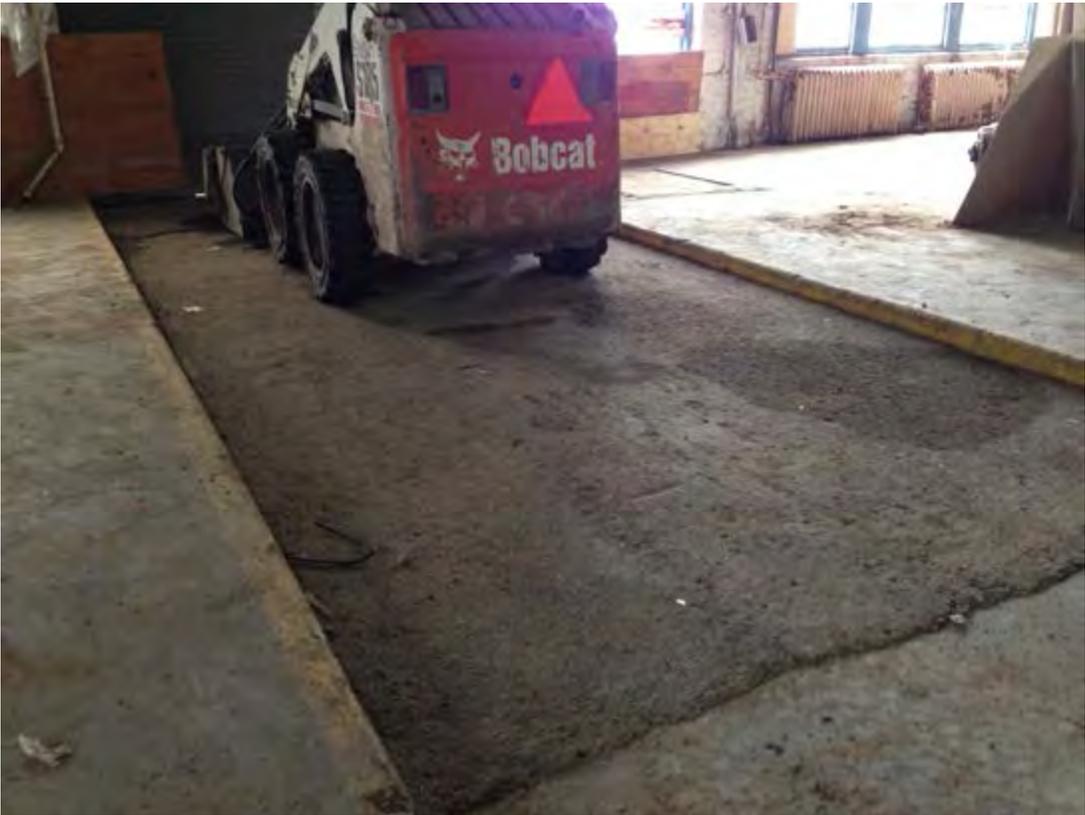
Ramp from west garage door to be filled.

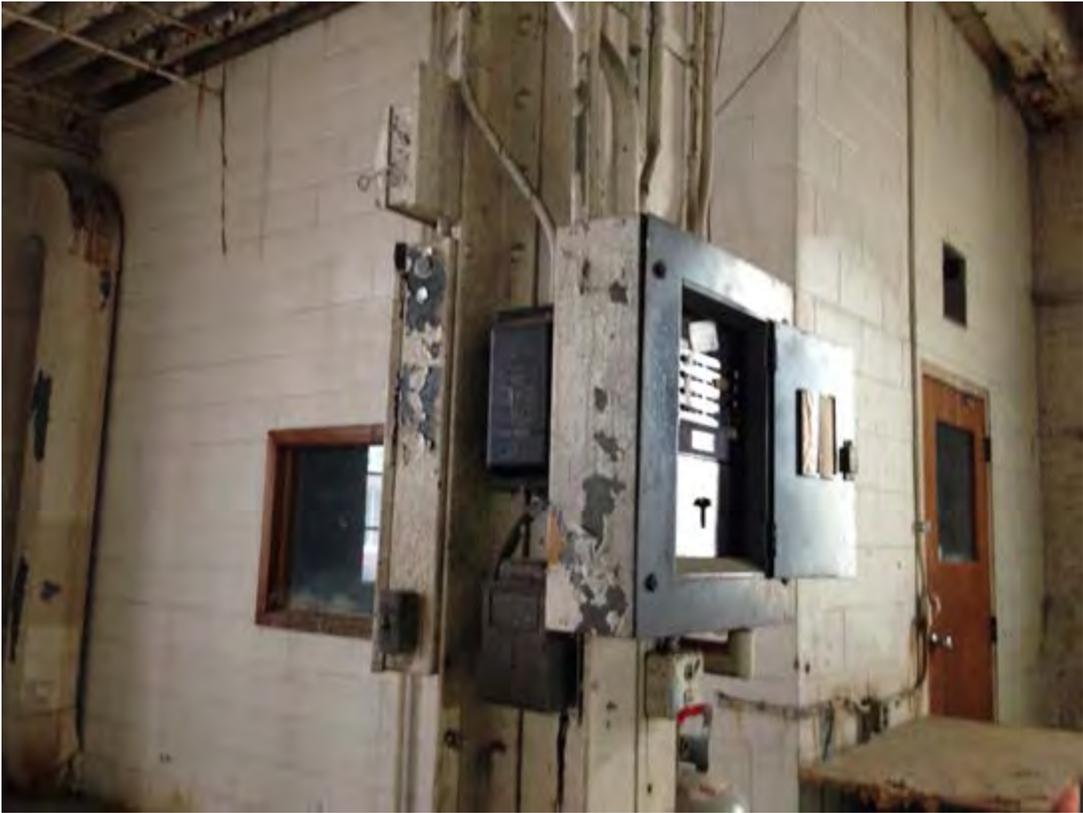
Electrical items to be de-energized and remain in place.

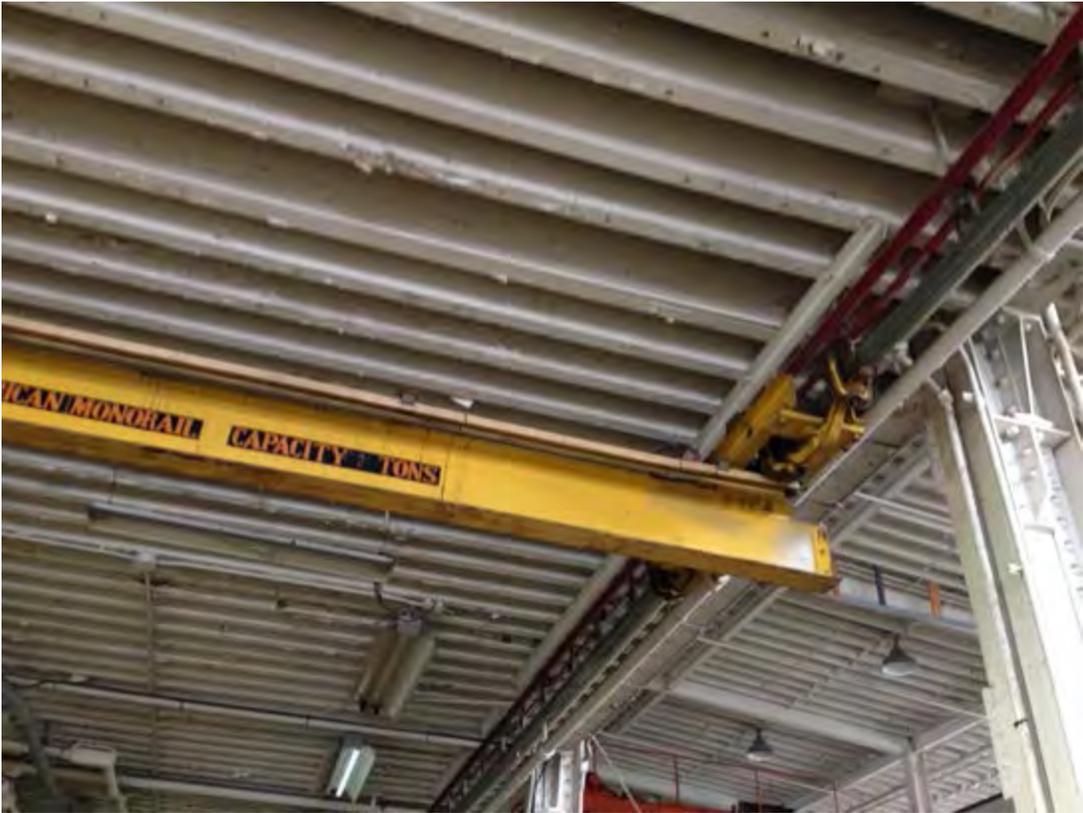
Overhead crane to remain.

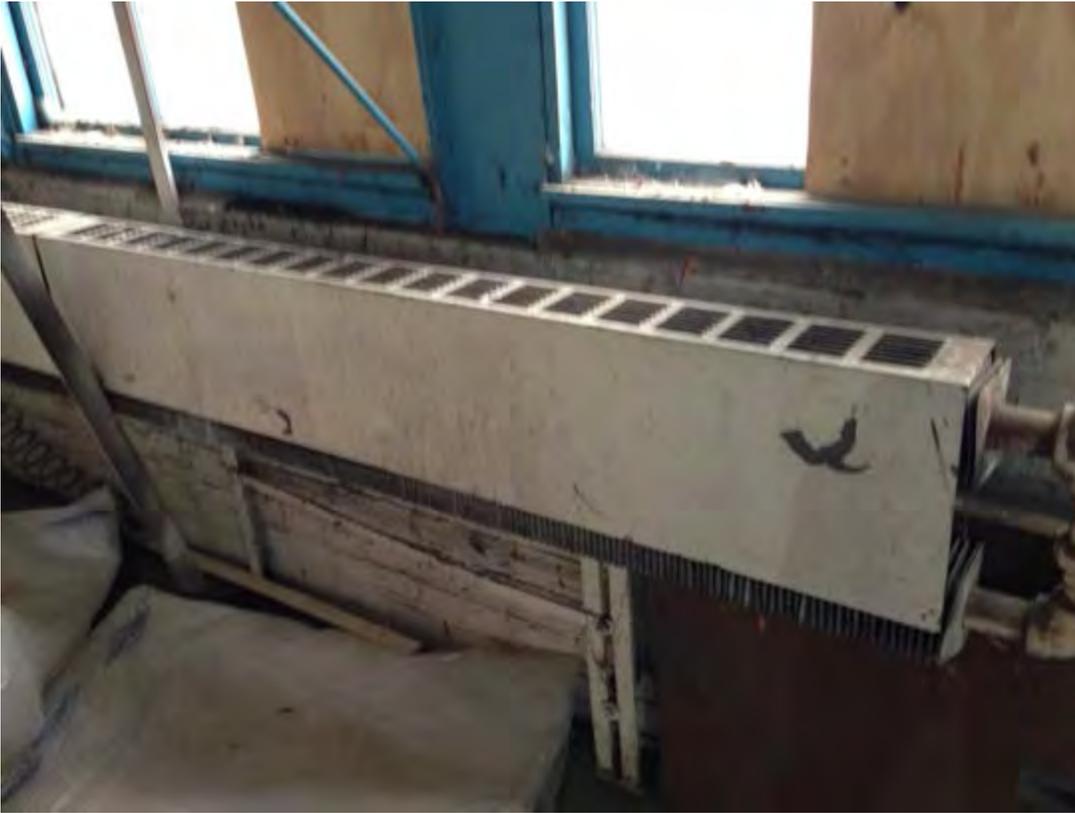
Existing fin tube radiators to be removed and replaced with new fin tubes.

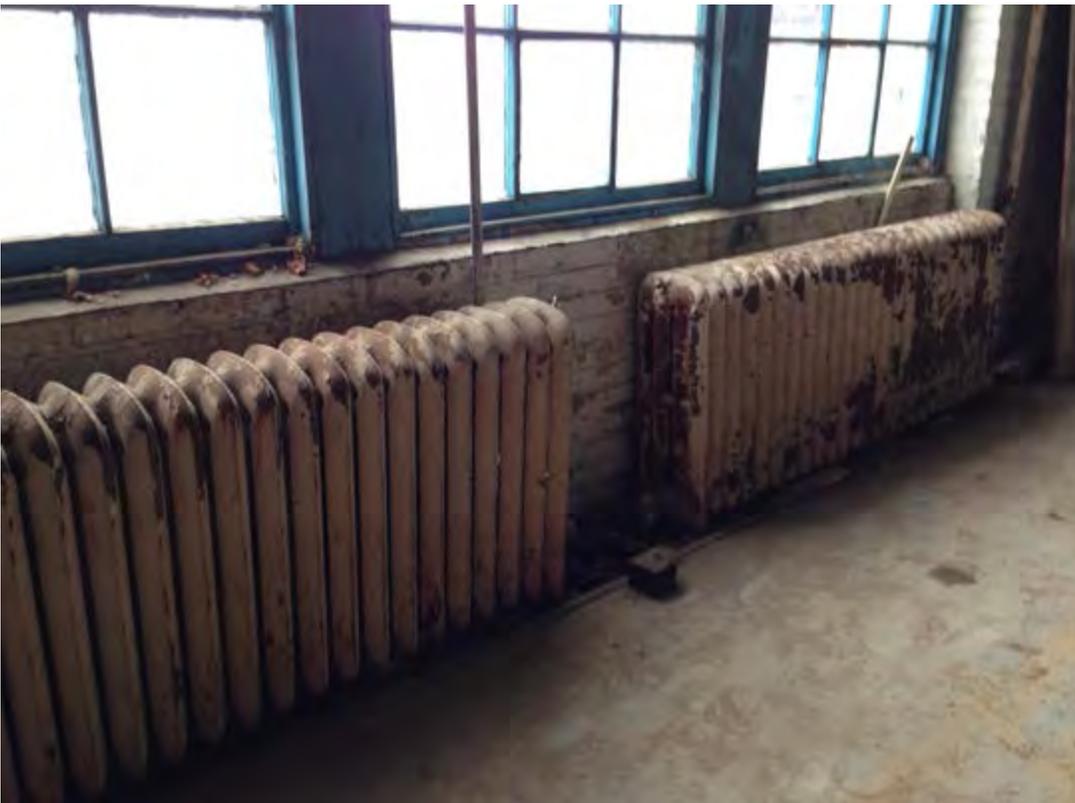
Existing radiators to be removed.

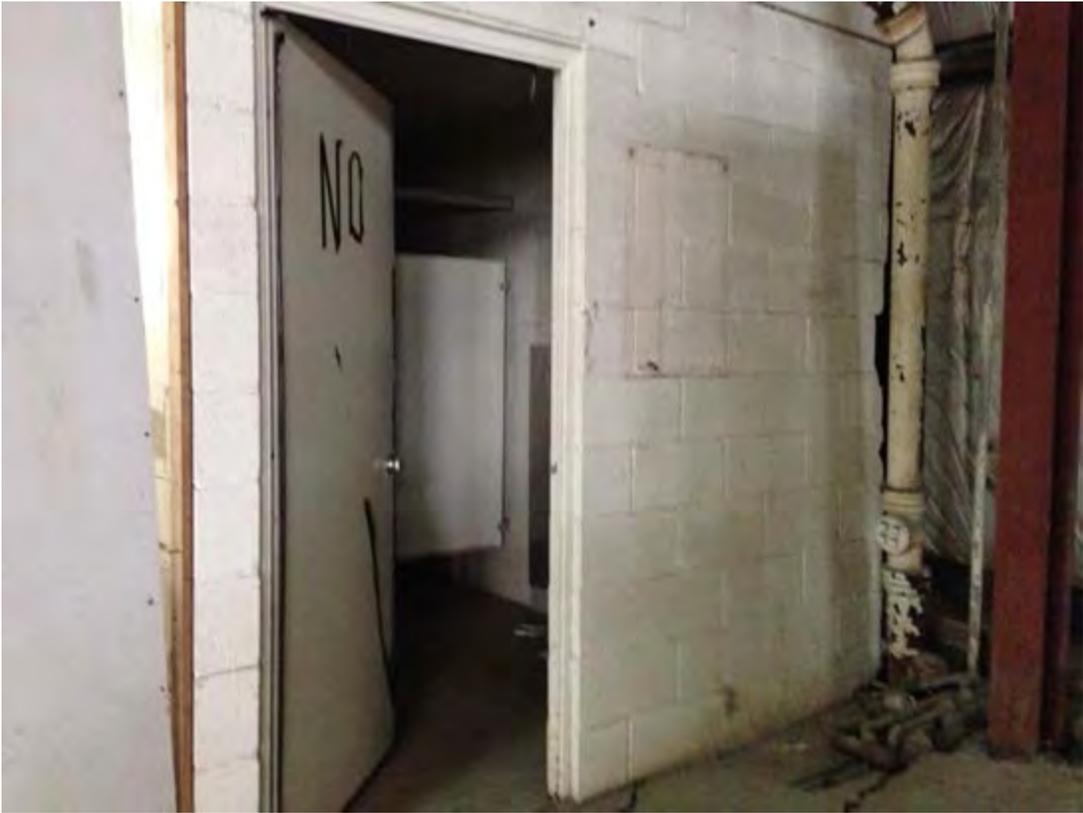
First floor bathroom to be demolished.

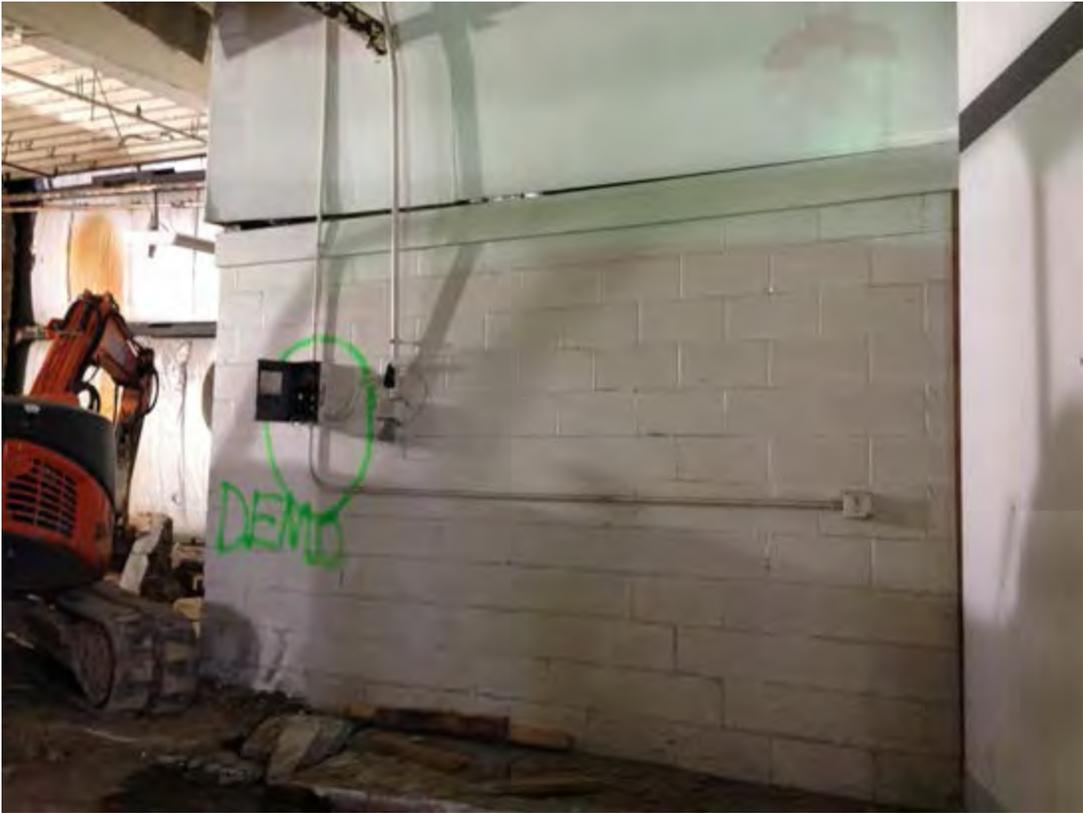
First floor bathroom to be demolished.

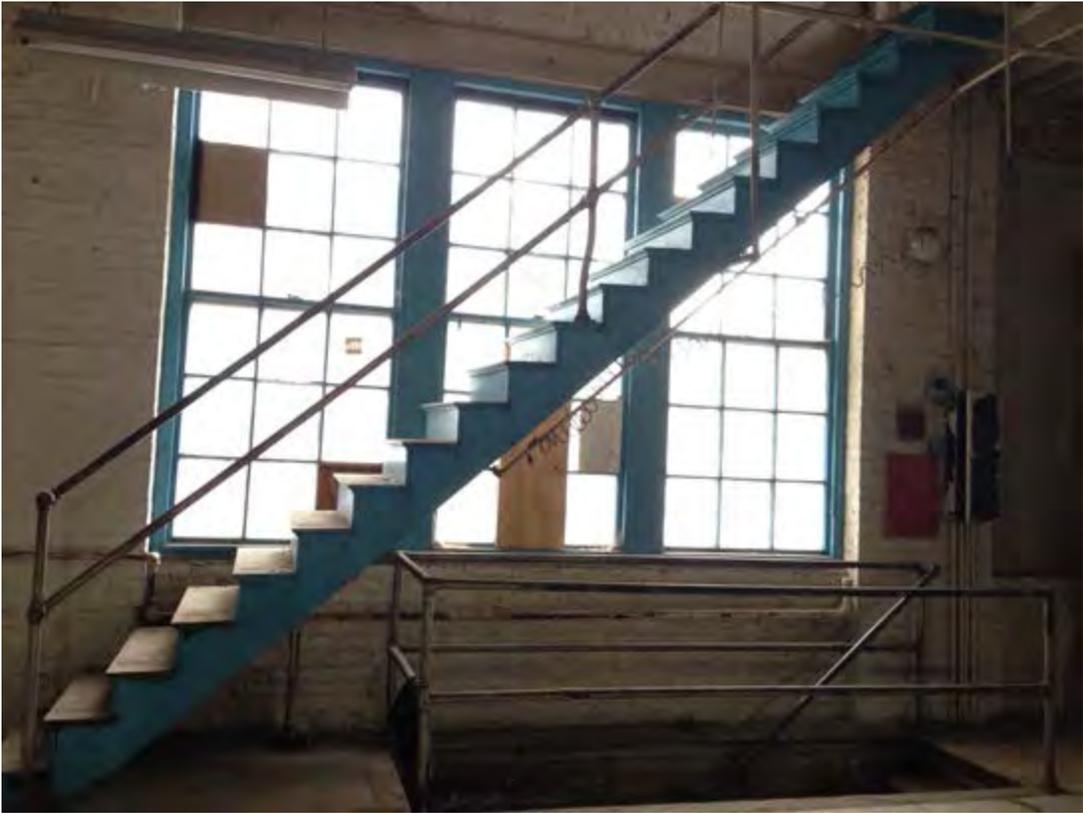
West staircase leading to second story to remain.

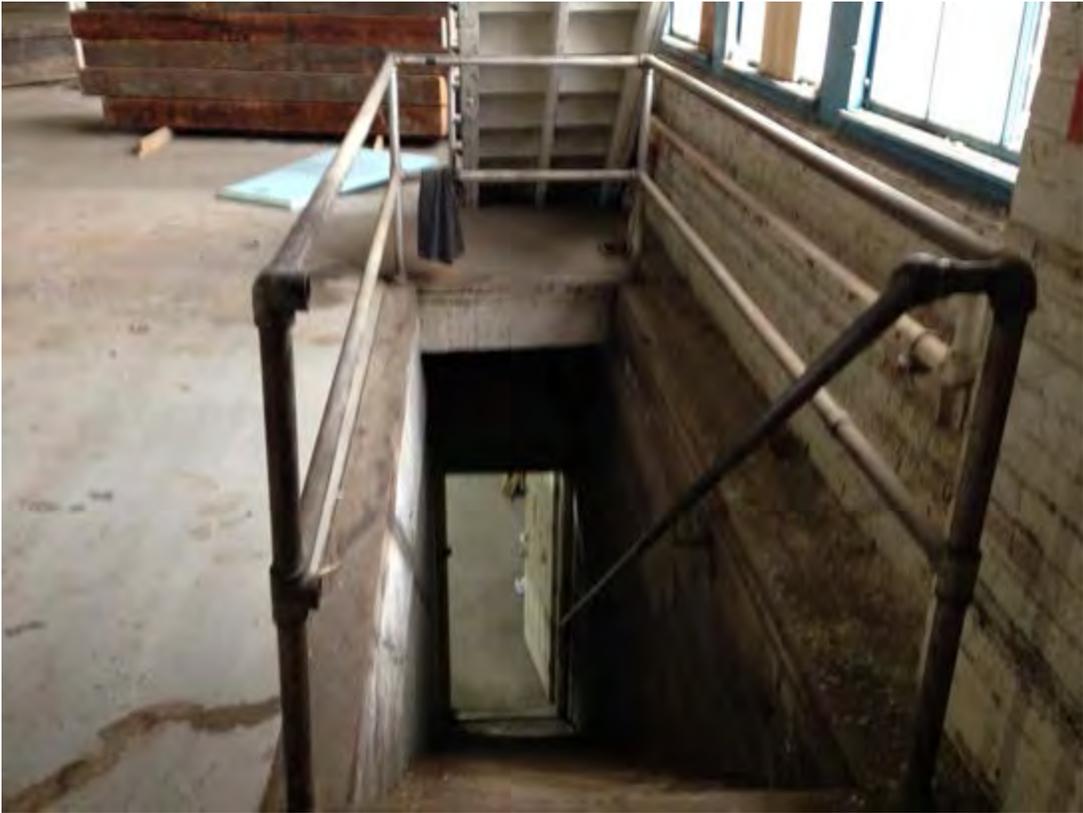
West staircase leading to basement to be removed and blocked off with concrete cap.

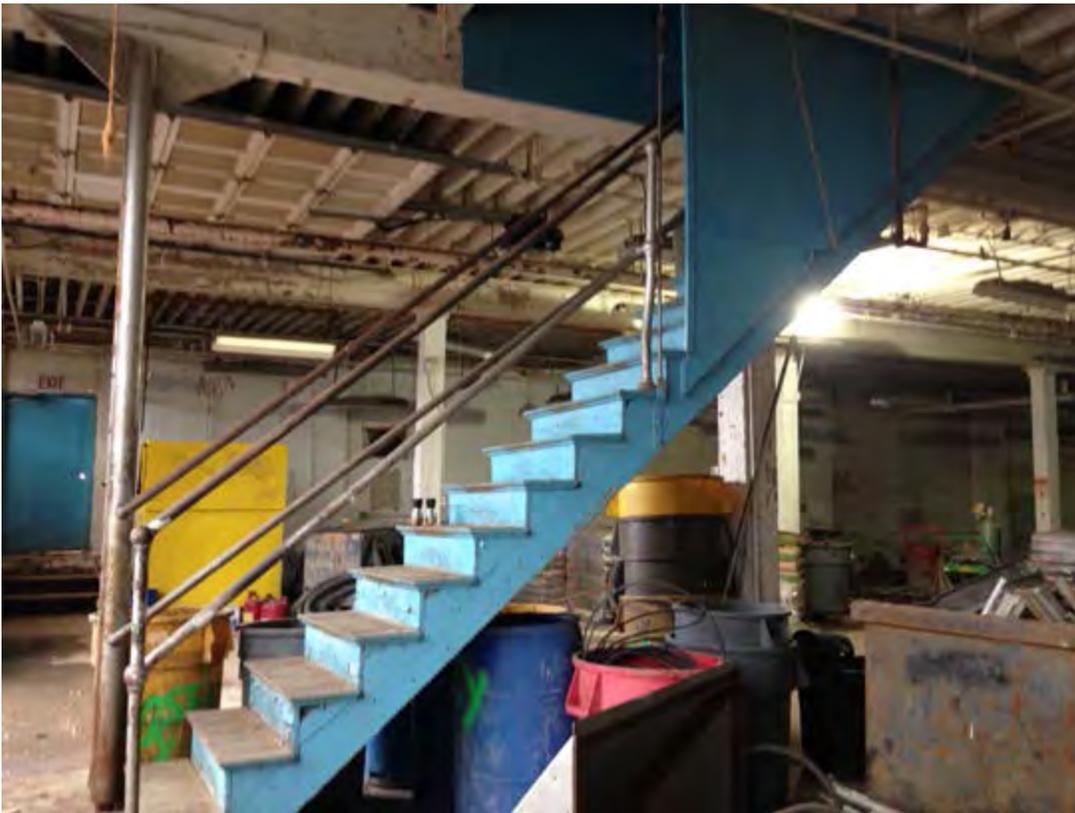
Central staircase leading to second story to remain but filled in at second story.

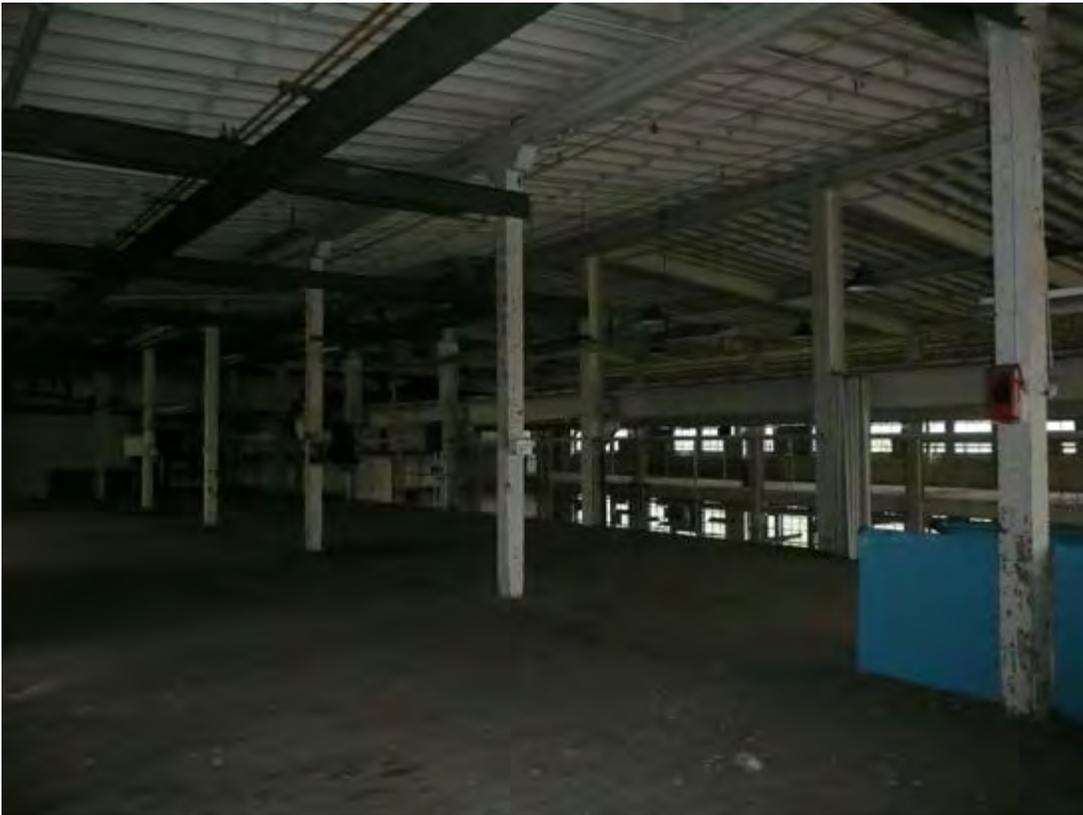
Opening and railings of central staircase on second story mezzanine will be filled and closed for use.
